### Preventive Intervention in a Group of Buildings Located in the Historic Centre of Manresa (Barcelona)

C. Diaz<sup>a</sup>, C. Cornado<sup>a</sup>, A. Griera<sup>b</sup>, O. Caselles<sup>c</sup>, V. Alegre<sup>d</sup> & P. Santamaria<sup>a</sup>

# PREVENTIVE INTERVENTION IN A GROUP OF BUILDINGS LOCATED IN THE HISTORIC CENTRE OF MANRESA (BARCELONA)

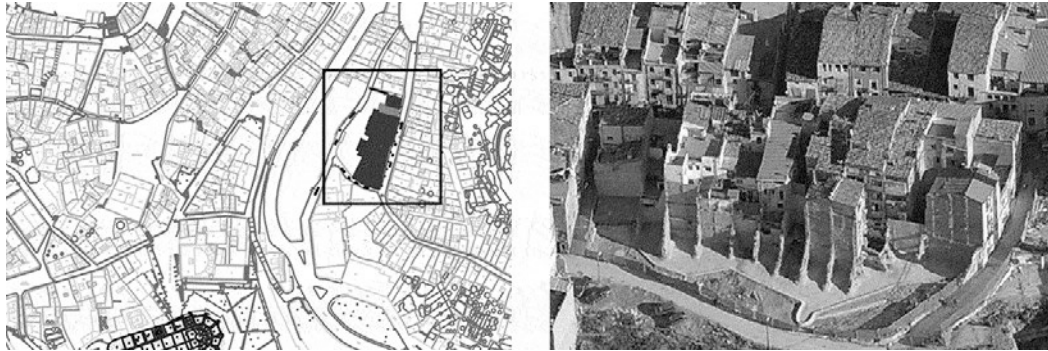
The demolition of half of the urban block had the effect of exposing the rear dividing walls of the remaining buildings and eliminating the contact which had previously existed with the demolished buildings. Due to it, this demolition worsened the initial stability of the buildings (figure 2).

Figure 2: Facades of the buildings and rear view after demolitions had taken place.

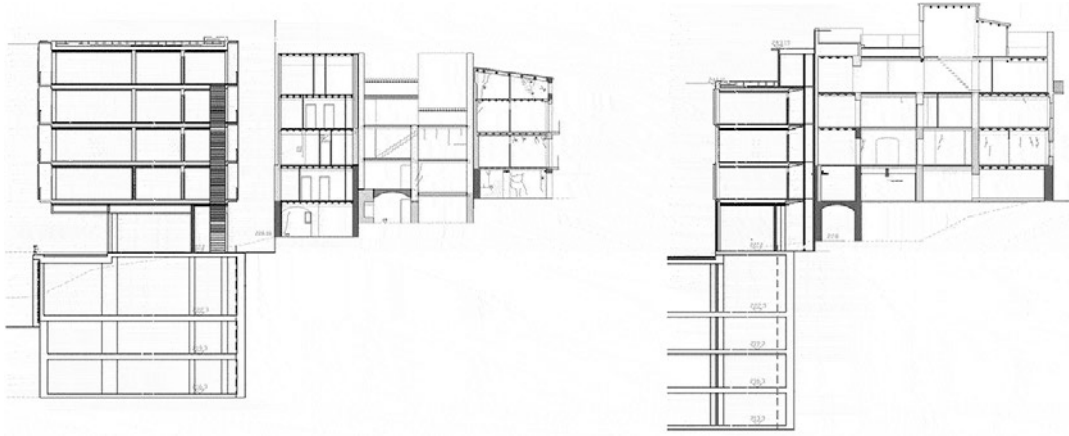
The new residential building was originally planned with three underground storeys for car parking (figures 3, 4) in close proximity to the foundations of the existing buildings. The excavation had to be carried out in a soil formed by an alternation of hard marl and soft conglomerate of the Paleocene (Institut Geològic de Catalunya 2011). Due to the characteristics of the foundation soil, the excavation might create a risky situation due to vibrations. There exists some significant previous research about excavation close to historic buildings (Hanson, Towers, and Meister 2006, Chuaqui, Ford and Janes 2007, Balachandran 1998). However, the present combination of hard-soft soil and brittle buildings caused a specific problem not previously investigated or dealt with in previous research.

Figure 4: First floor plan of the existing buildings and proposed new building.

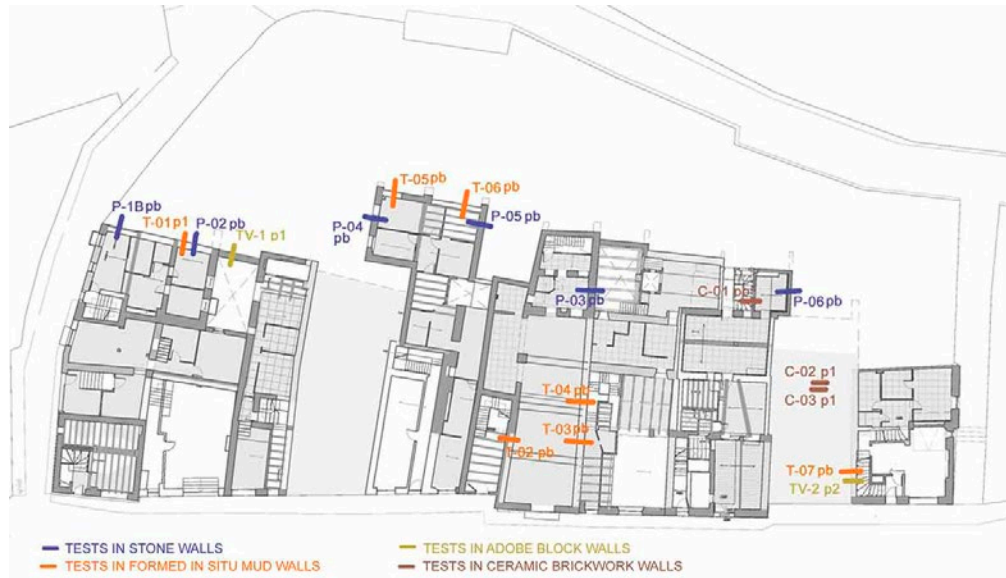
The locations to carry the tests were chosen by prioritizing the most heterogeneous and loaded zones (figure 9). The total number of valid tests was 15, of which 2 were carried out in 2 adobe block walls, 7 in rammed earth walls and 6 in random rubble masonry walls. The location and number of tests was greatly constrained by the ability to access to the dwellings and the difficulties in manipulating the tools necessary to carry out the drilling (Binda, 2003, Clarke, 1994). Tests were not carried out in brick masonry walls because of their relative scarcity and their non-critical placement.

Figure 9: Location of the various wall tests.

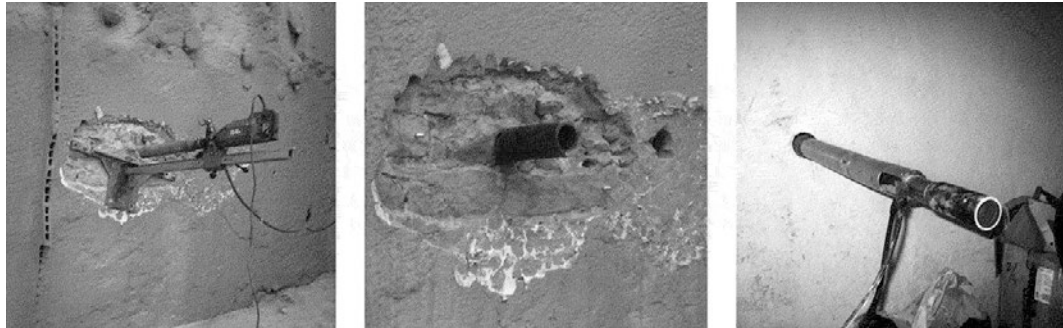
The testing method used (known as PiD) consists of the perforation of the wall with drills of a diameter of between 70 and 80 mm and the subsequent fitting of a probe of expandable material with the same diameter as the hole (figure 10). Knowing the surface of the probe in contact with the wall and the pressure-stress values generated in the contact between the probe and the wall under successive levels of loading, allows the stress-strain values of the wall to be graphed and the ultimate strength to be estimated. This method is explained in greater detail in Díaz et al. (2008). The PiD has a precedent in the method described in the

Figure 10: The process of setting up the probe in a Wall of ordinary masonry: Making the hole (left), inserting the probe (centre) and adding pressure (right).

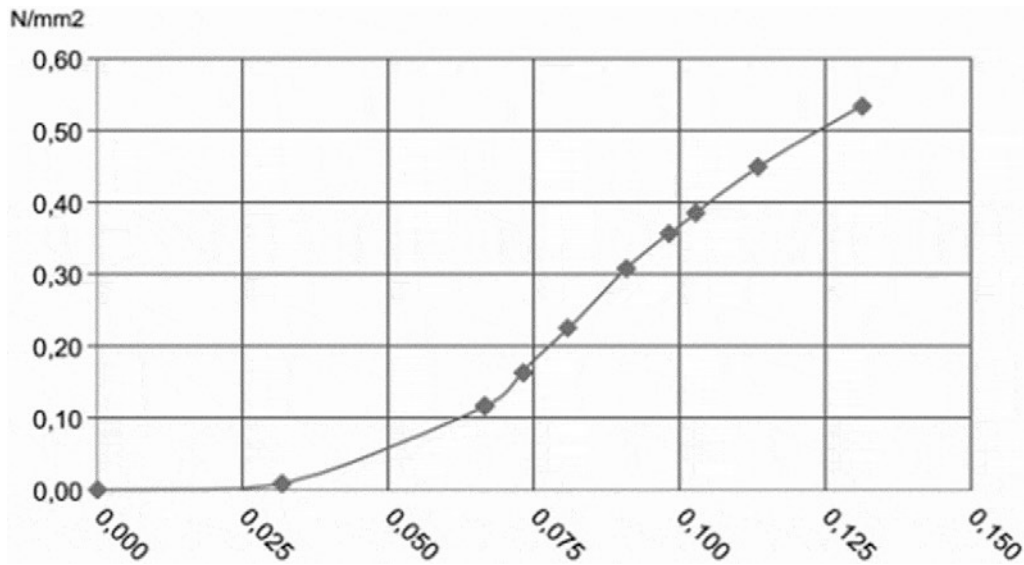
It is worth noting that the compressive strengths obtained (table 1 and figures 11, 12 and 13) are in the range of the standard values of walls with similar characteristics. Also, the results for the random rubble masonry walls (with the random nature of the mortar joints) reflect both the lack of gaps in the stonework and the quality of the lime mortar (figure 13). If there had been any major deterioration in its cohesion, this would have damaged the probe and invalidated the test. On the other hand, the slightly higher ultimate strengths of the adobe block walls (figure 12) with respect to the rammed earth walls (figure 11) can be interpreted as being due to the contribution of the lime mortar joints to the overall strength. Moreover, the comparison of the stress-strain graphs of the different types of walls (figures 11, 12 and 13) indicates a greater stiffness of the stone walls compared to those of adobe blocks or rammed earth. These graphs include a first almost horizontal branch which corresponds to the free expansion of the device until it contacts the perforation surface.

Figure 11: Graphs of stress - strain carried out on rammed earth walls.

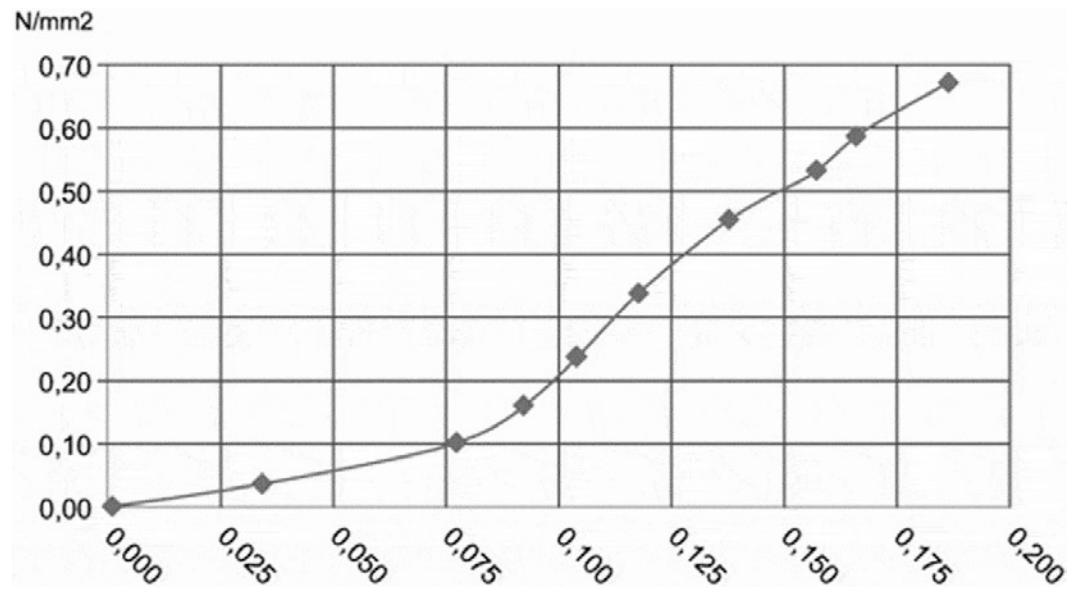
Figure 12: Graphs of stress - strain carried out on adobe block walls.

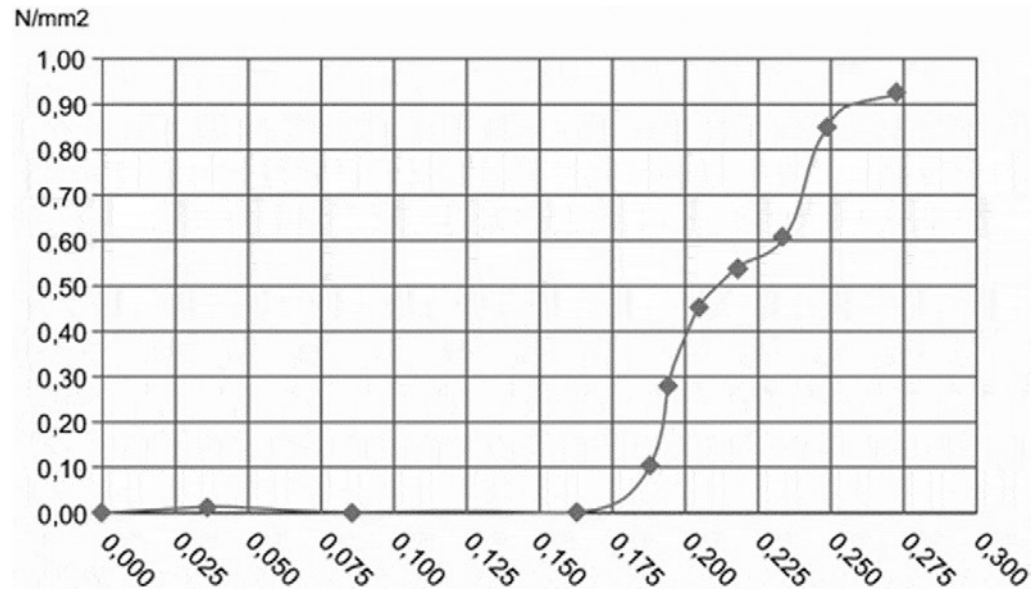
Figure 13: Graphs of stress - strain carried out on masonry walls.

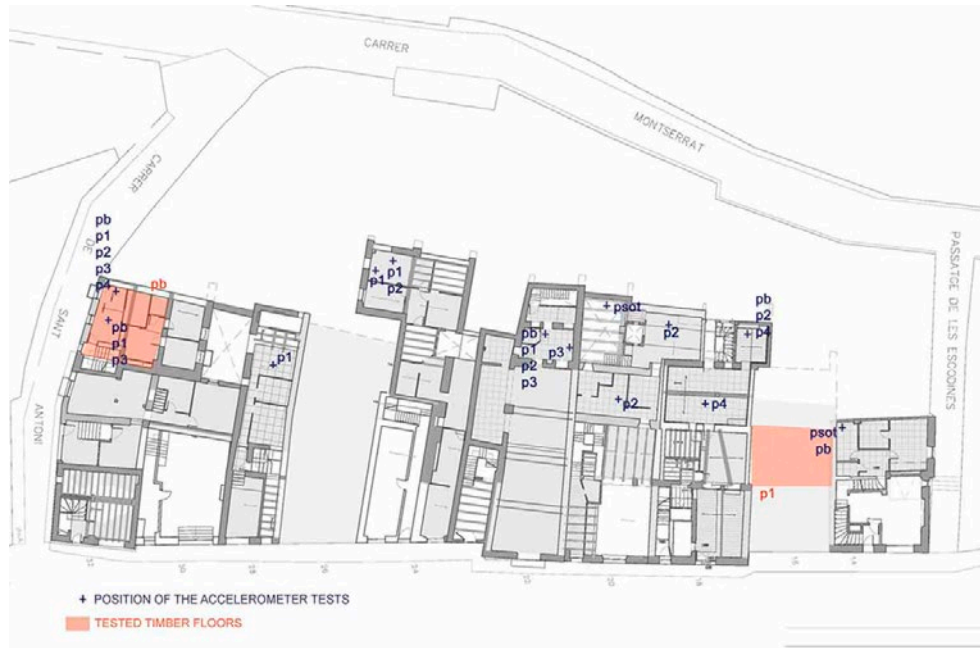
designated as LOT 1, LOT 2 and LOT 3 in figure 14 and table 2. Samples were taken and tests carried out on joists that showed signs of dampness and also in joists located in dry environment with no sign of dampness.

For this purpose, an excavator with a hydraulic percussion hammer with operating weight from 780 to 1500 kg was brought to the site. Measurements were taken in the foundations, floors and walls of the buildings close to the drilling zones with piezoresistive accelerometers fixed to selected points. Tests were also carried out on the floor slabs to identify their resonating frequencies (figure 14).

Figure 14: Positions of the accelerometer tests and the tests on timber floors.

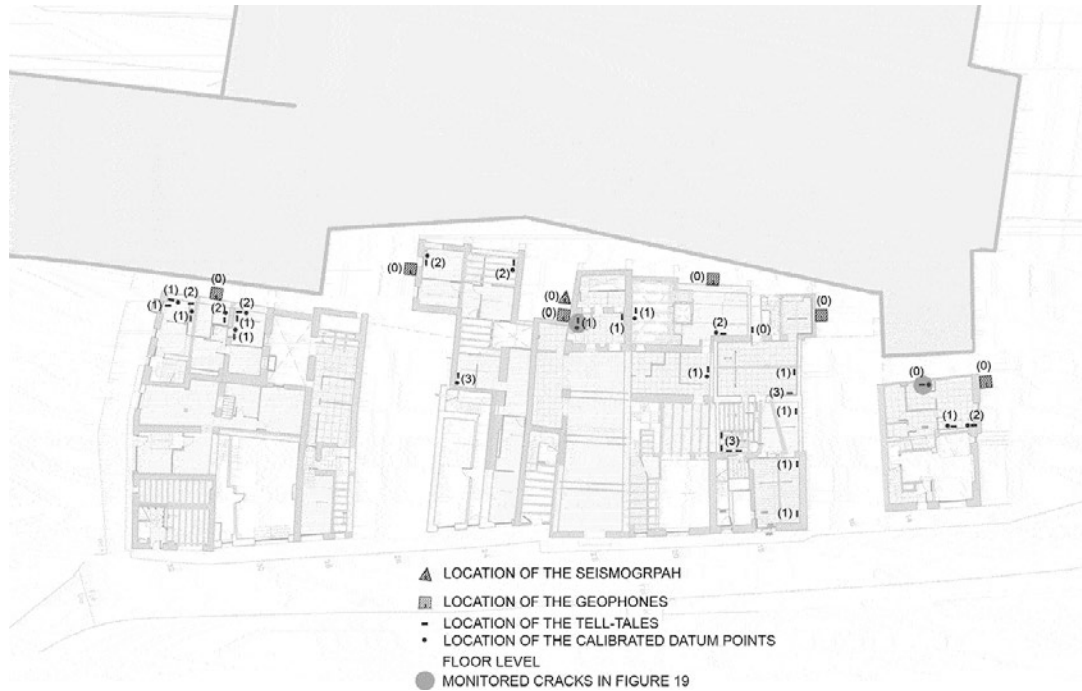
Figure 17: Site plan showing the seismograph, the geophones, the inclinometers, the tell-tales and the calibrated datum points.

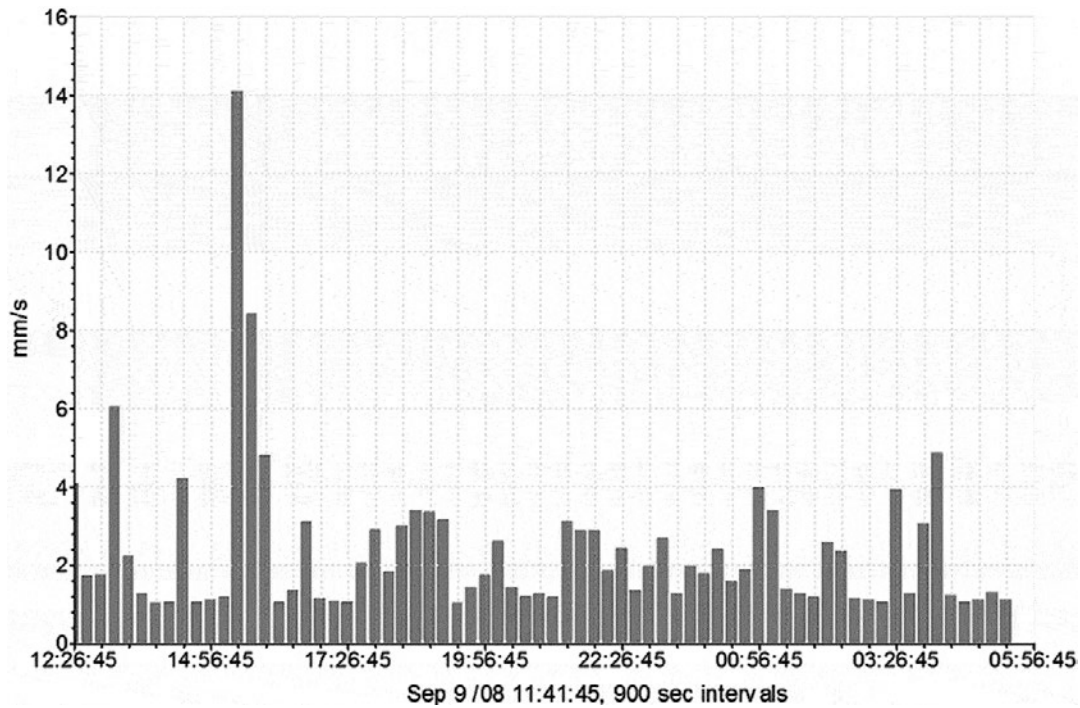
Figure 18: Example of one measurement of the daily variation of the vibration velocity and detection of maximum values.
