ADVANCED MASTERS IN STRUCTURAL ANALYSIS OF MONUMENTS AND HISTORICAL CONSTRUCTIONS

Master's Thesis

Investigation of a Faulty Historical Structure: Saint Barbara Church

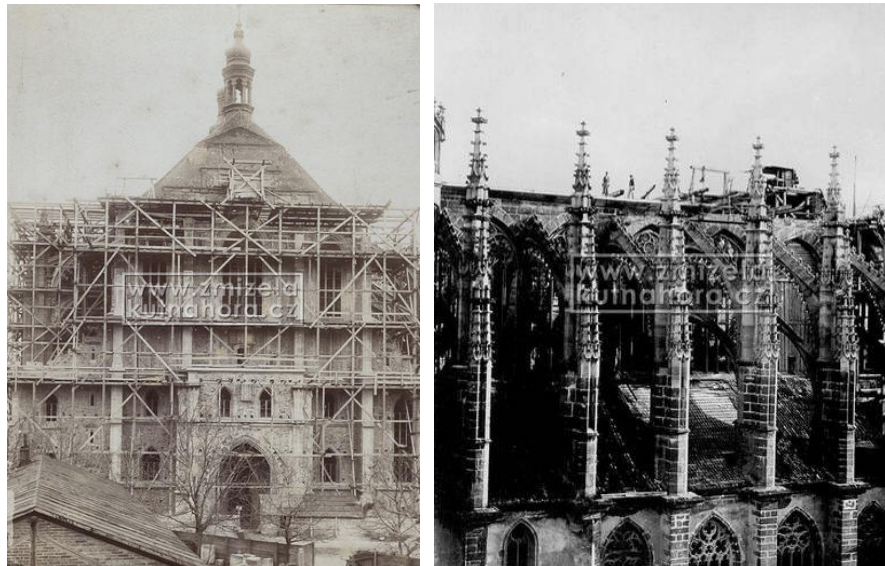
Figure 14 Change of the roof to its original shape [19]

The restoration performed on the late 19th century was characterized by the idea of presenting the buildings in their original purity. [27] It can be describe as a stylistic restoration, were restoration was conceptualized as an operation of stylistic re-integration through which the architect should try to attain the unity that the monument had in its primitive condition. [20] Under this concept, liberations and demolitions of later additions, such as the Baroque ones, were legitimate. [Figure 14]

Due to the lack of knowledge about materials compatibility, a vital error was made during this restoration. The majority of the original limestone block of the buttresses were changed and replaced by copies made of sandstone. As well the tracery of the windows of the nave and some stones of external sculptures were replaced with the same material. The mixture of sandstone and limestone is an inadequate combination because of the different nature of the mineralogical composition and porosity of the rocks. Limestone is basically composed by calcium carbonate, that itself has not a disintegrating effect once it has crystallized. However, under the influence of meteorological conditions the calcium carbonate can be transformed to calcium hydroxide (gypsum) and can be mobilized. In this case, the water is the transport medium and solvent for the gypsum. Due to the high porosity of the sandstone, the gypsum as a solution can penetrate in it. In the process of crystallization of gypsum, big forces are generated and consequently the sandstone is damaged. Also crusts were formatted on the sandstone surfaces.

Other mistake of this restoration was that lead was placed into the joints between stones. Lead and sandstone have different thermal expansion coefficients as a result of thermal cycles; the expansion and shrinkage of the material generate cracks on the interface between lead and sandstone. In the current restoration those crack were fill with mortar, to avoid their propagation and opening, which will lead to more complicated repairs. Moreover, lead was also used in the joint of the buttresses but it did not introduce any positive effect since it has no capacity to take shear.

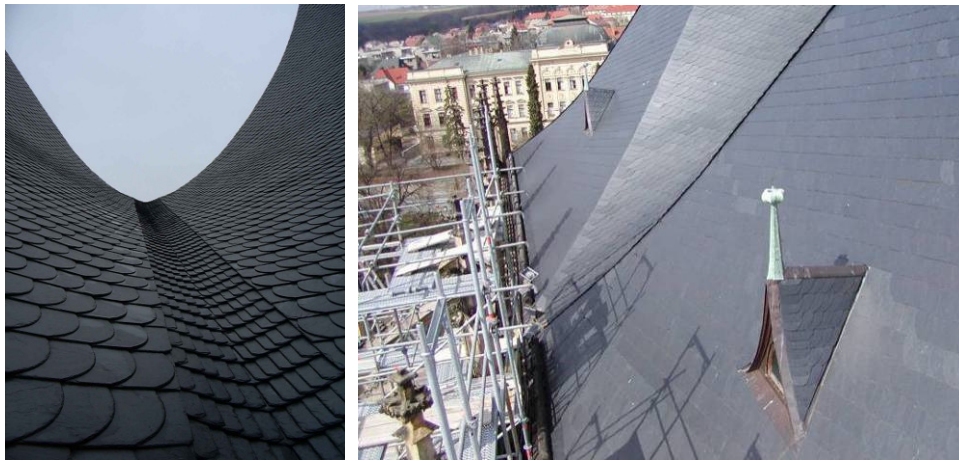
Figure 15 Restoration of the roof [22]

In 1996 the first steps of the investigations were carried out, including research on the building history and a preliminary structural analysis for a draft design for the repair. Before starting with the restoration works, photogrammetric documentation of all the different parts and details was done. In 2000 according to the results of the first researching stage, the roof was restored since its damaged condition allowed rain water to penetrate in the stone and this was deteriorating the vaults and some sculptures that have an important artistic value. The roof was covered with slate and restored too; flashings were done from cooper sheets.

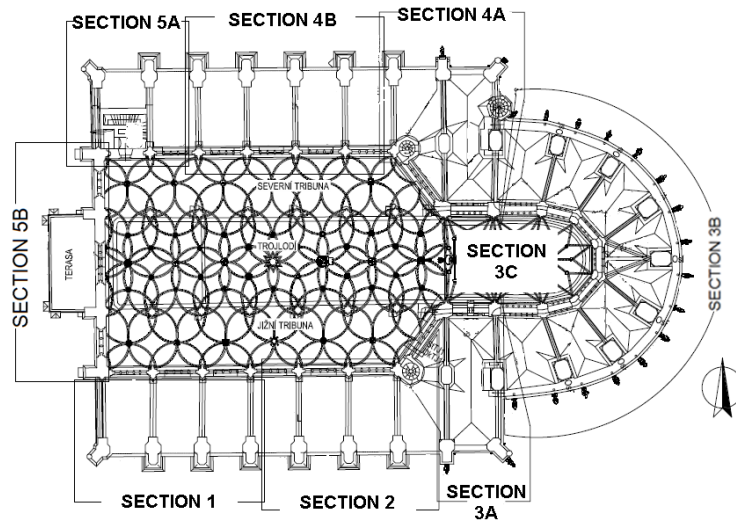
Figure 16 Restoration sections [15]

During 2002 scaffoldings to perform supplementary analysis of the first section of the façade were placed. This section is called "Section 1" in Figure 16. Under the preservation aims, a temporary securing system was implemented on the buttress of this section including wedging of the opened joints and supporting of the sagged flying buttresses (Figure 17). By this stage further analysis were prepared, such as a petrologic survey and a detailed study about the construction process, construction techniques and previous restorations of stones and windows. Also, models of the faulting buttresses were carried out to clarify the causes of damaged. Base on those studies the restoration project of the buttresses was defined and during 2003 it was developed.

While the restoration of Section 1 was implemented, scaffoldings were placed on Section 2 to permit the study of this section. The design of this intervention also included the same method of strengthening of the buttresses used in Section 1. This section was restored in 2004.

Through the first half of 2004 scaffolding were placed in section 3A to restore the transept and during the second half of 2004 scaffolding were placed in section 3B to repair the façade of the choir and the glazed windows. [Figure 20] In this section the buttresses were not extremely damaged, however since the decay of the buttresses has a cyclic pattern it was considered worth to perform a preventive restoration of them and also make the strengthening of the buttresses using the same procedure that in Section 1.

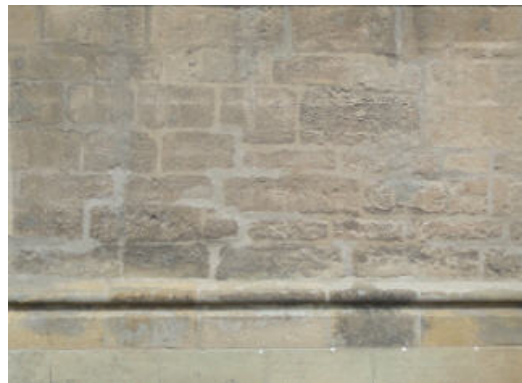
Figure 21 Repointing on the exterior walls

The external walls are made of stones of diverse sizes. It can be notice that the naves were built with smaller stones than the sacristy. Additionally, no settlements of the walls are seen. The current state of the walls is good, showing repointing form the last restorations.[Figure 21]

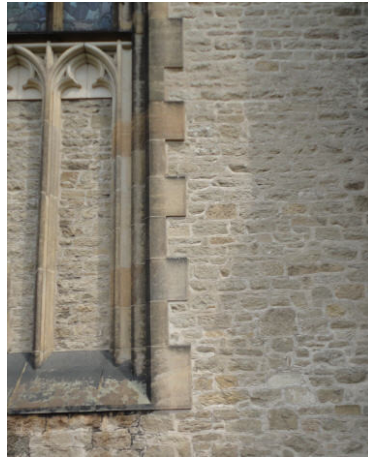
The façade was made of stone of diverse sizes since it was erected very fast. In particular, shaped stones were used for the window jambs, spandrel, cornices and border of piles; while the rest of the masonry of the façade was done of quarry stone. The masonry made of shaped stones has thinner joints than the masonry made of quarry stone. Moreover, it has a lower quantity of joints per unit of high. As a result, the load tends to concentrate in the window jambs. It this areas the presence of small settlements can be noticed, on the contrary the spandrel of the windows do not show existence of settlements. These differences in settlements cause cracks in the spandrel of the windows and lead the load to move to the tracery. Consequently, cracks are also developed in the tracery. In Figure 22 the random size of the stones and a border from one of the windows can be seen.

Figure 22 Window of the façade

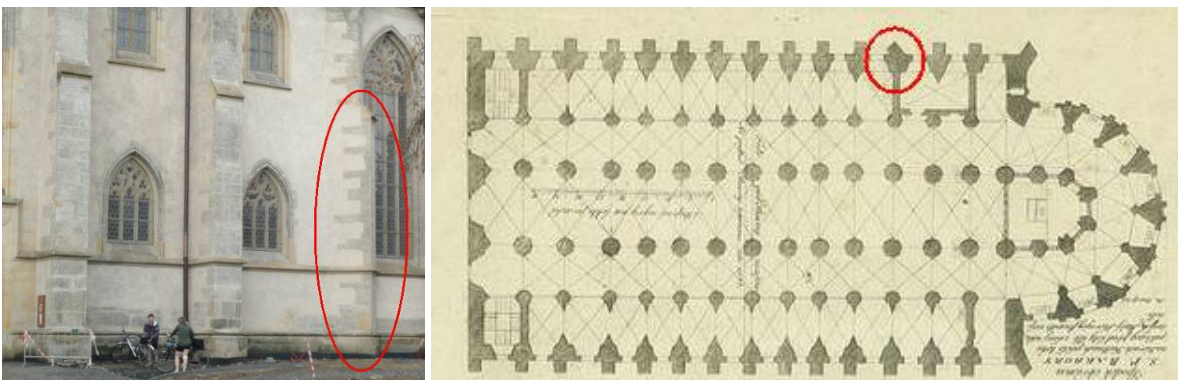
From the outside of the building it can be notice that one lateral column on the North side has a different section [Figure 24]. This column is a clear evidence of the change in the design of the building from a triple nave type into a five nave building.

Figure 24 Different shape in column a) elevation b) plant [19]

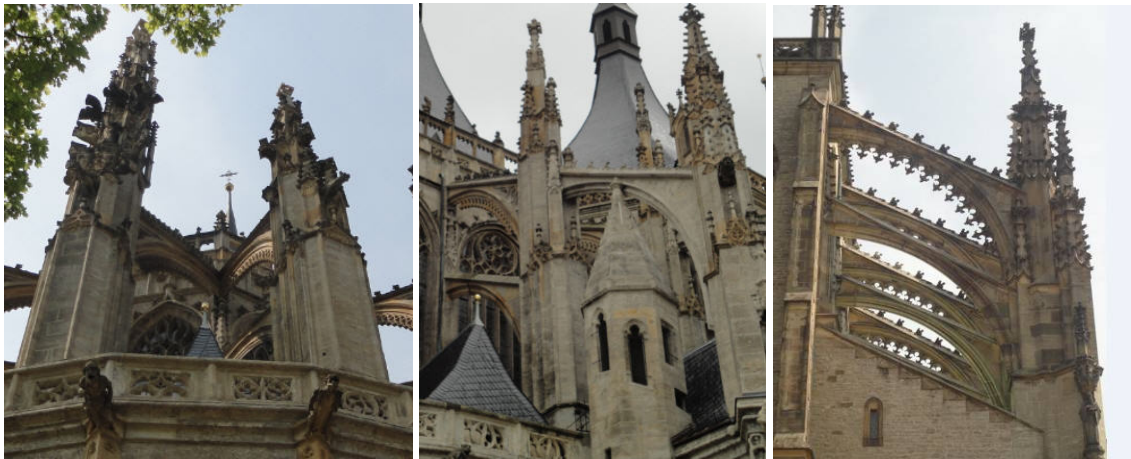
From the outside three different types of buttress can be distinguish in correspondence with the presbytery, the transept and the nave as can be seen in Figure 25. In all the cases where two level of flying arches are present, it can be seen that the lower arches have a smaller section than the upper ones.

Unfortunately, by the time of the visit the scaffoldings were already removed and it was not possible to see the buttress from a near point of view. However they seem to be in a good condition. In the buttresses that have been restored small dark spots can be seen. They are located in the places were the holes were made and then filled with lime mortar. [Figure 26]

Figure 25 Type of Buttresses

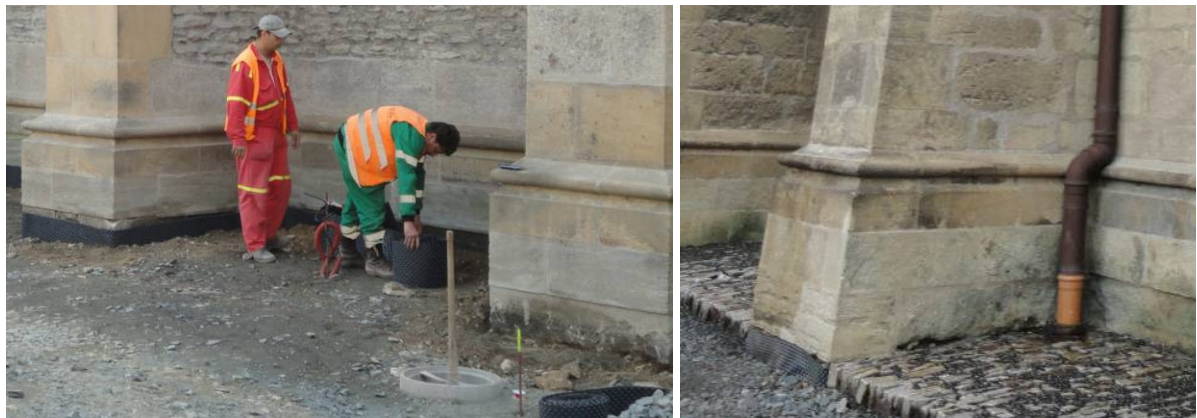
The presence of moisture seems to be due to rain water that was not well evacuated and remains near the base of the wall. This water can draw up by capillarity action into the masonry generating the humidity spots. To eliminate the rising damp it is necessary to control the localize water sources. Figure 30 shows the current works from the outside wall. A geotextile is being place between the soil and the masonry and then the space between pillars is being covered by a porous fill. The pipes and gutters have already been renovated.

Figure 30 Geotextile and porous fill

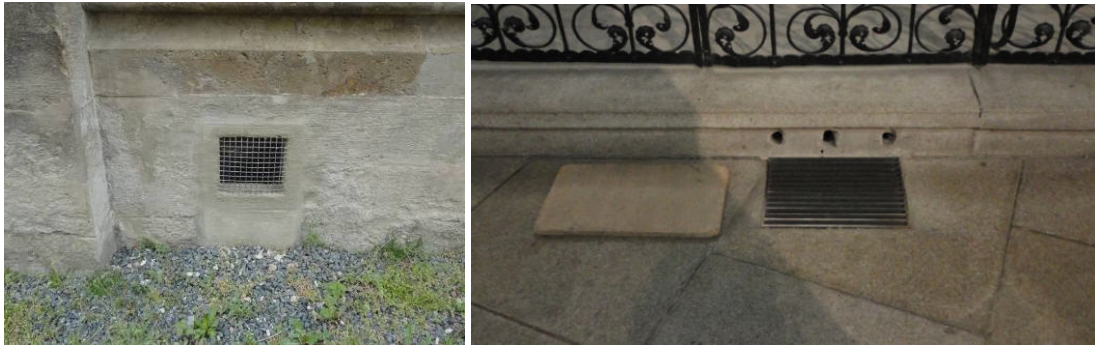
On the other hand, it is remarkable that the church has natural ventilation helping to prevent humidity problems in the interior. The air can pass from the exterior to the interior through vents that joint the exterior walls of the church (in correspondance with the chapels) to the floor of the ambulatory. The air can also move from the interior to the exterior along holes that are located in the vaults. The vents under the floor in the chapels were done in the year 1937. During the current restoration works the vents were cleaned and the wholes in the vaults were reopened. The main problem of this system is that people tend to close the ends of the vents because the fresh air makes them feel uncomfortable.

Figure 31 Grilles at the end of the vents a) from outside b) from inside

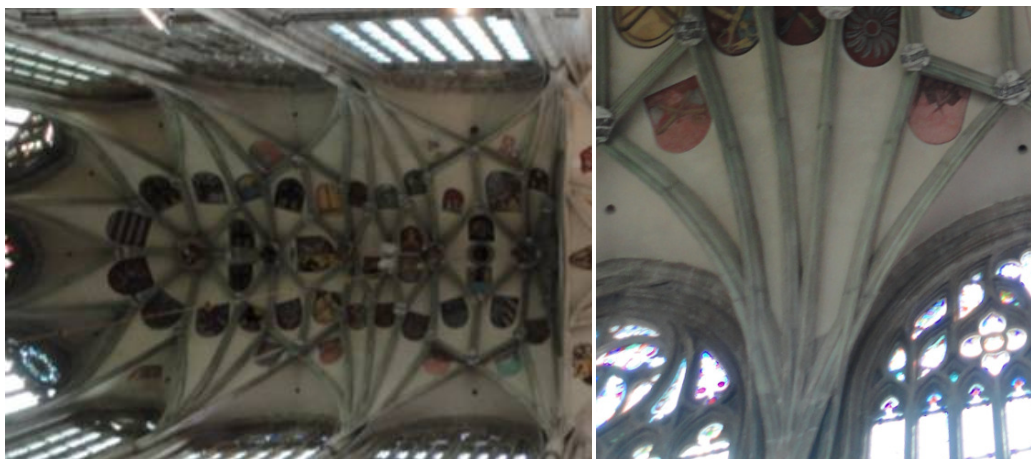
The jumping vaults of the presbytery are built from ribs that emerge from the pillar between windows to the lower arches and the thickness of the vault end in pointed arches in the windows. These vaults are covered from the inside with plasters. There are 39 shields on the surface dated from 1501. The vaults of Rejsek were restored during 2007 and at the present do not show damage. [Figure 34]

Figure 34 a) Presbytery vault b) ribs emerging from the pillars

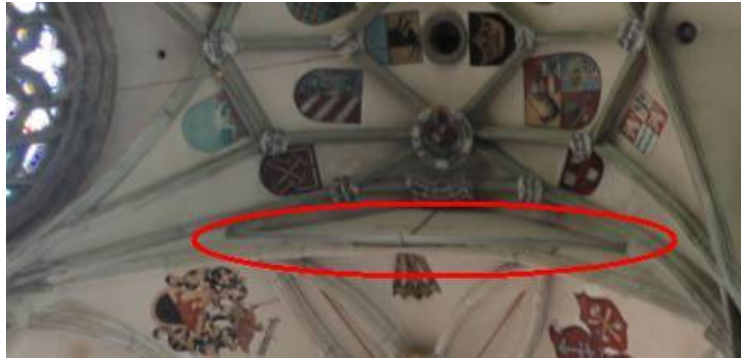
The vault of the presbytery is higher than the vaults of the principal nave; as a result there are not equilibrated horizontal forces in the joint between them. The necessity of an element sufficiently long and rigid in this joint was satisfied, during the restoration of the end of the 19th century, by a railway rail which still forms part of the building. [Figure 35]

Figure 35 Railway rail located between the vaults

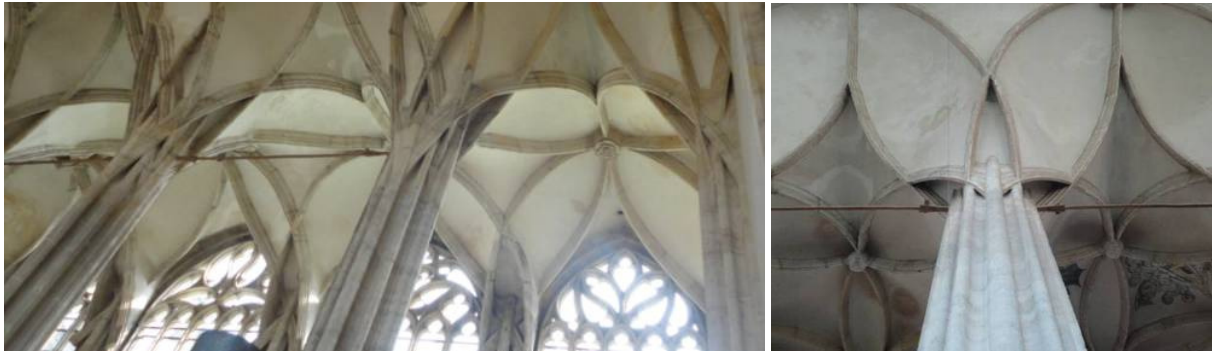
Due to the façade was not built until the end of the 19th century, tensors bars bracing between the springing of the arches located in the vaults (at the upper level of the pillar) were built at the time of the construction of the vault. Those bars are still present in the structure and it can be noticed that the part that was added later does not have them. The ribs of the vaulting never touch the bars in the columns, but penetrate into the space between them, highlighting the lightness of the structure as can be observed in Figure 37.

Figure 37 a) tensor bracing b) Joint between column and ribs vaults

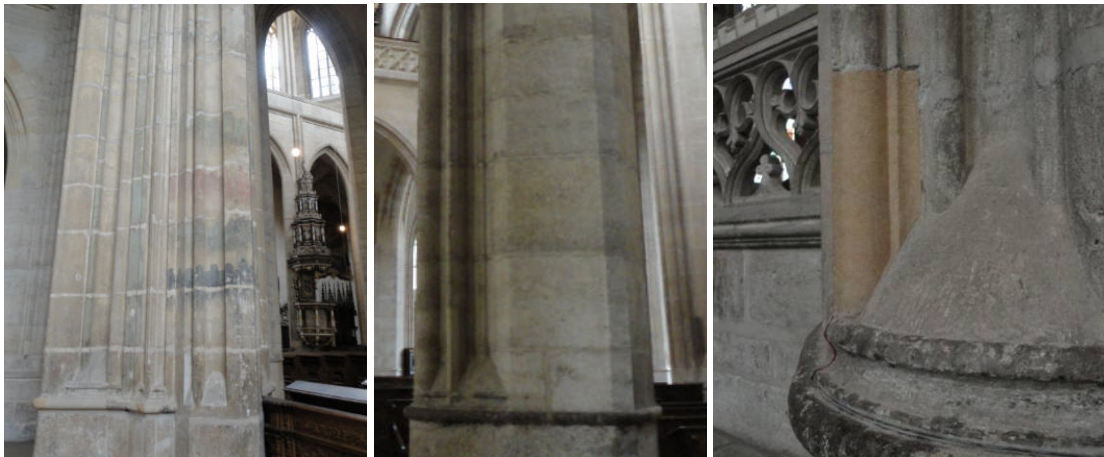
The interior of the nave have slender pillars, some of them still have a bit of color from the old times. The current state of the columns is good and it can be notice that some stone were replaced in the restoration of the 19th century.

Figure 38 Interior columns

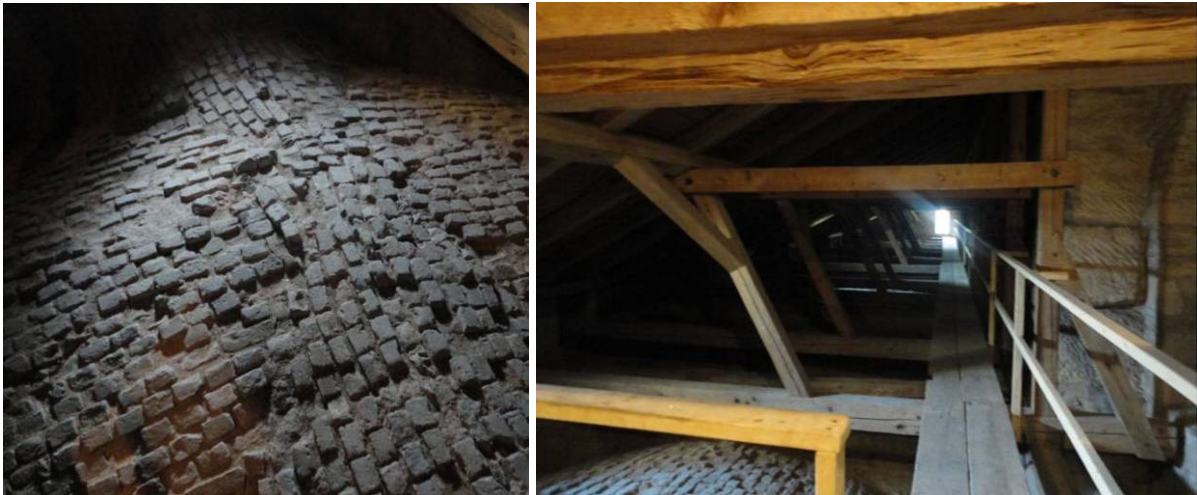
absence of infill over the vault. The vaults are made of bricks and are in good condition as can be seen in Figure 41 a).

Above the vaults there is a timber structure dating from the restoration on the 19th century. This timber roof supports the tent roof. The general impression is that the wood elements are globally in a good condition. In Figure 41 b) it can be seen that the central nave is connected to the lateral one trough timber tensors.

Figure 41 a) Extrados of the vaults b) Timber structure from the roof

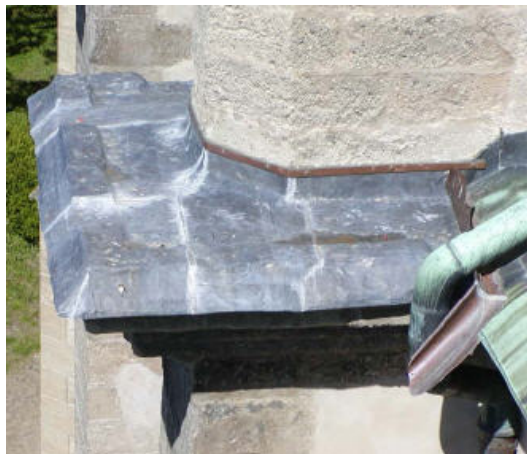
The inspection also includes the roof of the church. It can easily notice that it is in a well state of conservation due to the restoration of 2002. The roof is characterized by its shape and its slate covering. A combination of different metals can be noticed on the outside of the roof, such as zinc and cooper. The last one is placed in the joints between metals and between metal and stones due to its good behavior against corrosion. Lead flashings are located along the cornices to protect the stone from water filtration. Stones sculptures with historical value are covered in its upper part with lead flashing too. Due to the malleability properties of lead, it is considered a very good material to covering irregular shapes.

Figure 42 Lead flashing on a cornice

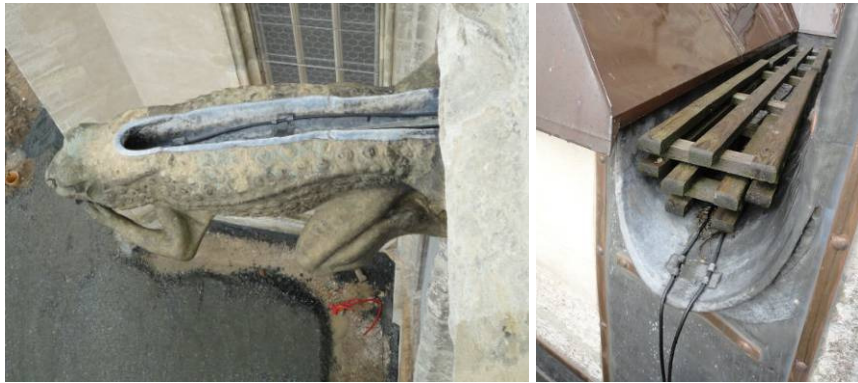
The drain system is vital for the maintenance of Saint Barbara church. The nave's drain system is composed by gutters and pipes; while in the presbytery the upper flying arches from the buttress and gargoyles also take part of the drain system. The gargoyles and gutters on the roof have special sensors which turn on the gutter's and gargoyle's heating system when the presence of snow and frost is detected and automatically turn the system off when the snow is melted and the surface is dry. The gutters transport both the raining water from the roof and the water that is coming from the snow. [Figure 43]

Figure 43 Heating system a) On gargoyles with slate cover b) on gutters

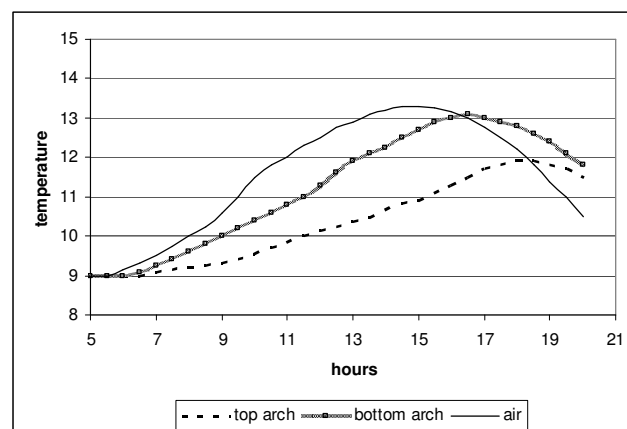
As expected differences in temperature along the arches was found in the analysis, which bring a problem regarding the difference in elongation of the arches and as a consequence stresses. It was also noticed that the temperature in the lower arch change more quickly than in the upper arch as a result of the difference in areas. In Figure 45

Figure 45 it can be clearly seen that the amplitude of the range of temperatures during a day is bigger in bottom arch than in the upper one. In addition the lower arch reaches the maximum value before than the upper arch. That is also a problem, since while the lower arch is already decreasing the temperature value; the upper arch goes on increasing its temperature.

Figure 45 Temperature values at the central point of lower and upper arches 31/03/2005 [8]

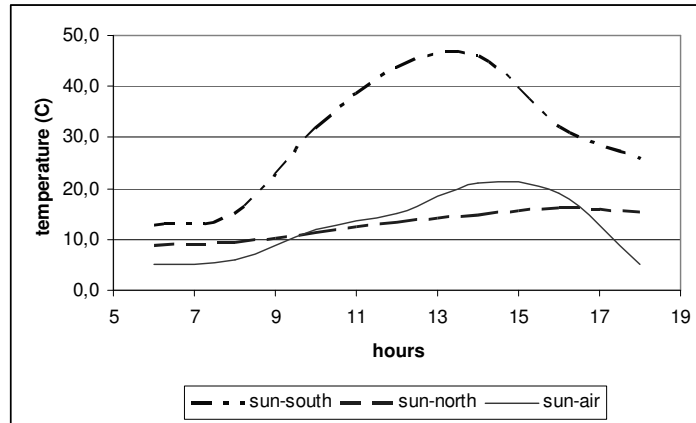
The orientation of the structure plays a fundamental role regarding the temperature influence. The South West part of the structure is much more affected than the North West part. This can be explained through Figure 46, where it is shown the temperature variation on a sunny day in the south and the north sides.

Figure 46 Temperature variation on south and north sides [8]

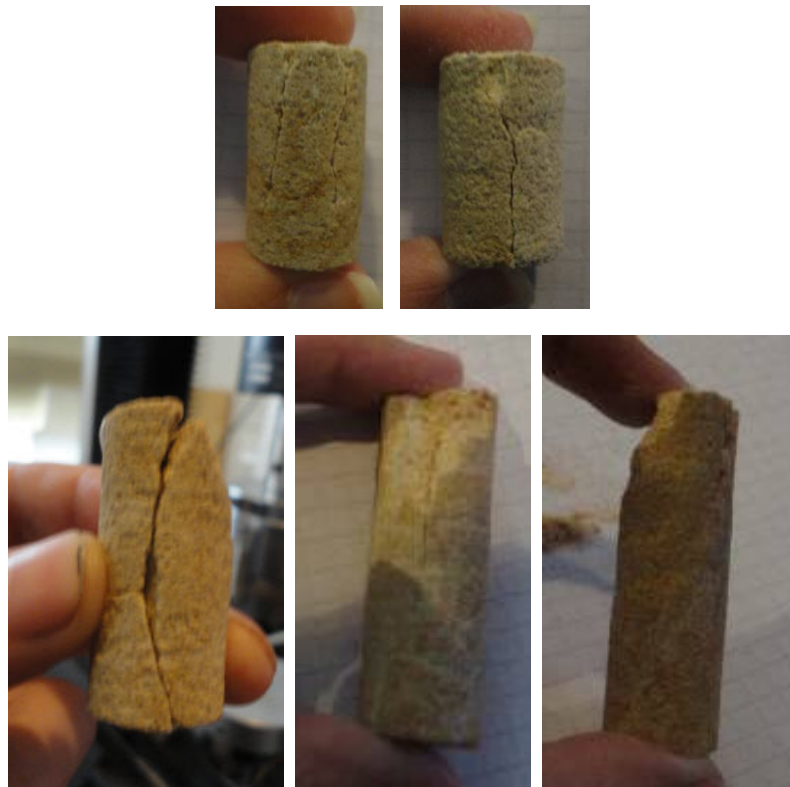
Figure 53 Samples 1 to 5 after Compression Test

From the test it can be said that the samples had a good compression behavior characterize by well define longitudinal planes of fracture. Generally the specimens showed longitudinal cracks along their longitudinal axes before the final fracture. Pictures of samples broken are shown in Figure 53.

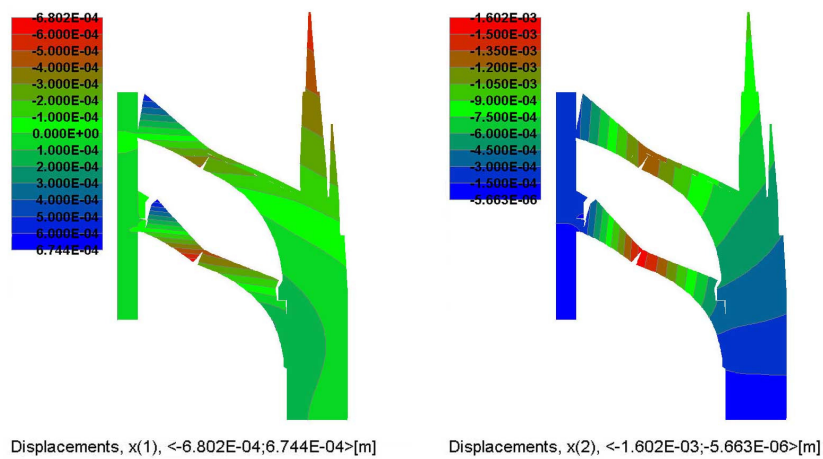
Figure 63 Displacements Model 1 Load history A

As expected the structure deform more in the extreme cases, it means minimum temperature in winter (Load history A) and maximum temperature in summer (Load history C). Regarding the shape of the deformed structures, it can be seen that Load history A have joint openings pattern similar as the one seen in the real structure. In particular, this Load history, show the three typical hinges that an arch develops when crack appears because of tension.

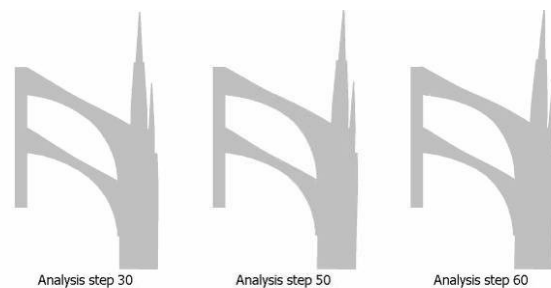
Figure 70 Development of deformation Model 1 (Load history D)

In Figure 70 it can be notice that the phenomenon of joints opening do not occur. That confirms the hypothesis that temperature in winter generates worst conditions for the structure than the temperature in summer.

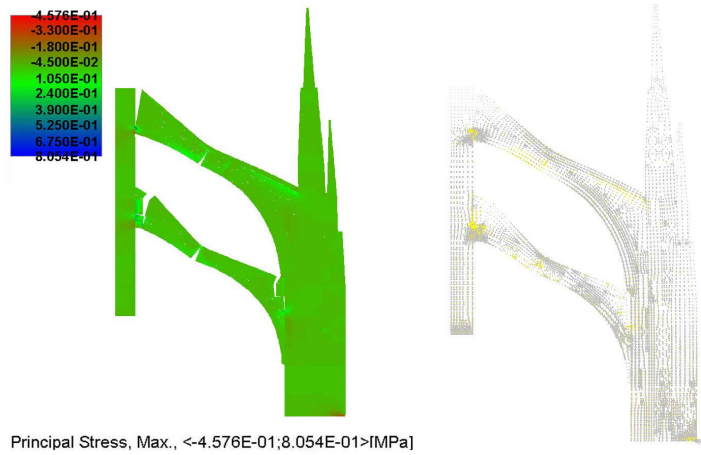
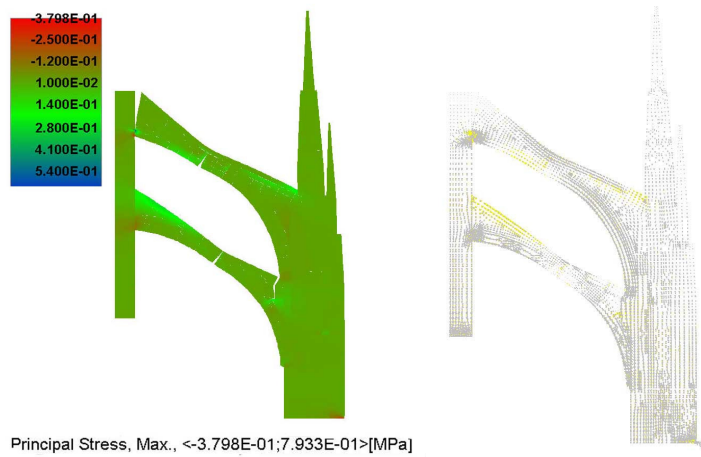
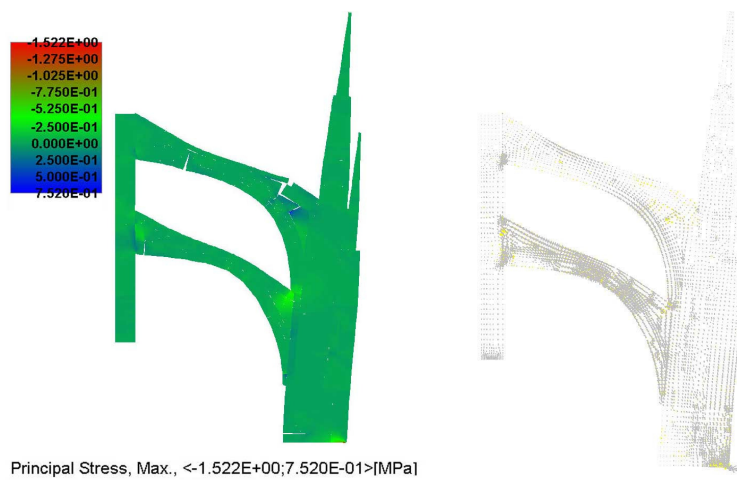
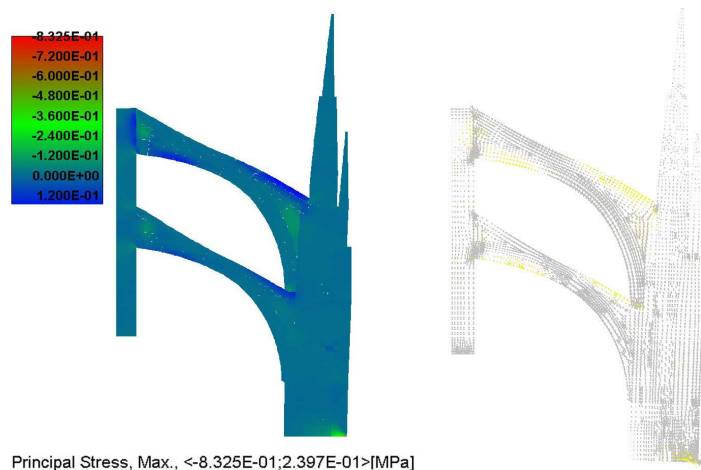
In the figures above it can be seen that the structure under Load histories A to C have similar values of maximum stresses, while under Load history D the maximum tensile stress is significantly slower. In all the cases it can be notice that the areas with traction are located in the places where the process of development of the cracks is taking place or is near to be started. The places where the crack is completely developed are characterized by compression forces. It can also be notice that the compression stresses predominates in the structure.

It is vital to mention that the structure do not present cracks in the stones in any of the four cases of load history. However, since the main problem has a cycle behavior cracks can appear after some temperature cycles.

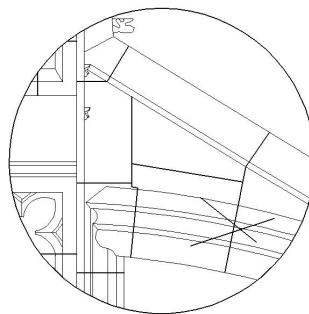
Figure 76 Detail of left voussoirs on the lower arch

Figure 76 shows a detail of the left side of the lower arch. There it can be notice that the last joint was not reinforced. Moreover, the especial geometry of the stones can be seen. This geometry was copy in the model, since it has a particular behavior regarding the possibility of sliding of the stones.

stones that are present in this position, which form a kind of step that could prevent the slip between stones caused by shear. This joint is particularly affected by temperature loads, as can be clearly notice on the models. Moreover, this joint is vital for the stability of the buttress.

Following the minimal intervention theory it is understandable that this joint was not reinforce. However, it is important to notice that the restoration was carried out in very respectful way and it is invisible from the outside. Moreover, the geometrical arrangement is not as reliable as the physical joint generated by the stainless bars and is not able to guaranty stability outside its plane. In addition, the place were this joint is located is not easily accessible. As a consequence, in the case of needing to reinforce this joint later, the cost of placing the scaffolding should be extremely high. Because of all those reasons, I believe that the joint under discussion should have been reinforced too, in order to guaranty the stability of the arch in the same way that in the other joints.

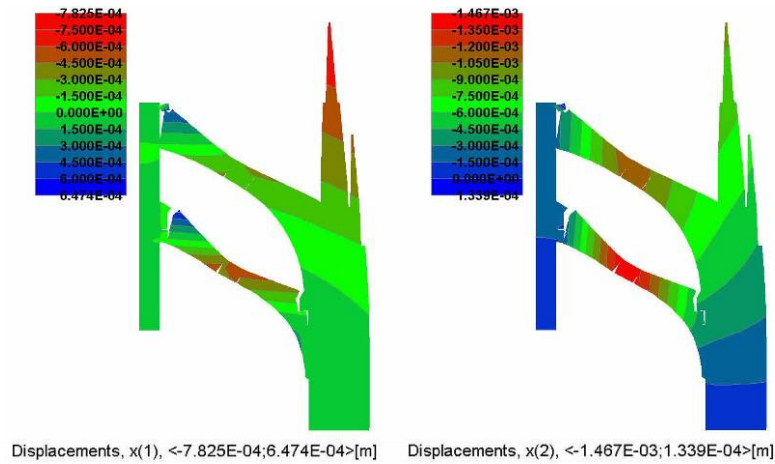
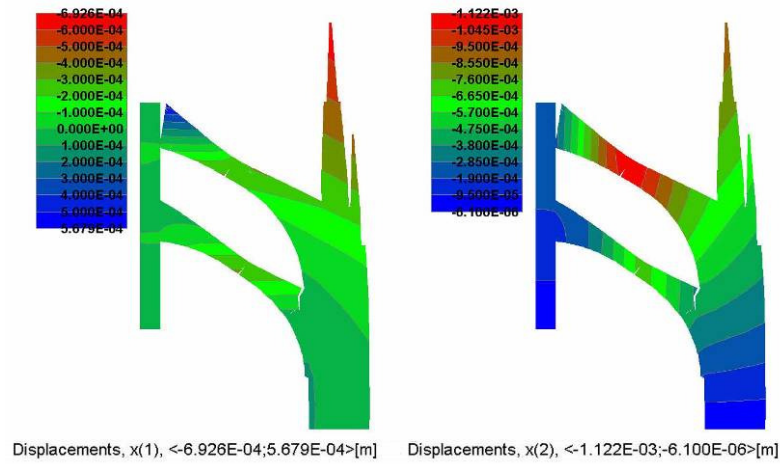
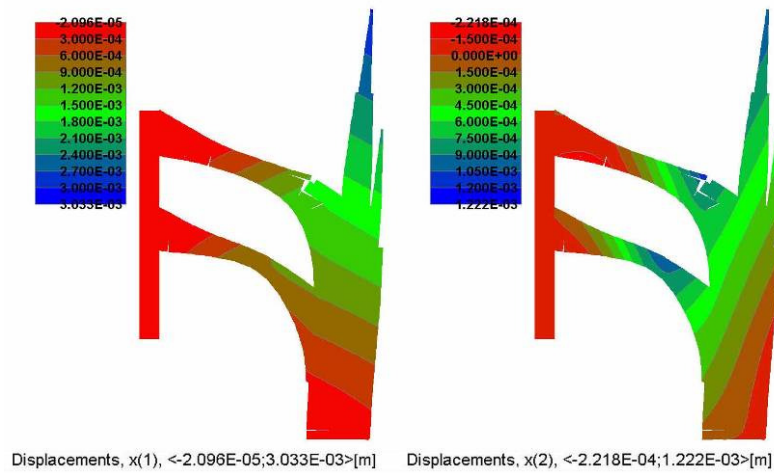
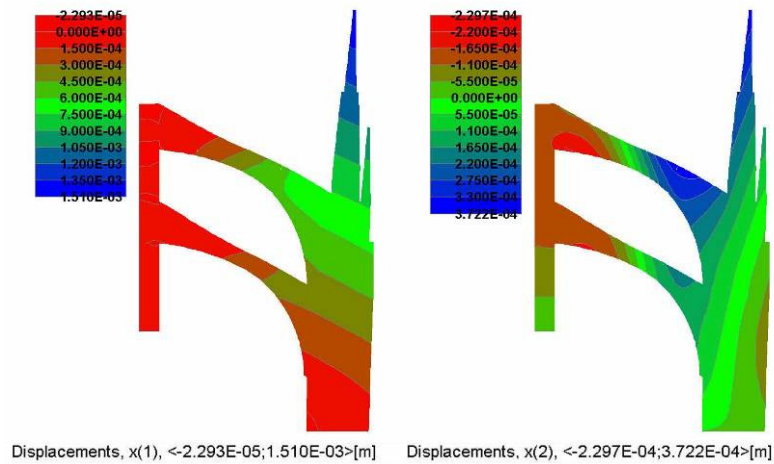
I would like to point out that in this model the structure deforms in each load history with a shape similar as in Model 1. However, the values of the displacements are smaller. In the load histories A and B the deformation of the lower arch is characterized by the opening of two cracks in the central part whereas in Model 1 only one crack was developed in that place.

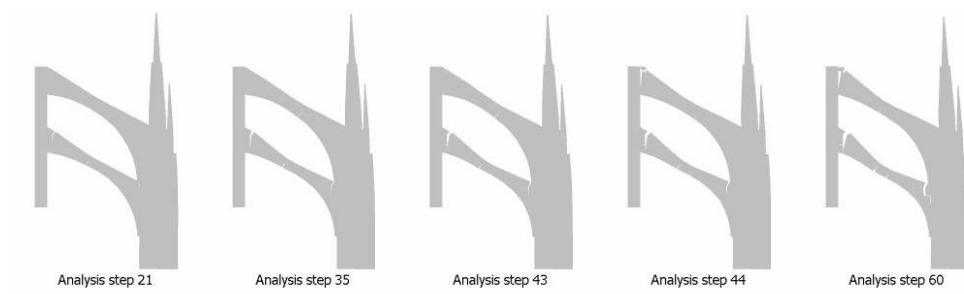
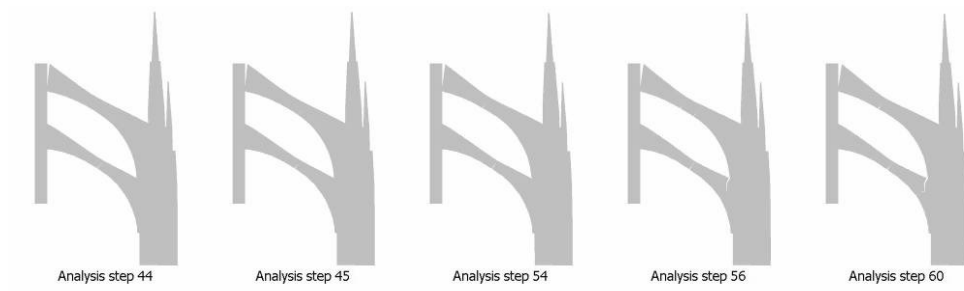
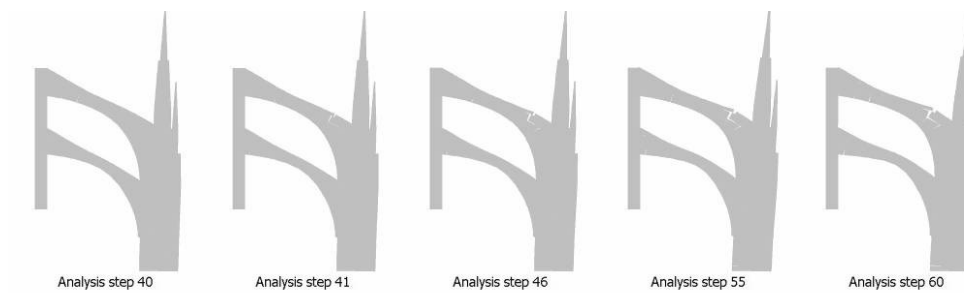
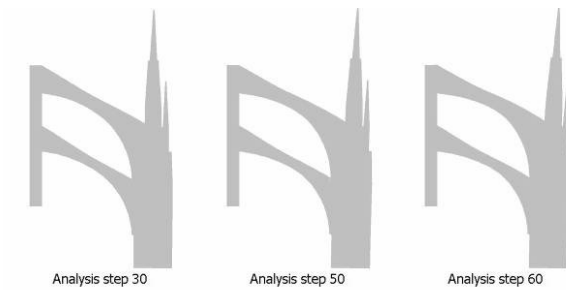
Figure 82 Development of deformation Model 2 (Load history A)

Figure 83 Development of deformation Model 2 (Load history B)

Figure 84 Development of deformation Model 2 (Load history C)

Figure 85 Development of deformation Model 2 (Load history D)

In the figures below it can be seen that the development of joint opening for load histories A and B occurs later than in model 1, which means that the reinforcements delay this phenomena. However for Load histories C and D, the reinforcements are not able to defer the development of joint opening because of the relative locations between reinforcements and joint openings.

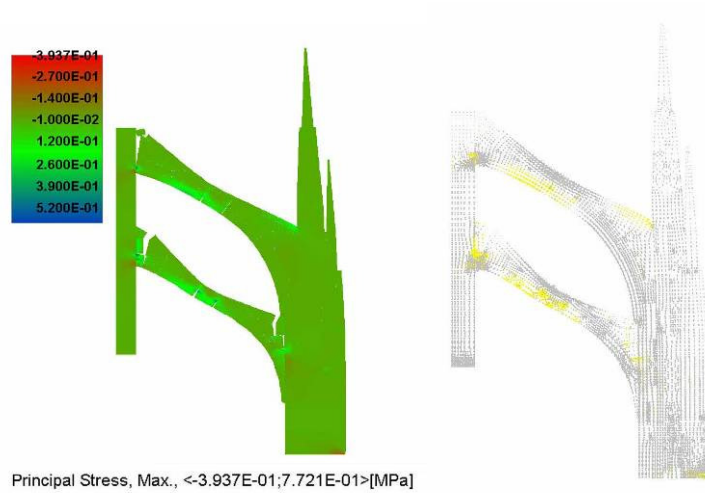
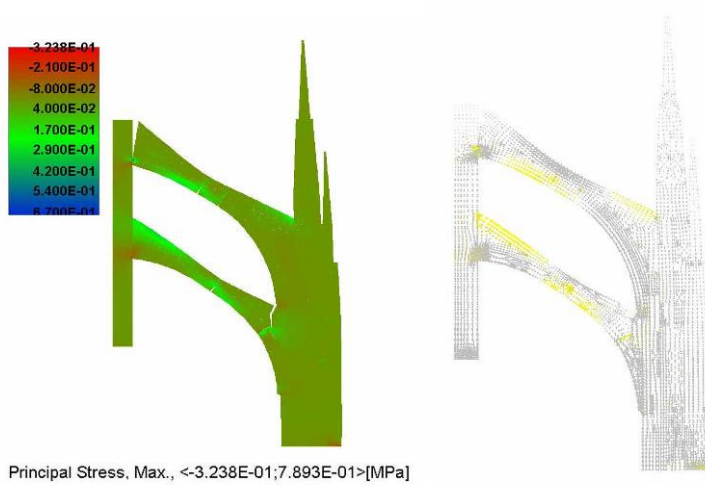
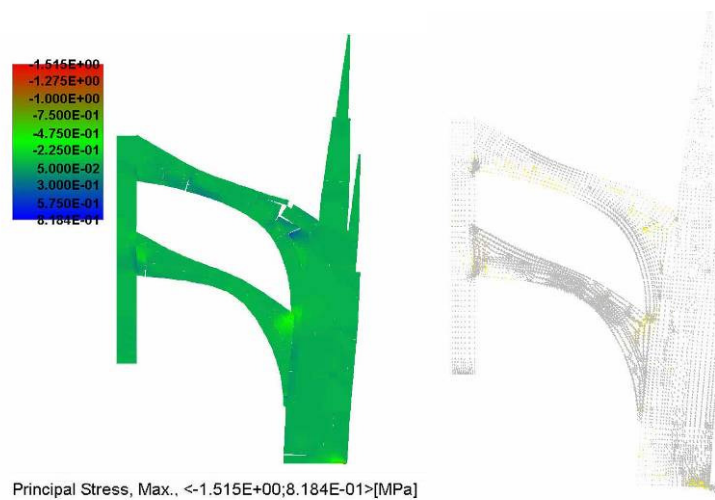
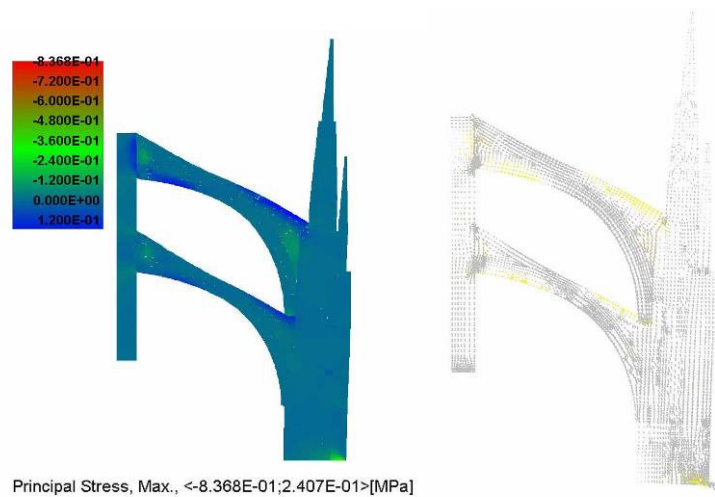
Figure 86 Model 2 Load history A a) Principal stresses b) Tensors

Figure 87 Model 2 Load history B a) Principal stresses b) Tensors

Figure 88 Model 2 Load history C a) Principal stresses b) Tensors

Figure 89 Model 2 Load history D a) Principal stresses b) Tensors

It can be seen that the values of principal stresses do not change significantly. However the distribution of stress is different since tractions are usually located near the places where opening of joints is not possible due to the presence of the reinforcement.

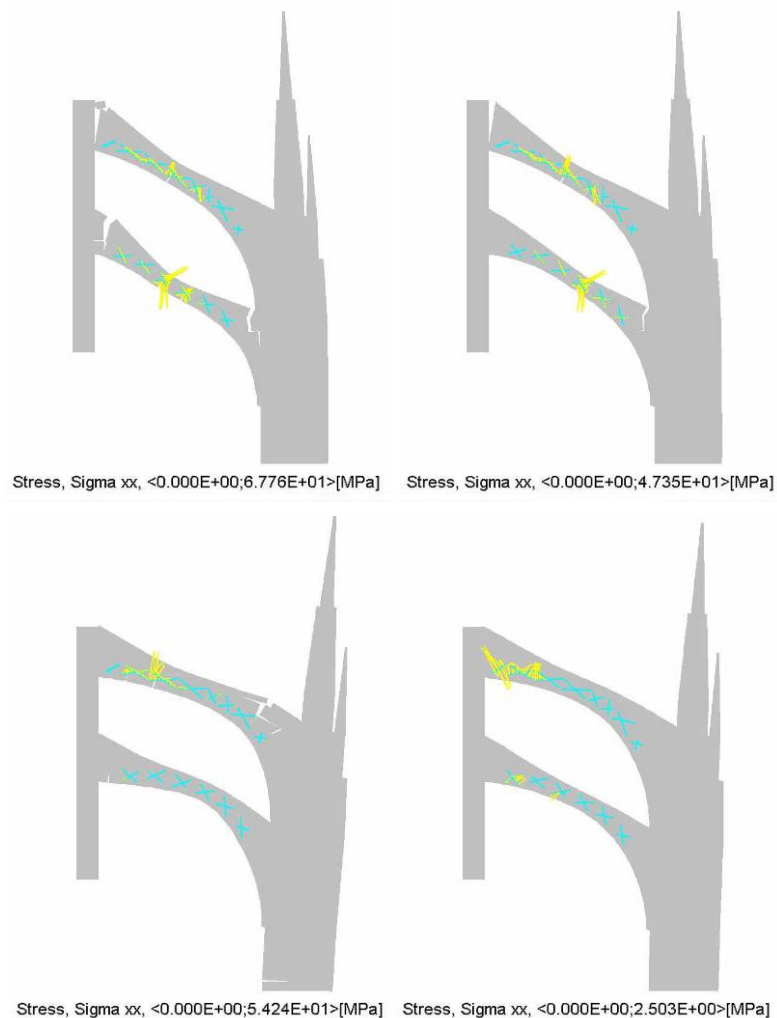
In this model it is also interesting to evaluate the stresses in the reinforcements. Figure 90 shows the stresses along the principal axis in the reinforcements (stress σ_x). It can be seen that, as expected, the reinforcements of the lower arch have in load histories A and B higher stresses than the upper arch. While, for load histories C and D the reinforcements of the upper arch have higher stresses than the reinforcements of the lower arch. The maximum values of tension are small and far from reaching the yield stress ($\sigma_y = 500$ Mpa), that means that the reinforcements have more capacity to take eventually increases of tension.

Figure 90 Stresses Sigma x in the reinforcement (Load histories A to D)

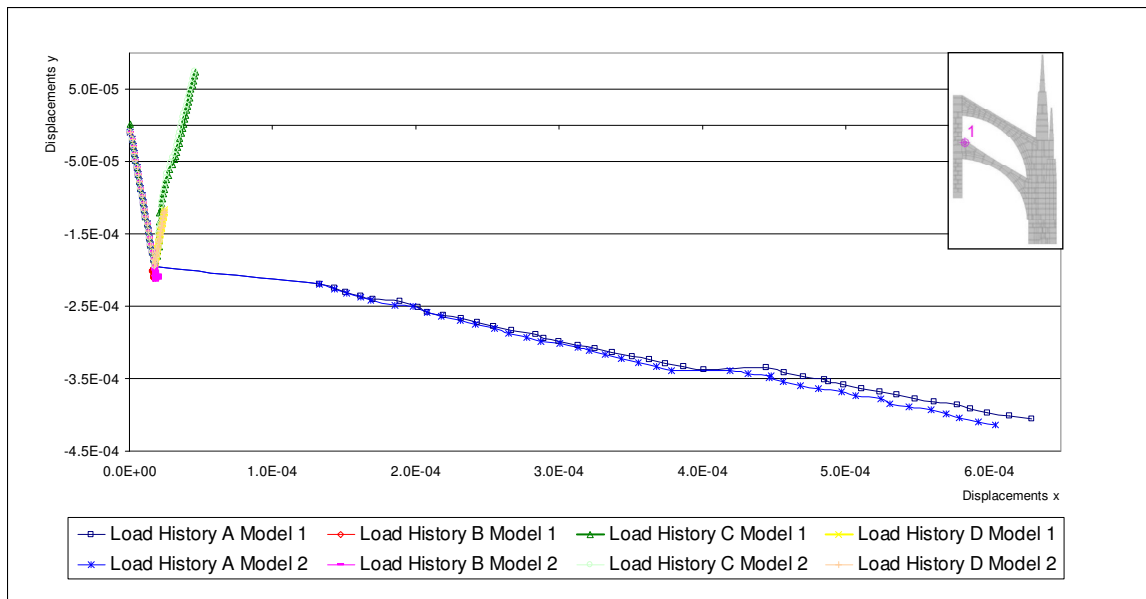
Figure 91 Monitoring point 1

Above, Figure 91 shows the displacements for Monitoring point 1, which is located in the superior left edge of the lower arch. In the first 20 load step it can be clearly distinguish in all the curves a first branch due to self weight, which is exactly the same for all the cases. After this, for Load history A, horizontal displacements predominate. At load step 21 the joint located at this place opened, what can be appreciated in the horizontal step on the curve. It can also be seen that for Model 2 the final displacement is a bit smaller.

For Load history B, since the lower arch does not have a considerable change in temperature, the displacements are insignificant and similar for Model 1 and 2.

In the case of Load histories C and D the lower arch tends to have an expansion, which is reproduced in the figure as an ascending branch. This branch is practically linear since the point move without any opening of joints.

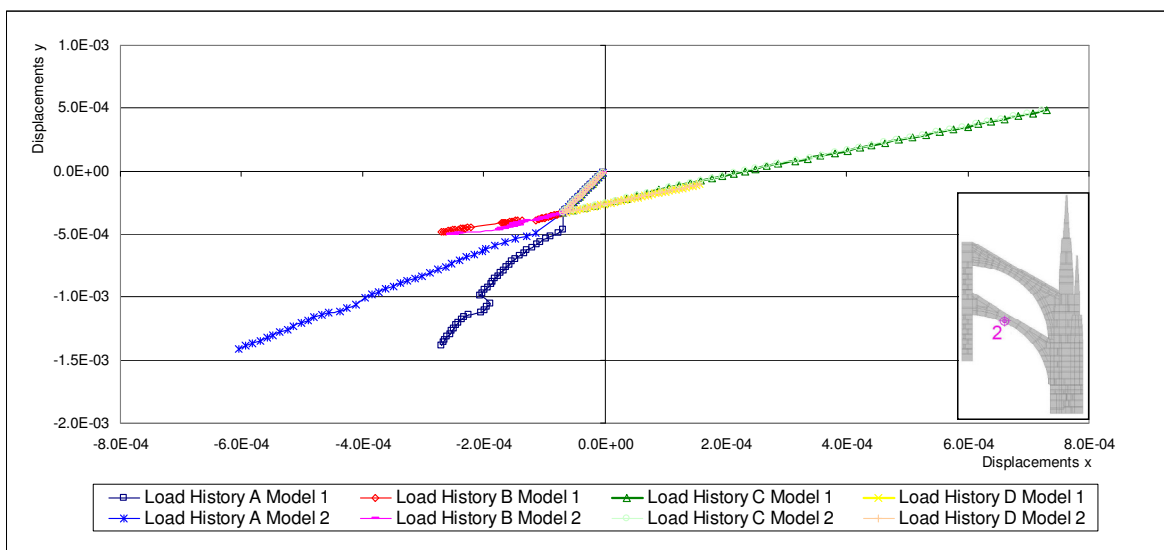
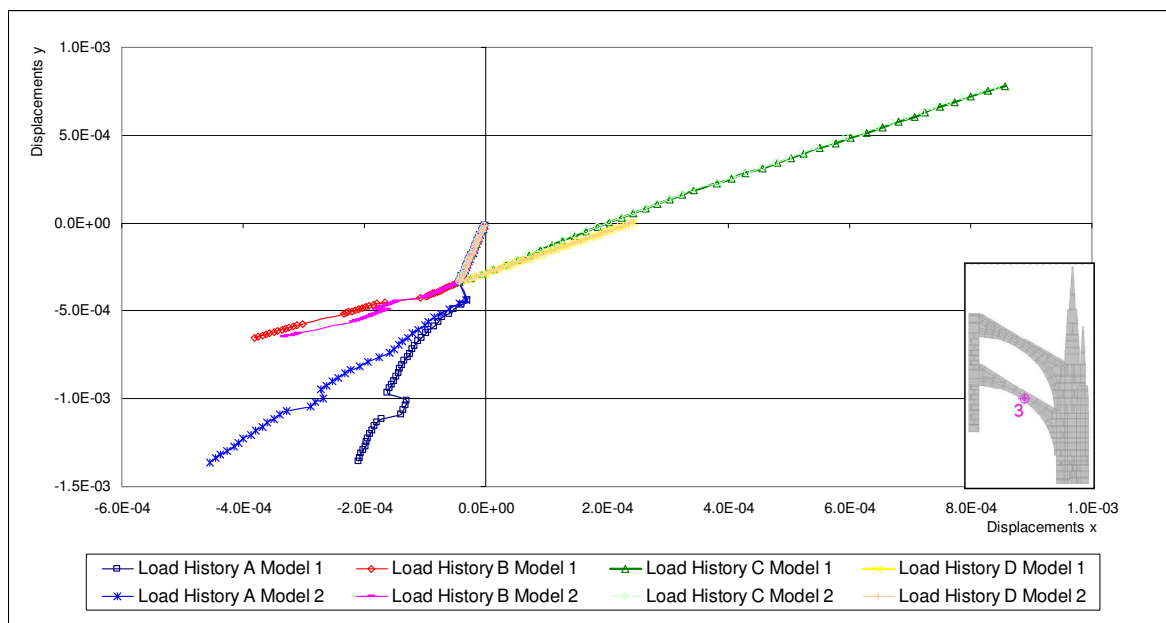
For Load history A it can be observed that both monitoring points have the same displacement curve for Model 1, that is because only one opening of joint take place. The later is located in

correspondence with monitoring point 2. However, the curves that represent Model 2 are different. The curve that show the displacements of monitoring point 3 under load history A for Model 2 has a higher value of displacements that the one for monitoring point 2, since joint opening phenomena occurs in both locations in that case. As expected, the displacements in Model 2 have a global behavior where the displacement of each point is dependent of the movements of the others due to the fact that the stones are joined by the rods. For instance, the displacements of monitoring points 2 and 3 are bigger for Model 2 than for Model 1 under Load history A, but it does not mean that the width of the opened joint is higher since the whole arch deform together and tends to move in the same direction. This situation of global movement can be also notice in Figure 95.

Figure 92 Monitoring point 2

Figure 93 Monitoring point 3
