ADVANCED MASTERS IN STRUCTURAL ANALYSIS OF MONUMENTS AND HISTORICAL CONSTRUCTIONS

Master's Thesis

Investigation of a Faulty Historical Structure: Saint Barbara Church

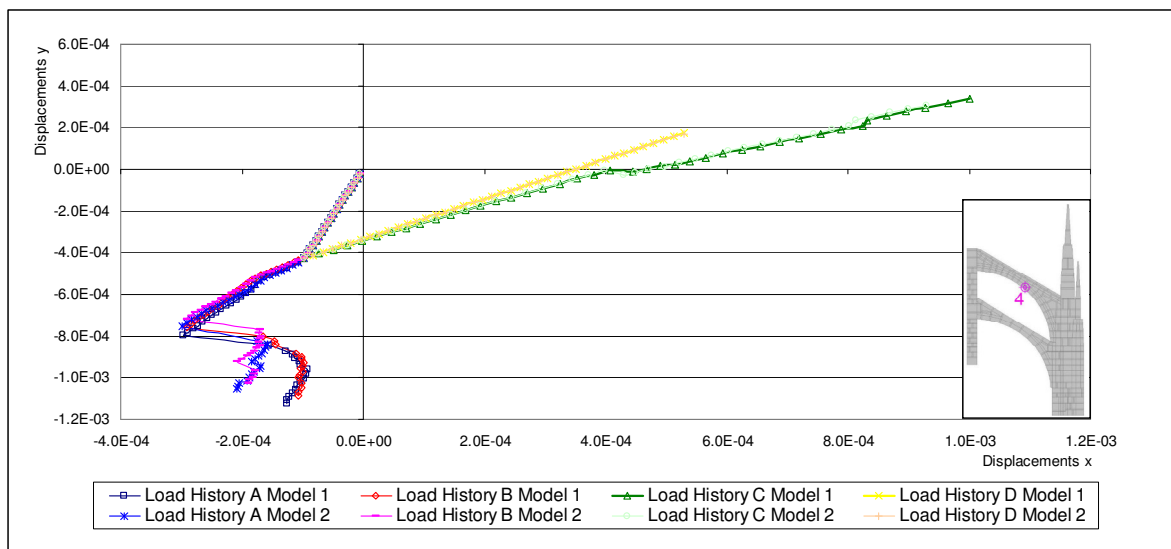
Figure 94 Monitoring point 4

In the following figure the recorded displacements of monitoring point 4 are shown. This point is located in the lower central part of the upper arch. In this case it is remarkable that the first part of the curves for Load histories A and B evidence the same behavior until step 45, where the joint in the left border of the upper arch opened. Consequently a horizontal displacement can be observed in the displacements curved. From load step 45 to 60, it can be appreciate that under those load histories the monitoring point tends to move more in Model 1 than in Model 2. The reason for that could be that the width of the opening that take place in the left side is bigger in Model 1 than in Model 2, since in the last one the displacements are reduced by the rods.

Again, for Load history C and D and expansion movement take place. Particularly, for load history C it can be observed a horizontal displacement followed by an increase in the slope of the curve which represent the separation of stones that take place in the upper part of the arch on the right side. The curves in those load histories are the same for model 1 and 2 because the rods are located in the lower part of the arch and do not able to avoid the opening of the joints in the upper part.

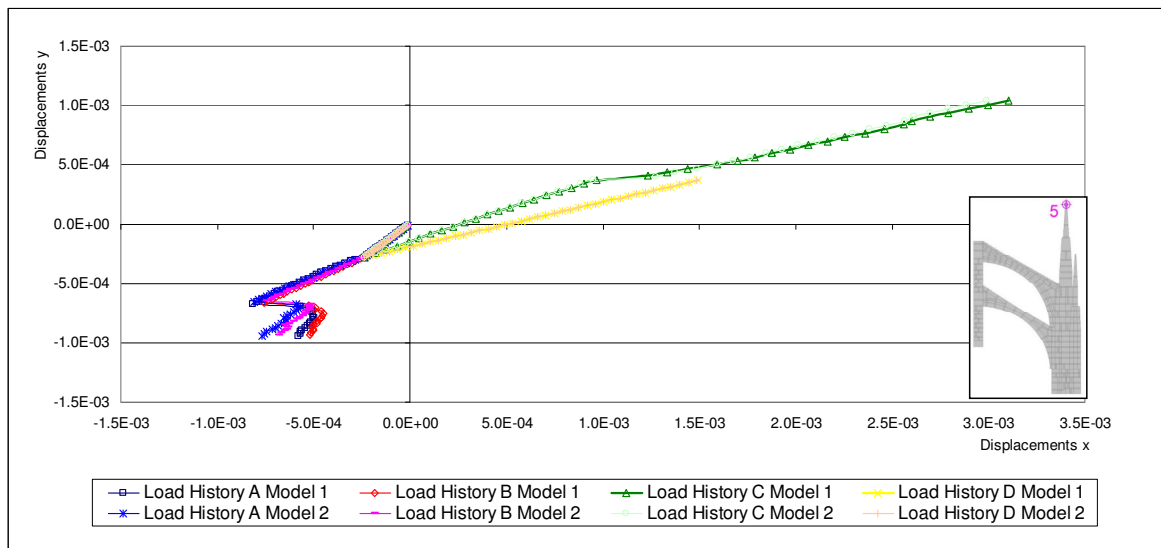
Figure 95 Monitoring point 5

Figure 95 shows the displacements of monitoring point 5 which is located in the upper part of the pinnacle. Once more the curves begin with a common line followed by an expansion movement for load histories C and D. In this case for Load histories C a concentrated horizontal displacement take place representing the opening of the joints in the superior part of the upper arch. After that the pinnacle continues its expansion with a higher slope. For load histories A and B the same behavior explained in monitoring 4 takes place.
