## Mechanical Properties of Abandoned and Closed Roadways in the Kushiro Coal Mine, Japan

*The objective of this research is to clarify the mechanical properties and self-healing ability of Excavation Damaged Zone (EDZ) around rock caverns in clastic rock. Observations of nearly 100 closed roadways up to 50 years old, which can be regarded as very severe EDZs with no initial sealability and are up to 300 m deep in clastic rock, were made at Kushiro Coal Mine, Japan, to accomplish the objective. Most old roadways were closed, though a few remain open. Closure of old roadways was mainly due to roof deflection and/or floor heave. Large plastic deformations dominated; however, severe fractures were seldom observed in closed old roadways. Rayleigh wave velocity and hydraulic conductivity in the closed old roadways were in the range of 0.3 km/s to 1.2 km/s and  $5 \times 10^{-7}$  m/s to  $1 \times 10^{-7}$  m/s, respectively, and*

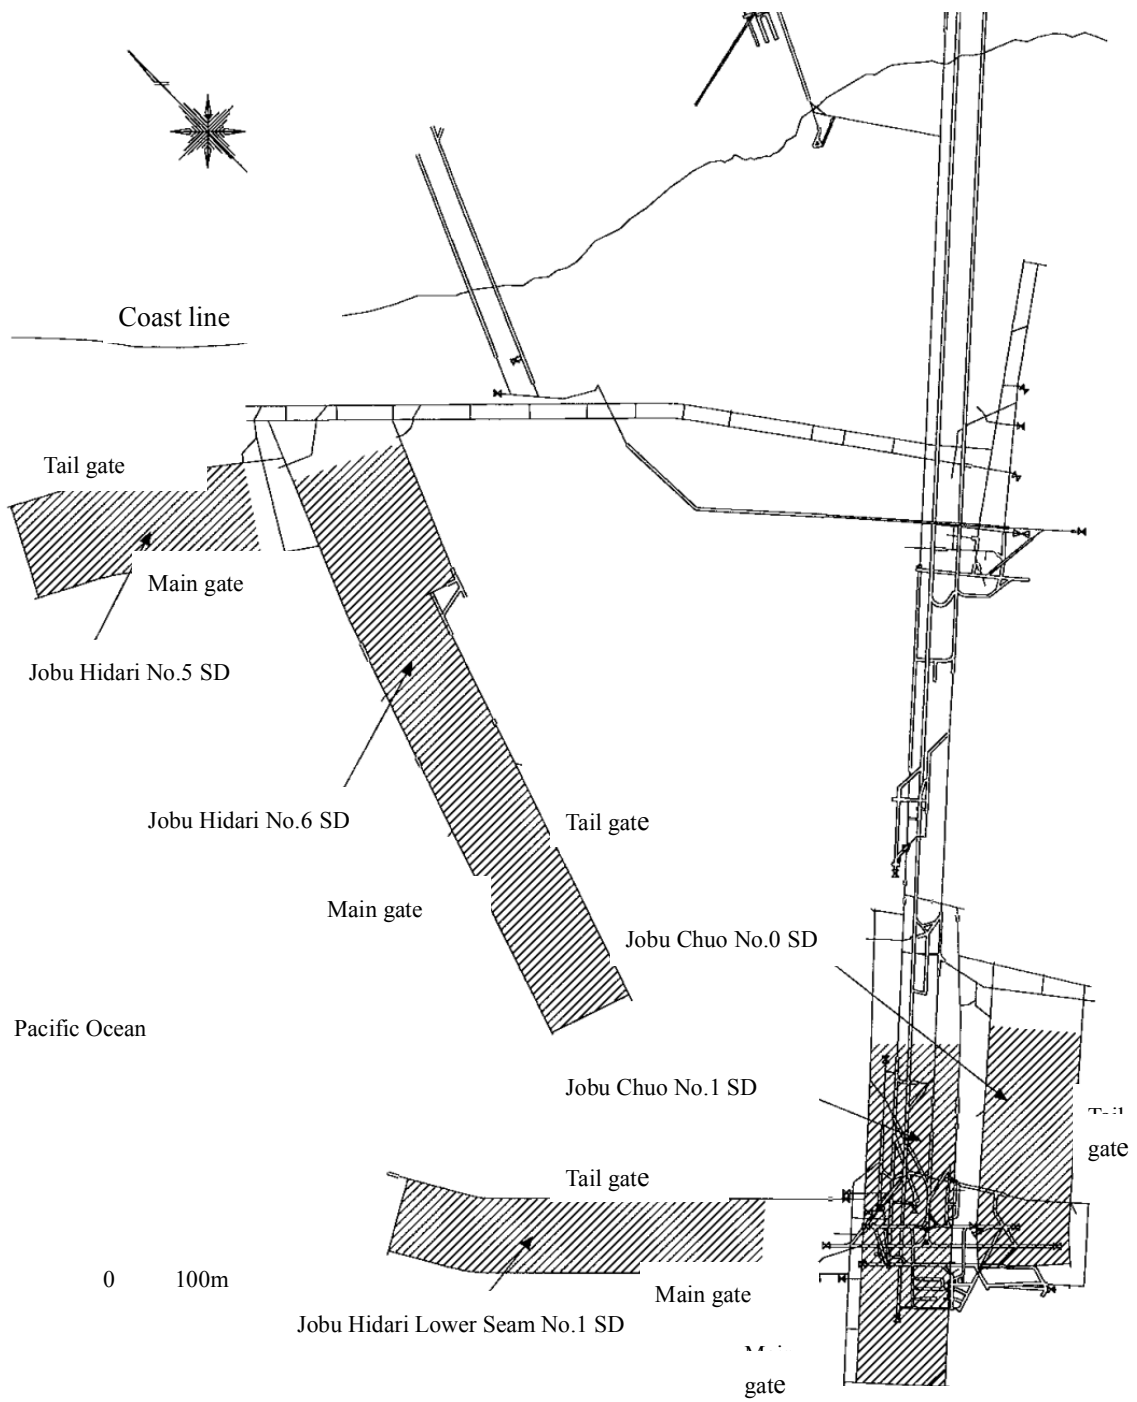
Fig. 2 Longwall mining panels in which old roadways were observed

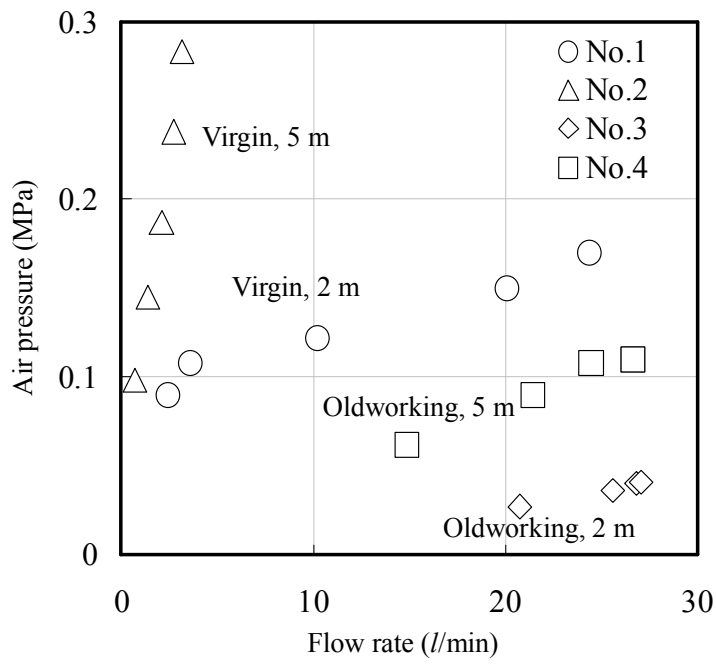
The 2-m hole in the closed old roadway showed the least pressure at the largest flow rate in the air test series (Fig. 16). It was impossible to raise pressure beyond than the critical pressure. The 5-m hole in closed old roadway and the 2-m hole in the virgin rock mass exhibited critical pressures beyond which the slope of the flow rate-pressure curves decreased. The 5-m hole in the virgin rock mass did not reach critical pressure up to 0.28 MPa.

Fig. 16 Injection pressure vs. flow rate obtained by Lugeon test when the compressed air was used as fluid.

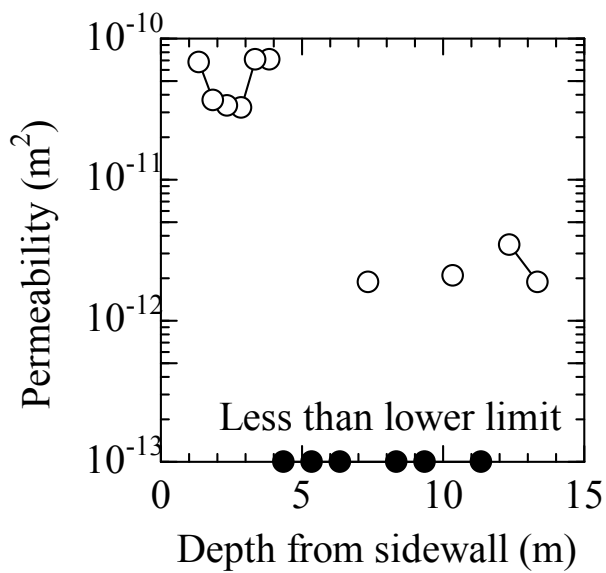
The instruments were almost the same, but a double packer was used to divide the pressurized part at 0.5 m. The test was carried out in a 15-m long and 15-degree upward borehole drilled in the sandstone seam at the tailgate of Jobu Hidari No. 5 SD (Fig. 2) before the abutment pressure appeared. Permeability was on the order of  $10^{-11}$  m<sup>2</sup> less than 4 m deep and on the order of  $10^{-12}$  m<sup>2</sup> or less for depths more than 4 m (Fig. 17). It is estimated that the rock mass within 4 m from the sidewall was an EDZ. It was impossible

Fig. 17 Permeability distribution along a borehole.

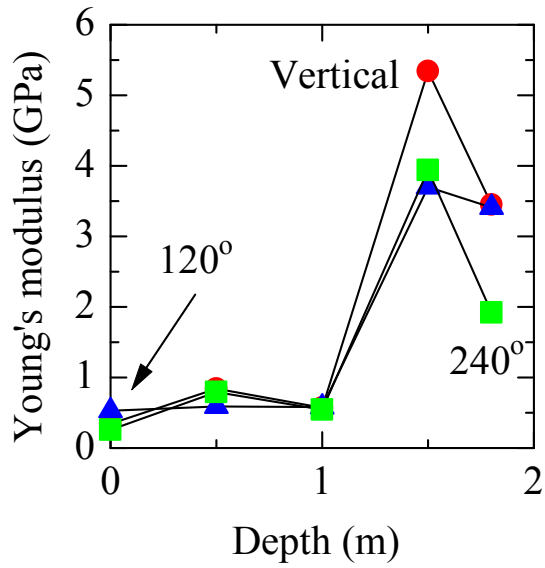
Young's modulus of rock mass was measured with a Goodman jack. Tests were carried out at the tailgate of Jobu Hidari No. 5 SD (Fig. 2). The first test was carried out for a horizontal borehole drilled from the sidewall into the virgin field of siliceous rock. The UCS and the Young's modulus of the intact saturated specimen were 52 MPa and 12 GPa, respectively. Loading was carried out in three directions: vertical and 120 degrees and 240 degrees from vertical. A significant anisotropy was not observed in this plane (Fig. 18). Young's modulus for rock mass within 1 m from the sidewall was much smaller than that for rock mass deeper than 1.5 m. The EDZ boundary was estimated to be between 1 m and 1.5 m from the sidewall.

Fig. 18 Distribution of Young's modulus along the borehole in siliceous rock.

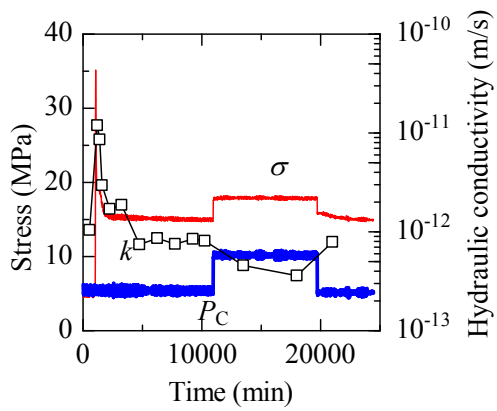
Hydraulic conductivity increased with specimen failure (Fig. 19); however, it gradually decreased with time in the residual state and reached almost the same level as that for the intact rock specimen. Hydraulic conductivity decreased with the increase in confining pressure and then increased with its decrease. The variation of hydraulic conductivity with confining pressure looked reversible and associated with elastic deformation of the rupture plane. Similar results on Kimachi sandstone can be seen in Takada & Fujii [4].

Fig. 19 Axial stress ( $\sigma$ ), confining pressure ( $P_c$ ) and hydraulic conductivity ( $k$ ) versus time obtained under the triaxial compression test using sandstone.
