Continuous debonding monitoring of a patch repaired helicopter stabilizer: Damage assessment and analysis

S. Pavlopoulou^{a,*}, S. Grammatikos^b, E. Z. Kordatos^c, K. Worden^d, A. Paipetis^e, T. Matikas^e, C. Soutis^a

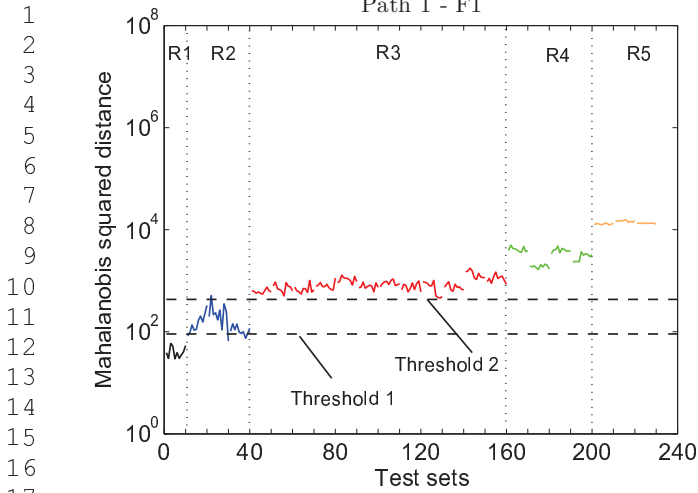
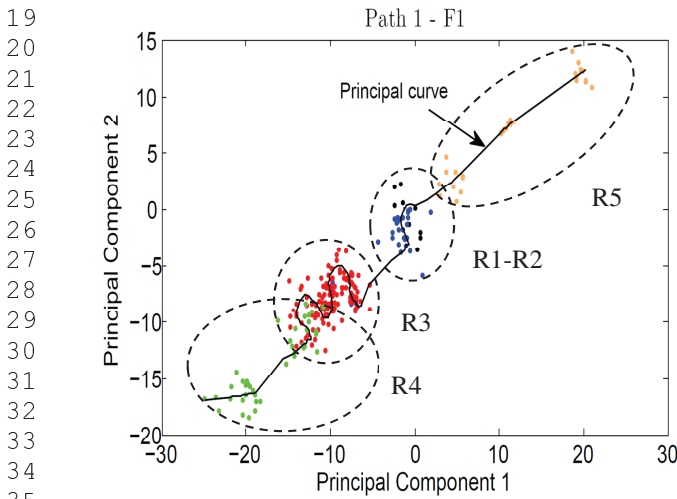
Figure 9: (a) Outlier analysis (OA) and (b) principal component analysis (PCA) for path 1 - feature 1 (F1). Threshold 1 estimated through Monte Carlo technique and Threshold 2 assigned to reflect changes in boundary conditions, outliers above thresholds represent damage, regions R1-R5 show progressive damage increase in the form of increasing Mahalanobis distance OA values and as separate PCA clusters.

Region R3 (15,000– 405,000 cycles) in Figure 9(a) is only slightly flagged above the thresholds but without any considerable deviation. However, there is a certain increasing tendency which suggests that damage has started accumulating in the monitored area (path 1). Region R4 (405,000 – 480,000 cycles) shows a higher deviation from the thresholds than region R3 while the region R5 (480,000–580,000 cycles) clearly cor-

responds to a stage where significant damage has developed. Feature 1 (F1), shown in Figure 9(a), which corresponds to the part of the waveform that has been captured by the sensor without interacting with any other features/boundaries, shows more distinctive differences than feature 2 (F2), shown in Figure 10(a). However feature 2 (F2) exhibits higher values of deviation from the normal condition (higher Mahalanobis squared distance) (areas R3–R5).

Principal component analysis (PCA) results show how well the clusters that correspond to each region separate when they are projected on the baseline reference set (0 cycles - pristine condition). F1, shown in Figure 9(b), exhibits a clear separation between the clusters, indicating the successful assignment of the regions in the OA, and verifying the deviation of the behaviour of the monitored system from the normal condition. As for feature (F2), which is shown in Figure 10(b), even though there is a certain separation of the orange dots (R5) from the

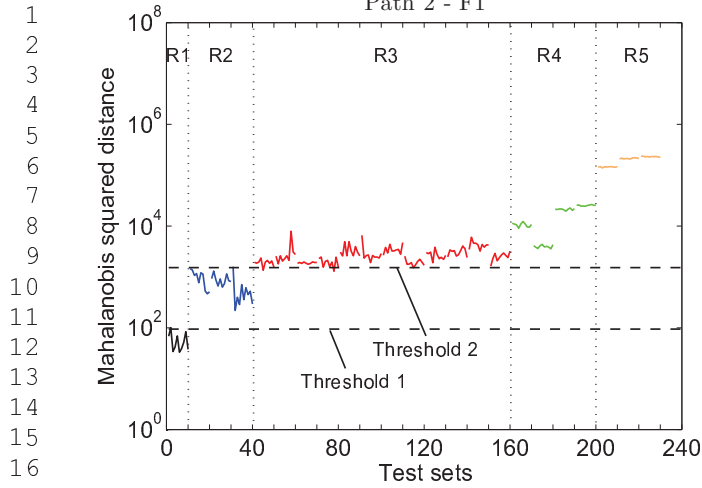
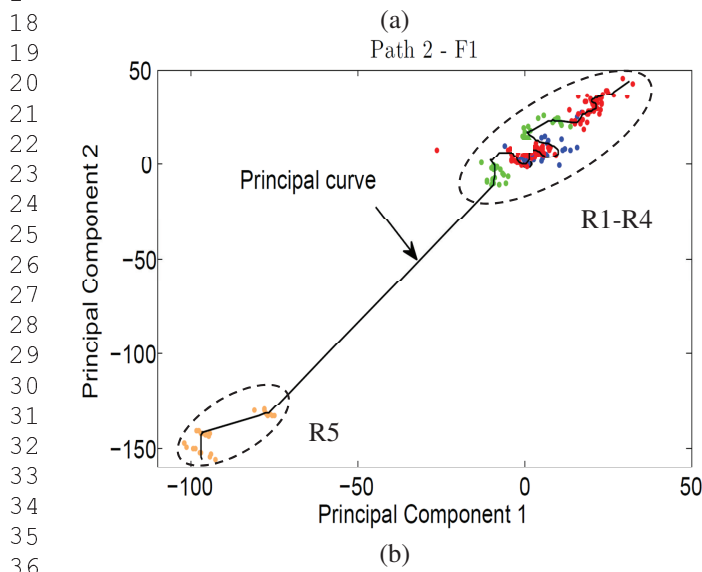
Figure 11: (a) Outlier analysis (OA) and (b) principal component analysis (PCA) for path 2 - feature 1 (F1). Threshold 1 estimated through Monte Carlo technique and threshold 2 assigned to reflect changes in boundary conditions, outliers above thresholds represent damage, regions R1-R5 show progressive damage increase in the form of increasing Mahalanobis distance OA values and as separate PCA clusters (R1-R4 and R5).

Figures 11 and 12 illustrate the same results but for path 2. The y-axis is scaled in the same way as for path 1 for comparison purposes. The first observation is that the same regions (R1-R5) can be assigned in the OA figures, which indicate the level of deviation from the baseline reference (pristine condition) and from the assigned thresholds as shown in Figures 11(a) and 12(a). One difference is that region R4 starts one set of data later (e.g. 170 test sets) for the second feature (F2) compared to F1 for the same path and also compared to both features F1 and F2 for path 1. Furthermore, PCA exhibits quite mixed clusters, from which only the region R5 can be separated for the F1, as shown in Figures 11(b) and 12(b).

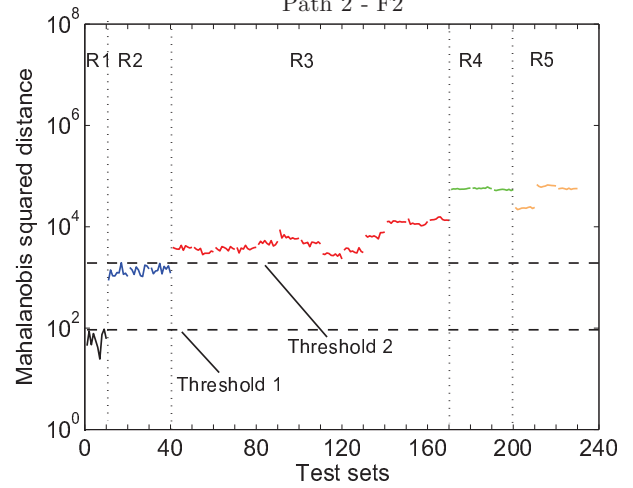
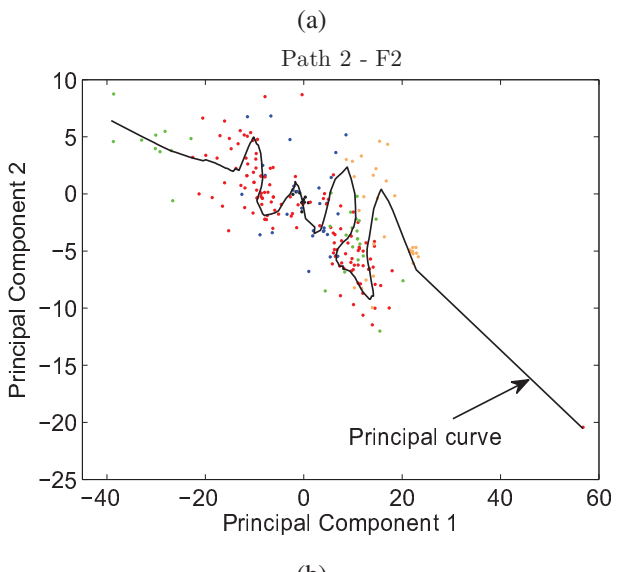
Figure 12: (a) Outlier analysis and (b) principal component analysis for path 2 - feature 2 (F2). Regions R1-R5 are clear in OA results and while PCA clusters can not be attributed to certain region.

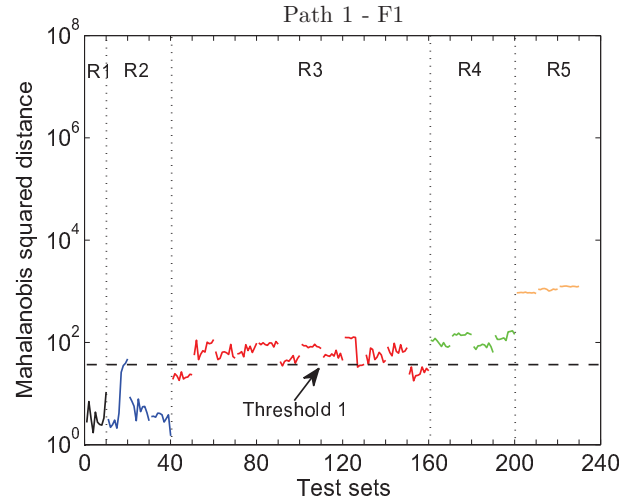
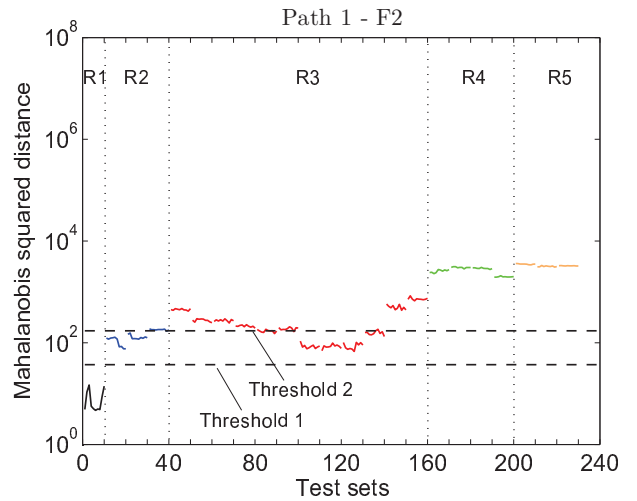
Figure 14: (a) Outlier analysis at the first 10 principal components for path 1, corresponding to feature 1 (F1) and (b) feature 2 (F2).

Feature 1 (F1) in Figure 14(a) shows that the results are more representative of the assumption made for the OA on the original time signals in section 4.1; it verifies that region R2 is not indicative of damage. This means that regions R1 and R2 are indeed labelled as inliers (below the threshold 1) while region R3 is very close to the threshold only slightly flagged above it without any considerable variation. In this case there was no need to assign threshold 2. It is only after 480,000 cycles that OA gives clear outliers (regions R4 and R5). On the other hand, feature 2 (F2) shown in Figure 14(b) illustrates a slightly different be-

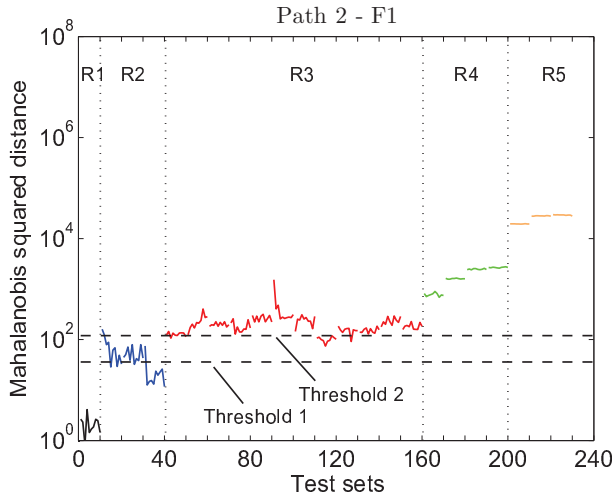
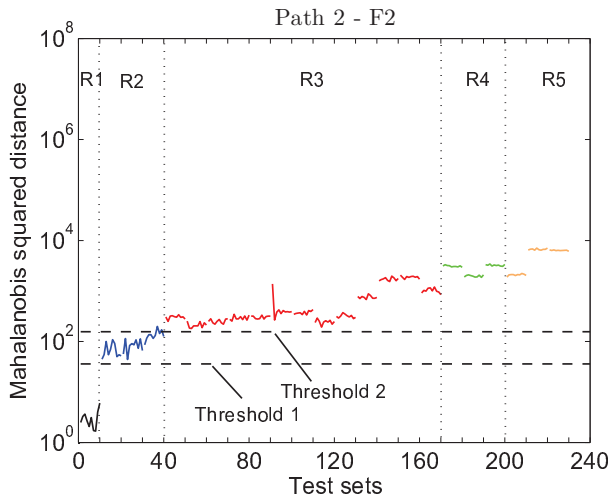
Figure 15: (a) Outlier analysis at the first 10 principal components for path 2, corresponding to feature 1 (F1) and (b) feature 2 (F2).

Figure 15 illustrates the same OA results for propagation path 2. Feature 1 (F1) exhibits a similar behaviour for the same feature F1 of path 1, exhibiting lower deviation from the normal condition and the thresholds than what the respective original time signal showed in section 4.1. In addition, regions R1 and R2 are below the threshold 1 and threshold 2, respectively, while region R3 is very close to threshold 2, exhibiting a relatively steady behaviour. In a similar way as with propagation path 1, R4 and R5 (above 480,000 cycles) are clearly flagged as outliers while the boundaries between the two regions are quite distinctive. On the other hand F2 exhibits a similar behaviour with the feature taken from the original time signal, without any underlying difference. The main assumption derived here is that at least F1 for both paths shows an improved behaviour
