Lessons on internal erosion in embankment dams from failures and physical models

J.J. Fry

EDF-CIH 73 373 Cedex, Le Bourget du Lac, France

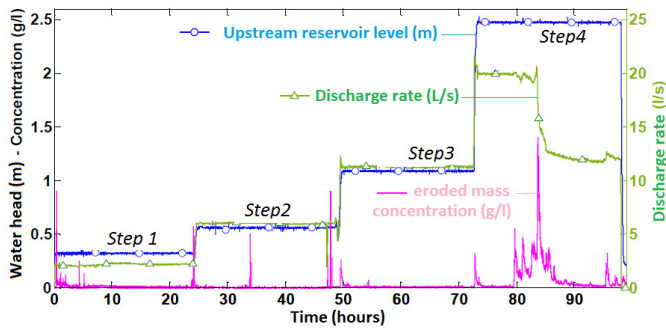
Duration of the first test was 99 hours. Four steps of hydraulic load were applied by varying the water level in the upstream reservoir (Fig. 9). During the three first steps, a peak of turbidity and transported fines were observed in water as soon as the step

commenced. The phase of fines transport lasted about one hour and then stopped.

Figure 9. The change of upstream head, discharge flow and turbidity versus time

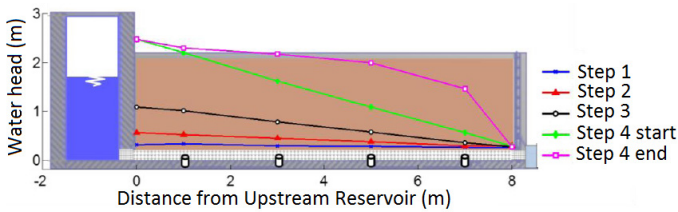
Figure 10. The changes of piezometric line in the gravelly foundation, caused by clogging of downstream toe.

At Hour 79 during the last step (at an upstream head of 2.5 m and flow rate of 20 L/s), a massive surge of transported fines transport was suddenly triggered. The eroded fines came from the upstream part of the model. At Hour 83, the flow rate began to decrease at constant head. There was a sharp decrease of hydraulic head under the downstream part of the model. This was the consequence of a decrease of the downstream permeability (as shown in Fig. 10). At Hour 84, downstream settlement occurred (Fig. 11). At Hour 96, a sinkhole occurred

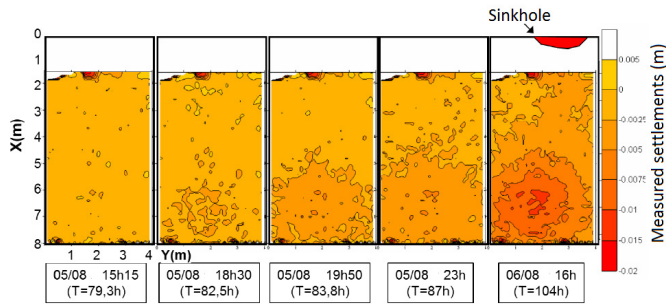
Figure 11. The settlement isocontours in plan versus time.

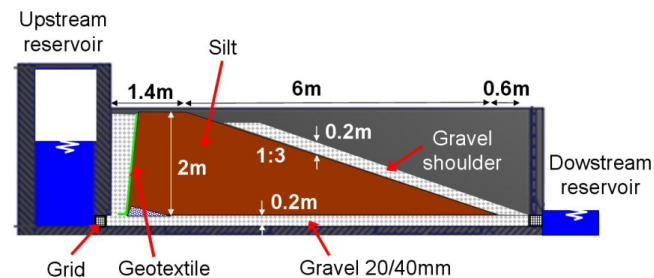
Figure 15. Large scale of levee suffering contact erosion studied in the second series of models (from Beguin 2011).

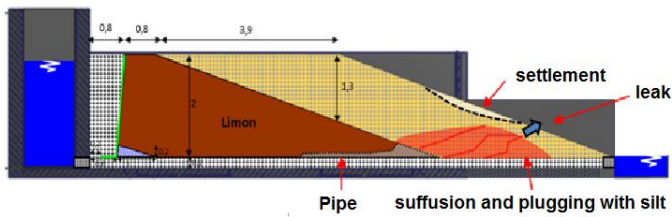
The reason for this upward progression is the clogging of the shoulder by eroded silt. The materials appeared to be less compacted and the silt dryer in

Test 2.2 than in the other tests. The exit of the flow was plugged by the eroded silt, and the erosion of the shoulder fill progressed upwards near the surface of the slope (Fig. 18).

Figure 18: Interpretation of the progression of erosion on the downstream face of test 2.2

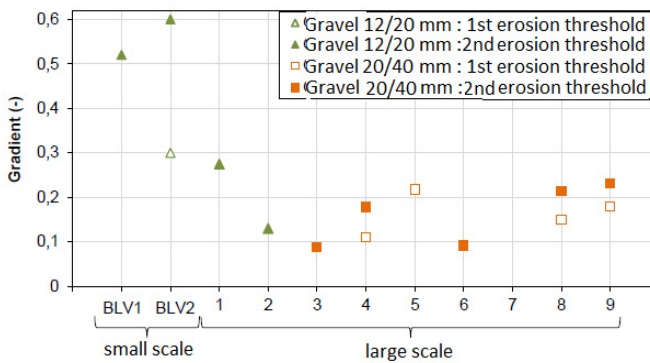
Figure 23. Critical hydraulic gradients at small and large scales.

Higher critical hydraulic gradients occurred when the gravel layer was clogged by the transported fines. Thinner is the gravel layer, larger is the clogging and larger are the threshold values: that is the explanation of the higher values at small scale. The scatter of the critical values of the hydraulic gradient is larger than the scatter of the critical values of the

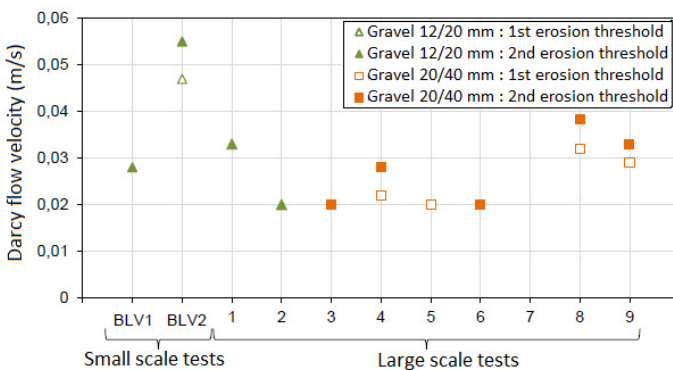
Figure 24. Critical hydraulic Darcy flow velocities at small and large scale.

Darcy flow velocity. The minimum critical value of Darcy flow velocities at small scale, 2 cm/s, is equal to the minimum value of Darcy flow velocities at large scale (It is not the same for the hydraulic gradient). According to the large pore sizes of the gravel, the permeability is not constant: it follows the Forcheimer relationship; the Darcy flow velocity gives a better threshold of contact erosion. Based on that result, we can conclude that with enough thick gravel layers, there is no scale effect on the critical value of Darcy flow velocity. However the critical hydraulic flow velocity can be increased by clogging of the thin gravel layer (< 20 cm).

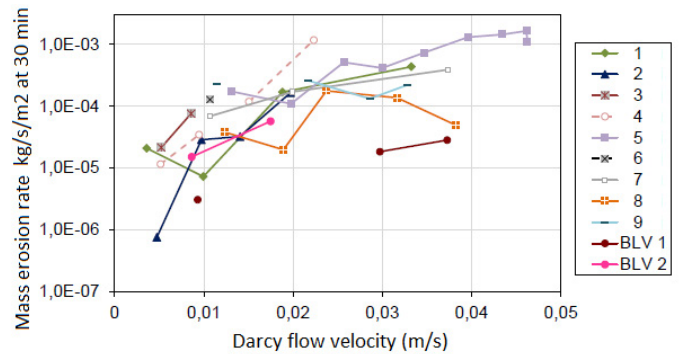
The observed critical flow velocity is the start of a continuing transport of fines, eroded from the silt contact. It does mean than below that critical flow velocity there is no erosion. The figure 25 shows the trend of the erosion rate measured in the first 30 minutes of the tests: the threshold value is not seen on that figure.

Figure 25. Mass erosion rate versus measured in the 2 small scale tests and the 9 large scale tests (Beguín 2011).

Erosion occurs with a Darcy flow velocity lower than the critical value, however that erosion decreases and stops quickly; after the transport of the finest particles, the largest particles lay down on the contact and do a temporary open filter, up to a new increase of the flow velocity.

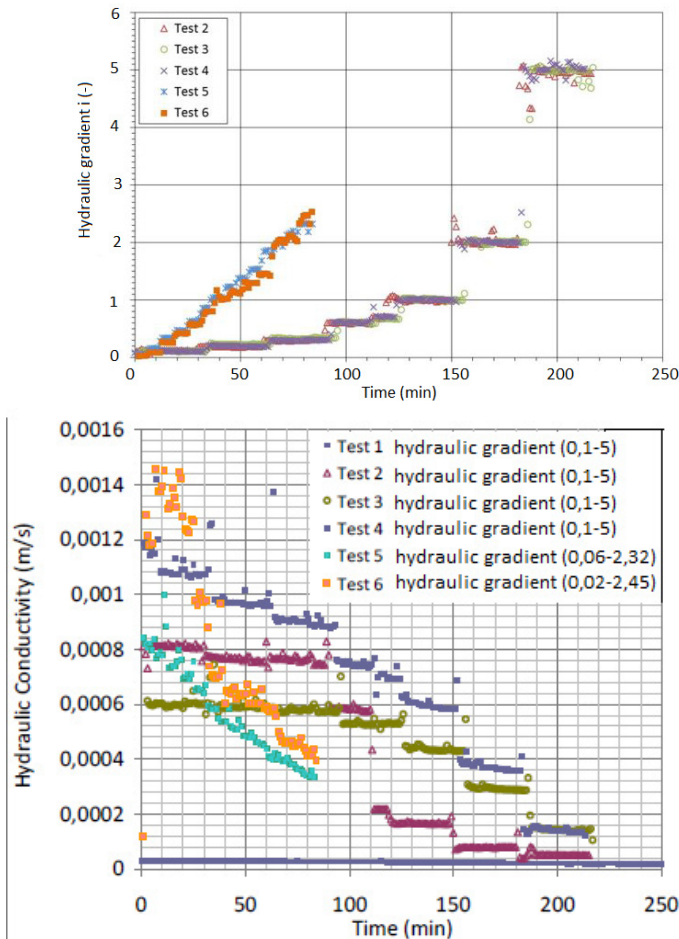
transport of fines, the second is the clogging of gravel by transported fines leading to a decrease of permeability (Fig. 26) and the third is the hydraulic fracture leading to crack formation and sudden release of leakage. The initiation of the first step was difficult to observe, the second step was observed under a large range of values of hydraulic gradient and the third step triggered the shoulder failure or backward erosion. It is difficult to define a critical value of the hydraulic gradient from the measurements of permeability in the oedo-permeameter of the GeM (Fig.26).

Figure 26. Hydraulic gradient and permeability of the Chavanay gravel (Marot & al 2014).

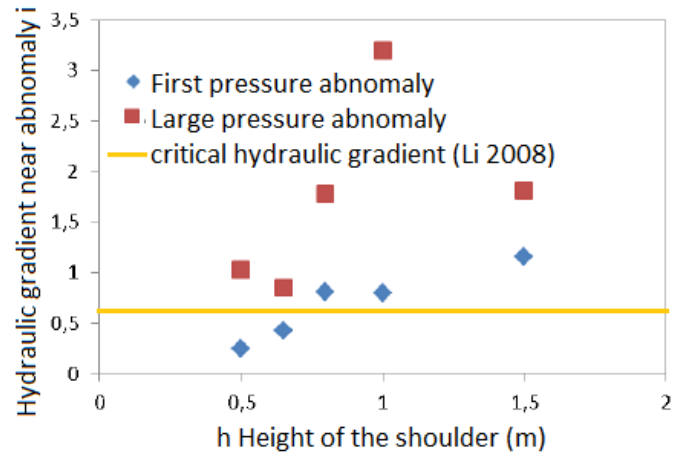
In some experiments the permeability has been decreasing since the lowest value of the hydraulic gradient, in some others there is a clear decrease for hydraulic gradients i higher than 0,6. The value $i_c=0,6$ is in agreement with the critical hydraulic gradient defined by Li (2008). However the scatter of the critical hydraulic gradient is one more time observed in the large scale tests. In Figure 27, the critical gradient $i_c=0,6$ is compared to the calculated hydraulic gradient nearby the pore pressure cell detecting in the large scale tests a first change and a large change of pore pressure, assuming signs of massive transport of fines. From the pore pressure cells the critical hydraulic gradient increase with the vertical stress (the height of the shoulder). This point needs clarification.

Figure 27. Comparison of critical hydraulic gradients for the suffusive Chavanay alluvium.
