**TR-335  
2008**

## **Thermal Imaging of Canals for Remote Detection of Leaks: Evaluation in the United Irrigation District**

**Texas Water Resources Institute Technical Report  
November 2008**

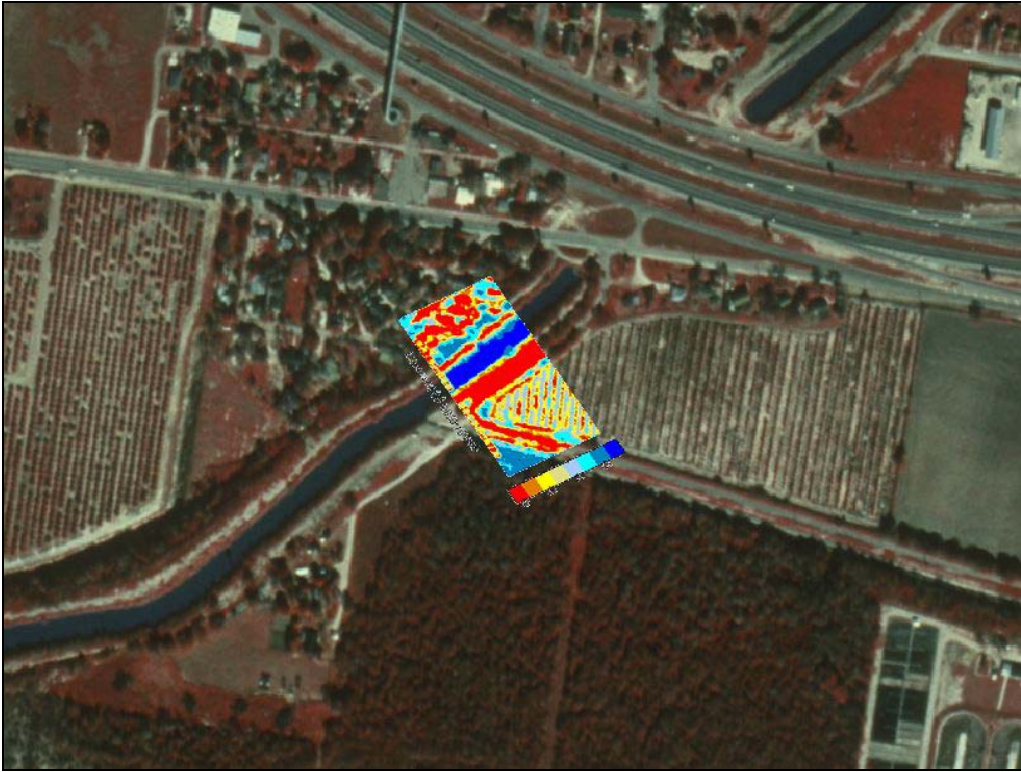
Figure 2b. Site 1 – Inverted image, overlaid onto the DOQQ.

As seen in figure 2a, on one side of the canal (right side on the image) there is a wide strip which is likely a dirt road on the canal levee. On the same side beside the canal, an area showing the possibility of wetness or vegetation (mark circled on the right of the image). On the other side of the canal (left side on the image), there is another area of vegetation and/or wetness and a narrow dirt road (mark circled on the left of the image).

To help locate the site, the image was inverted and overlaid onto the DOQQ image (Fig. 2b). The results of the field rating were as follows:

- Wetness: 2
- Vegetation:
  - Grass – 2
  - Trees – 2
  - Crops – 0
- Seepage: 2
- Cracks: 0
- Holes: 2

Photographs taken at this location show a large tree and the dirt road on the same side of the canal (Figure 2c). Water appears to be flowing out of the canal through a large hole located near the tree. Figure 2d shows thick vegetation (grasses and bushes) with a narrow stripe of dirt road. The site evaluation matched very well our interpretation of the thermal imagery.

***Conclusion: this canal segment has a severe seepage problem at this location caused by a hole in the canal.***

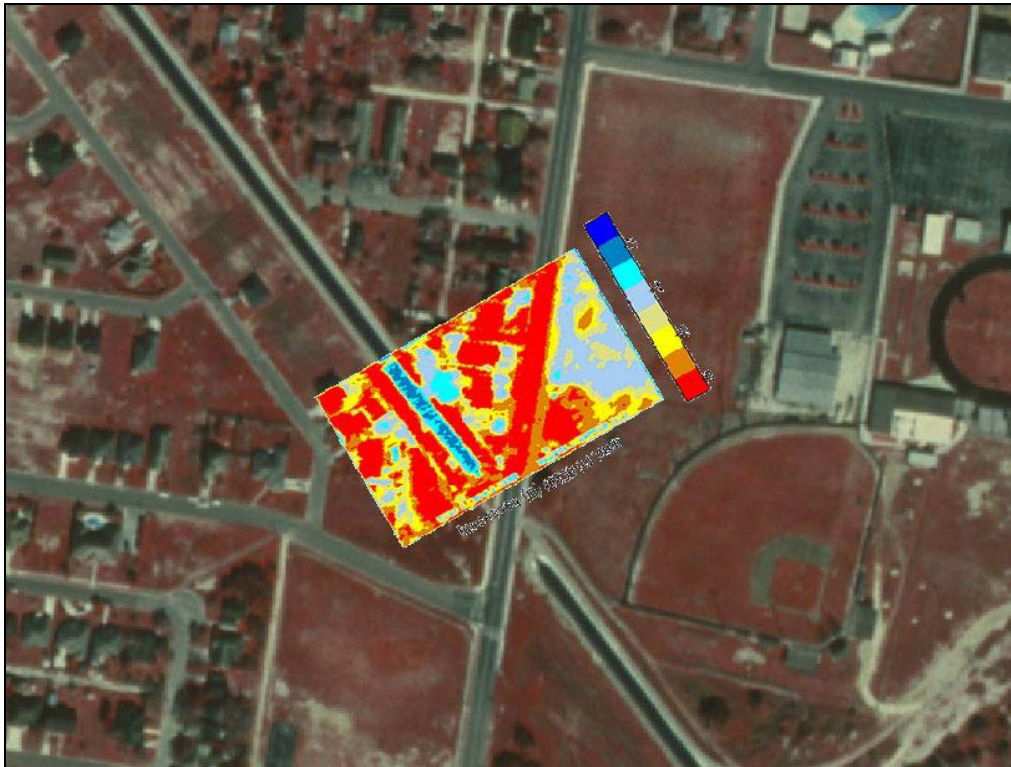
Figure 3b. Site 2 – thermal image inverted and overlaid onto the DOQQ.

As shown in Figure 3a, the thermal image shows two areas of wetness (mark circled on the image) on either side of the canal. Figure 3b shows the inverted image overlaid onto the DOQQ (Figure 3b). The results of the field evaluation are as follows:

Site photographs (Figure 3c-d) show a structure on the side of the canal which appears to be an abandoned gate through which water is flowing. As this is the only place along the canal with thick vegetation, the abandoned gate is likely the only source of the leak.

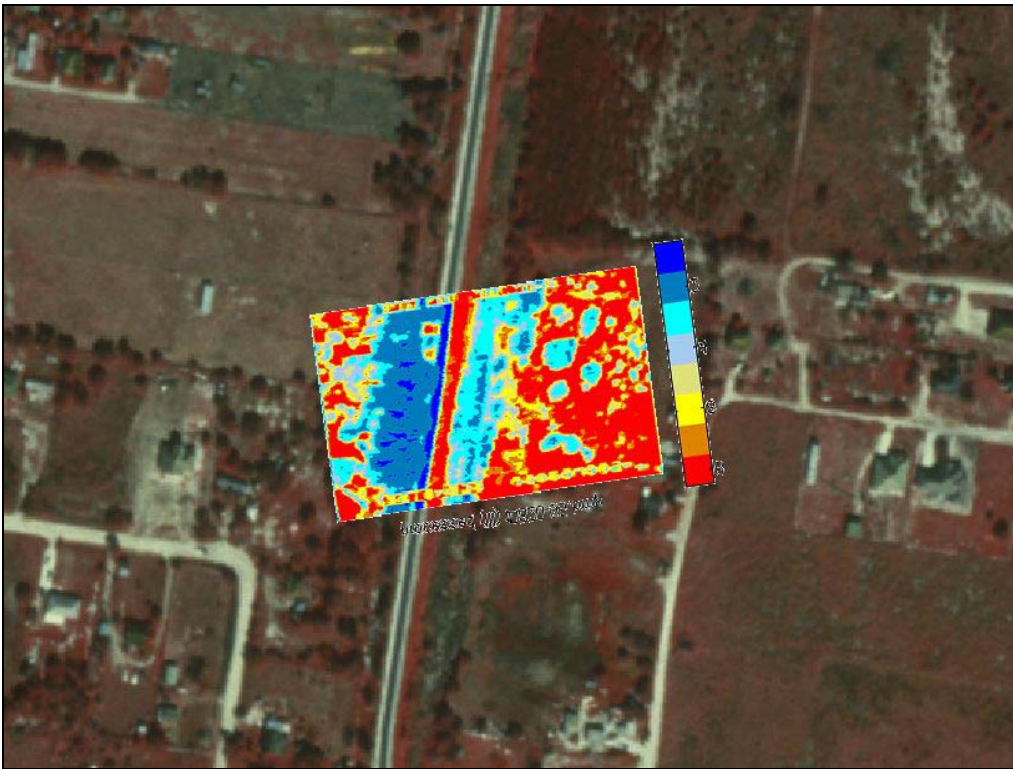
Figure 4b. Site 3 – Inverted thermal image, overlaid onto the DOQQ.

As shown in figure 4a, there is likely a seepage area along one side of the canal (left side on the image). The rating of this site is as follows:

The field photograph (Fig. 4c) shows thick vegetation on the side of the canal having and many cracks. Some of the cracks are sealed but others are not. These unsealed cracks appear to be the cause of the seepage from this canal segment.

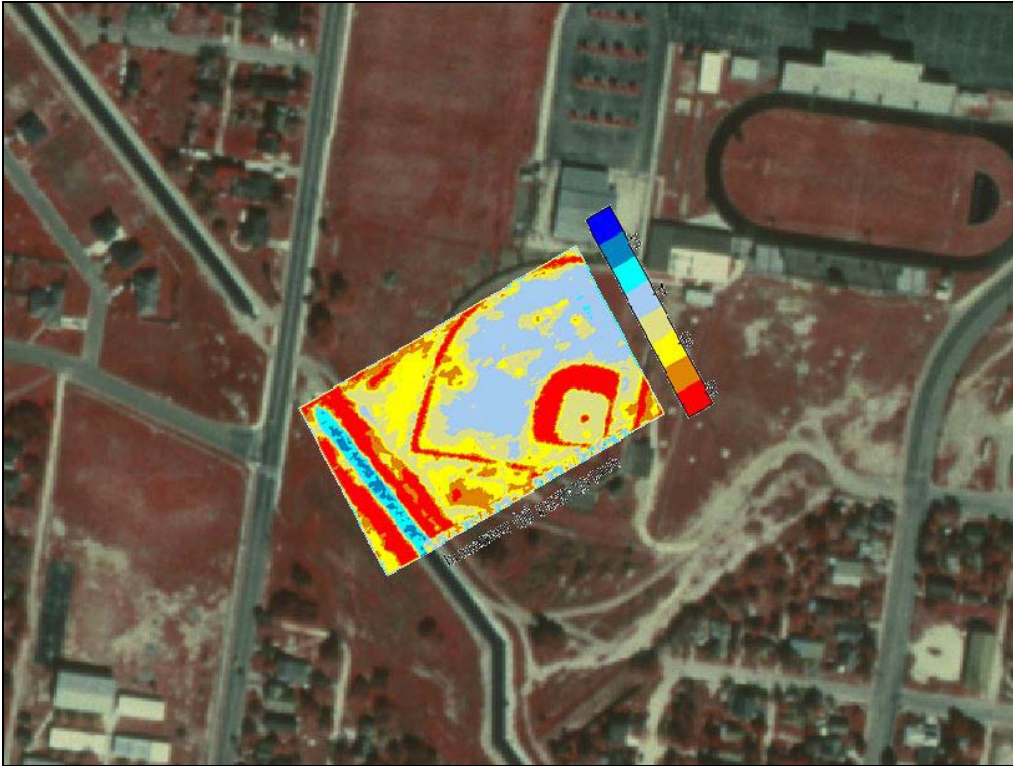
Figure 5b. Site 4 - inverted and overlaid onto DOQQ.

Figure 5a shows a canal segment beside a baseball field. While there is no indication of vegetation or wet areas along this segment, there is something other than a dirt road (line-marked on the image). This image was inverted and overlaid on the DOQQ image (Fig. 5b). The rating results are as follows:

The photograph (Fig. 5c) shows some dead vegetations spread over the sides of the canal, but otherwise the conditions of the canal is good. This canal segment does not have a detectable leak.
