THE REHABILITATION OF PIPE NETWORK FROM SPRINKLER IRRIGATION PLOTS

Mihail LUCA¹, Alexandru-Lucian LUCA², Nicolae MARCOIE¹ Ilie LOGIGAN¹

The case study was drawn up for an sprinkler irrigation plot located in the „Albița – Fălciu Complex Facility” Vaslui County. The irrigation plot 7 is located at the southern boundary of Satu Nou - Berezeni village, Berezeni commune, Vaslui County (Luca M., 2015). The total irrigated area within the plot is 1222 ha. The irrigation system was designed by I.S.P.F. Bucharest in 1977 and was executed between 1977 and 1980.

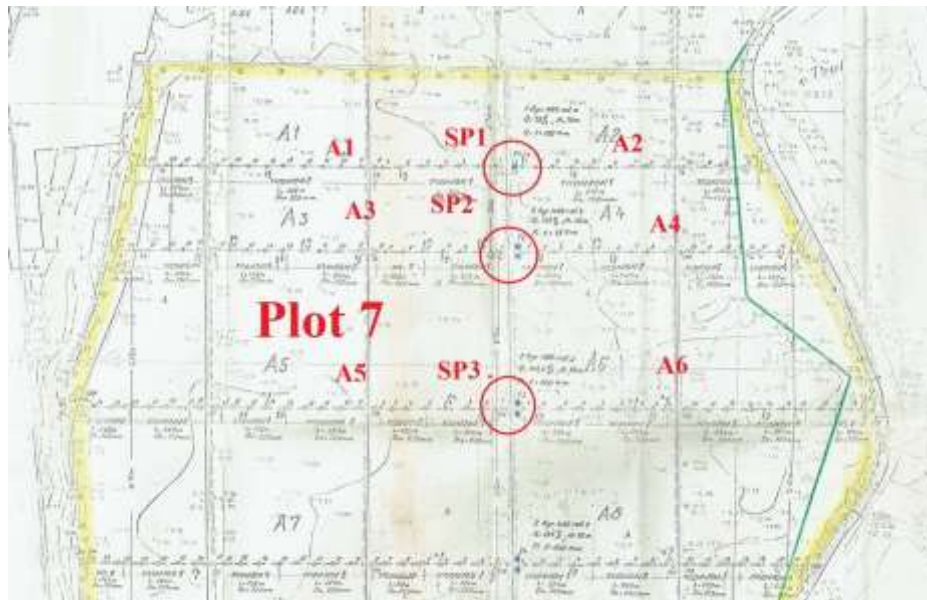
Figure 2 Doniceasa – Fălciu Irrigation Plot 7 site plan (North area) for the designed version (Luca M., 2016)

The layout of Plot 7 covers 1222 ha and is supplied with water by the CSD82 canal connected to the CA5 canal (*figure 2*). Irrigation water is taken from Prut River with the reversible pumping station SRP4 Berezeni and introduced into the CA5 canal. Irrigation plot 7 Doniceasa - Fălciu was designed for watering by aspersion and the sizing was done for watering equipment used in the 1980s (IIAM-17 watering installations). The operation used two watering installations batteries, which imposed operational flows and pressures.
