A LEGACY SLOPE FAILURE IN PENLEE QUARRY - A WARNING TO OTHERS

McAllister, R., Walton, G., Coggan, J. and Wetherelt, A. 2013. A legacy slope failure in Penlee Quarry - a warning to others. *Geoscience in South-West England*, **13**, 183-190.

Penlee Quarry has a 90 m high slope which is 50-60 years old and is showing increasing signs of instability with two significant collapses in 2010 and 2011. The latter collapse gave rise to a possible flow slide at the toe and a significant air blast. This paper presents details of the underlying joints controlling ground movements, the investigation of these joints and proposals for remedial works. There are implications for other similar slopes elsewhere in England.

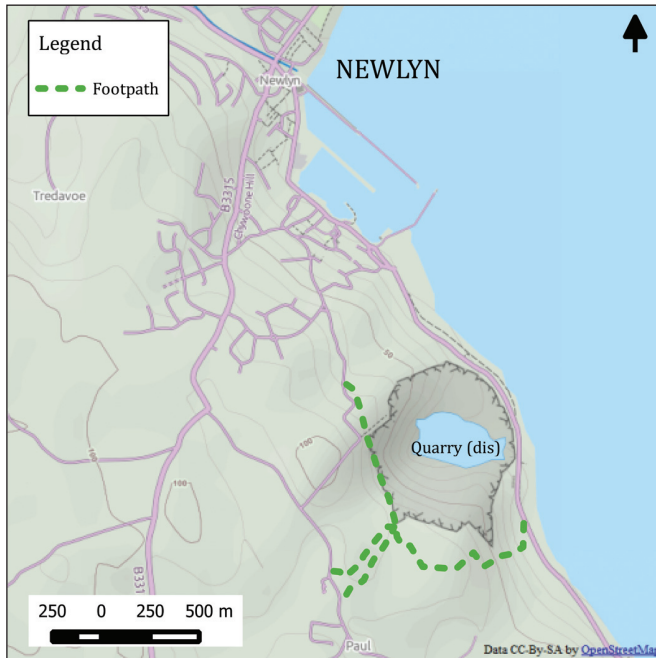
The western highwall has its toe at *c.* 10 m A.O.D., is about 90 m high and has a single debris choked bench at *c.* 45 m A.O.D. The slope runs parallel to the site boundary, immediately beyond which lies a public footpath and arable farmland (Figure 2).

Figure 2. Location of Penlee Quarry showing the generalised slope ornamentation for the western highwall and the quarry pond.
