Large Steel Tank Fails and Rockets to Height of 30 meters - Rupture Disc Installed Incorrectly

Published in:
Safety and Health at Work

Publication date:
2016

**Vertical cylindrical 90 m³
steel tank operated at
"slight overpressure"
rockets to height of 30 m –
rupture disc overpressure
relief device inoperative,
installed upside down**

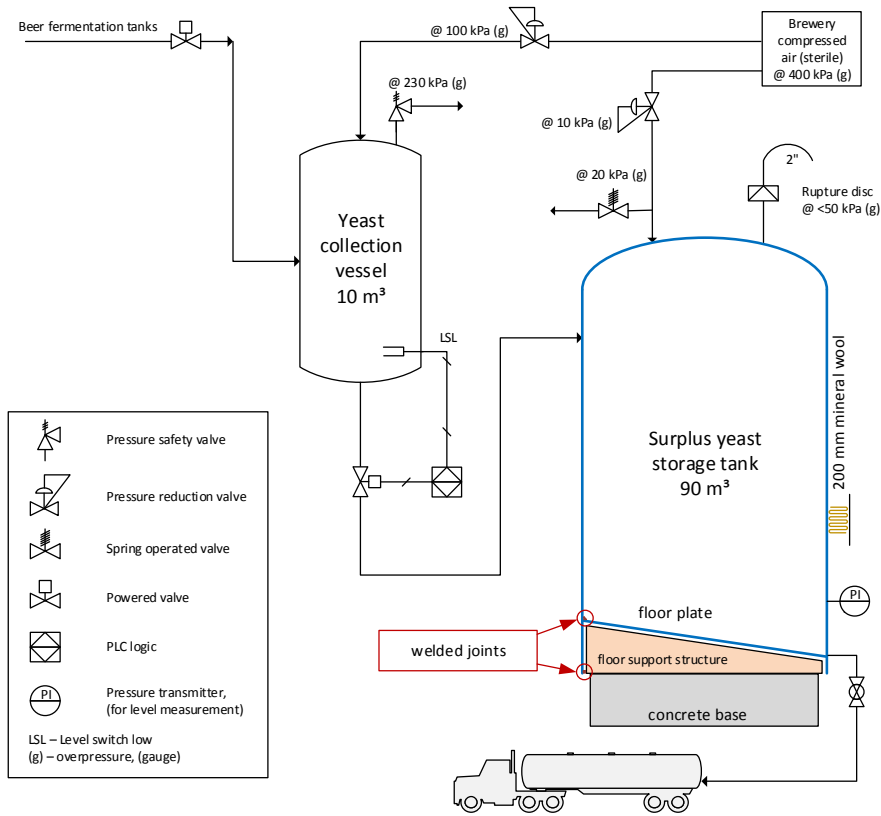
Figure 1 Schematic representation of surplus yeast system

Surplus yeast is a biologically active material and an excellent medium for the growth of unwanted microbes. Occasional nuisance foaming is a concern and the storage tank was therefore modified to operate at a pressure of 10 kPa to suppress foaming. A spring operated pressure valve was set at 20 kPa (g) to allow for tank breathing during loading, when the incoming liquid reduces the headspace vapor volume in the tank. An overpressure relief device, a rupture disc (bursting disc), was installed in the tank's two-inch vent line. The vendor specification sheet gives the burst pressure range of 43-49 kPa @22 °C.

The rupture disc was intact. It was a reverse buckling type device that had been installed upside down (i.e. with the dome facing away from the tank). The vendor stated when asked, that the

rupture disc likely could withstand an overpressure of at least three times the stamped pressure (i.e. 150 kPa or more) before bursting, if installed upside down.
