# INVESTIGATION OF THE FUNDAMENTAL RELIABILITY UNIT FOR CU DUAL-DAMASCENE METALLIZATION

## ABSTRACT

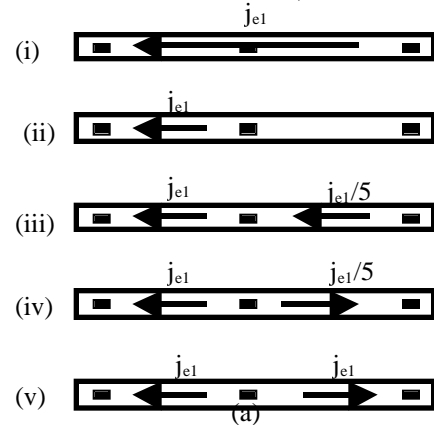
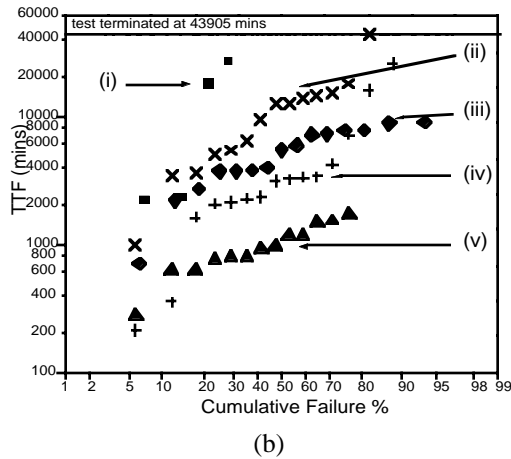
Five different current configurations were tested on a 0.28 $\mu\text{m}$ -wide and 500 $\mu\text{m}$ -long dotted-I structure as shown in Figure 6(a). Figure 6(b) shows the lognormal distribution of the times-to-failure (TTF) of the dotted-I structures tested at 350 $^{\circ}\text{C}$ , with a constant current density of  $j_{e1} = 2.5$  MA/cm $^2$  in the left limb, and a current density with varying direction and magnitude,  $j_{e2}$ , in the right limb. Failure was defined as the minimum time for a 30% increase in the resistance in either one of the segments in the test structure. The lognormal plots indicate that the lifetime of the test structure depends on the current configuration in the right segment, with  $t_{50}$  increasing from case (v) to case (i). Similar values of  $t_{50}$  were obtained for case (v) in the Sematech samples.

Fig. 6: (a) Schematics of dotted-I test structures with five different current configurations used in the experiments. Tests were carried out at  $T = 350^{\circ}\text{C}$  and  $j_{e1} = 2.5 \text{ MA/cm}^2$ . The arrows show the direction of electron flow. (b) Times-to-failure for 500µm-long, 0.28µm-wide dotted-I structures with different electron current configurations as shown in (a).

The lognormal plot in Figure 6(b) shows that the direction and magnitude of the electron current in the right segment of the dotted-I structure affect the overall reliability of the whole interconnect tree. The  $t_{50}$  increases from test configuration (v) to (i), which is different from what was observed in Al metallization [3]. We will discuss each of the five different cases below.
