**Video and Laser Microscopy Investigation of Adhesive
Joint Fracture in Fiber Reinforced Composite Materials**

Master of Science in Naval Architecture and Marine
Engineering

MASSACHUSETTS INSTITUTE OF TECHNOLOGY

June 1996

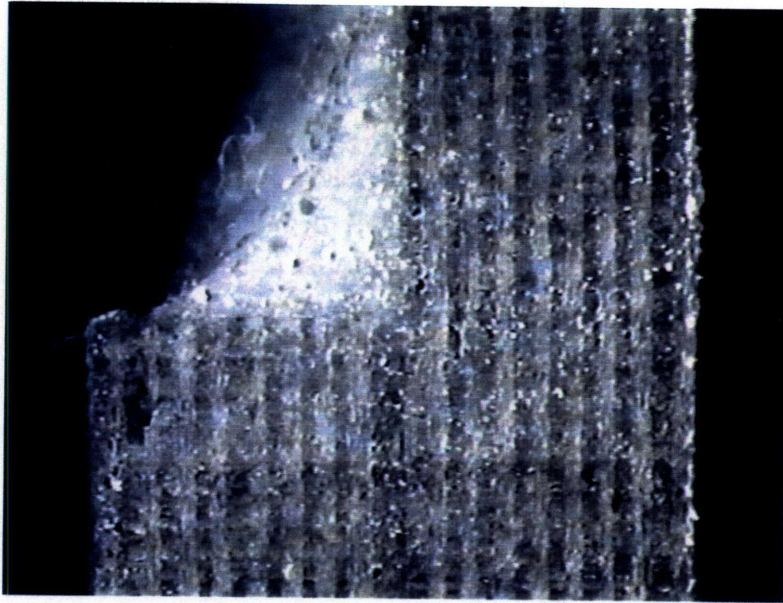
Figure 4.1: Typical Hysol Sample Before Testing

The Hysol samples, with one exception, exhibited failure in the adherend itself. The one exception, **h4**, is likely to have been an imperfectly cured batch of adhesive. The specimen failed with a dull thud, as opposed to a sharp cracking sound of the other samples, and the surface of the failed adhesive felt greasy. For the other four, the adherend was observed to fail by delaminating, and the crack both propagated and opened. The crack failed at the interface between the outer 0° ply and the adjoining 90° ply. The initiation of the crack was actually outside of the actual joint area for at least one sample, **h2**, and at the end of the joint for the others.

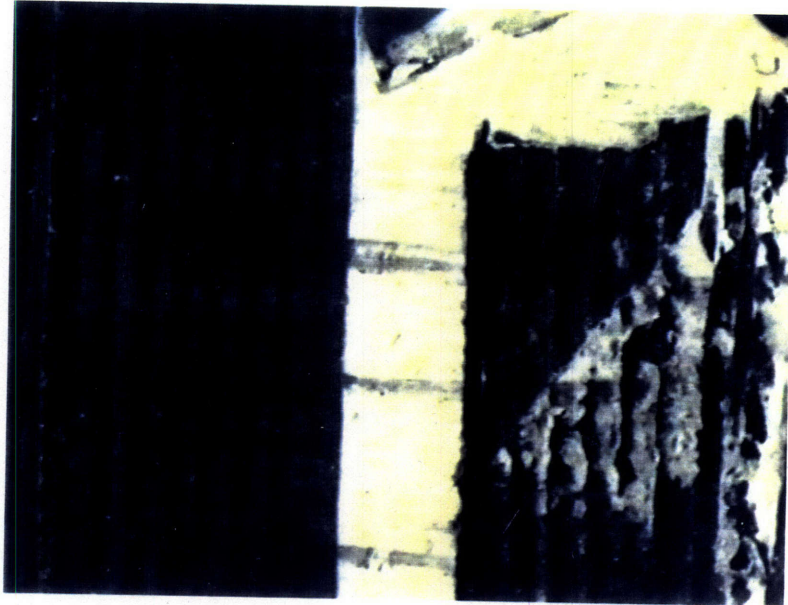
Figure 4.2: Typical Plexus Sample Before Testing

The Plexus samples showed deformation in the adhesive. This could be observed as a distortion of voids on the surface, and a distortion of marks created by the sanding process used to clean the edges for observation. These marks were normal to the plane of the joint. The distortion was entirely in the adhesive, originally indicated as deformations of voids or the sanding marks. As the displacement continued to increase, neighboring voids would distort and join with what appeared to be a ductile fracture. Failure would also occur at the adhesive-adherend interface, with a crack appearing and opening in what seemed to be Mode I failure. In at least one specimen, a crack at the adhesive-adherend interface rapidly cracked from one interface to the other in an approximately 45° direction. This would indicate that the cracking changed from Mode I to Mode II, and then back to Mode I. While the overall fracture surface after failure appeared to be a shear mode, the video data showed that the bending moment created by the couple contributed to Mode I failure, as

cracks could be seen to be opening in a direction normal to the applied load, with the crack extension parallel to the applied load.

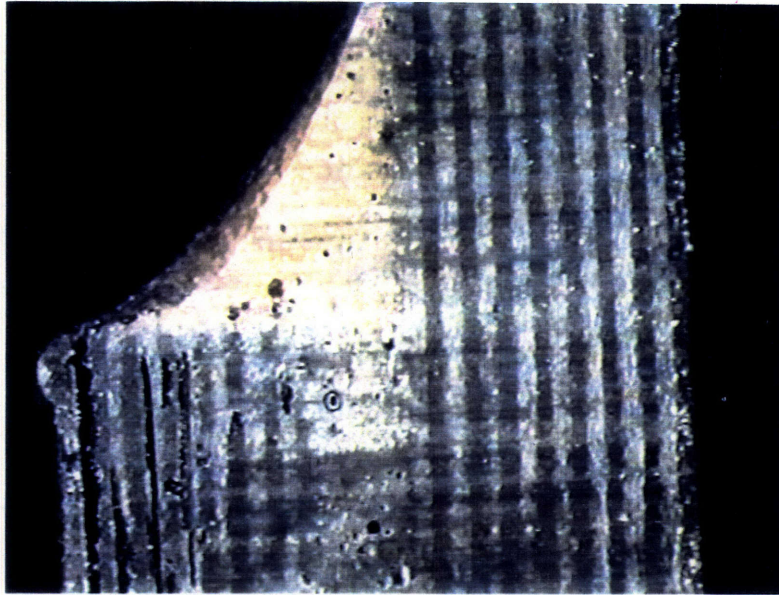
Figure 4.3: Typical Gougeon Sample Before Testing

These samples had the lowest failure loads. The load increase was very linear. These specimens exhibited no visible yielding, and they were the most consistent in failure load and mode. The failure was always in adhesion between the adhesive and the adherend, and very brittle; no cracking of the adhesive or delamination of the adherend was observed prior to the onset of sudden failure. There was some slight fiber transfer observed on the fracture surface after failure.

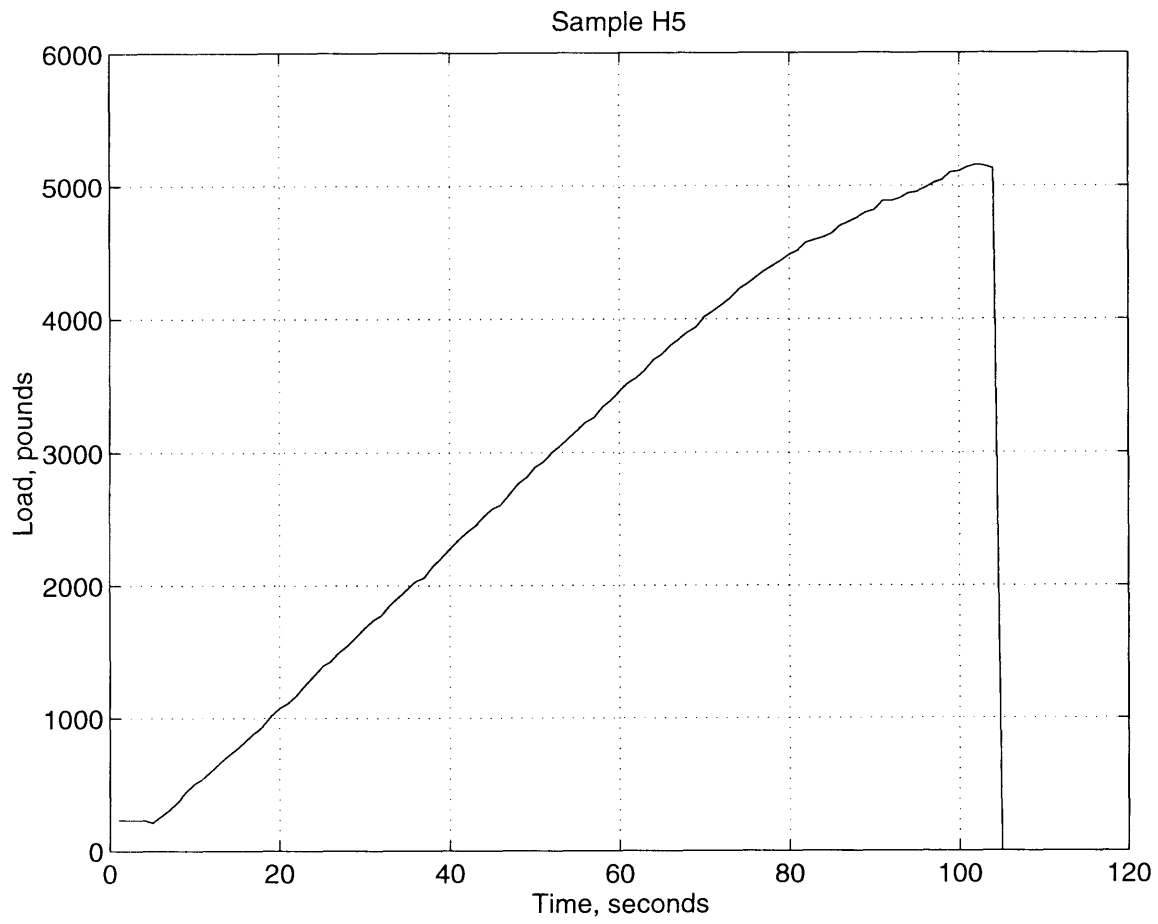
Figure 4.11: Hysol Sample **h5** Load vs. Time Graph

At this time, no cracking can be observed. The load increase, see figure 4.11, is still linear.

The very beginnings of a crack can be observed at this point. The crack is occurring underneath the end of the joint, in the middle of the image. The load increase in figure 4.11 shows the beginnings of a non-linear behavior at this time.

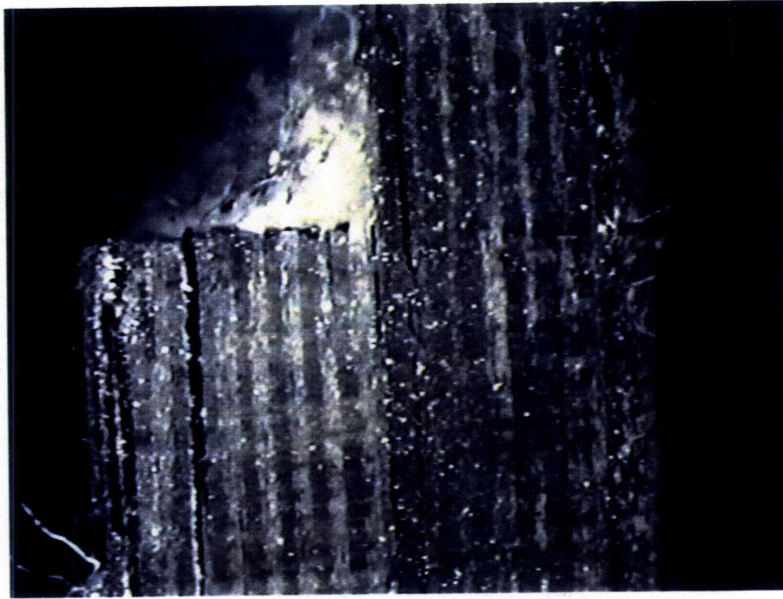
Figure 4.17: h5, 100 seconds

The crack is now rapidly propagating under the joint. However, the greatest opening displacement is beyond the ends of the joint. At the top of the image, fiber failure appears to have occurred, as can be seen by the distinct jog in the crack path

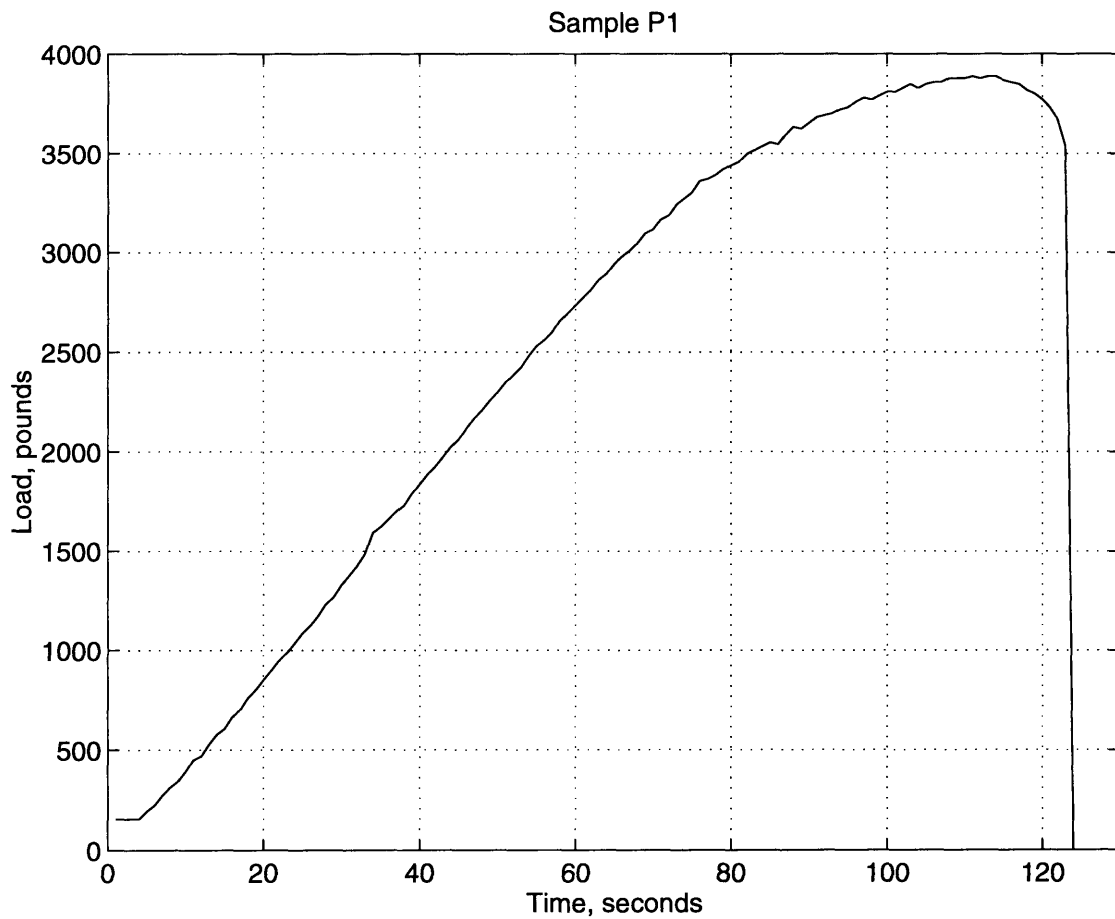
Figure 4.18: Plexus sample p1 Load vs. Time Graph

This image is taken at 60 seconds. As can be seen in figure 4.18, the load increase has just begun to exhibit a non-linear behavior. It can be seen that the adhesive has begun to distort in a Mode II manner, the scribed reference mark is no longer in a straight line.

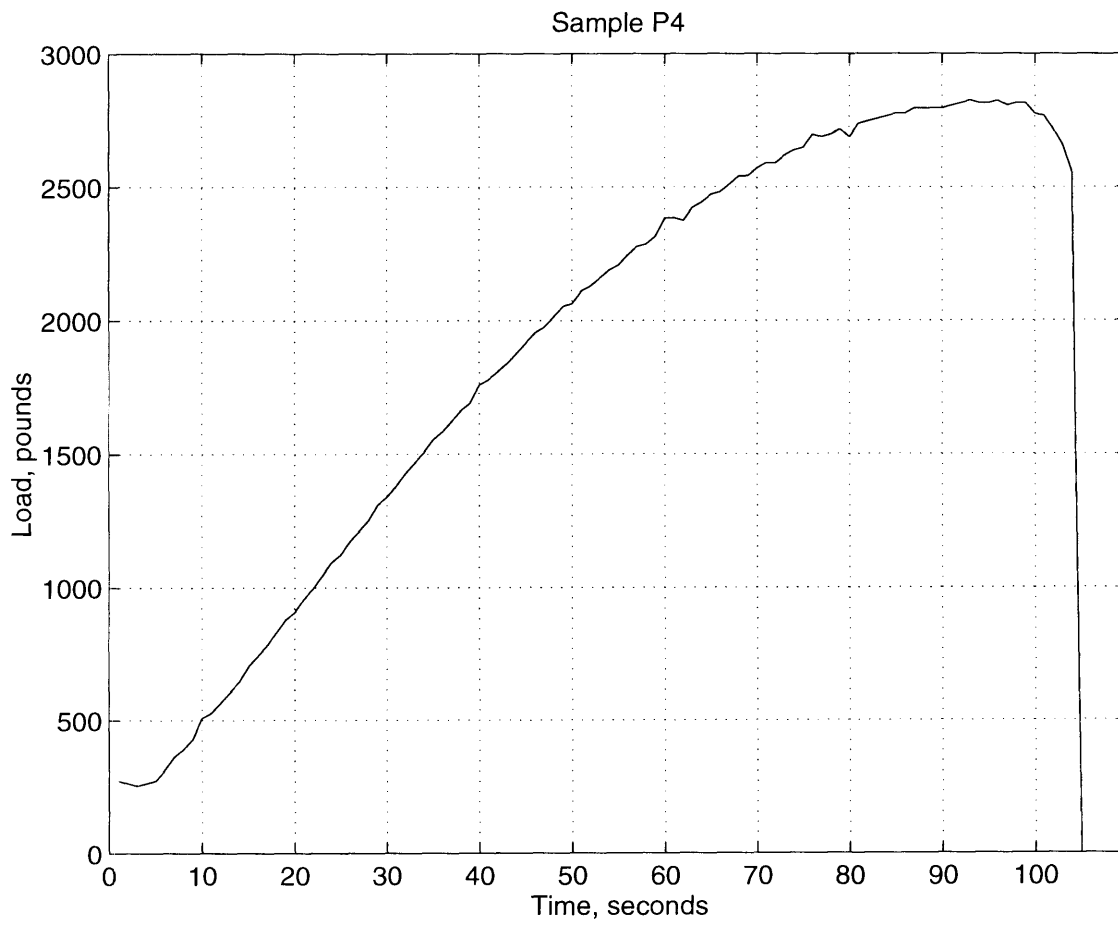
Figure 4.23: Plexus sample **p4**, Load vs. Time Graph

At this time, the void can be seen to be distorting. In addition, the reference mark shows Mode II movement of the joint. Figure 4.23 shows that the load data is beginning to exhibit a non-linear behavior at this time.

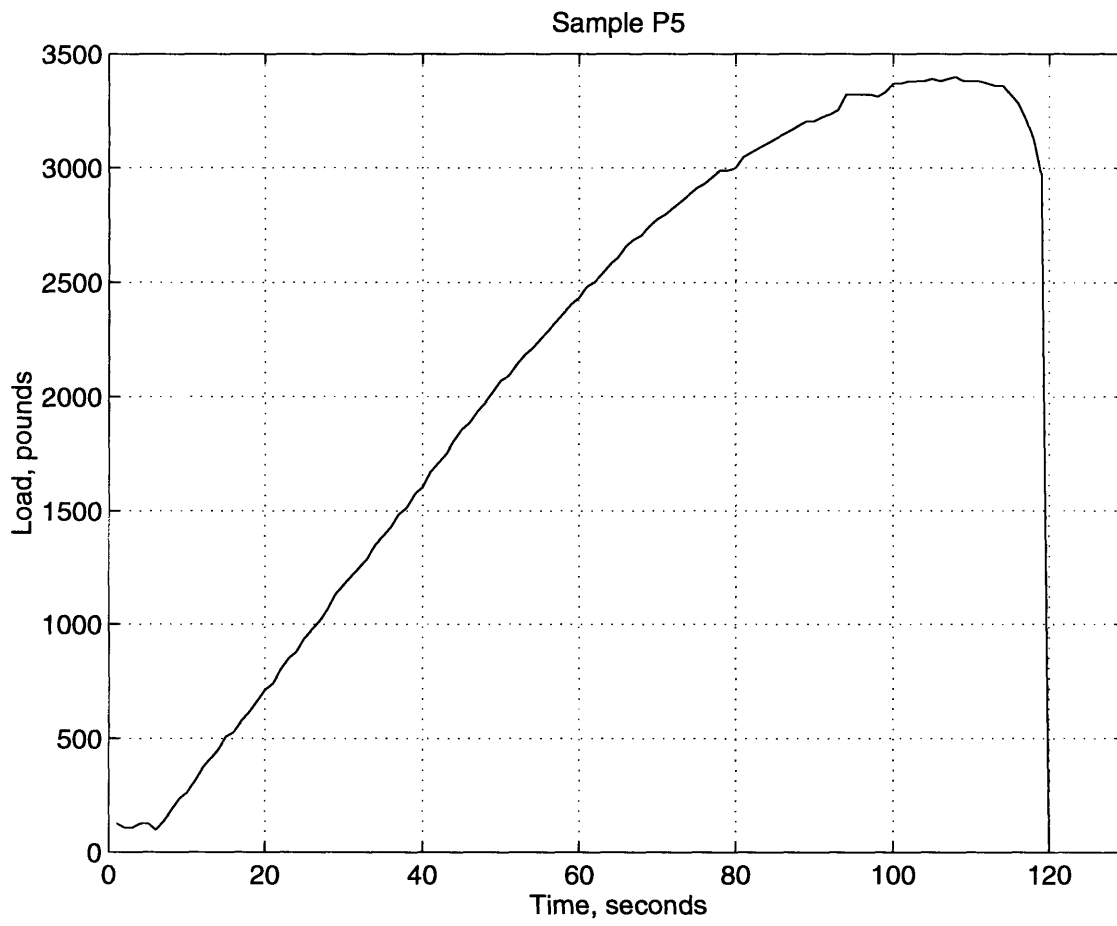
Figure 4.30: Plexus sample p5, Load vs. Time Graph

For this image, the microscope has been lowered to follow the crack tip. The crack is continuing to open in a Mode I fashion, and the crack tip is progressing down the adhesive adherend interface. At the lower left part of the image, another crack can be seen to be forming. At this point the load increase is beginning to flatten considerably, as can be seen in figure 4.30.
