XRD ANALYSIS IN FRONT OF A CORROSION CRACK TIP

C. GHEORGHIEȘ, S. LEVCOVICI, V. PĂUNOIU, L. GHEORGHIEȘ,
C. OANCEA, I. OSTACHE, P. ALEXANDRU

During exploitation of the heat exchangers some damages can appear in the contact region between the gaskets and the stainless steel walls. The studies upon the material were performed using SEM microscopy, X-ray diffractometry and the finite element method. The obtained data allow the explanation of the complex damage mechanism of the heat exchanger wall. Following our research, the manufacturing technology of the heat exchangers was changed and this way the rebuts were eliminated. The performed research is based upon physical methods and the damage mechanism of the heat exchanger plates is explained by means of the physical phenomena that appear and develop during working conditions.

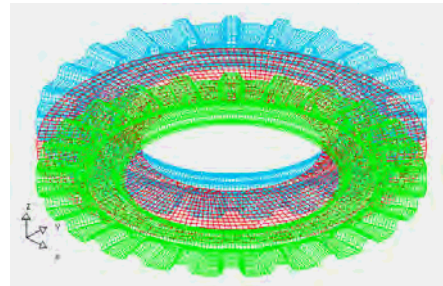
We can see in figure 1 the complex geometrical model in the simulation position. After an 80 hours running program, we could get a complex simulation, starting with 2500 elements and finishing with 67852 elements because of the automatic remaking of the finite elements net.

Fig.1 The complex geometrical model in the simulation position

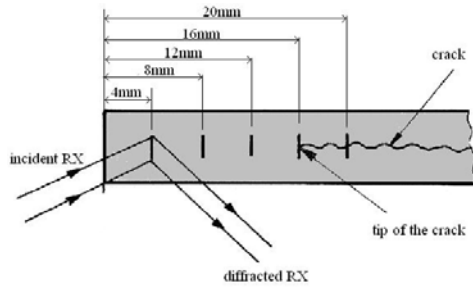
Fig. 12, a - X-ray irradiation scheme with a beam perpendicular on the direction of the crack

Fig. 12, b - X-ray irradiation scheme with a beam parallel with the direction of the crack
