CERN TE-Note-YYYY-000

EDMS No. 1054648

Summary of QRL 7-8 repair and re-installation leak test results.

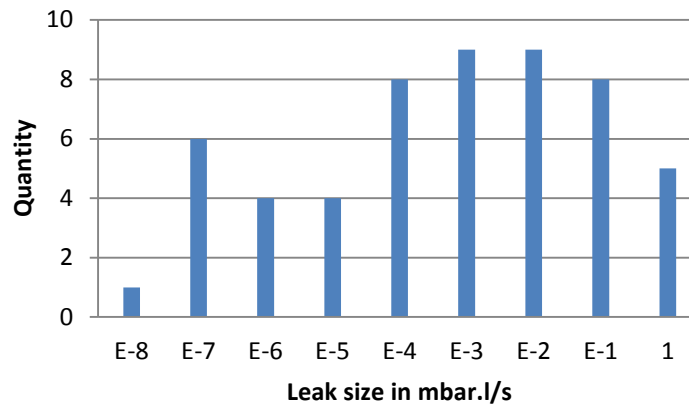
Figure 9 – Size distribution of detected and localised leaks.

Tables 1 to 3 below give a summary of the leaks classified by location, origin, type. Figure 9 shows the leak size distribution. Appendix D gives a full overview with the relevant details for every leak.

Origin of leak	Quantity	Examples
Leaks in tunnel welds	27	pinholes, cracks, lack of penetration, unfinished welds
Imported leaks	25	leaking welds, leaking compensators, leaking cryo-valve
Leaks caused by parallel tunnel activities	8	badly mounted instrumentation feedthrough, untight gyrolok connection, drilled hole in compensator
Total	60

Type of leak	Quantity
Welds	48
Bellows	2
Drilled holes	3
Cefilac seals	3
Others and unknown	4
Total	60
