# Reconstruction of the Grenfell Tower Fire—Thermomechanical Analysis of Window Failure During the Grenfell Tower Disaster

*Maxime Koohkan, Virginie Dréan, Bertrand Girardin\*, Eric Guillaume and Xavier Duponchel, Efectis France, route de l'Orme Des Merisiers, 91193 Saint Aubin Cedex, France*

**Abstract.** Observations and numerical studies have allowed an understanding of the fire development inside apartments and over the façade during the Grenfell Tower fire. During these analyses, the highlighted need was for a deeper investigation into the failure of windows during the fire. This detailed and complex model for window failure validates the thermal breakage criteria used in fire simulations of the whole Grenfell Tower fire. However, the present investigation is dedicated to a single pathway for the influx of fire and toxic smoke. Other pathways from the façade to the apartments, such as the melting of elements surrounding the window frame, are not addressed here. To analyse window behaviour during fire, Finite Element Method thermomechanical modelling is used. First, a heat transfer analysis is performed for windows subjected to the external flames from the identified façade f

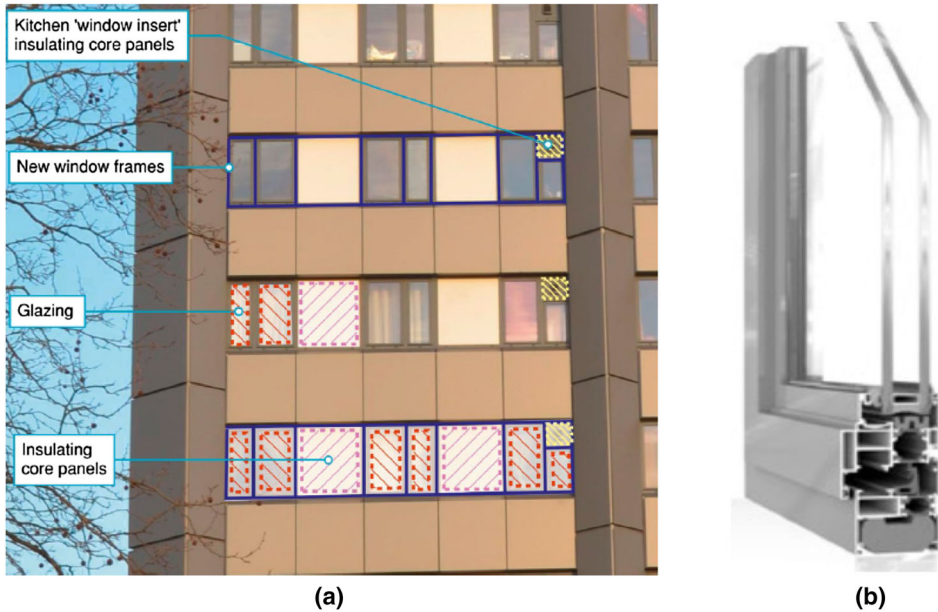
**Figure 1. a View and schematics of the different window framing arrangements used for different parts of Grenfell Tower at or above the 4th floor. Window infill panels are aluminium faced polymer foam-filled composite panels—Moore-Bick report of the public inquiry (Fig. 6.1, p. 34) [29]. b Cross section of the window System 5-20 used in the refurbishment of Grenfell Tower [38].**

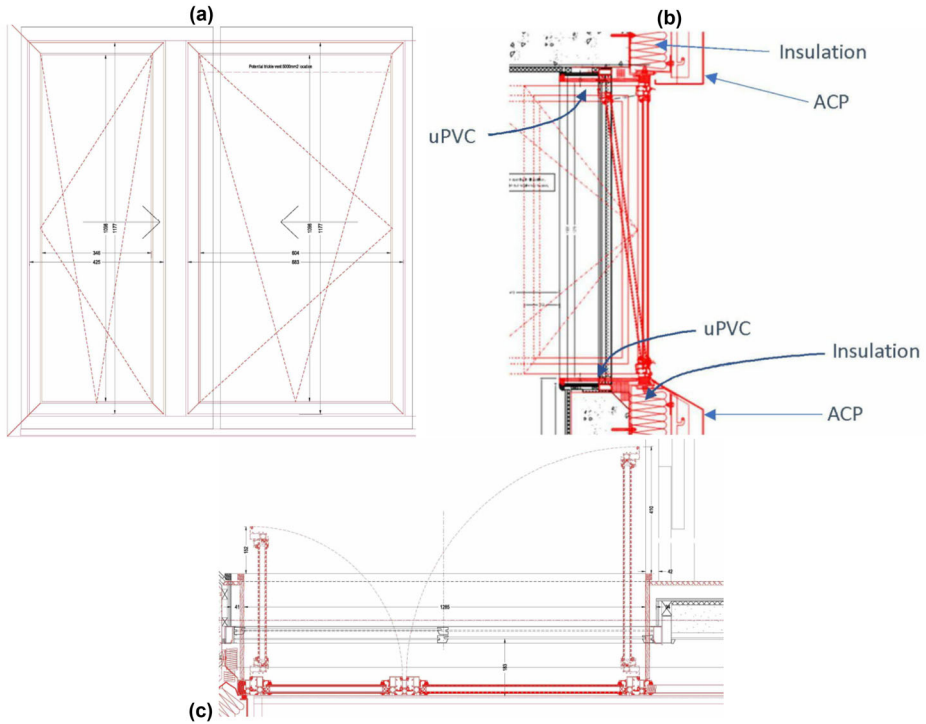
The details of the the window unit structure according to [39] are shown in Fig. 2. The window unit comprises two glazed elements of different size. Different opening configurations are allowed: closed, open, and in-tilt. The right side opening is restricted to 100 mm opening in the tilt position. The left side casement window pivots around the left side frame column.

**Figure 2. Details of the window system used in the refurbishment of Grenfell Tower a front view, b side view (from J. Torero's expert report [32] Fig. 8, p. 40), c top view.**

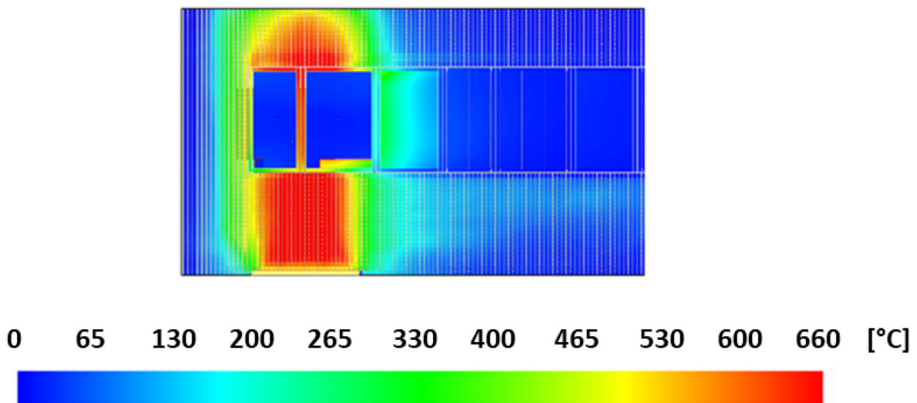
**Figure 5. Numerically modelled temperature of the external window on the 5th floor, directly above Flat 16 of the Grenfell Tower, after 4 min of façade fire exposure [34].**

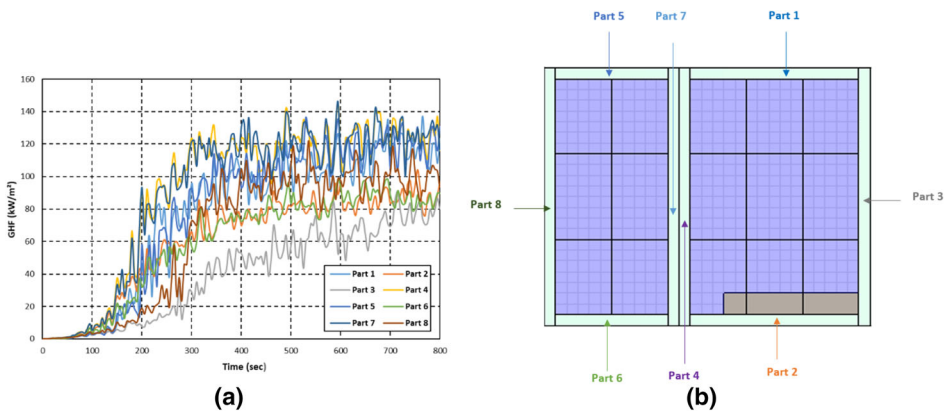
the external frame of the window located at the 5<sup>th</sup> floor, directly above Flat 16, were subjected after 4 min of façade fire exposure. The heat flux fields applied to the exposed face of the window are addressed in Fig. 6a. The position for each part of the window is indicated in Fig. 6b. These thermal loads are representative not only of fire break-out through a typical window, but also of the developed façade fire during vertical fire spread over the tower, as observed in Fig. 7. At later stages of the façade fire, the numerically estimated thermal loads (in terms of gauge heat flux) on window frames are consistent with the general flux evolution indicated in Fig. 6. The maximum heat fluxes imparted to Parts 1, 5 and 7 of the window frame (Fig. 6b) is about  $120 \text{ kW/m}^2$  after 3–4 min of fire exposure, while the minimum heat fluxes evaluated for the lower Parts 2 and 6 and lateral Part 3 of the window frame (Fig. 6b) are between  $30$  and  $70 \text{ kW/m}^2$ . There are differences for the windows attacked thermally during horizontal fire spread where thermal gradients can change slightly. Flames affect Part 8 of the frame before Part 5 (Fig. 6b) but the delay in such horizontal gradients is less than 1 min.

**Figure 6. Heat fluxes to which the outer face of windows were exposed for all sections of the frame—Position of each window frame section [34].**

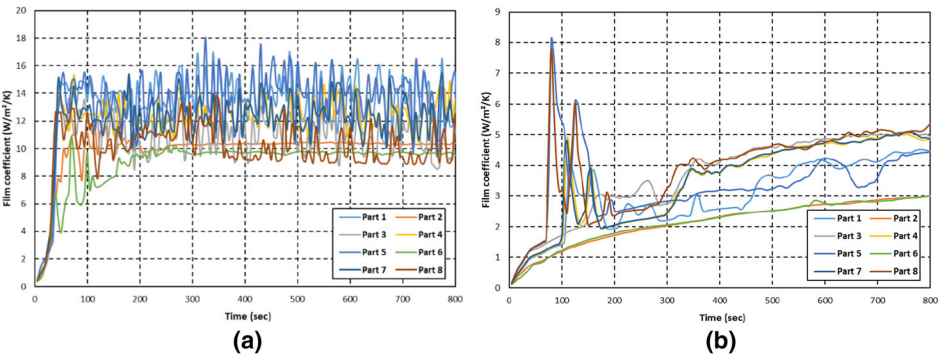
For the outer and inner faces of the window, the heat transfer coefficient (film coefficient) is taken from the CFD simulation (see Fig. 8). As shown in Fig. 8, the coefficient ranges between  $10$  and  $15 \text{ W}\cdot\text{m}^{-2}\cdot\text{K}^{-1}$  for the exposed side of the window, where the flow is turbulent, and is about  $4 \text{ W}\cdot\text{m}^{-2}\cdot\text{K}^{-1}$  at unexposed side of the window.

**Figure 8. Evolution of the convective coefficient applied to the exposed (a) and un-exposed (b) faces for all sections of the window frame.**

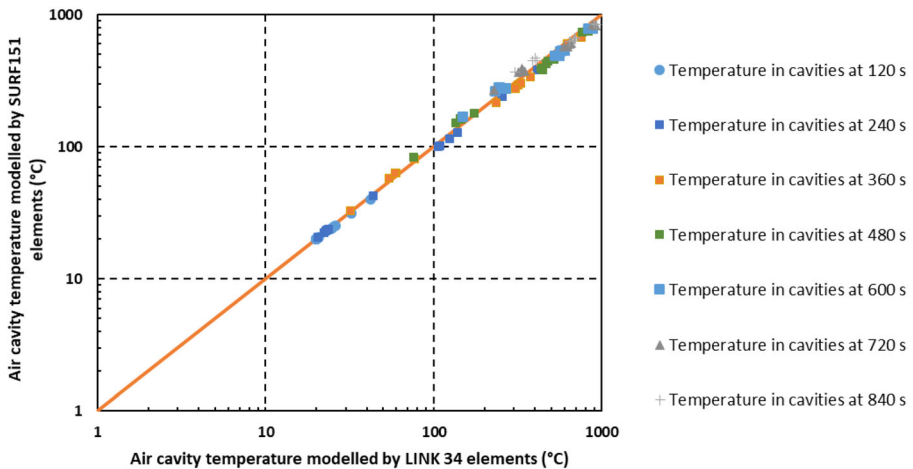
**Figure 10. Comparison between the bulk temperatures for the modelling of convection by LINK34 elements versus SURF151 elements in the cavities of the window frame.**

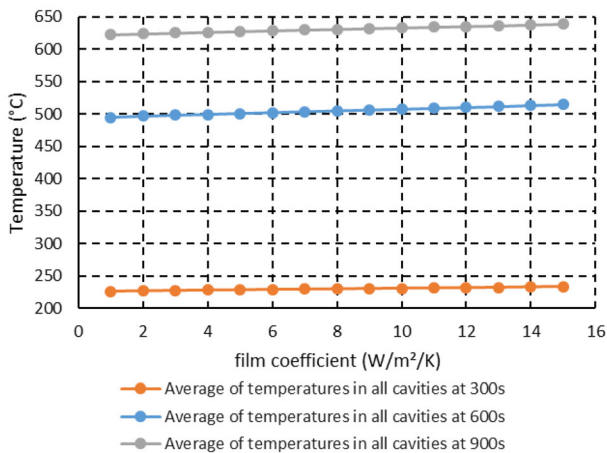
A sensitivity analysis is performed for the convective coefficient in the cavities, for window Part 1 (see in Fig. 6b). Heat fluxes and adapted exchange coefficients are applied to the exposed faces (see in Figs. 6 and 8). Figure 11 presents the average temperature in all cavities at 300 s, 600 s and 900 s. The computations show that the variation of film coefficient in the cavities for this study may be neglected. The average increase of the temperature in a cavity for an increase of  $1 \text{ W}\cdot\text{m}^{-2}\cdot\text{K}^{-1}$  of film coefficient is about  $0.46 \text{ }^\circ\text{C}$  at 300 s and  $1.08 \text{ }^\circ\text{C}$  at 900 s.

**Figure 11. Average temperature in all cavities of the window frame at 300 s, 600 s and 900 s.**

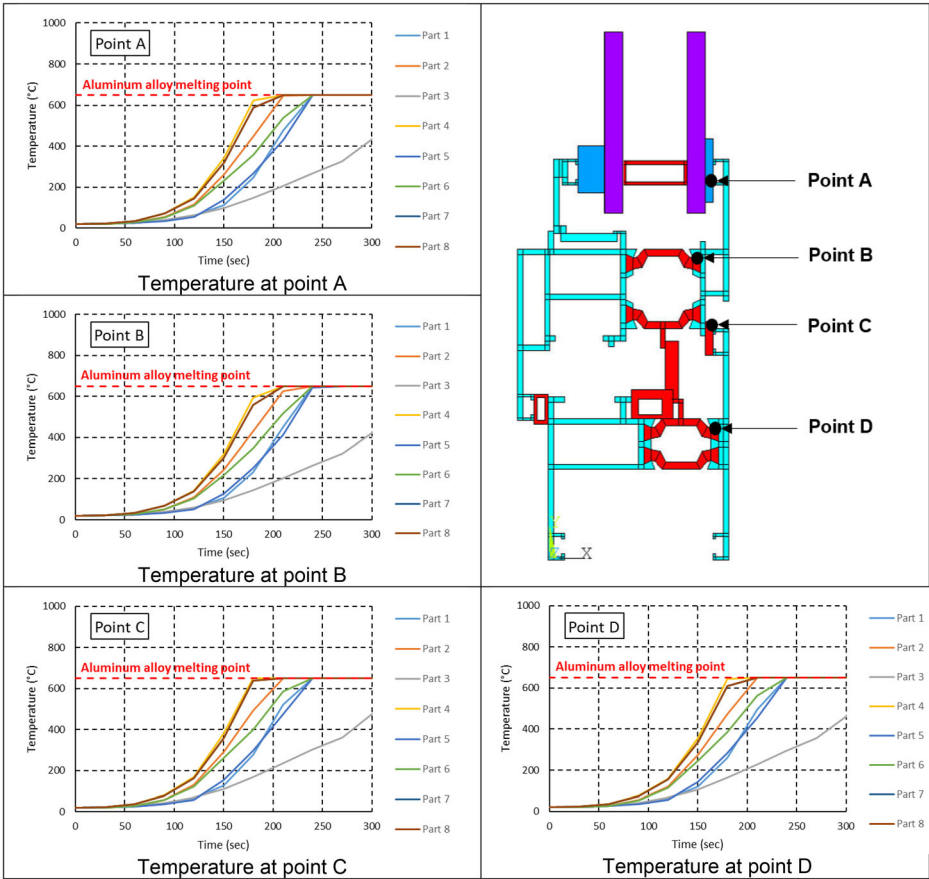
Time-history temperatures are evaluated for all of the frame sides (Parts 1 to 8). Temperatures at four locations A, B, C and D, located close to the polyamide thermal breaks, are indicated in Fig. 12. Temperatures are up to  $80 \text{ }^\circ\text{C}$  between 1.5 min (on Parts 4 and 8) and 2.5 min (on Part 3) of external fire exposure of the polyamide thermal breaks, and up to  $200 \text{ }^\circ\text{C}$  between 2 min (on Parts 4 and 8) and 4.5 min (on Part 3) of exposure for all positions close to the external side. This is consistent with the numerical observations in [34] where the external fire breaks the left part of the window first. Therefore, the thermal failure of the window frame is expected before 5 min of external fire exposure. This is consistent with the criterion of 4 min for the partial window failure considered in the fire model [34].

**Figure 12. Temperature over time, evaluated at four locations (A, B, C and D) in the window frame.**

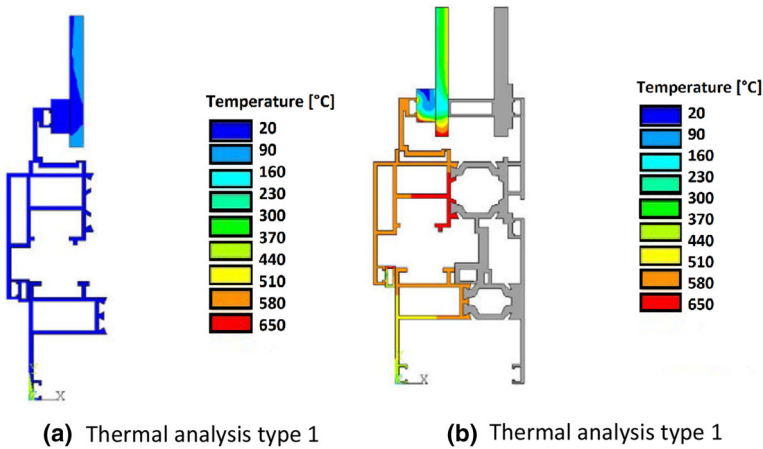
**Figure 14. Temperature fields at 240 s of fire exposure for the inner section of Part 8—(a) with external section in place (b) without the external section.**

The thermal heating of the internal profile of the window frame, in the above model, is no longer valid after the failure of the outside section of the frame.

Therefore, a new thermal analysis was set up (called thermal analysis type 2). The outside section of the window frame wall is deactivated. Surface boundary elements and conductive elements are removed (so called killed) during the analysis. Then, the new boundary surface elements are created (so called birth) on the inner face of the internal profile at 3 min. The thermal fields for Part 8 of the window frame at 240 s of fire exposure are shown in Fig. 14. Figure 14a shows the temperature field on internal profile of the window frame at 240 s, assuming that the external profile resists thermal heating (thermal analysis type 1). The maximum temperature is lower than 90 °C for the inner profile of Part 8 at this time. Figure 14b shows the temperature field of internal profile of the window frame at 240 s, assuming that the external profile fell away or melted at 3 min (thermal analysis type 2). The temperature of the internal profile, when the external profile has fallen away or melted, indicates that the internal profile may well melt or fall away before 4 min (240 s).
