# Remote assessment of tsunami damage in Japan by means of Google Street View images

## Project Report

Jessica Miles and Alan G. Bloodworth

University of Southampton

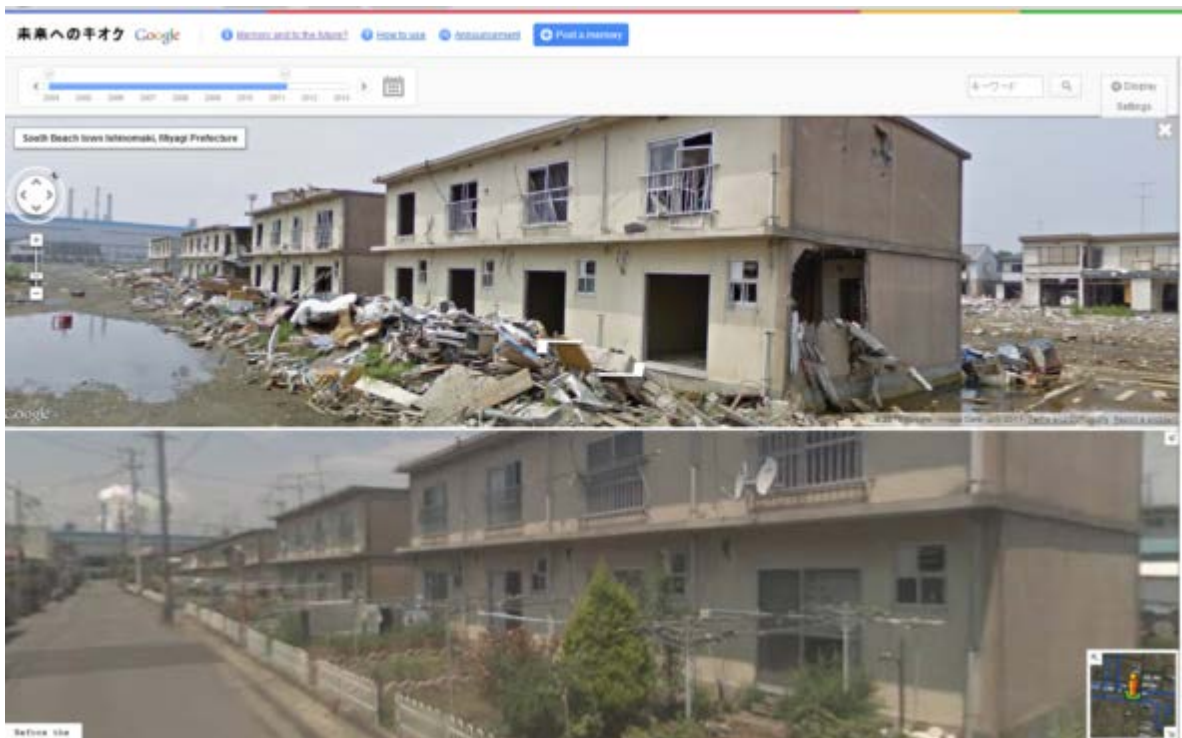
Google Street View cars were sent around major cities and coastal areas of Tohoku, photographing streets over a six month period starting four months after the tsunami. Images were compiled with those taken before the event to produce an accessible digital archive laid out to allow straightforward comparison of the 'Before' and 'After' situations at any location. Figure 1 shows a typical screenshot.

**Figure 1** 'Before' and 'After' Google Street View image (Google Street View, 2013a)

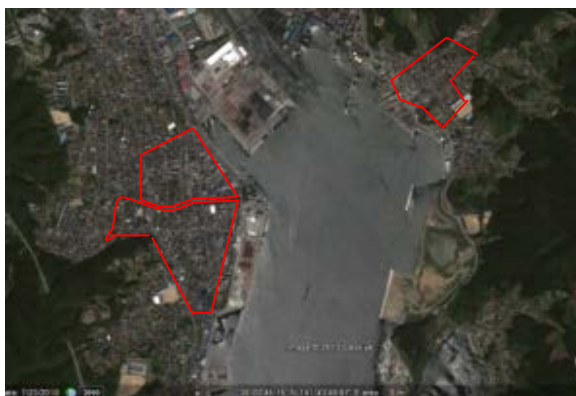
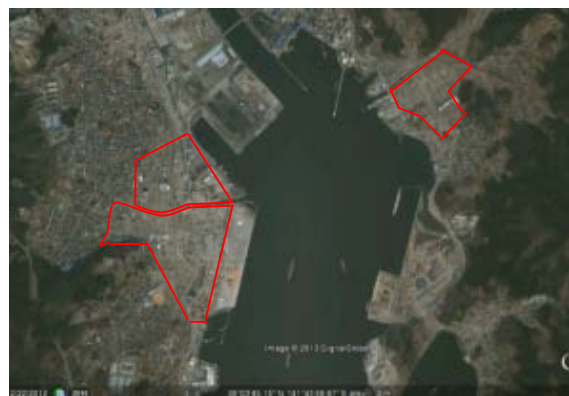
Ofunato is a city on the ria coastline, located in a narrow bay bounded by steep hills. Despite the wave funnelling to an inundation height of 13.13m at the shoreline, the steep rise in topography meant that 69% of housing escaped inundation (EEFIT, 2011). The harbour front is occupied by commercial buildings. Sample zones were chosen either side of the bay (Fig. 3) containing a total of 696 buildings before the tsunami, of which 108 (15.5%) remained standing sufficiently to be surveyed.

Figure 3 Sample zones at Ofunato 'Before' and 'After'- 04/04/10 (Google Earth 7.0, 2010a) (left) and 03/04/12 (Google Earth 7.0, 2012a) (right)

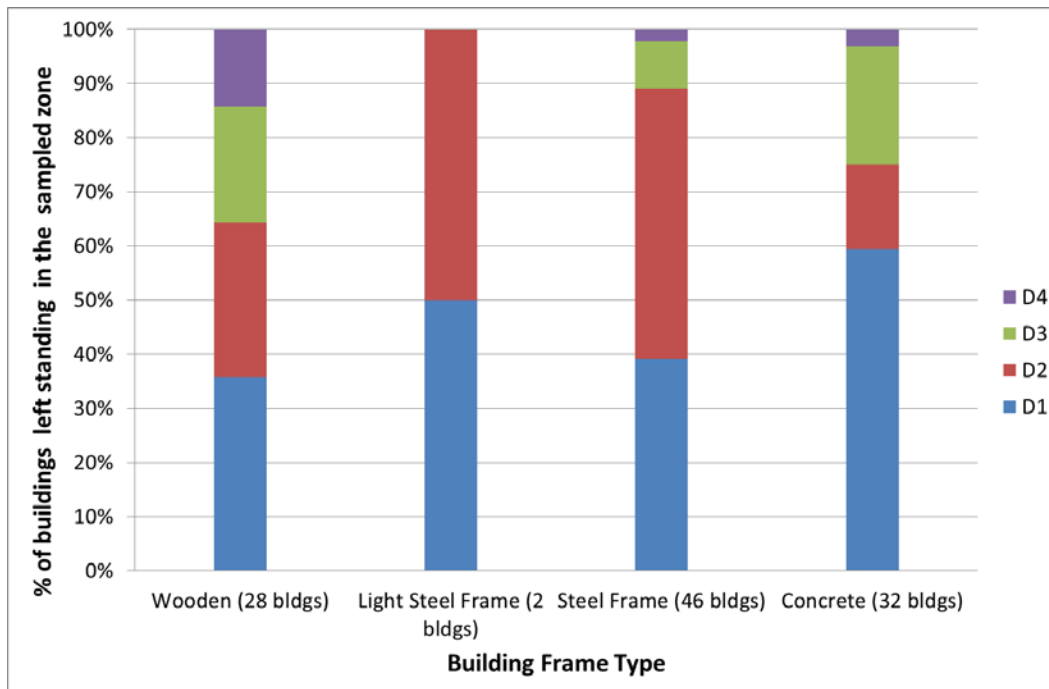
Data for the three sample zones were aggregated for analysis as they showed similar building distributions. Figure 4 shows that timber buildings were most heavily affected, with 36% of those left standing suffering D3 or D4 damage, followed by RC (25%), followed by steel (11%). More data on light steel framed buildings is available from Ishinomaki.

**Figure 4** Damage levels by building frame type for Ofunato (aggregated for all sample zones)

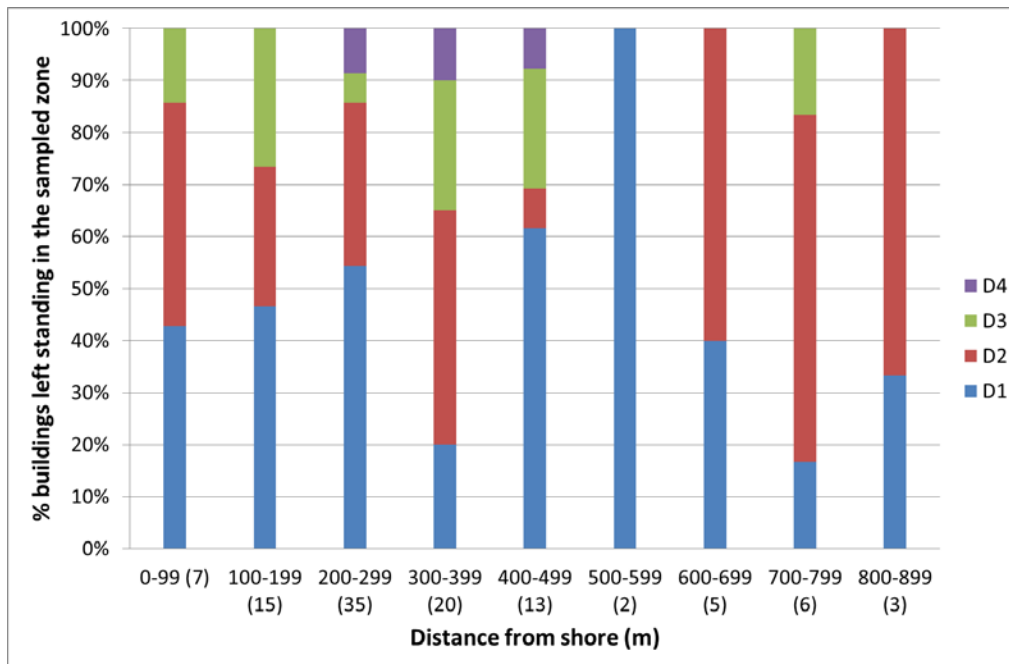
Figure 5 shows damage level with distance from shoreline, for all structure types. Only beyond 500m from the shoreline did the proportion of D3 and D4 buildings decrease (although the number of buildings is small at that distance). In the first 500m there is no clear damage trend, even though as the wave travels inland its speed and energy would be expected to decrease. A possible explanation is that accumulation of debris at the wave front, as noted by eye-witnesses, contributed to damage as the wave moved inland.

Figure 5 Damage levels with distance from shoreline – Ofunato (aggregated for all sample zones and building types, number of buildings at each distance in brackets)

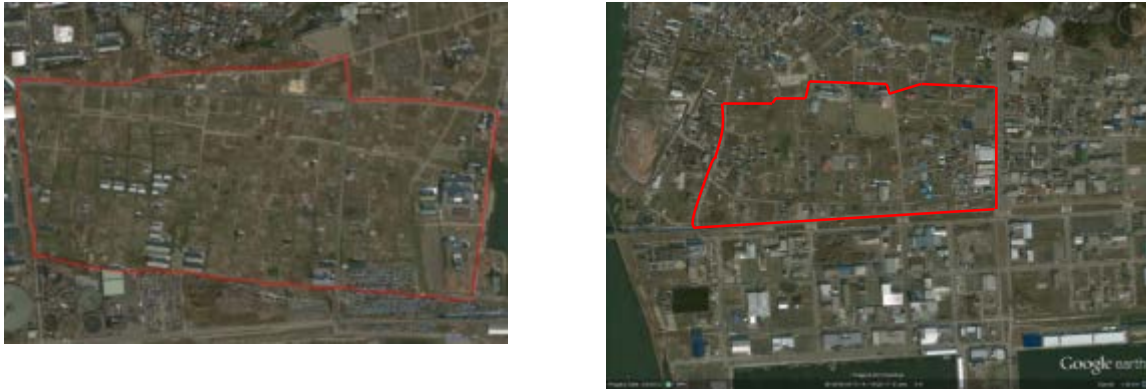
Figure 7 shows the sample zones in more detail after the tsunami. Although both contained mainly residential and small commercial buildings, their situation relative to the shoreline is different, with Area A in close proximity but Area B set back about 400m behind the port. Area A experienced approximately 91% obliteration of buildings compared to 68% in Area B. This is likely to be due to shielding by the port area that was densely filled with large industrial steel framed buildings, many of which remained standing to some extent.

**Figure 7** Ishinomaki: Area A 'After' - 03/04/12 (Google Earth, 7.0, 2012b) (left), Area B 'After' - 03/04/12 (Google Earth, 7.0, 2012c) (right)

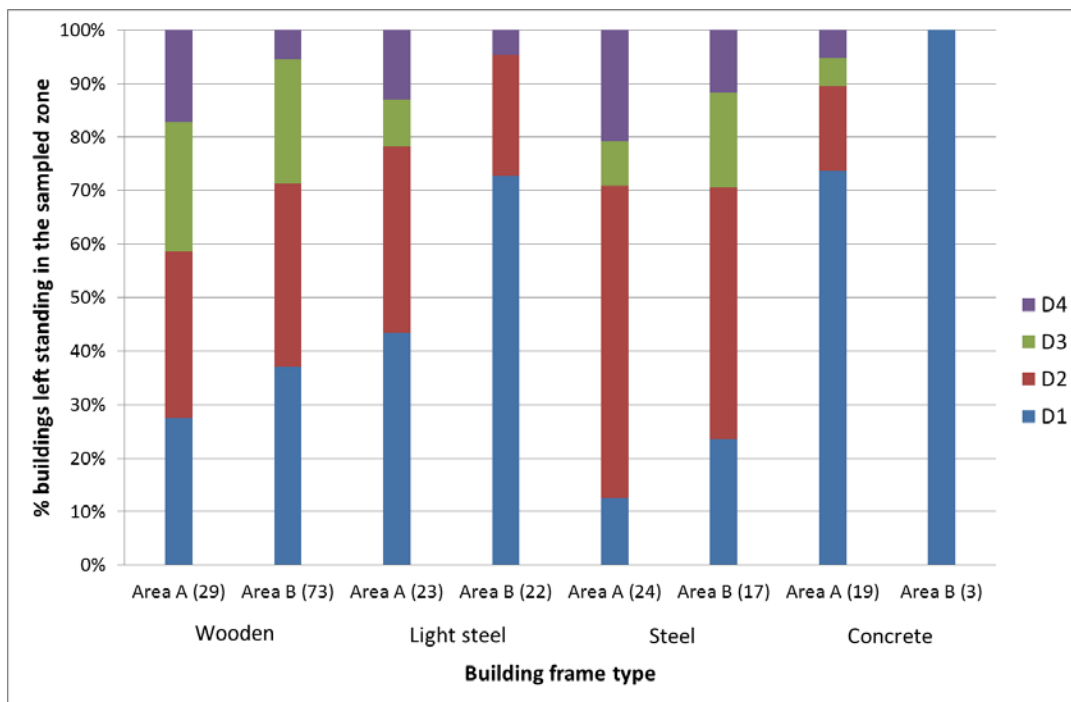
From the relationship between structure type and damage categories (Fig. 8) it can be seen that as the strength of the building frame increases (from timber to light steel to RC), damage severities decrease. Light steel performed better than timber. There is an unexpected trend of greater damage to steel-framed buildings, where it was noted that 61% of surveyed buildings suffered partial or complete loss of cladding and subsequent damage to the non-structural components of the building. 42% of steel buildings were commercial/industrial with light panel cladding, which proved to be insufficiently robust against the tsunami impact.

**Figure 8** Damage levels by building frame type for Ishinomaki (Areas A and B) (number of buildings of each type in brackets)

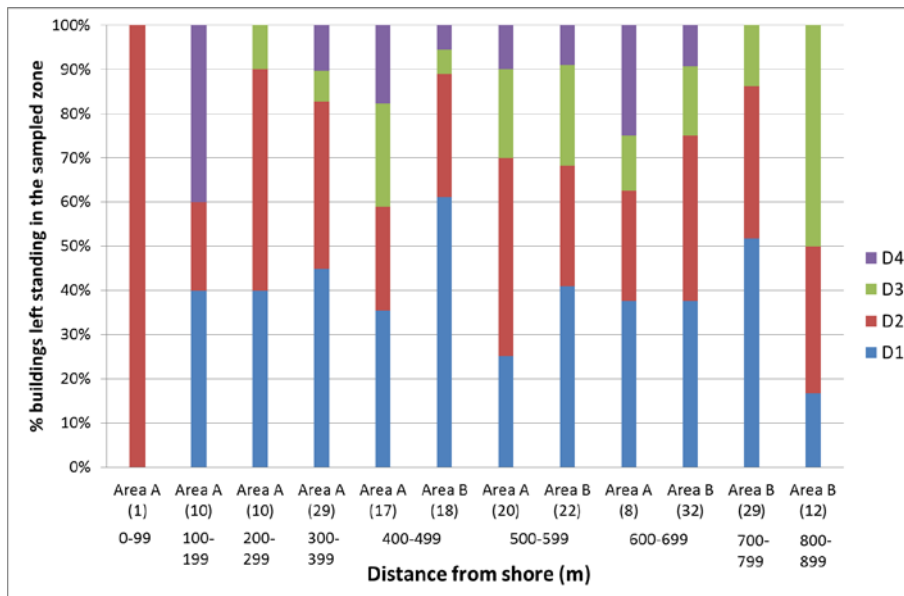
Thus, although lighter construction forms such as timber and light steel do not survive well under tsunami impact, the noticeably better outcome in Area B (Fig. 9) suggests that positioning major infrastructure and larger structures on the shoreline can significantly improve performance in zones inland.

**Figure 9** Damage levels with distance from shoreline – Ishinomaki (Areas A and B)
