Experimental Evaluation Of A Precast Concrete Beam-To-Column Prototype Design Under A Column Removal Scenario

A Thesis
Submitted to the Faculty of
Mississippi State University
in Partial Fulfillment of the Requirements
for the Degree of Master of Science
in Civil Engineering (Structures)
in the Department of Civil and Environmental Engineering

A full-scale experiment was conducted to investigate the structural performance of a prototype design under a column-removal scenario. The test assembly frame, consisting of three columns and two beams, was subjected to a displacement controlled vertical force acting at the center to characterize the failure modes and collapse mechanisms. Brittle-failures of critical structural elements were observed and significantly impacted the performance.

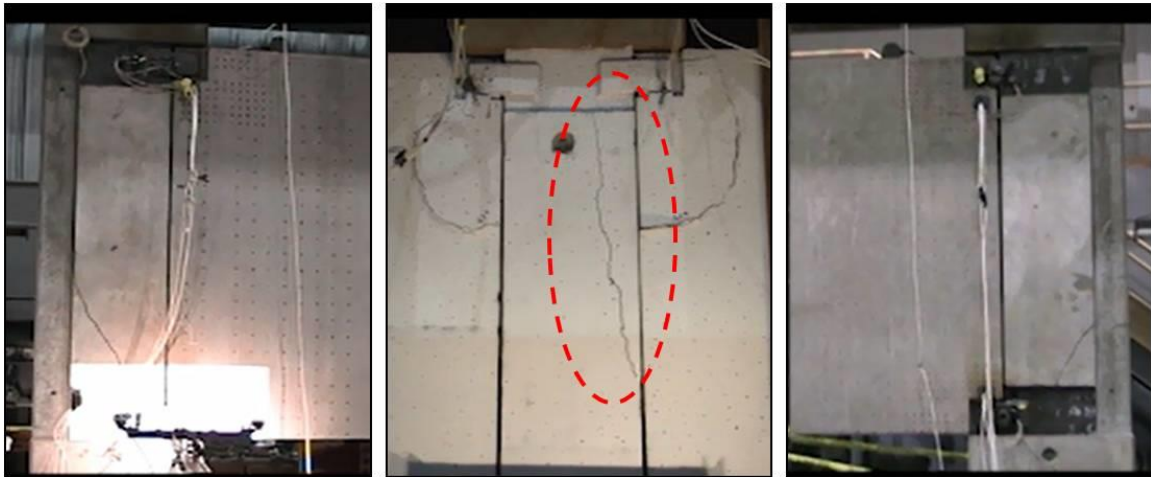
Figure 2.3) yielded, concrete cracks developed in the beams near these steel link plates as shown in Figure 4.2. Figure A.9 and Figure A.11 show load-strain plots for steel link plates #2 and #4, respectively. These concrete cracks in the beams were first observed when the specimen reached an approximate Δ of 0.38 in. (9.6 mm) at 42.92 minutes of testing. After a ten-minute pause, the load continued to be increased over the center column. The OMRF specimen showed resistance to flexure; however, as the load increased, both end-columns began to show well-defined diagonal cracks at the bottom corner as shown in Figure 4.3. These concrete cracks in the end-columns were first observed when the OMRF reached an approximate Δ of 1.8 in. (45.7 mm) at 120 minutes of testing. Then after a brief pause, the displacement in the ram continued to be increased. The first crack in the unsupported center column or stud was then observed as shown in Figure 4.4.

Figure 4.4 Elevation views, development of the first observed crack in center column at Δ of 2.1 in. (52.7 mm)

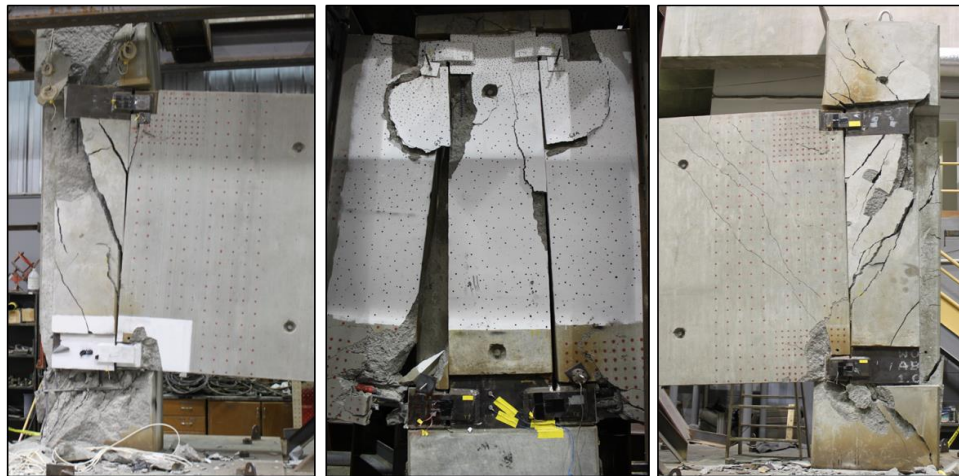
(b) Posttest elevation view of OMRF specimen

Figure 4.5 Pretest vs. posttest views of the OMRF test specimen

Figure 4.5(b) shows the posttest structural damage of the OMRF test specimen. All structural members suffered major damage. Damage was particularly heavy at the

end-columns. A considerable amount of debris, some fairly large in size up to approximately 20 in. (508 mm) by 12 in. (305 mm), had fallen from the OMRF test specimen. Major concrete cracks developed along the assembly due to the high-magnitude bending moments at the supports.

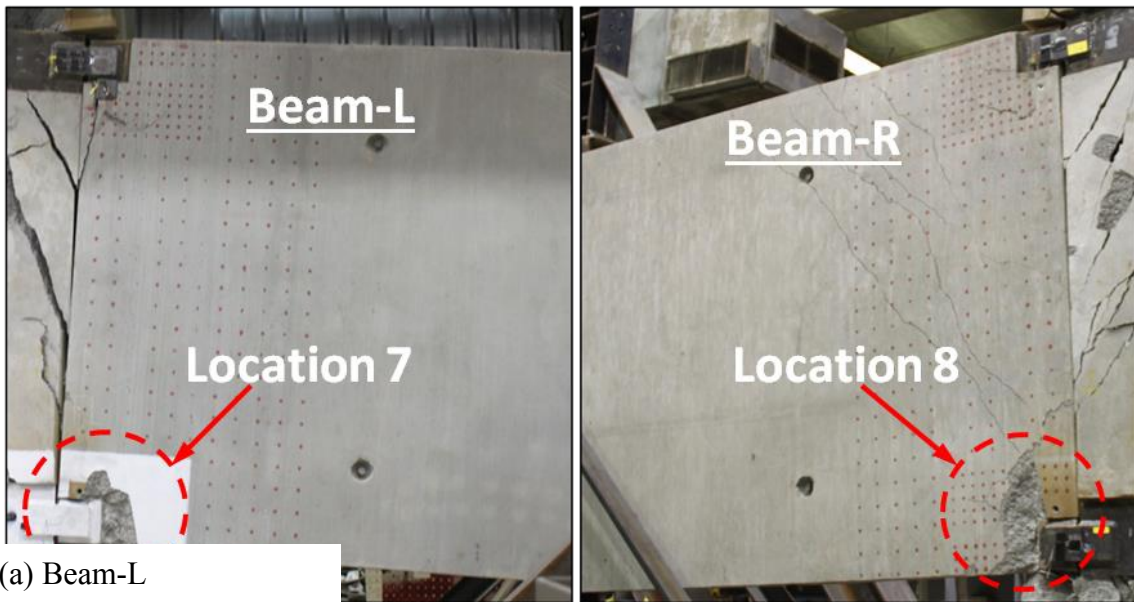
(a) Beam-L

(b) Beam-R

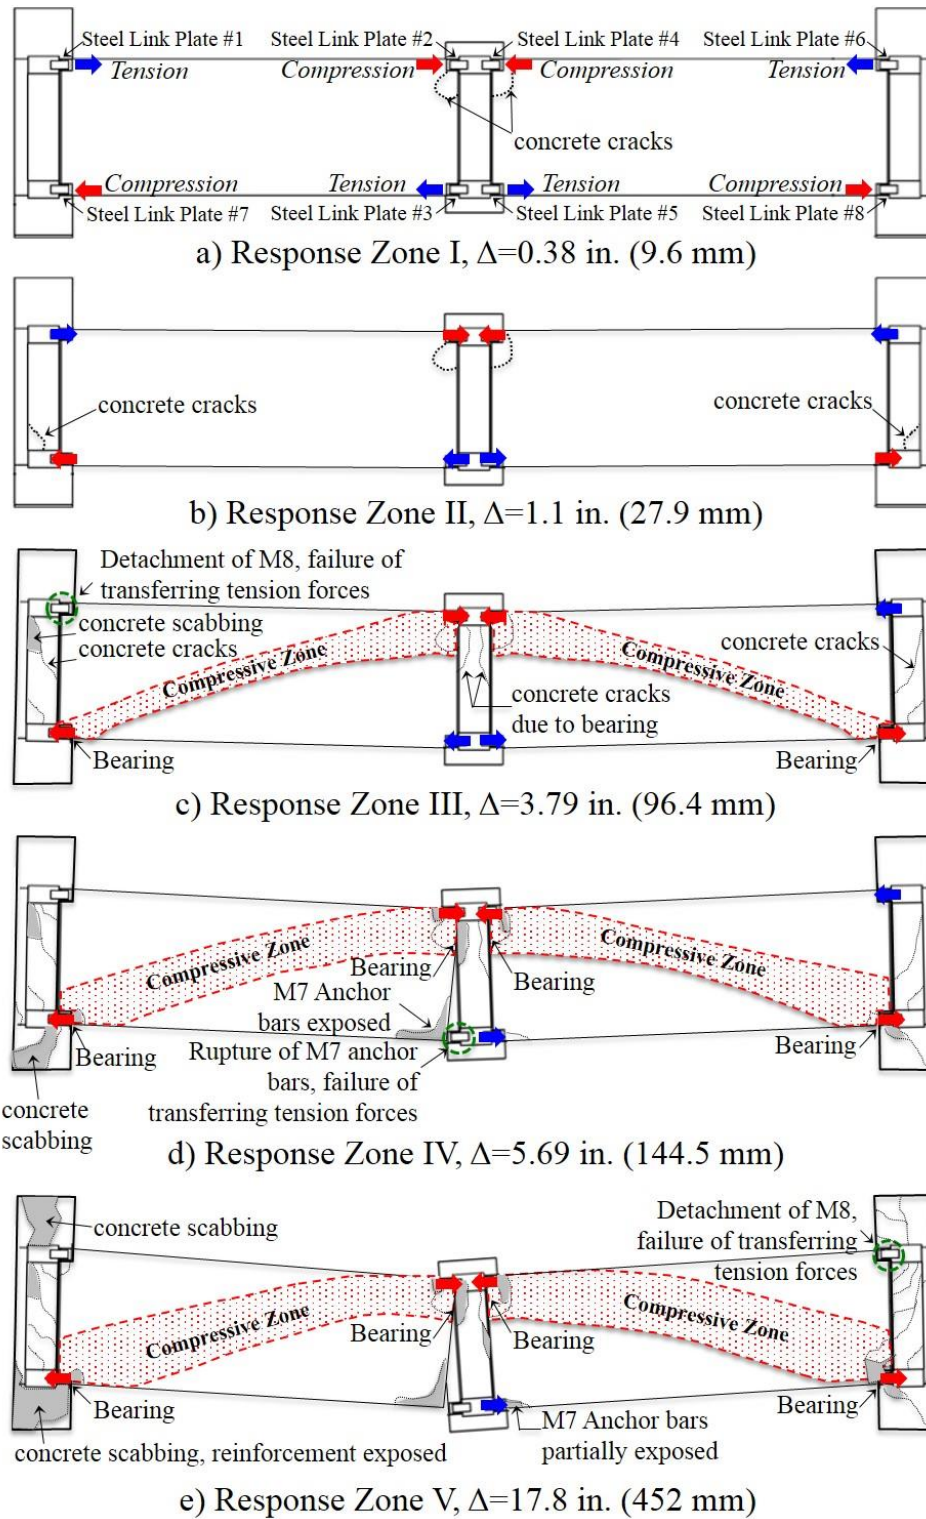
Figure 5.2 Elevation view of OMRF test specimen, damage per response zones

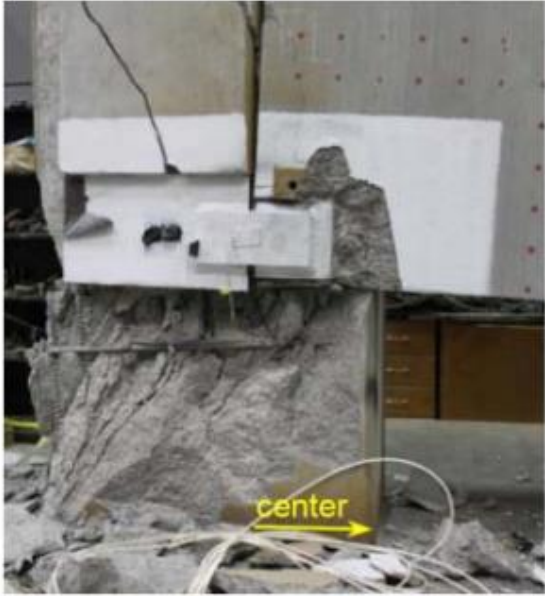
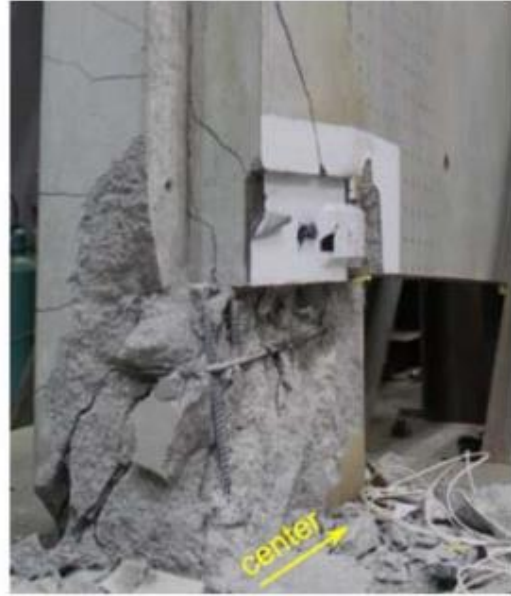
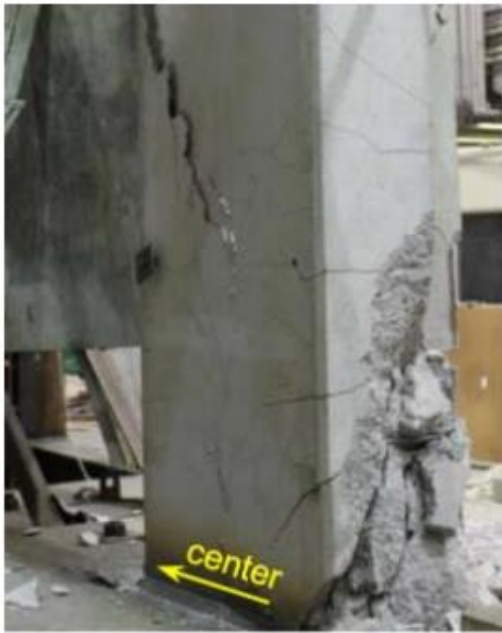
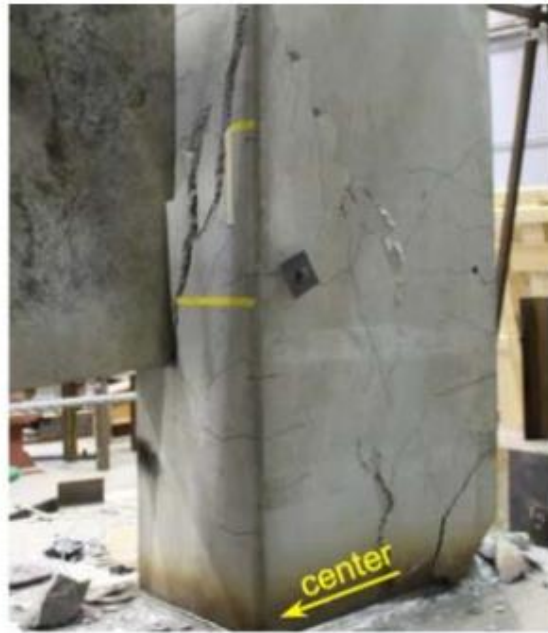
Figure 5.14 Elevation view, posttest damage to the left (east) end-column

(a) Left (east) end-column, fracture of lower torsion bar at left end column, and concrete spalling and shear deformation of left end column below beam level. (b) Center column/stud, response zone V – incident (k): $\Delta \approx 10.6$ in (269 mm). (c) Right (west) end-column, concrete cracking around top M8 plate in right (west) end-column.

After closely examining the posttest damage to the end columns, it was observed that both columns suffered torsional rotation about the vertical y-axis. This rotation is attributed to the out-of-plane behavior generated by the eccentricity of forces at the connection (see Figure 5.4(b)), in addition to the axial moment generated by the eccentricity between the columns and the spandrel beam centerlines, especially during the development of the arching action.

The diagonal cracking, scabbing, and shear deformation of the end-columns observed in these tests (see Figure 5.14 and Figure 5.17) indicate that lateral forces due to beam arching action could potentially result in shear failure of columns, particularly considering the eccentricity between the centerline of the columns and the spandrel

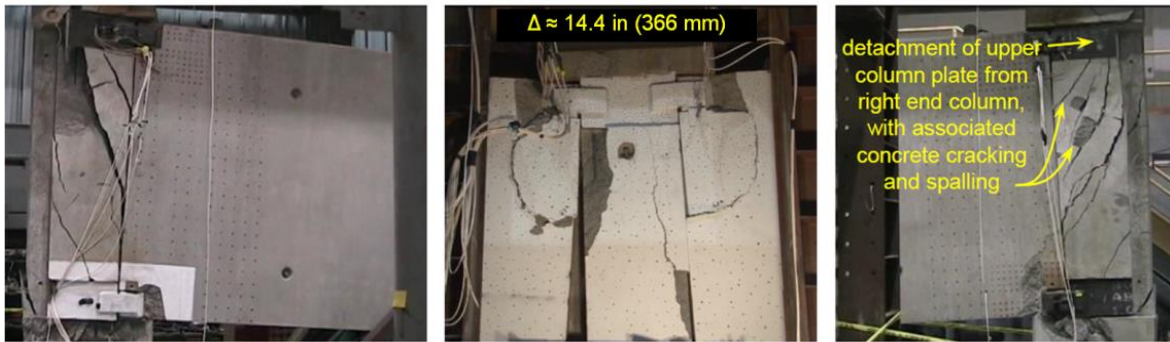
Figure 5.15 Elevation view, response zone V – incident (I): detachment of the upper M8 plate embedded in the right (west) end-column

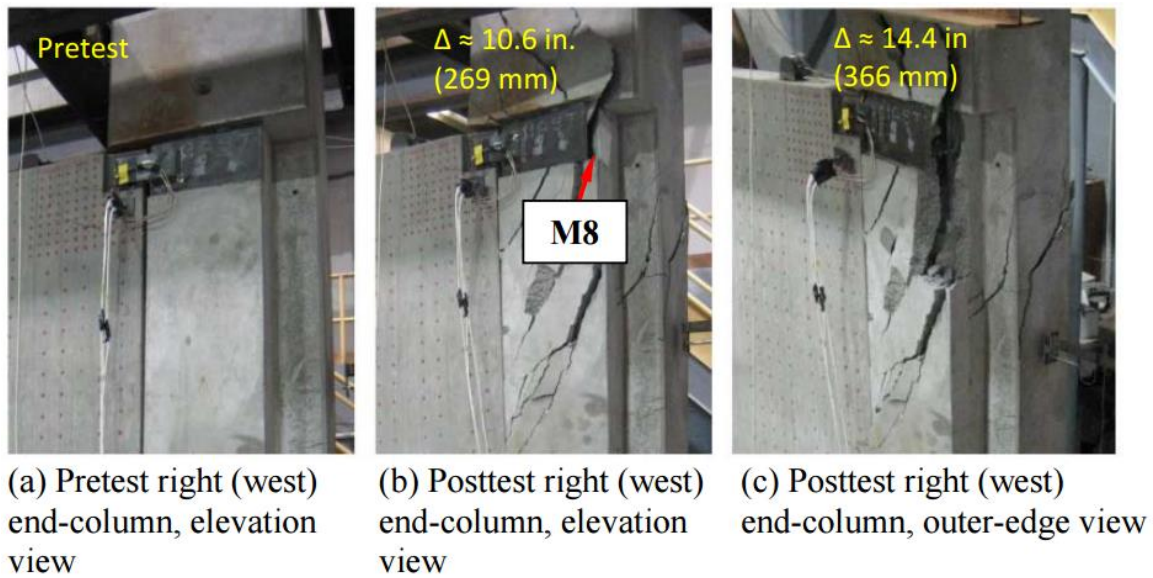
Figure 5.16 Response zone V – incident (I): detachment of the upper M8 in the right (west) end-column

The out-of-plane bending moments also contributed to the bond failure that led to the detachment of the upper (M8) embedded plates in the end-columns, initially in the left (east) column and later in the right. The result was the complete detachment of the steel link plate #1 and later of the steel link plate #6 from the assembly. As the vertical displacement increased, the gap or space between the beam and column gradually closed, and the beams began to bear against the columns. As a result, additional resistance occurred through the development of significant compressive forces associated with arching action. However, at the time the load reached a maximum value of 168.2-kip (748-kN), the upper anchor failed. The failure of the upper #10 (#32) Grade 60 anchor bar welded to the M7 embedded plate resulted in the complete detachment of the steel link plate #3 from the assembly, consequently imposing additional out-of-plane bending forces to the remaining steel link plates connected to the assembly. The system continued to carry load without collapsing, but heavily relied on the additional resistance provided by the post-ultimate compressive forces developed through the arching action.

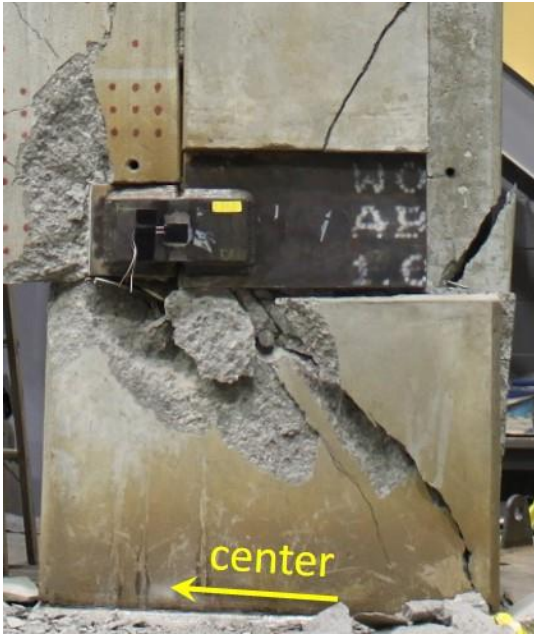
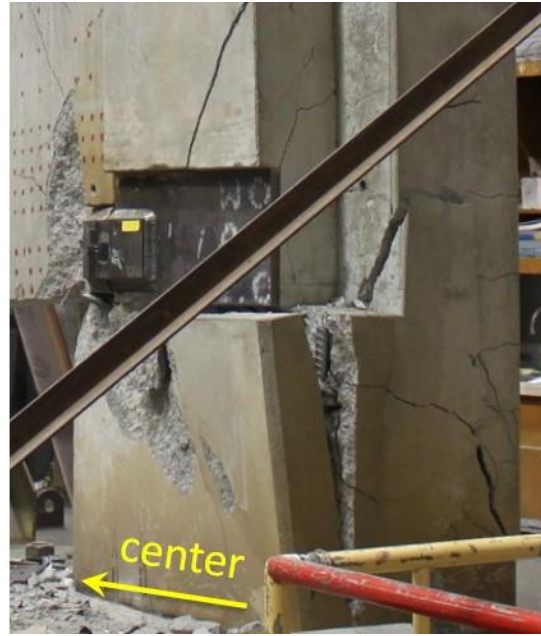
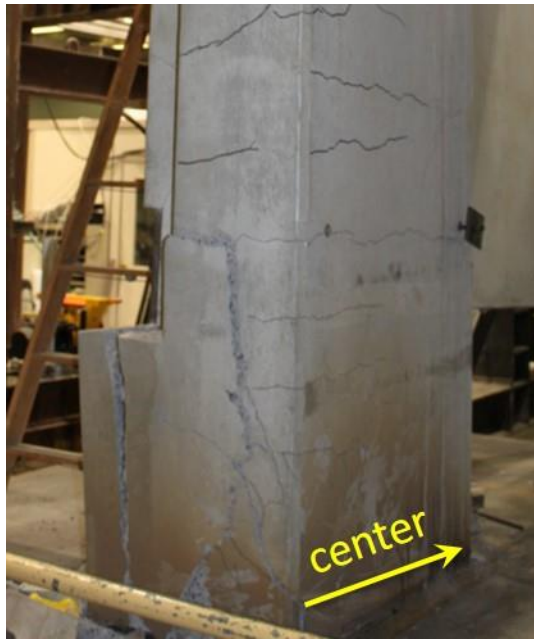
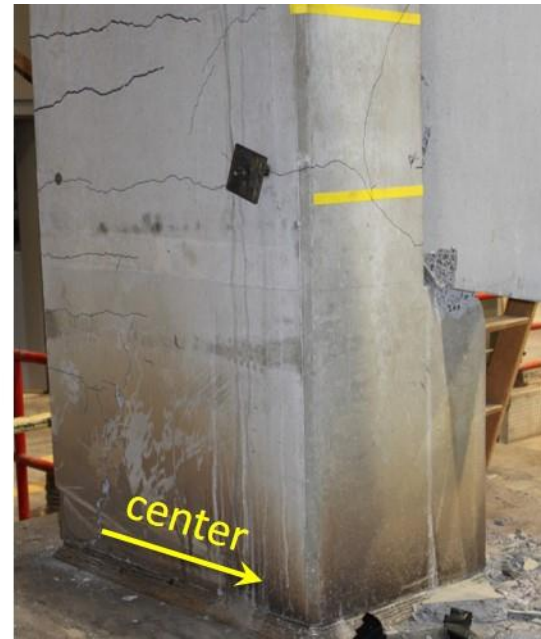
Figure 5.17 Elevation view, posttest damage to the right (west) end-column

The OMRF specimen continued deflecting beyond incident (k); however, the propagation of cracks along the system, in addition to the system's out-of-plane deflecting behavior, began to diminish the ability to maintain arching action. The top torsion bar through the right (west) end-column was ejected, and concrete began to fall from the perimeter of the top M8 plate in the same column. By the time the OMRF specimen reached a Δ of approximately 14.4 in. (366 mm), the upper M8 plate was detached from the right end-column, benchmarking incident (l). The structural damage observed at incident (l) is shown in Figure 5.15. The failure observed in incident (l) was similar to the failure observed previously on the left (east) end-column in incident (f). Figure 5.16 shows the detachment of the upper M8 plate in the right (west) end-column. This failure was accompanied by cracking and scabbing of concrete on the right (west) end column. Shear deformation of the right (east) end-column occurred with extensive concrete scabbing, Figure 5.17 shows the final stage viewed from several angles. Finally,

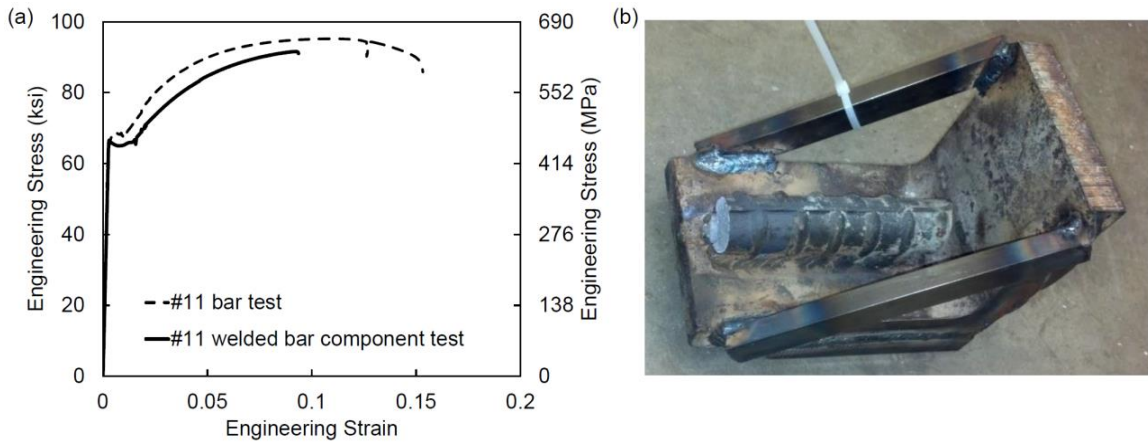
The weld in the bar had also significantly reduced its deformation capacity, with a fracture stress reached at an engineering strain of 0.092 in./in., compared to the tensile test bar that reached a fracture stress at an engineering strain of 0.15 in./in., which resulted in a large reduction of 38% in deformation capacity when the welded bar data are compared to the tensile test data.

Figure 5.23(b) shows the fractured anchor bar after the component test. It is evident that the fracture occurred at the end of the weld, very similar to the plane of failure observed in OMRF M7 anchor bars (see Figure 5.11). NIST reported that the reduced ductility of the welded anchor bar is believed to have been caused by changes in material properties in the “heat-affected zone” near the weld in the SFRM specimen, e.g., microstructural changes such as the formation of brittle martensite, adversely affecting the overall structural performance of the SFRM prototype model.

Figure 5.23 Results of welded anchor bar component test (Main et al., 2015)

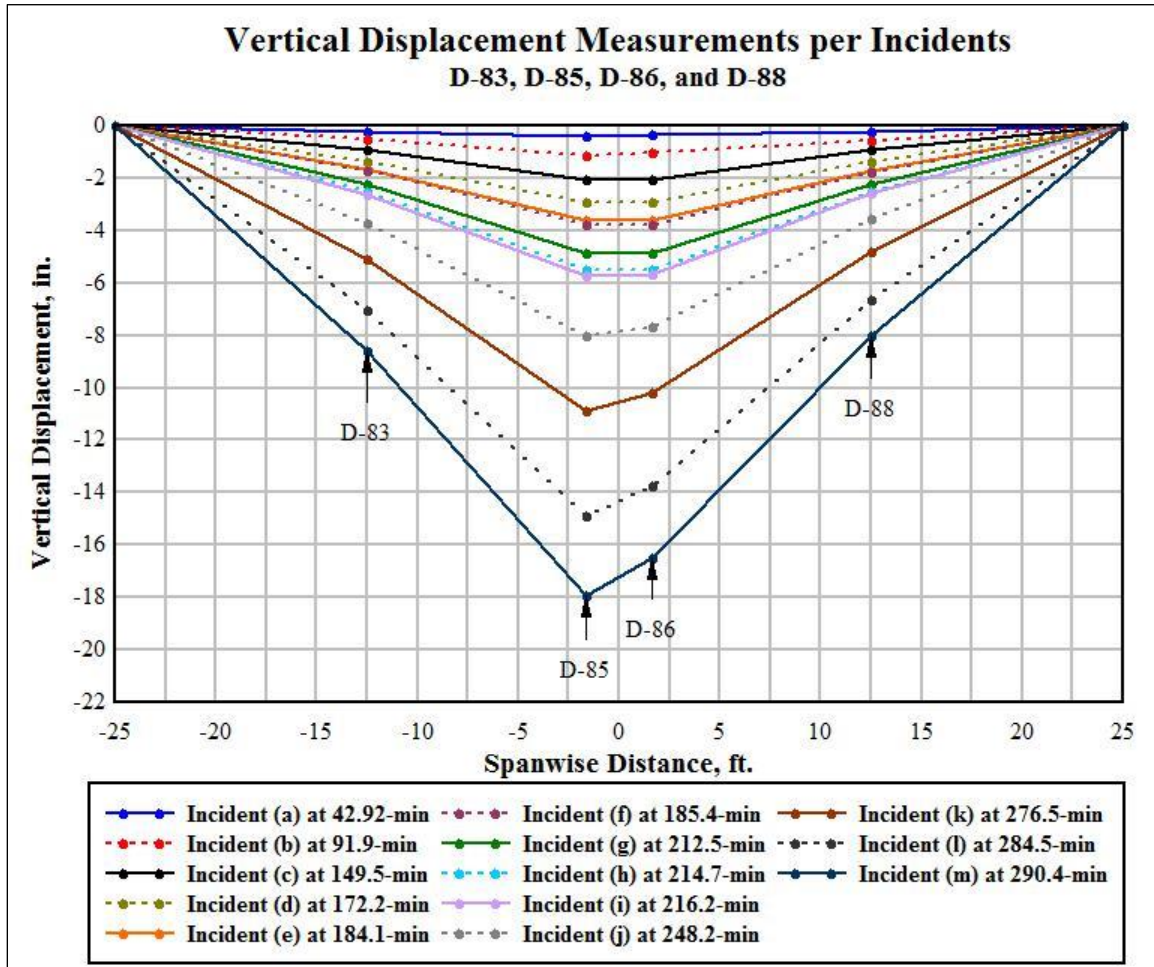
Figure 5.24 Vertical displacement measurements by incidents

The vertical displacement recorded in all four “string potentiometer” gauges at each incident is illustrated in Figure 5.24. This graphical representation of the OMRF vertical displacement progression throughout the experiment is evidence of the lack of symmetry in the assembly. Certainly, the failure of the second (top) M7 anchor bar at incident (i) had the most significant impact into the out-of-plane behavior. The eccentricity of forces caused by the offset of the steel link plates to the anchor bars could

have also played a role in the premature failure of the M7 anchor bars, as well as the detachment of the top M8 embedded plates at the end-columns. These two principal failures had a direct impact on the overall performance of the OMRF test specimen.

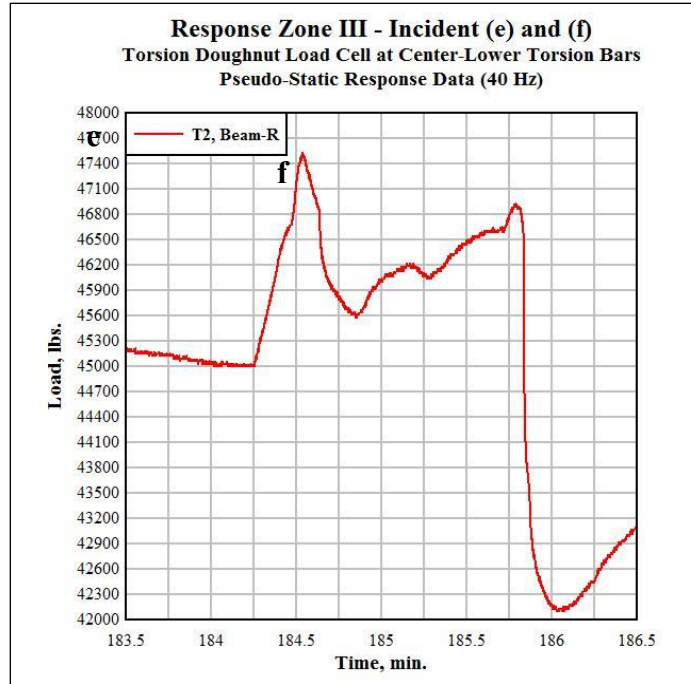
The initiation of detachment of the M8 plate corresponds to the drop in load observed in the torsional doughnut load cell (T2). Figure A.25 shows a sudden drop in load at 184.6 minutes of test time. This behavior is interpreted as a reduction in torsional load due to the partial detachment of the upper M8 plate in the left (east) end-column. Incident (e) is also evidenced by the sudden increment in strain captured in the pseudo-static response data recorded by the strain gauges located in steel link plate #1. Figure A.26 shows an abrupt drop in load associated with an abrupt change in strain measurements in the steel link plate #1 at incident (e). The concrete crack growth resulted in the detachment of the M8 plate, reducing the flexural resistance capacity of the system. Consequently, the beams began to bear against the columns due to the closing of the gap between them as it deflected, leading to an arching action (Figure 5.7). Soon after the initial cracks were observed around the M8 plate, the system began to show well-defined

Figure A.25 Response zone III – incidents (e) and (f): drop in torsion load at (T2)

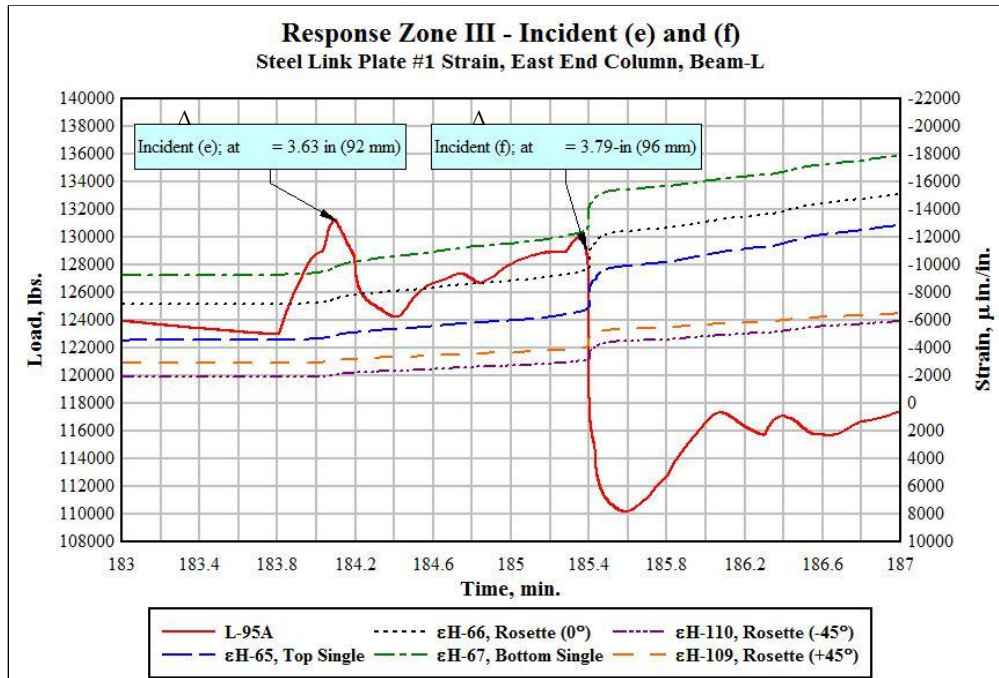
The strain data collected in all gauges attached to the front face depicted high levels of tension strain readings (Figure A.8), implying that, during the initial response zones, the link plate #1 was acting in tension to provide equilibrium in the assembly. However, at the time the M8 embedded plate in the left (east) end-column detached, the strain data in link plate #1 flattened, forcing the assembly to redistribute load to the undamaged steel link plates to preserve structural stability.

Figure A.26 Response zone III – incidents (e) and (f): steel link plate #1

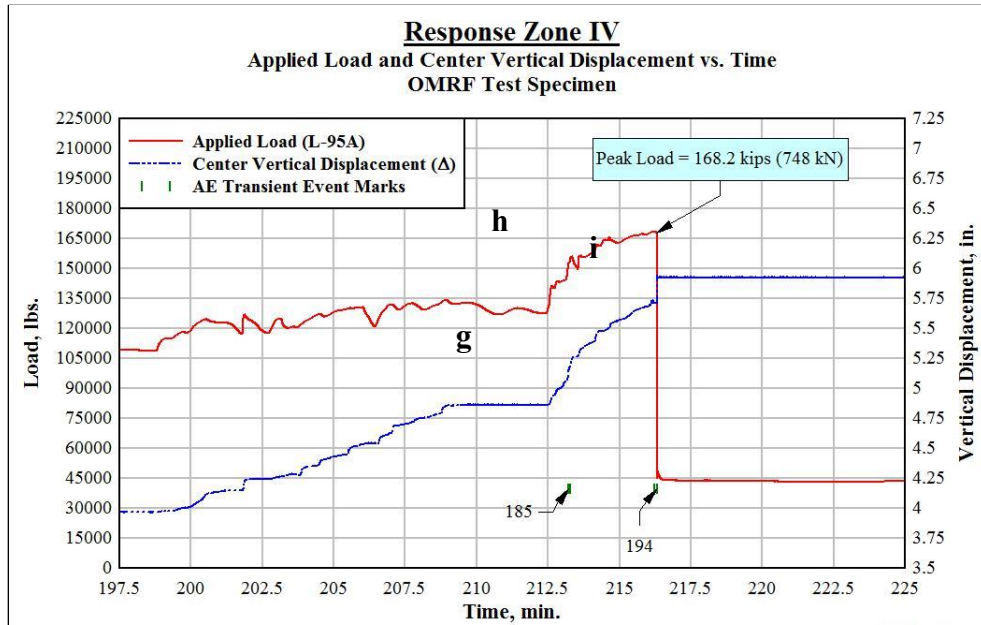
action but at a reduced capacity because of multiple failures that reduced the resistance of the beam-to-column connections. Specifically, these failures degraded the capacity for transfer of tensile forces through the steel link plate connections at the upper steel link plate #1 on the left (east) end-column and at the lower steel link plate #3 on the center column/stud, as illustrated in Figure 5.2(d). These major incidents are marked as (g, h, and i) within the response zone in Figure A.27, and each incident is linked to a specific structural response.

Figure A.27 Response zone IV: load and displacement vs. time, development of arching action at incident (g), concrete scabbing at the bottom corners of beams towards the center at incident (h), and brittle failure of top M7 anchor bar at incident (i)
