Reconnaissance on Liquefaction-induced Flow Failure Caused by the 2018 Mw 7.5 Sulawesi Earthquake, Palu, Indonesia

Abstract. The M_w 7.5 Sulawesi Earthquake 2018 was a catastrophic disaster that resulted in large numbers of casualties. This study aimed to investigate the damages of liquefaction-induced-flow failure in three areas in Palu city, i.e. Petobo, Balaroa, and Jono Oge. It was found that this flow failure occurred on a large scale at a very gentle ground inclination, ranging from 1 to 3%. In order to gain an understanding of the soil conditions in these specific locations, Portable Dynamic Cone Penetration Tests were conducted in Petobo. The results showed that the soil layers in the affected area were in a loose state compared to the non-affected areas. Furthermore, some spots of freshwater inundation were recognized in Petobo and Balaroa, even two weeks after the disaster. Based on this evidence, a mechanism of liquefaction-induced-flow failure caused by a confined aquifer is proposed.

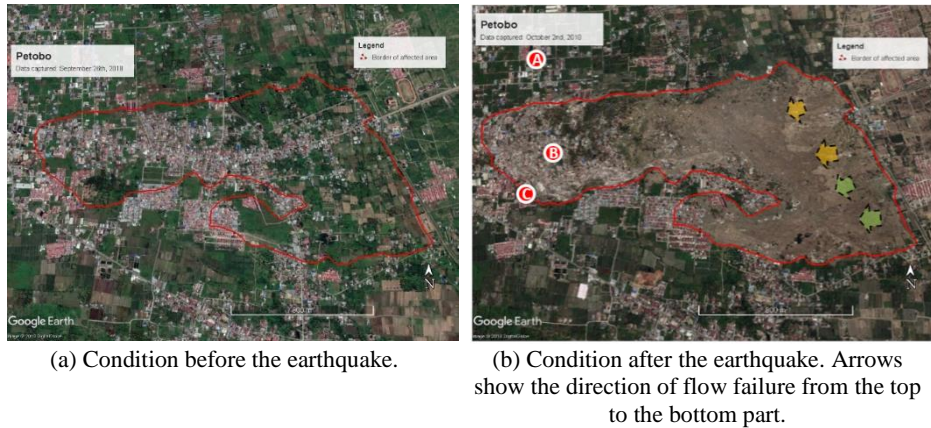
Figure 4 Conditions at Petobo before and after the earthquake.

In Petobo, approximately 1920 buildings were reported collapsed and affected by the mass movement, with the majority being residential houses. The scope of the affected area was reported around 180 hectares, with a ground surface gradient of 3%. Figure 4 provides images of before and after the mainshock at Petobo, as captured by Google Earth. Points A, B, and C in Figure 4(b) show the location where Figure 5 was captured.

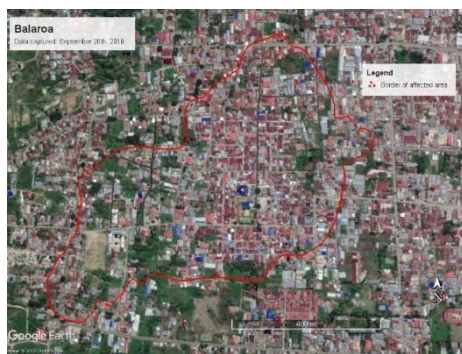
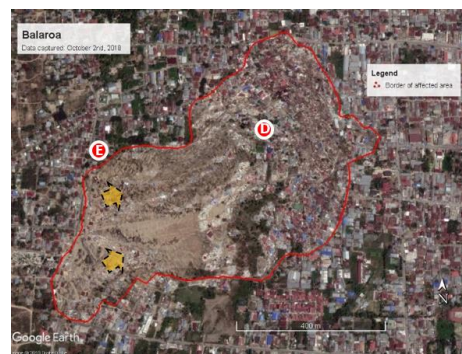
Figure 6 Conditions in the Balaroa area before and after the earthquake, captured by Google Earth.

Compared to Petobo, the affected area in Balaroa was smaller (about 40 hectares). The number of buildings collapsed was over 1300 units. The topography was identified as gentle, with a gradient of 3-4%. The conditions before and after the main shock are illustrated in Figure 6. Points D and E indicate the location where Figure 7 was captured. A witness shared that the ground surface was undulating during the earthquake. After the shock, a mudflow started to appear and pushed houses to a lower elevation.

At the top, massive subsidence and tensile cracks were identified. Residential houses located 700-800 meters downstream were brushed up by the mudflow. From the center to the bottom part the houses were safe, yet inundated by the thick mudflow.

(b) Conditions after the earthquake. The arrow shows the direction of mass movement from the top to the bottom part.

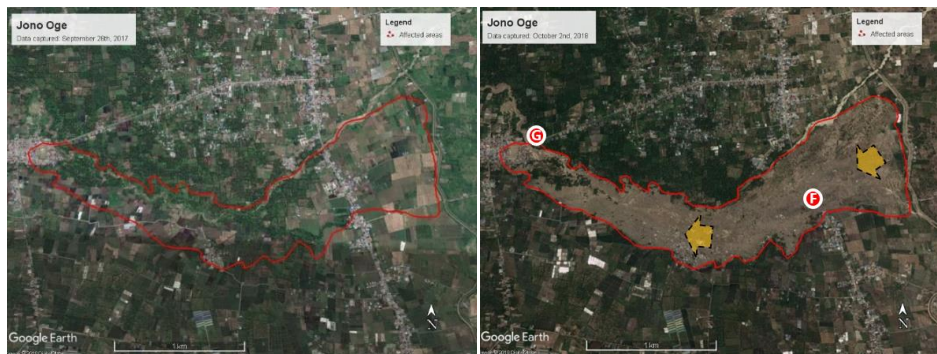
Figure 8 Conditions at Jono Oge area before and after the earthquake, captured by Google Earth.

In Jono Oge, the affected area was around 210 hectares and the total number of damaged houses was about 500 units. The width of the affected zone was about 1 km, and the length around 3 km with an average ground gradient of 1%, the most gentle slope compared to the other two sites. Figure 8 provides an image of the conditions at Jono Oge before and after the earthquake. Points F and G indicate the location where Figure 9 was captured.

(b) Conditions after the earthquake; the arrow shows the direction of mass movement from the top to the bottom part.

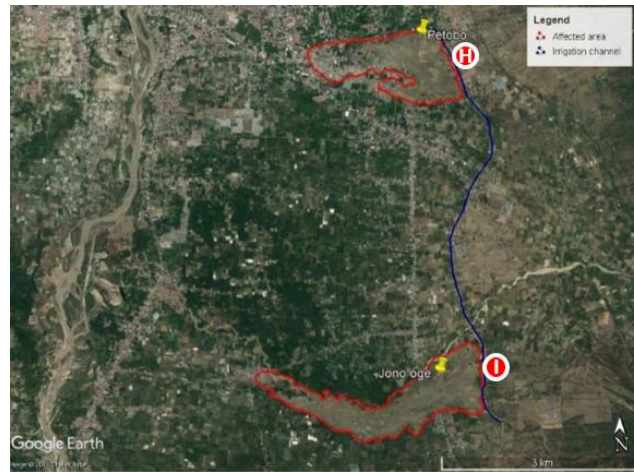
Figure 10 The irrigation section between Jono Oge and Petobo area (blue line).

The irrigation channel ‘Gumbasa’ was located parallel to two of the affected areas, Petobo, and Jono Oge (Figure 10). Points H and I represent the location where Figure 11 was captured. Due to the earthquake, the channel was severely damaged.

During the earthquake, the channel was operated with a certain level of water, which had disappeared after the earthquake through large cracks in the channel body. A witness living close to the crown area in Jogo One stated that the irrigation channel was constructed in the 1980s to supply water to paddy and crop fields in the surrounding area. Before its construction, it was hard for people living in the downstream area to find groundwater, but one to two years after the construction people could quickly collect groundwater. It can be inferred that the presence of this channel affected the groundwater profile in the surrounding area.

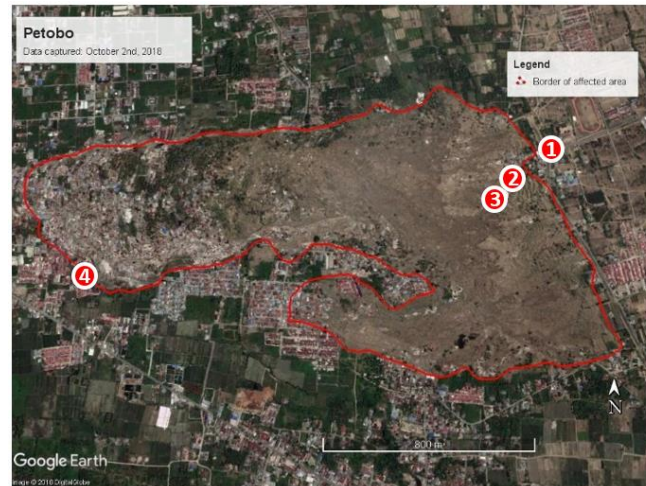
Figure 12 Locations of DCPT testing at Petobo, highlighted by red circles. Points 1 and 4 are outside the affected areas, while points 2 and 3 are near the crown area.

During the survey, portable dynamic cone penetration tests (DCPT) were conducted at four locations around Petobo, covering two points in the affected zone and the others in the non-affected zone. Figure 12 shows the locations of the test sites. By using the DCPT, the number of impacts necessary for the cone to penetrate 100 mm ground-depth are notated as N_d . This N_d value was then converted to an N-SPT value to represent the soil resistance as a more common variable. Takase and Sasada [11] summarized the empirical equations to convert N_d values to NSPT values for sandy (non-plastic) soil.

The DCPT conversion results are presented in Figure 3. From the test, the N-SPT value at point 1, which was several meters outside of the crown area, was relatively more dense than in the other spots. No evidence of liquefaction was observed around the spots. The groundwater level was identified at a shallow depth.

The soil condition in the crown area are represented by DCPT 2 and DCPT 3. In this location, up to a depth of 5-6 m, the N-SPT value was below 5, indicating that the soil was in a loose state. According to the Unified Soil Classification System, the sand ejecta samples taken at these points were classified as silt with low plasticity (ML), because the amount of fine content was more than 50% (Figure 14); the liquid limit (LL) was 28; and PI was 0 or non-plastic. The groundwater was found at a shallow depth. The combination of loose soil and shallow groundwater level possibly led to liquefaction due to earthquake shaking. DCPT 4 represents the soil condition at the bottom area. As this location is outside of the affected area, the N-SPT value was slightly higher than that of the affected locations. The groundwater level was identified at a shallow depth.
