INVESTIGATION OF CAUSES OF SCRAP OCCURRENCE IN THREAD CUTTING ON STEEL SLEEVES FOR MOTORCAR INDUSTRY

V. Marušić, I. Budić, T. Šarić, Faculty of Mechanical Engineering University of Osijek, Slavonski Brod, Croatia

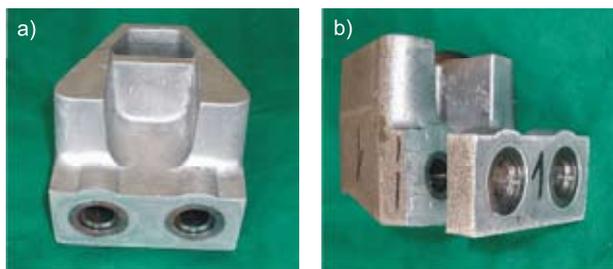
Motor carriers are manufactured by the process of die casting of Al alloy AlSi9Cu3(Fe)L226 obtained from secondary aluminum. Thereby, the melt at the temperature of 720 °C is poured around two steel sleeves, cooled with oil emulsion to ~ 300 °C, and afterwards cooled at air temperature. The entire process is automated. The appearance of the carrier is shown in Figure 1.

Figure 1. Carrier of motor components: a) Die cast; b) cut for experimental needs
Slika 1. Nosač dijelova motora: a) odliven tlačnim lijevanjem; b) prerezan za potrebe ispitivanja
