This article focuses on an original case history of replacement of a leaky 245 kV OIP bushing of a 220/132/33 kV, 160 MVA, transformer on site at the 220 kV Jabalpur substation, in Madhya Pradesh state in India with an available 245 kV OIP bushing having longer L-2.

Retrofitting of 245 kV OIP bushing with longer oil-end

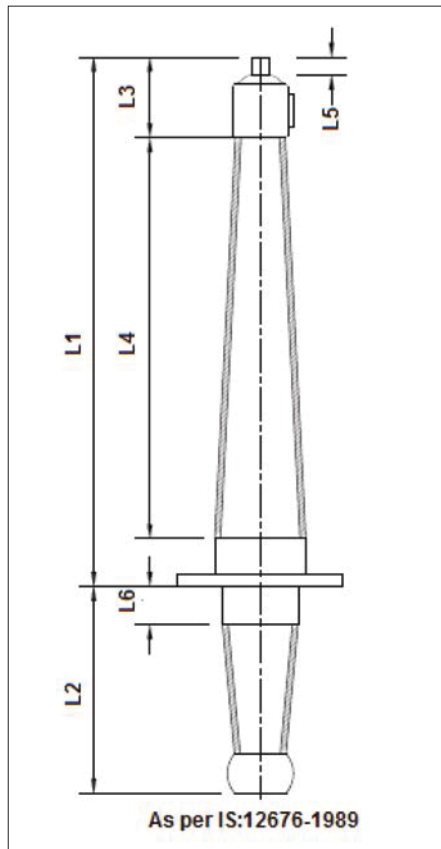
ment of a 245 kV bushing of a 160 MVA, 220/132 kV transformer made by GEC (year of manufacture - 1993) arose. The available 245 kV OIP bushing in the stores of M.P. Power Transmission Utility was with longer length of L-2, Fig. 1 (oil end length from flange to bottom) and to install the same was not possible as it would have fouled with the core coil assembly clamping frame (end frame) of the transformer. The OEM of the transformer was contacted and the extension piece of tur-

Figure 1. OIP bushing's physical dimensions depicting L2. [1]
