Oil Tanker Simplified Fatigue Assessment with Inspection and Repair Approach and Parameters

Ozgur Ozguc

doi: 10.7225/toms.v10.n01.003

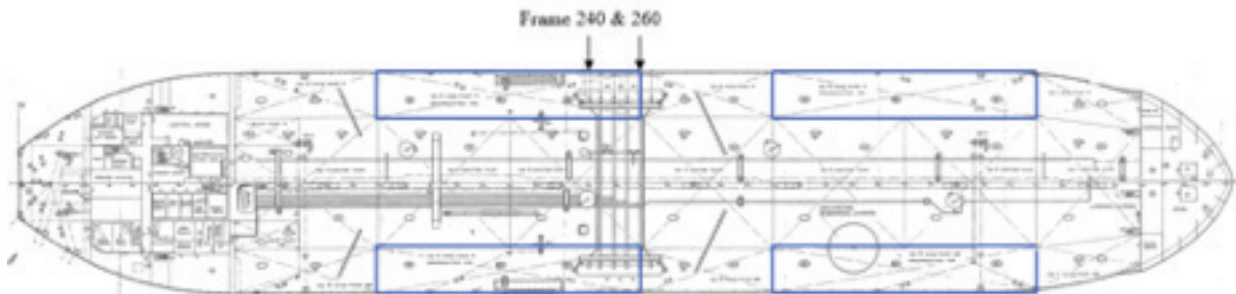
Figure 2.

In the ballast wing tanks, cracks were identified in the slots at various locations. Figure 2 shows a crack below the stiffener flange between the stiffener web and the transverse web frame

on the opposite side of the lug. Local corrosion is also evident from the picture and may give rise to corrosion fatigue in the base material. These web frames were partly cropped and renewed at the locations of the crack (longitudinal stiffener number L25). Cracks in the slots (at the web collar plates) were also found at other locations in the ballast tank, but these positions are not clearly specified. The web frames were partly cropped and renewed. Various cracks were identified and repaired over the past two years. The ship had been trading for around 19 years.

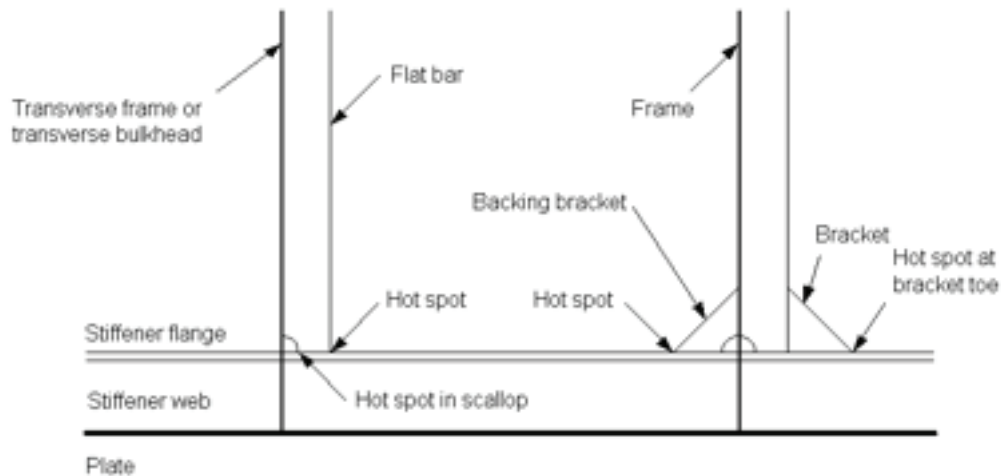
Top view of a longitudinal stiffener in the side shell presenting typical hot spots. The plate refers to the side shell plating. The scallop is also referred to as the heel, while the other marked hot spots are referred to as the bracket toes (DNVGL-CG-0129).

The K_g depends on type of loading; hence, K_g from axial tension/compression may be different compared to K_g from lateral pressure or relative deflection. K_n is only included for lateral pressure (but could be relevant for axial tension in case of snipped stiffener flange). Typical locations are bracket toes and scallops, as shown in Figure 3.

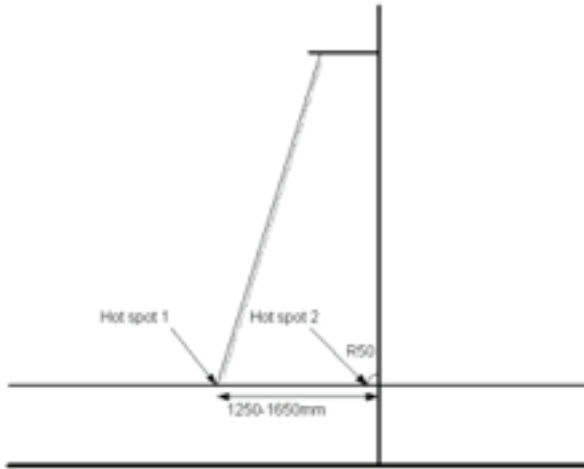
For the tripping bracket in the bottom shell shown in Figure 4, the following SCFs are used:

According to the tabulated stress concentration factors (SCF) for tripping brackets given in DNVGL-CG-0129, the highest SCF is located in hot spot 2. Hot spot 1 is given a reduced bending moment from lateral pressure. Maximum bending moment is used for hot spot 1 in the present study (based on experience with large tripping brackets in the finite element analysis). In addition, the crack is observed in the bracket toe instead of the heel. This means that the real SCF is larger at the toe than at the heel. Based on this, hot spot 2 is used to represent the fatigue life for the bracket toe.

Figure 4. Tripping bracket on top of T-profiles in bottom floors. The scallop is assumed with a radius of 50mm.

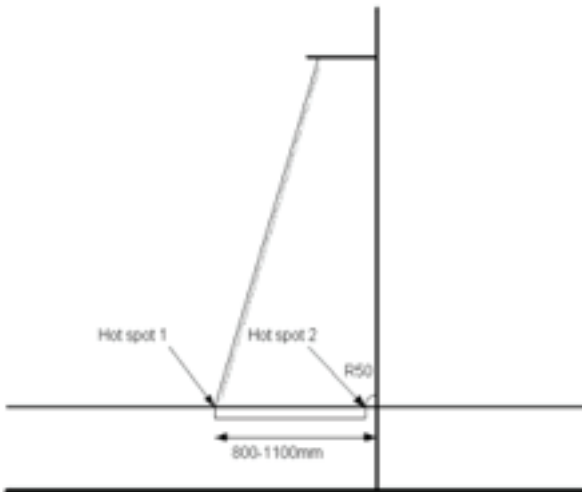
For the tripping bracket in the side, deck, and longitudinal bulkhead shown in Figure 5, the following SCFs are used:

Figure 5. Tripping bracket with overlap (L-profiles) located at deck, side and longitudinal bulkhead.

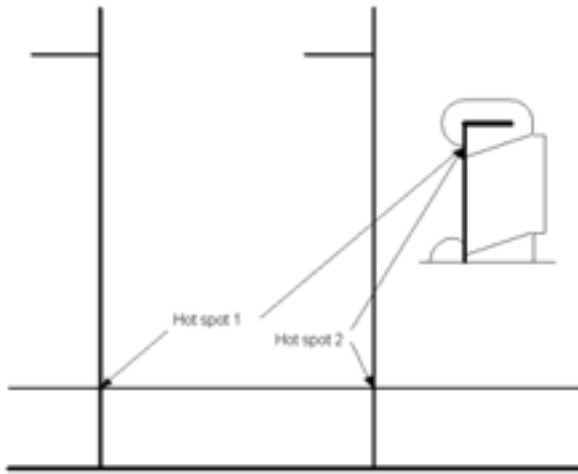
For the transition detail in side, deck, and longitudinal bulkhead shown in Figure 6, the following SCFs are used:

Hot spots 1 and 2 will have the same fatigue life and represent the same hot spot on two different frames. It should be noted that these SCFs represent the SCF in the web of the longitudinals and not the web frame scallops. The K_n factor depends on the L-profile dimensions and varies between 1.3 and 1.8.

Figure 6.
Typical transition detail at deck, side, and longitudinal bulkhead.

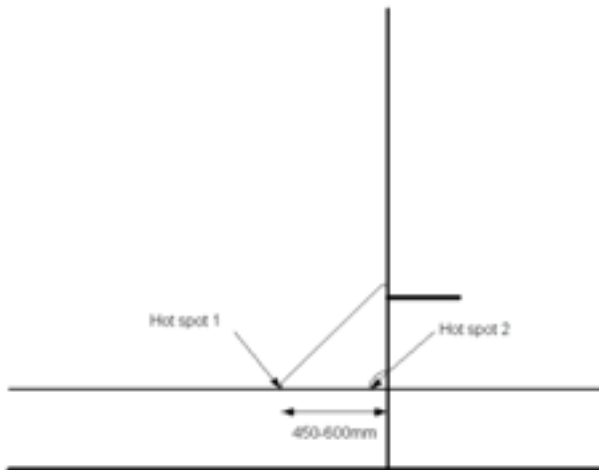
The last detail is a common bracket detail. A detail without overlap typical for bottom longitudinals is presented in Figure 7. For the common bracket detail, the following SCFs are used:

For the details with overlap, the K-factors are multiplied with the factor of 1.15. The factors become the same as for the tripping bracket with overlap. The main difference is that the maximum stiffener bending moment is located 2/3 of the length into the bracket. This means that the moment at the bracket toe is lower, where a reduction factor r_p is used from DNVGL-CG-0129. Hot spot 2 then becomes significantly worse than hot spot 1. At

Figure 7.
Common bracket in bottom and side.

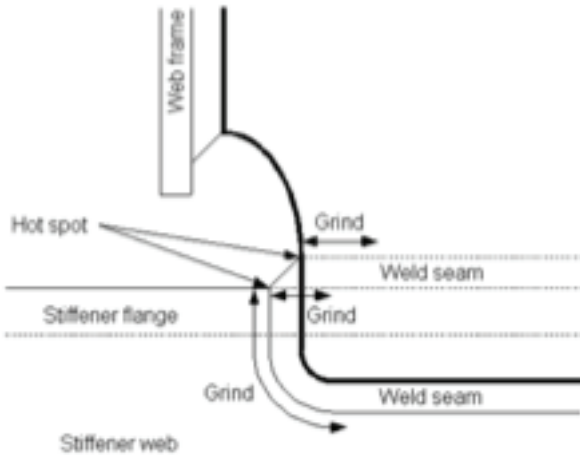
Figure 13.
Proposed grinding for scallops with overlap (IACS, 2017).

The crack may initiate in principle at three different locations as seen from Figure 12. It should be noted that the intention of the grinding above is to improve the fatigue life of the detail by removing the crack at location 1. The grinding procedure may reduce the fatigue life at location 3, while the fatigue life of location 2 will be unchanged. For the scallops the grinding is proposed as shown in Figure 13. Grinding of the scallops for brackets with overlap is similar as shown in Figure 14.

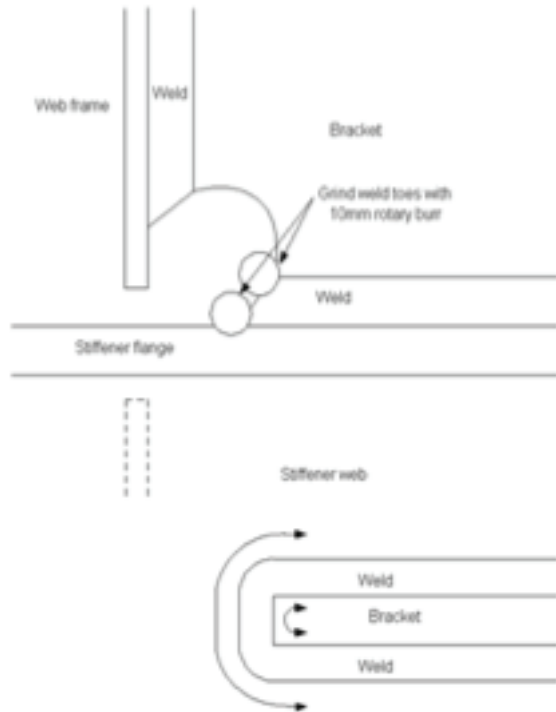
Figure 14.
Principle of grinding of critical weld toes in the scallops (shown with arrows), followed by DP or MPI (IACS, 2017).

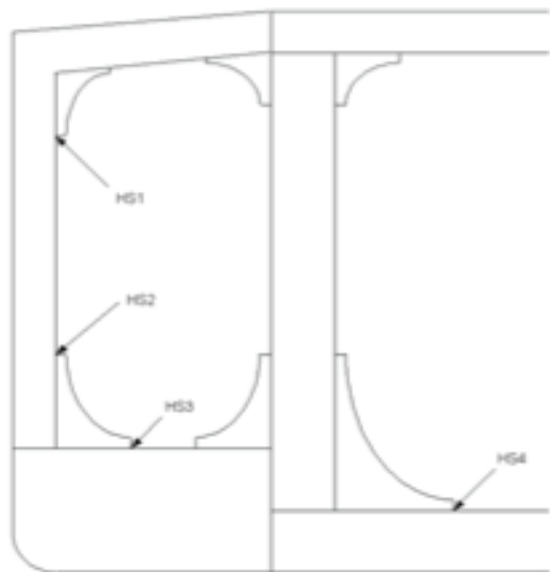
Figure 18.
Vertical girder at the transverse bulkhead and two critical details.

toe detail exposed to relative deflection, as shown in Figure 18.. The relative deflection effect is small for the bottom stiffeners; however, it is connected to a detail with significant longitudinal stiffness, hence these two effects make this detail probably the worst detail in the bottom. It is proposed to check the bracket toes at HS1 and HS2 at the transverse bulkhead, Frame 260.
