CIVIL ENGINEERING STUDIES
STRUCTURAL RESEARCH SERIES NO. 342

LOW CYCLE FATIGUE OF HY-130(T) BUTT WELDS

A REPORT OF AN INVESTIGATION CONDUCTED
by
THE CIVIL ENGINEERING DEPARTMENT
UNIVERSITY OF ILLINOIS, URBANA
in cooperation with
The Naval Ship Systems Command, U.S. Navy
Contract N00024-68-C-5125
Project Serial No. SF020-01-01, Task 729

DECEMBER, 1968

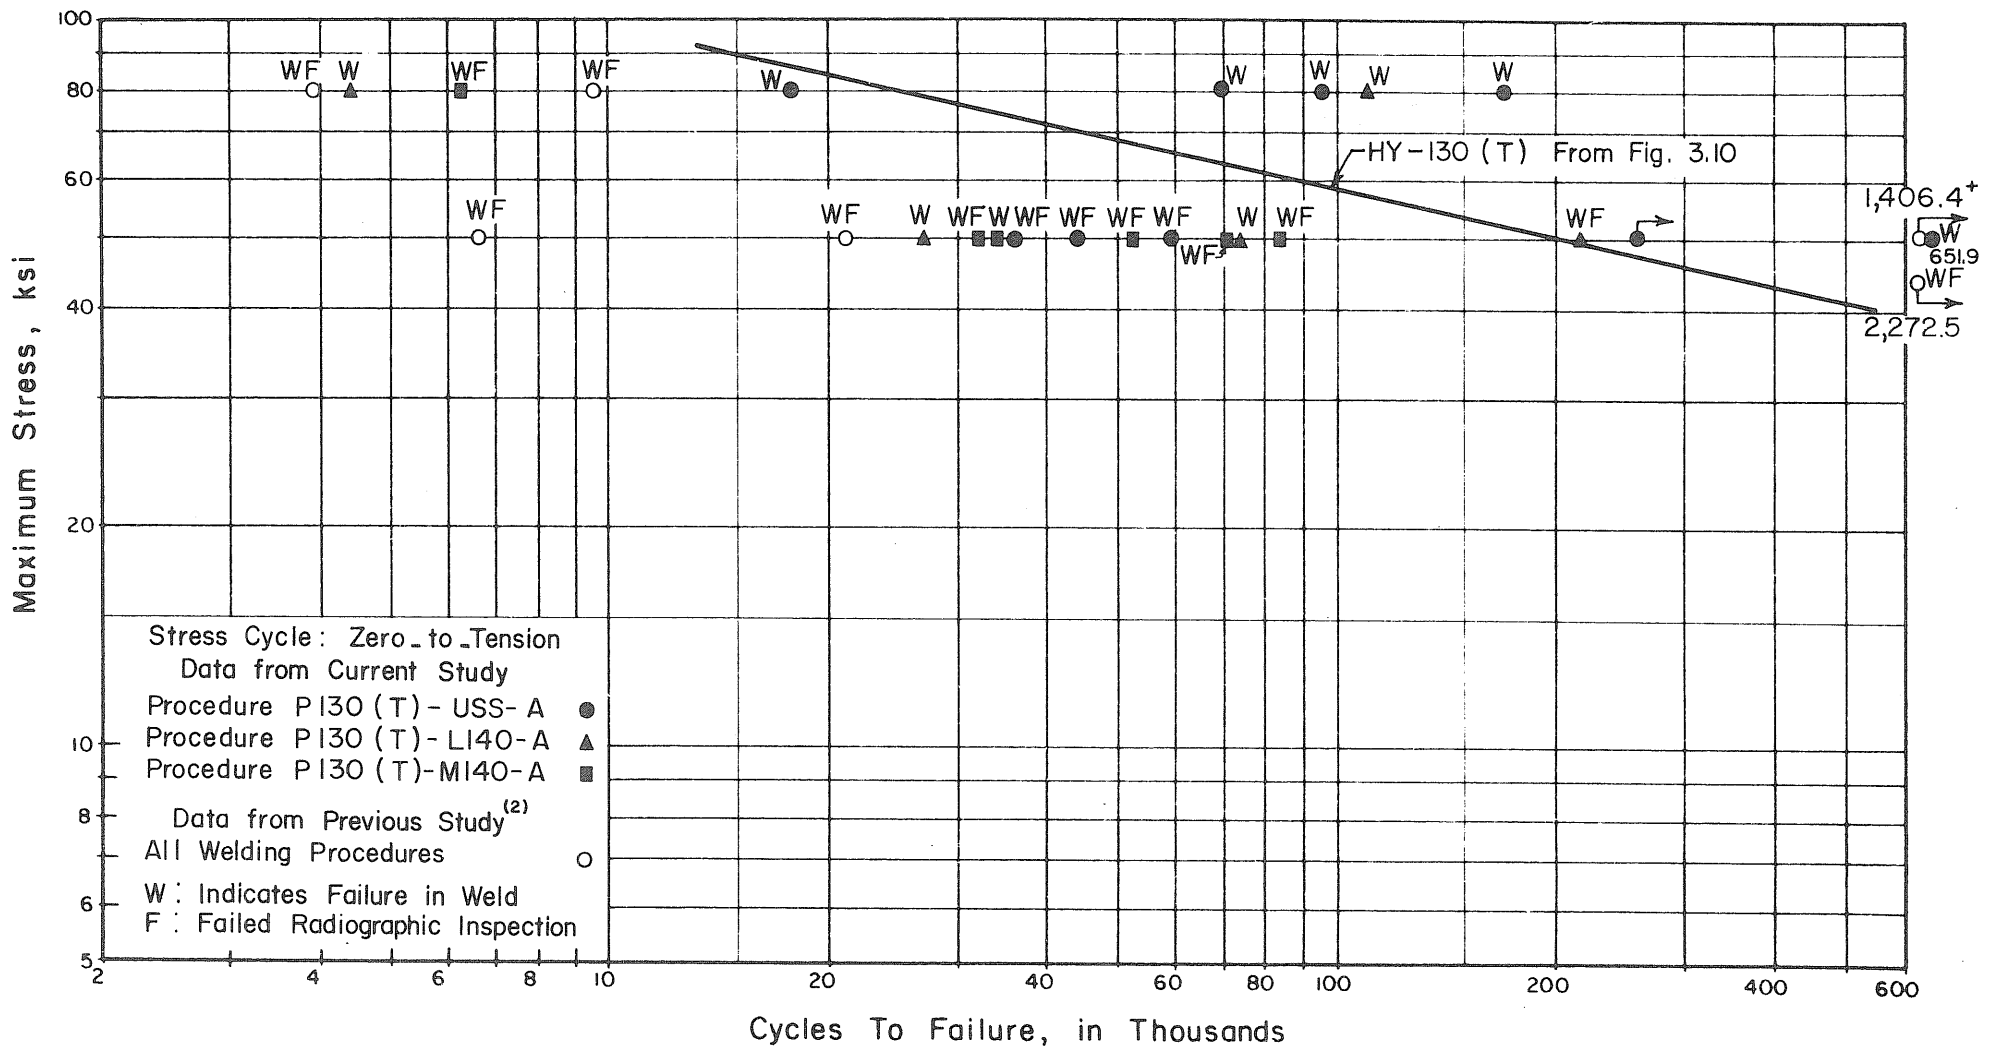
FIG. 3.11 RESULTS OF FATIGUE TESTS OF HY-130 (T) TRANSVERSE BUTT-WELDED SPECIMENS WITH REINFORCEMENT REMOVED

results of the fatigue tests, together with a description of the type(s) of defect observed on the fracture surfaces at the location of fatigue crack nucleation, are presented in Table 3.4; the fatigue test data are also presented graphically in Fig. 3.11. A number of specimens are reported in Table 3.4 simply as having failed "in weld metal" because no physical internal flaw was discernible, with the unaided eye, on the fracture surfaces. These specimens were subsequently examined metallographically to study the weld microstructure and type of microscopic defect at the site of crack initiation; the results of this investigation are reported in Section 3.2.4. Photographs of the fracture surfaces of specimens having failed at various internal defects are pictured in Fig. 3.12.

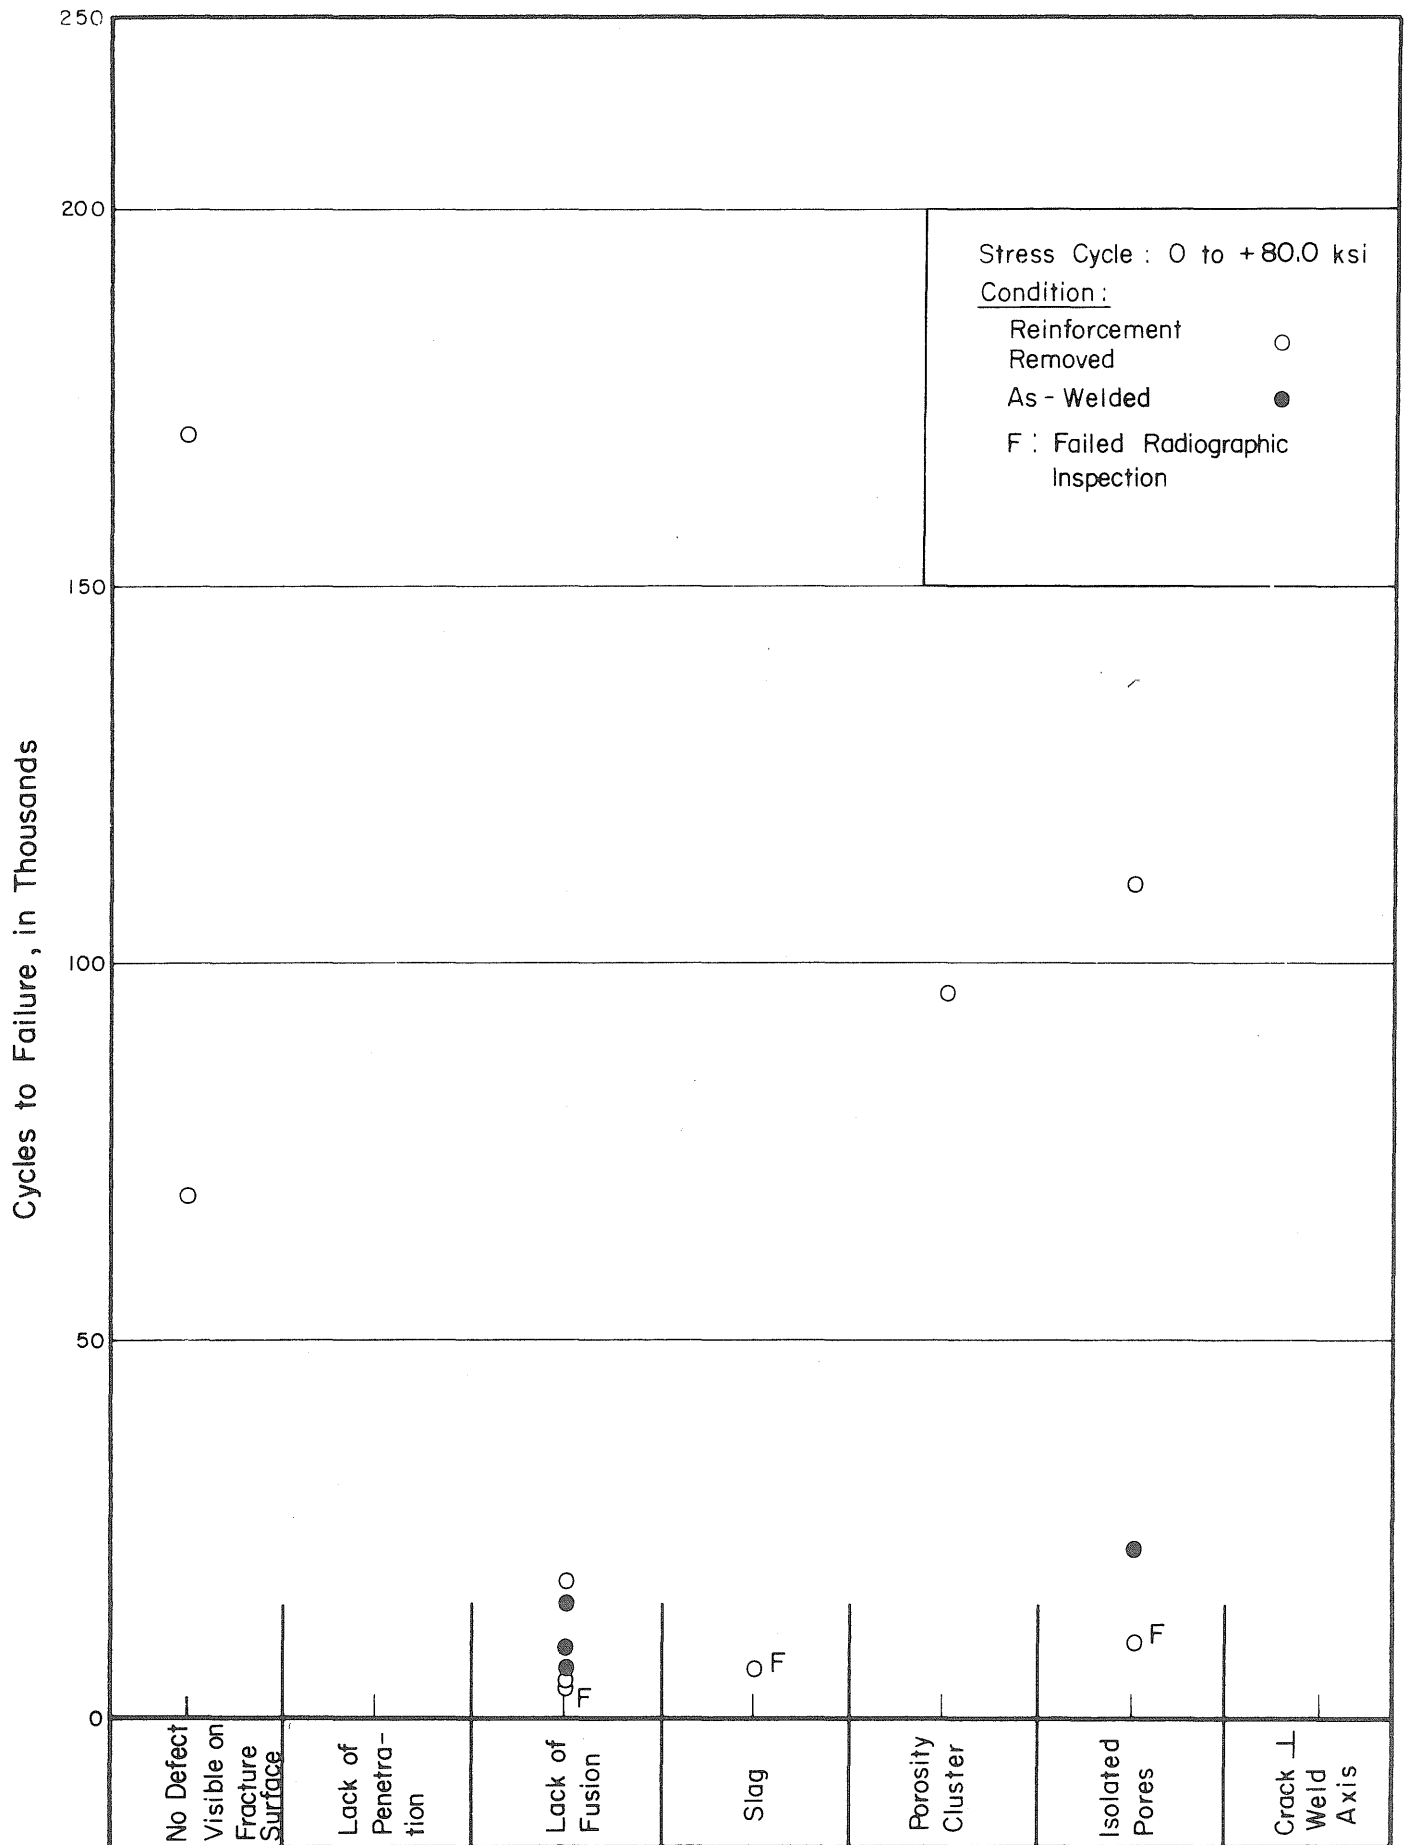
FIG. 3.13 EFFECT OF VARIOUS WELD DEFECTS ON FATIGUE OF HY-130 (T) TRANSVERSE BUTT WELDS (STRESS CYCLE : 0 TO +80 ksi)

No firm relationship between the crack-initiating defect type (as determined by fracture surface examination) and fatigue life could be established. The wide variation in fatigue behavior is clearly illustrated in Figs. 3.13 and 3.14 for specimens tested at stress levels of 0 to +80 ksi and 0 to +50 ksi, respectively. The data for as-welded specimens in which failure initiated at internal defects are also presented in these figures. From the data for tests conducted at 0 to +80 ksi, it appears that the irregularly shaped defects and the

linear defects, such as slag and lack of fusion, generally resulted in lower lives than those obtained for specimens containing isolated pores or clustered porosity. This could be expected, since the notch acuity and corresponding stress concentrations associated with the sharp, linear defects are considerably greater than for the approximately spherical configuration of the individual pores in porosity clusters. This expected performance was not enforced, however, by the data for specimens tested at 0 to +50 ksi (Fig. 3.14). For these tests, the scatter in data for all defect types is so large that it precludes drawing conclusions regarding the influence of any single flaw type. It should be noted, however, that the majority of specimens tested at 0 to +50 ksi had failed the radiographic inspection, and that greater consistency might be obtained if smaller defect densities were present.

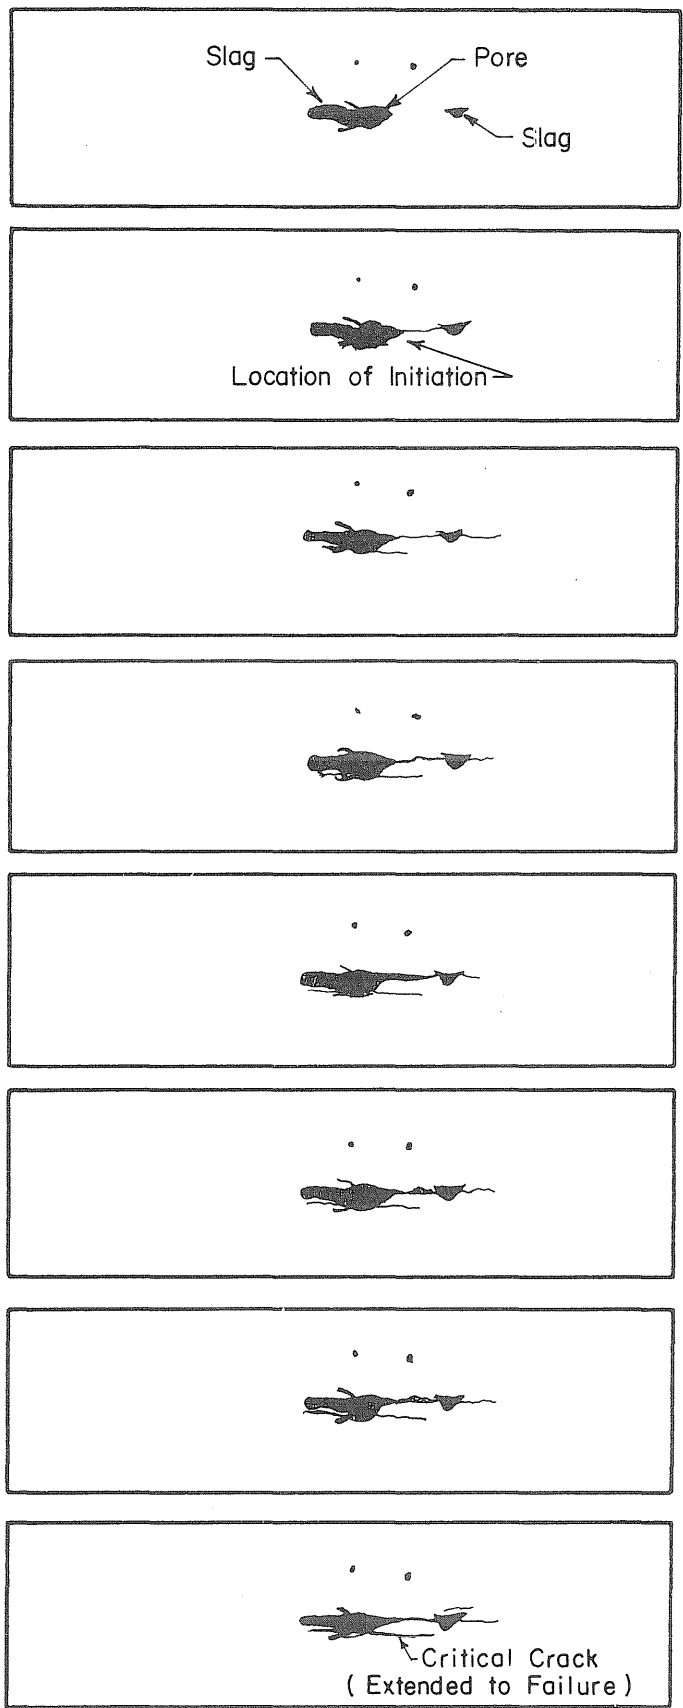
FIG. 3.18 TRACINGS OF RADIOGRAPHS TAKEN DURING FATIGUE TEST OF SPECIMEN ND-21

Examination of the tracings of the radiographs clearly demonstrates the complex and often unpredictable nature of the progression of a fatigue crack or cracks in the test weldments. In Specimen ND-21 (Fig. 3.18), for example, the fatigue crack which eventually extended to complete failure was not the first fatigue crack observed nor was it the longest crack until the latter stages of propagation. Further, in Specimen ND-17, fatigue cracks initiated near the tip of weld hot cracks oriented parallel to the direction of stress rather than at a seemingly more critical elongated slag deposit, Fig. 3.22. Despite these instances of unexpected behavior, the fatigue cracks in most of the specimens were found to propagate on planes perpendicular to the direction of external loading until such time as they had penetrated to one surface of the specimen; thereafter, during the latter stages of cycling, the cracks extended to complete failure along oblique planes in a typical "shear" mode of rupture.

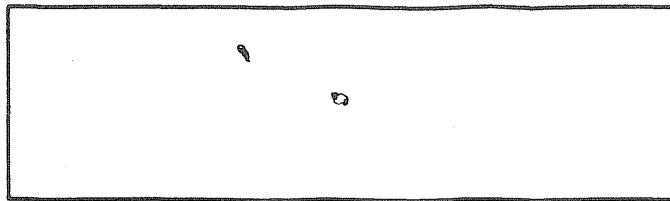
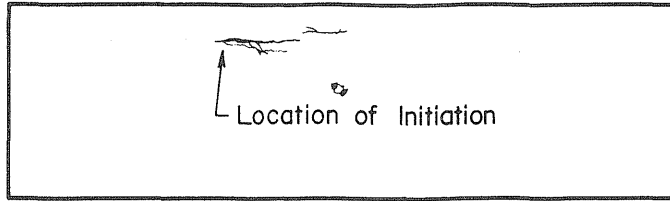
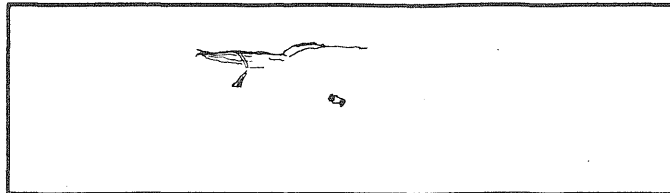
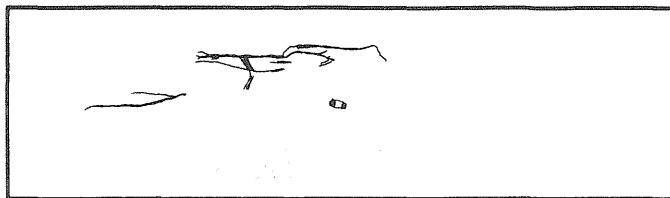
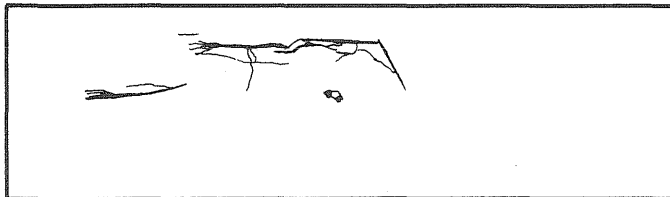
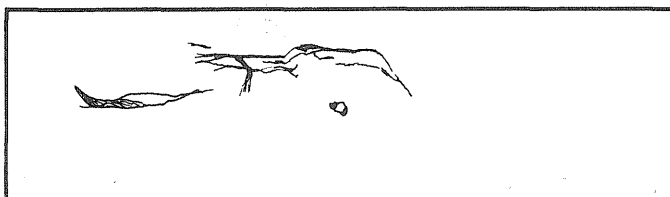
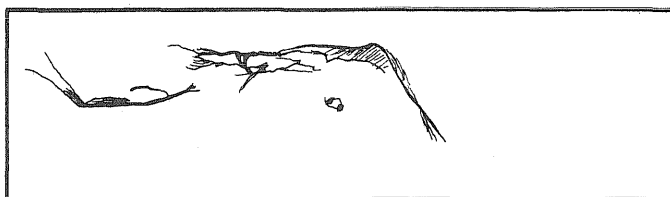
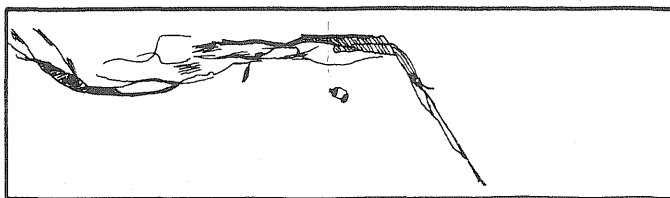
FIG. 3.20 TRACINGS OF RADIOGRAPHS TAKEN DURING FATIGUE TEST OF SPECIMEN ND-10

Tracings of selected radiographs obtained during the progress of fatigue cycling are illustrated in Figs. 3.16 through 3.25 for ten of the thirteen specimens examined in this phase of the investigation. (For Specimens NC-20 and NC-23, the anticipated fatigue lives were much longer than those actually obtained. Thus, the first X-ray taken after the start of cycling indicated that considerable crack growth had taken place and an insufficient number of radiographs obtained to adequately describe the complete crack progression process for these two weldments. Similarly, no radiographs of Specimen ND-12 were taken between 175,000 cycles, at which time no internal fatigue cracking was evident, and 219,200 cycles, when complete failure occurred.)

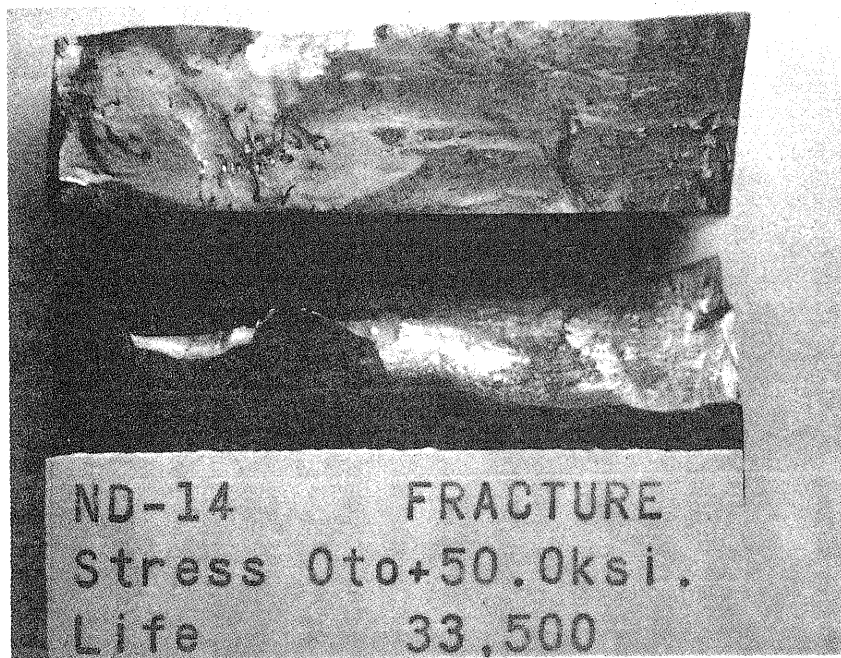
(e) Fracture Surface After Test

FIG. 3.36 (Cont.) FRACTURE SURFACE, AND ULTRASONIC INDICATIONS RECORDED FOR SPECIMEN ND-14

- 1) Internal weld flaws visible on fracture surface
- 2) Extent of fatigue crack propagation at intersection with surface

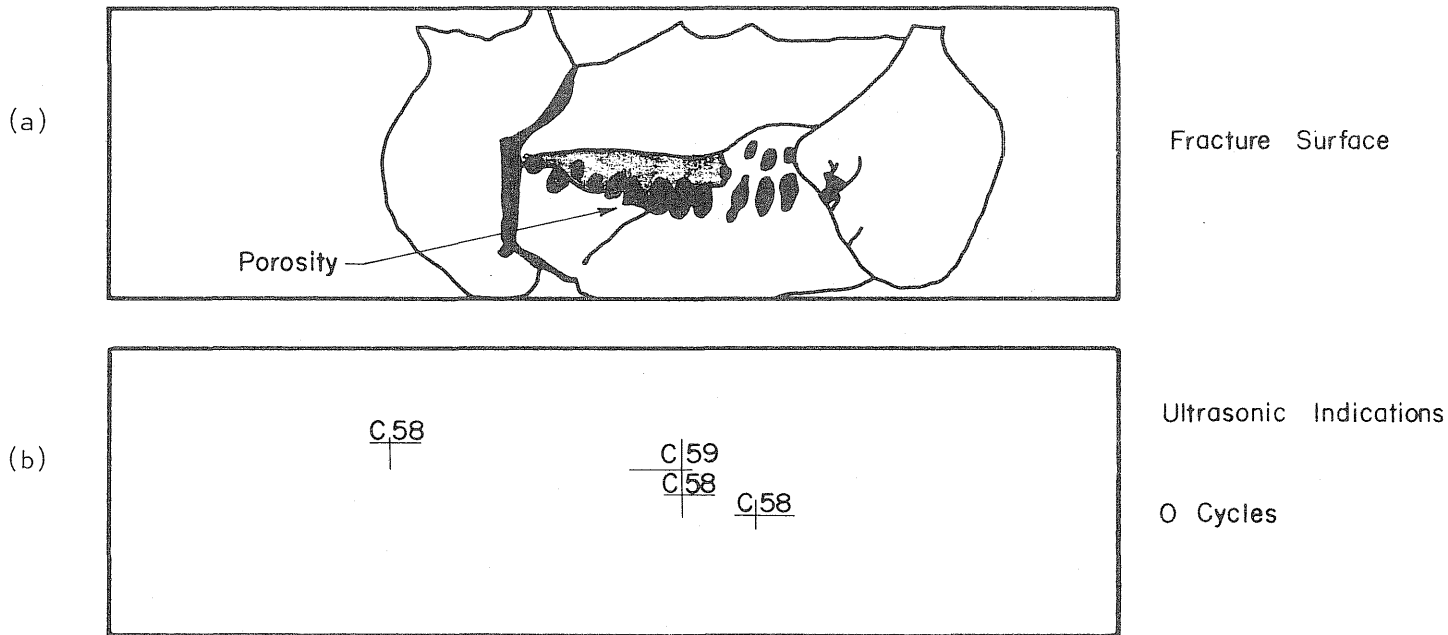
- 1) Location and extent of responses as indicated on detector scope
- 2) a. Number designation corresponds to magnitude of peak response as indicated on detector scope
- b. Letter designation corresponds to vertical location on specimen surface

FIG. 3.37 FRACTURE SURFACE, AND ULTRASONIC INDICATIONS RECORDED FOR SPECIMEN ND-15

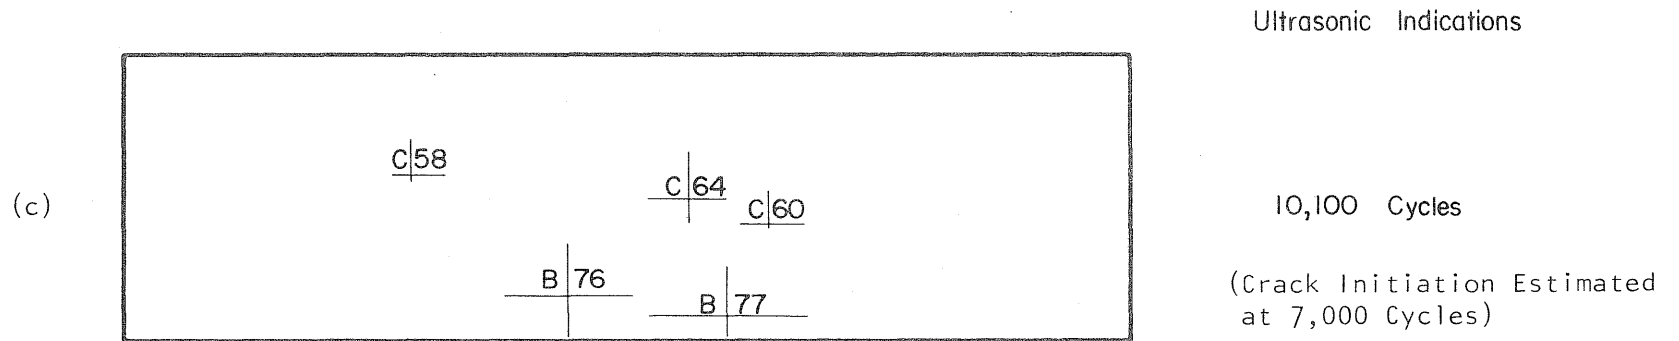
FIG. 3.37 (cont.) FRACTURE SURFACE, AND ULTRASONIC INDICATIONS RECORDED FOR SPECIMEN ND-15

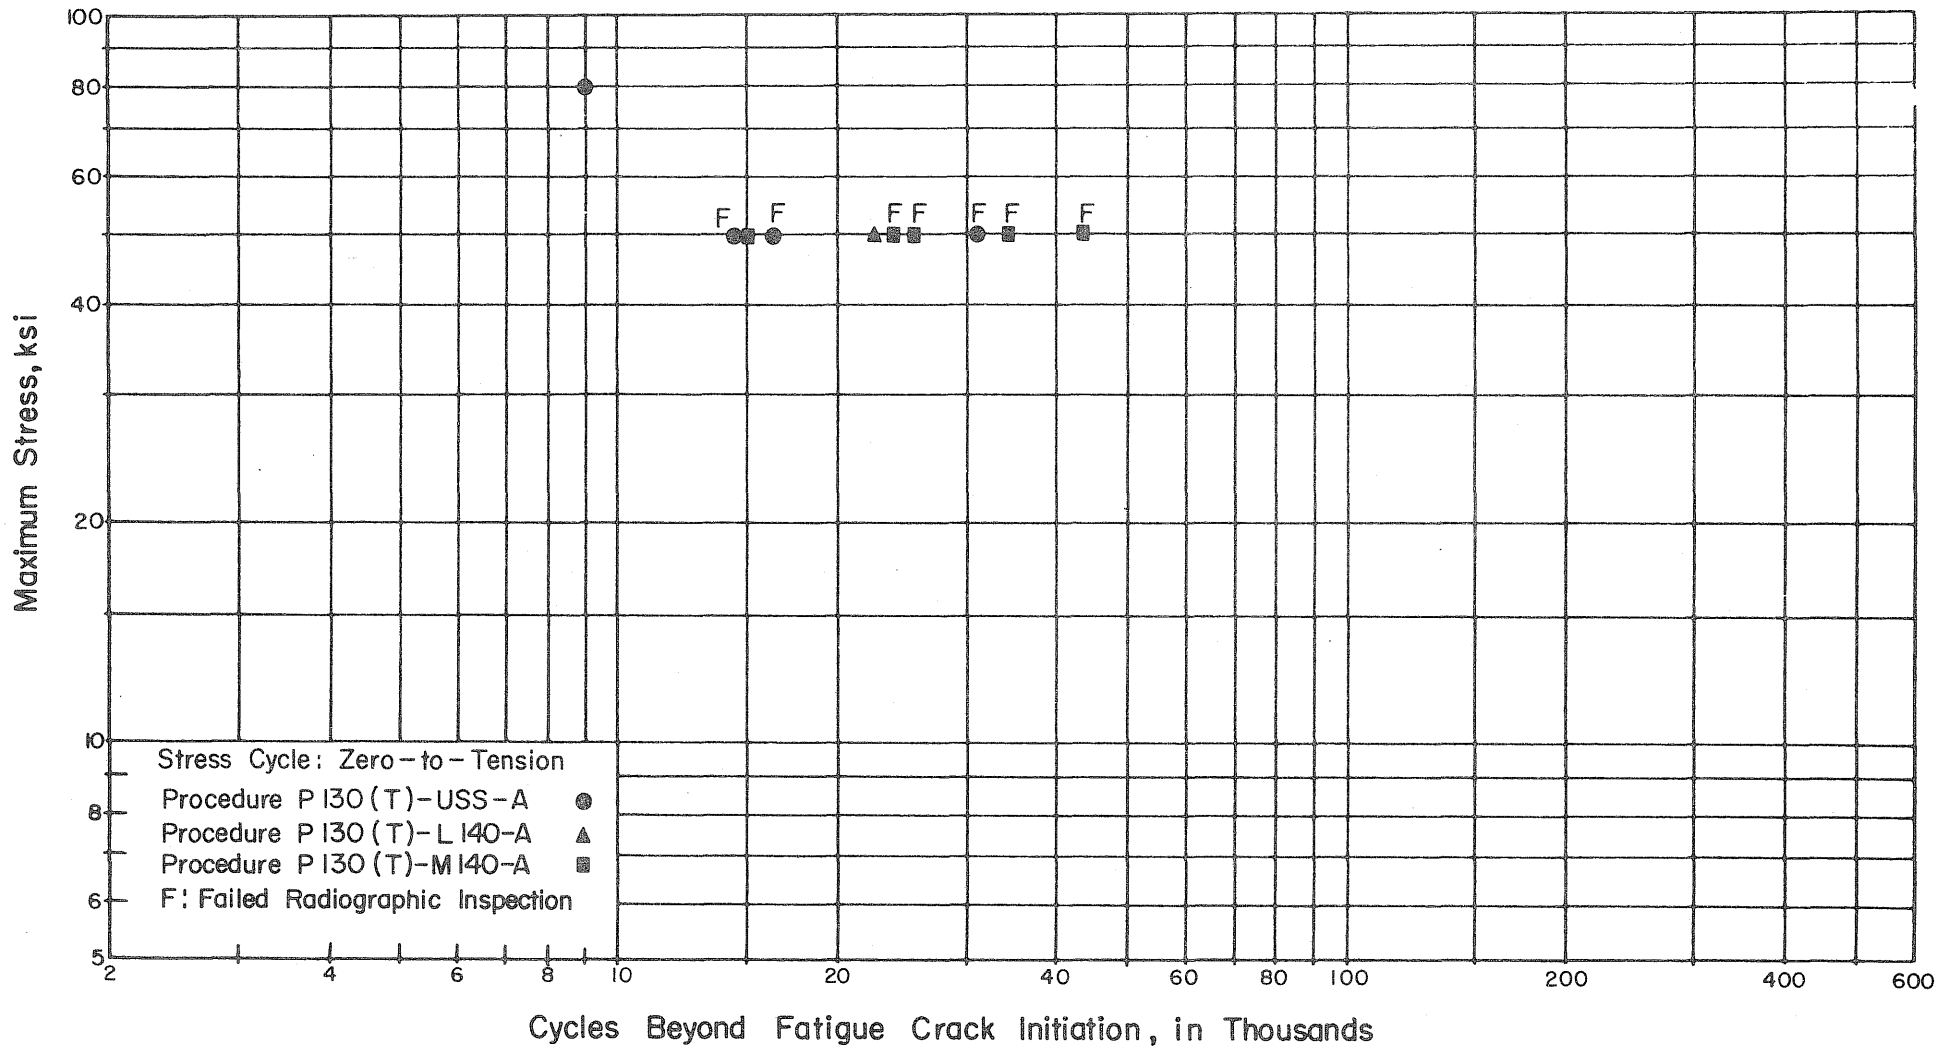
FIG. 3.38 CYCLES TO FAILURE FOLLOWING INTERNAL FATIGUE CRACK INITIATION IN HY-130 (T) TRANSVERSE BUTT WELDS WITH REINFORCEMENT REMOVED
