FATIGUE OF PLATES AND WELDMENTS IN HIGH STRENGTH STEELS

Final Report

The Naval Ship Systems Command, U. S. Navy
Contract N0bs 94232
Project Serial No. SF-020-01-05, Task 729-0

February 1967

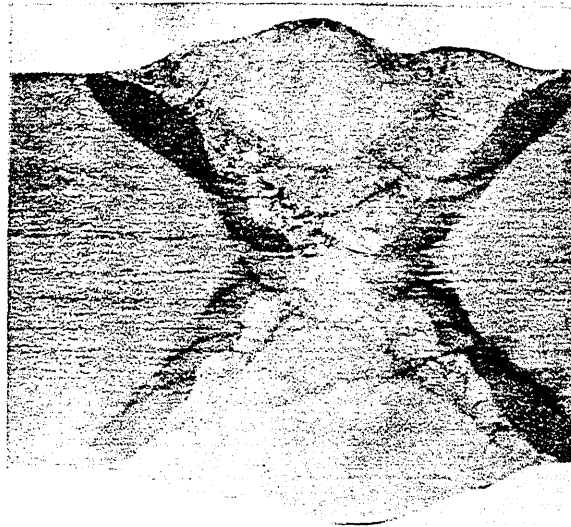
FIG. 4.14 COMPARISON OF TRANSVERSE SECTIONS OF HY-130/150 WELDED JOINTS FROM N.A.S.L., U.S.S. CORP., & U. OF I.

(a) U.S. Naval Applied Science Lab. 2x

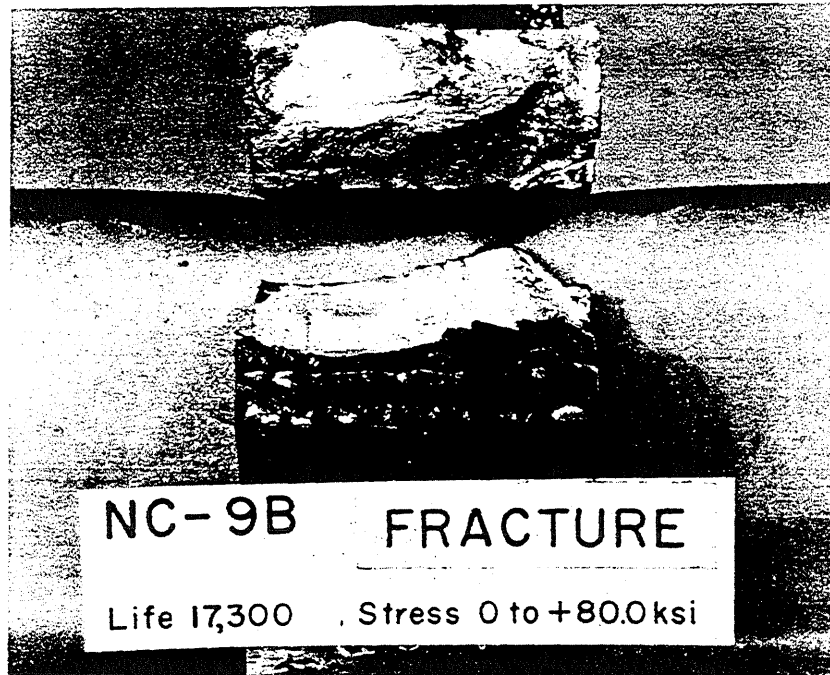
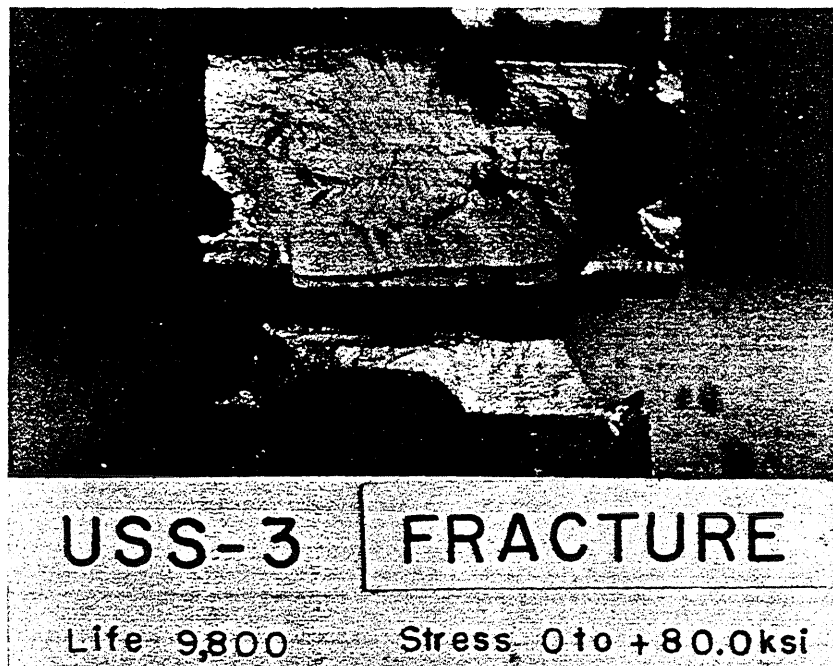
FIG. 4.18 FRACTURE SURFACES OF HY-130/150 TRANSVERSE BUTT WELDS IN THE AS-WELDED CONDITION

approximately equivalent, both in quality (soundness of weldment) and in the directly related axial fatigue behavior, at least at the 0 to +80.0 ksi stress level investigated. Typical fracture surfaces for specimens prepared at NASL and USS are shown in Fig. 4.18.

(a) Specimen Prepared By NASL

(b) Specimen Prepared By U.S. Steel

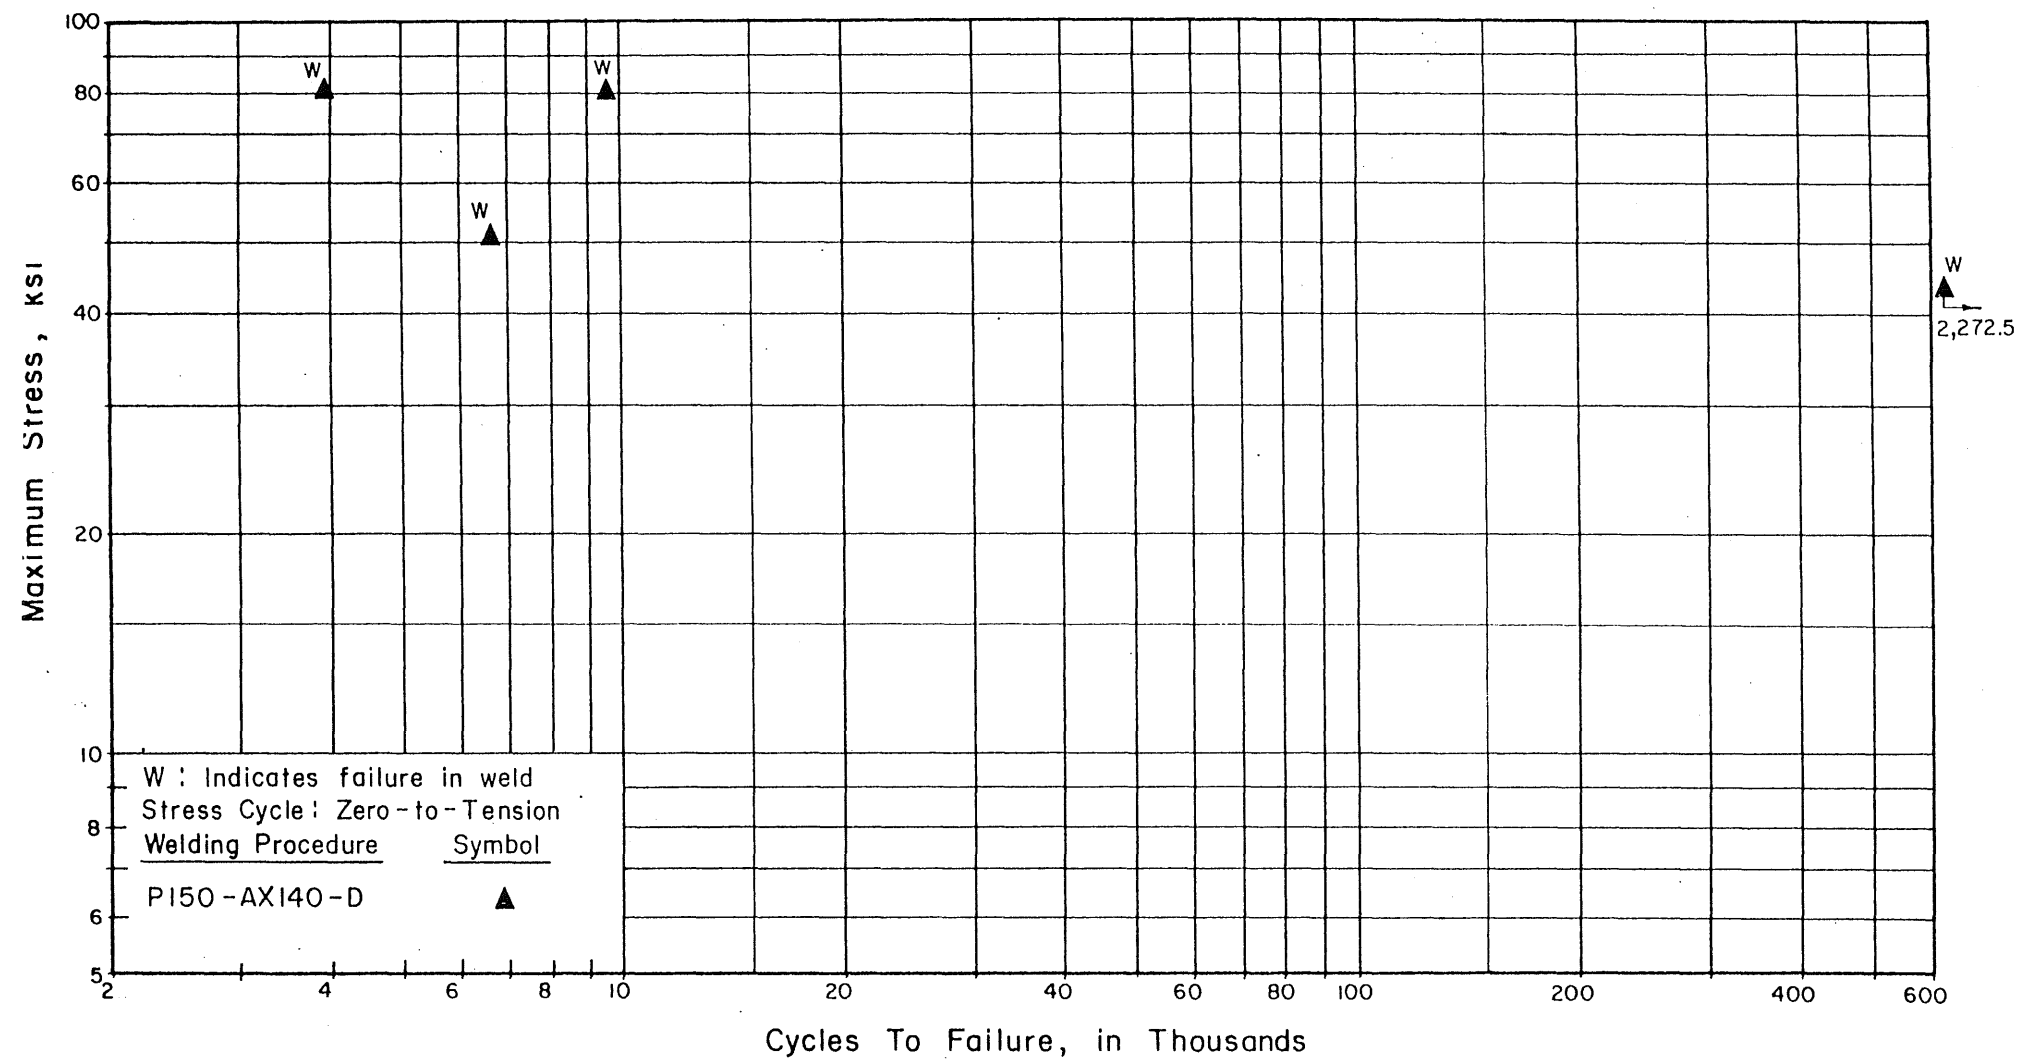
FIG. 4.19 RESULTS OF FATIGUE TESTS OF HY-130/150 TRANSVERSE BUTT WELDS WITH REINFORCEMENT REMOVED

All specimens tested with the reinforcement removed were cycled from zero-to-tension at one of three stress levels: 0 to +80.0 ksi; 0 to +50.0 ksi; or 0 to +43.0 ksi. The results of the fatigue tests are reported in Table 4.11 and plotted in Fig. 4.19. No S-N curve could be determined for these data because of the few tests conducted and the large scatter in results. The locations of fatigue crack initiation in the specimens with the reinforcement removed were the same as for those specimens tested in the as-welded condition; i.e., the failures initiated internally in regions where either porosity or lack of fusion was evident, Tables 4.8, 4.9, and 4.11.

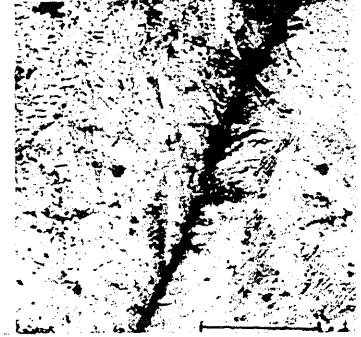
FIG. 4.23 REPLICAS OF THE FATIGUE FRACTURE ALONG THE CENTER OF A LOBE (ARROW) OF SAMPLE NC-2

Fatigue fractures were frequently observed to propagate along the center line of a weld lobe as shown by the arrows in Figs. 4.23 and 4.24, even though radiography did not indicate a crack in this lobe area prior to fatigue cycling. It is probable, therefore, that such weld lobe areas were also the nucleation points for internal fatigue failure in those specimens which exhibited no physical discontinuity (porosity, lack of fusion, etc.) at the fatigue crack origin (specimens denoted as failing "in weld metal"

in Tables 4.9 and 4.10). The plastic replicas shown in Figs. 4.23 and 4.24 of the fatigue crack in one lobe area indicate that there are many particles of the type mentioned above, both large and small, on the surface. The extraction replica shown in Fig. 4.23, taken directly from the surface of the fatigue fracture, reveals a detailed dendritic structure. The reason that such a detailed dendritic structure was extracted so completely from the surface of the fatigue fracture must be due to the fact that the fatigue crack propagated along the nonmetallic network which outlined the dendritic structure, especially along the center line of the lobe of the weld bead. It should also be noted that the spacing between droplets (dots) shown in the plastic replica of Fig. 4.24 is of the same order of magnitude as the spacing between the non-metallic particles outlining the dendritic structure shown in the extraction replica of Fig. 4.23.
