Tailplane or main wing stall? LOC-I event due to suspected icing

Kåre Halvorsen, NSIA, Norway

Michael Bromfield, University of Birmingham, UK

Nadjim Horri, Coventry University, UK

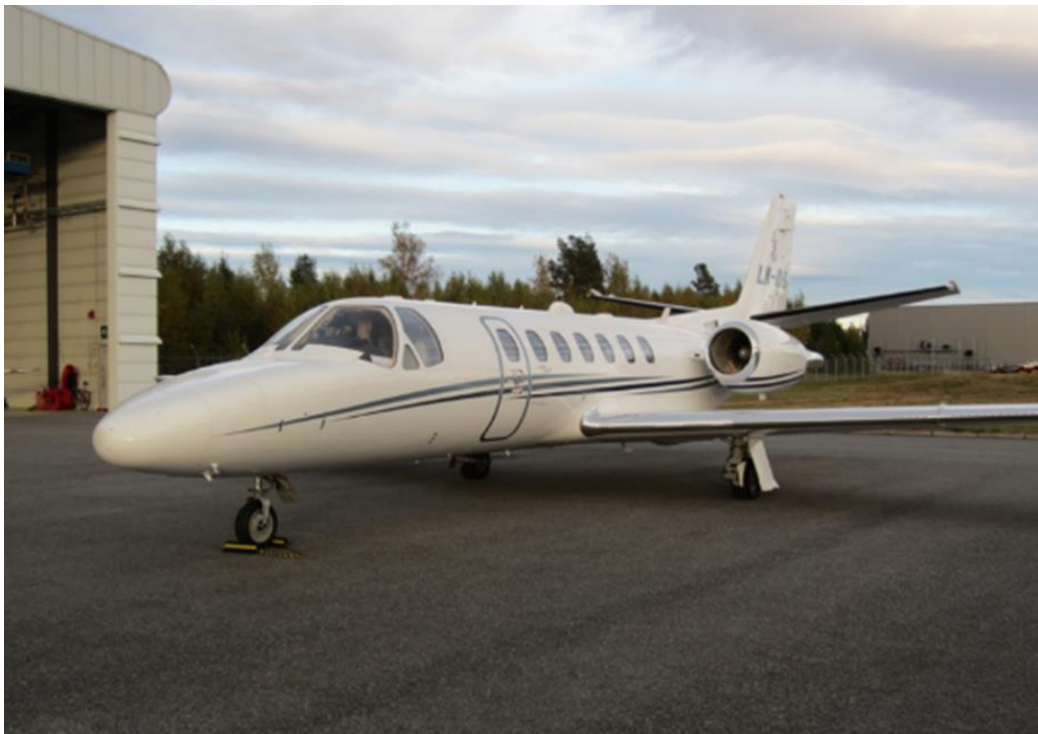
LN-IDB, a Cessna 560 Encore with serial number 560-0637 was manufactured in 2003. The aircraft type is certified for two pilots, commander and co-pilot. The cabin has room for 7 passengers.

Figure 1, Cessna 560 Citation Encore LN-IDB (Hesnes Air As)

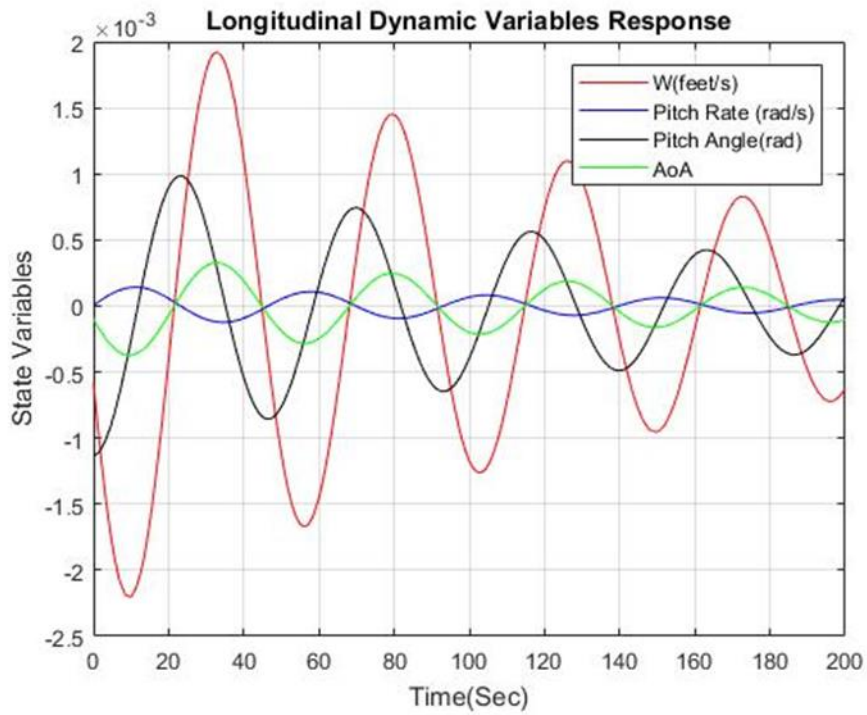
Figure 12, Long Period Oscillation (LPO) with 100% Horizontal Tailplane Efficiency

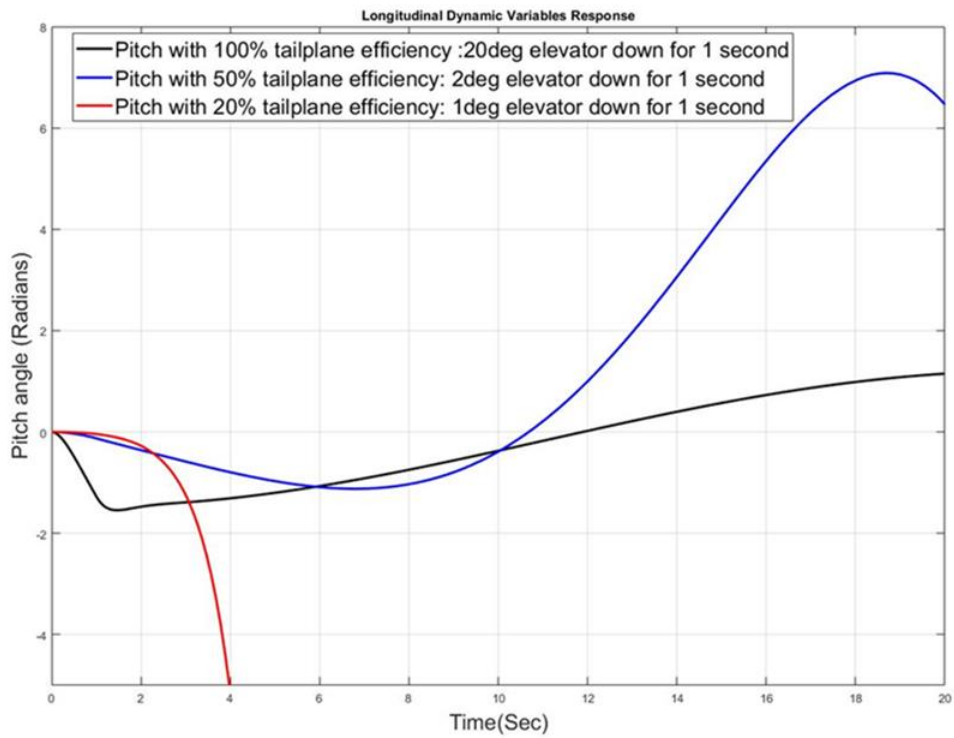
Figure 13, Dynamic Pitch Stability with varying Tailplane Efficiency

The results showed that static stability decreases as tailplane efficiency decreases, simulating the onset of tailplane icing and that increasing UP elevator (-VE) is required to compensate. At low tailplane efficiency the aircraft pitch response to elevator commands becomes unstable. Flap retraction initially helps, but not sufficiently to stabilise the response with low tailplane efficiency and a tailplane stall destabilises the system response. The safety investigation authority issued a safety recommendation to the aircraft manufacturer, requesting they inform the customers about the nature of the accident and the risk of tailplane stalling.

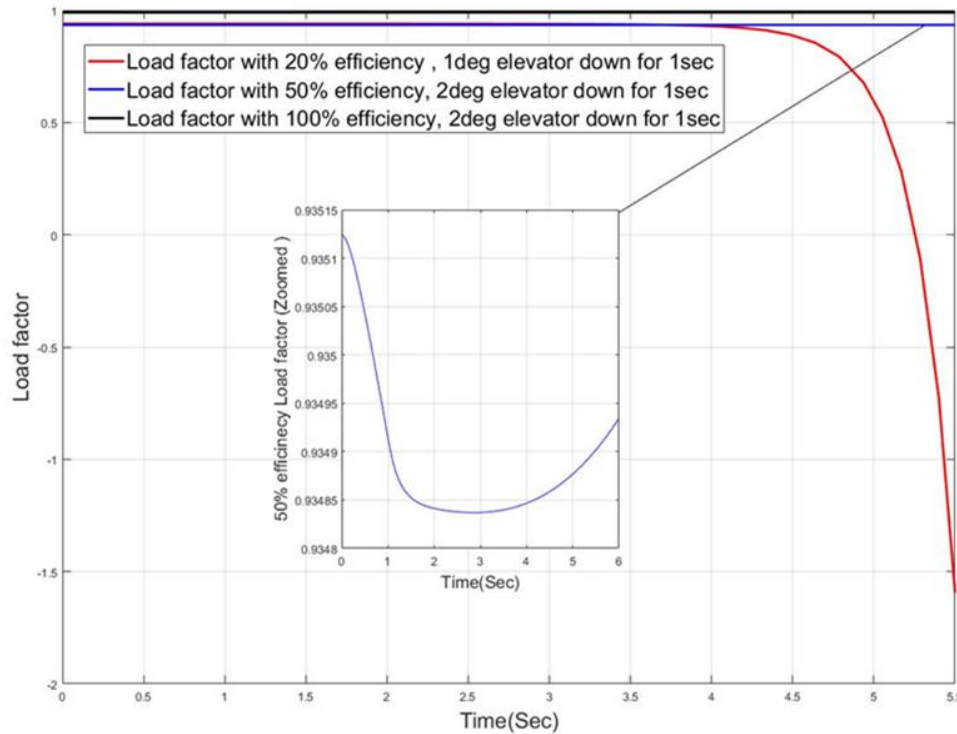
Figure 14, Load Factor with varying Tailplane Efficiency
