# Pathology, Evaluation and Repair of Bridges in Masonry

# 3. The case study: the bridge on river Kentra Stora Skida (North-East of Algeria)

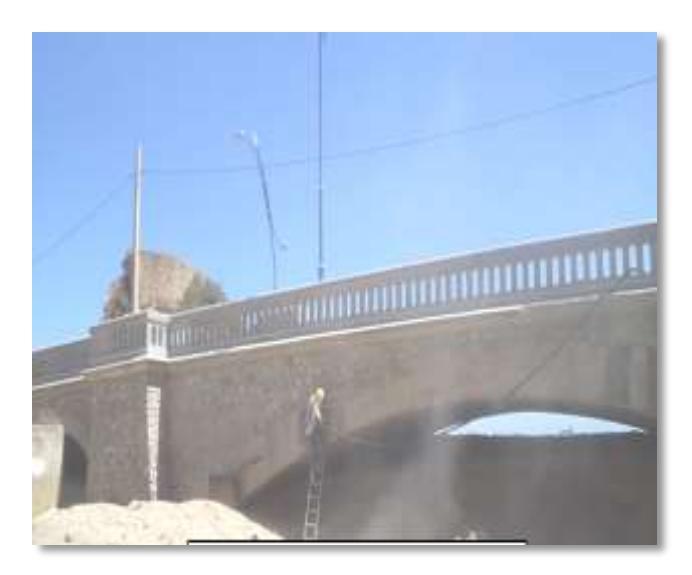
Fig 1. Elevation view of the structure

The presence of significant cracks on the entire structure: The slab of the deck also has significant delamination areas in addition to having a thickness insufficient by standards. The vault and the abutment show traces of water infiltration. The bursting of concrete with stripping and corrosion of the reinforcement at the cornices. Cracks are also visible on the masonry in Fig. 2. They usually run along the joints. Locally, splinters between the rubble are also visible.

The cracking developed is due to the presence of microcracking in the mass of the mortar and to the weaknesses of the stone - mortar interface (Stablon, 2011).
