# MONITORING OF PLAYA CALDERA AND COASTAL STRUCTURES WITH UNMANNED AERIAL VEHICLES (UAV)

GEORGES GOVAERE<sup>1</sup>, RONALD VIQUEZ<sup>1</sup>, HENRY ALFARO<sup>1</sup>, DIEGO CORNEJO<sup>1</sup>

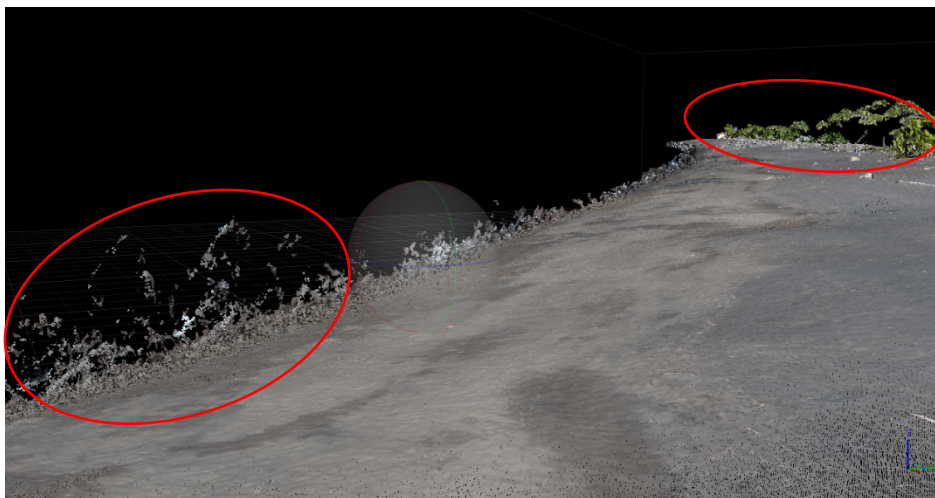
Plant cover affects primary results because ground level information is not possible to calculate. Similarly, nearby surf from water bodies increases noise (see Figure 3) producing non-representative data. To correct these issues manual post processing using Photoscan tools is conducted. Elevation in these conditions is interpolated, as long as there is reliable information about the general area.

Figure 3. Noise due to surf in water and vegetation presence.
