A case study for scientific research prior to conservation of marine metal artefacts

van der Stok-Nienhuis, J.; Kuiper, E.; Beentjes, T.; Joosten, I.; van Eijck, L.; Zhou, Z.; van Bommel, M.

Journal of Archaeological Science: Reports

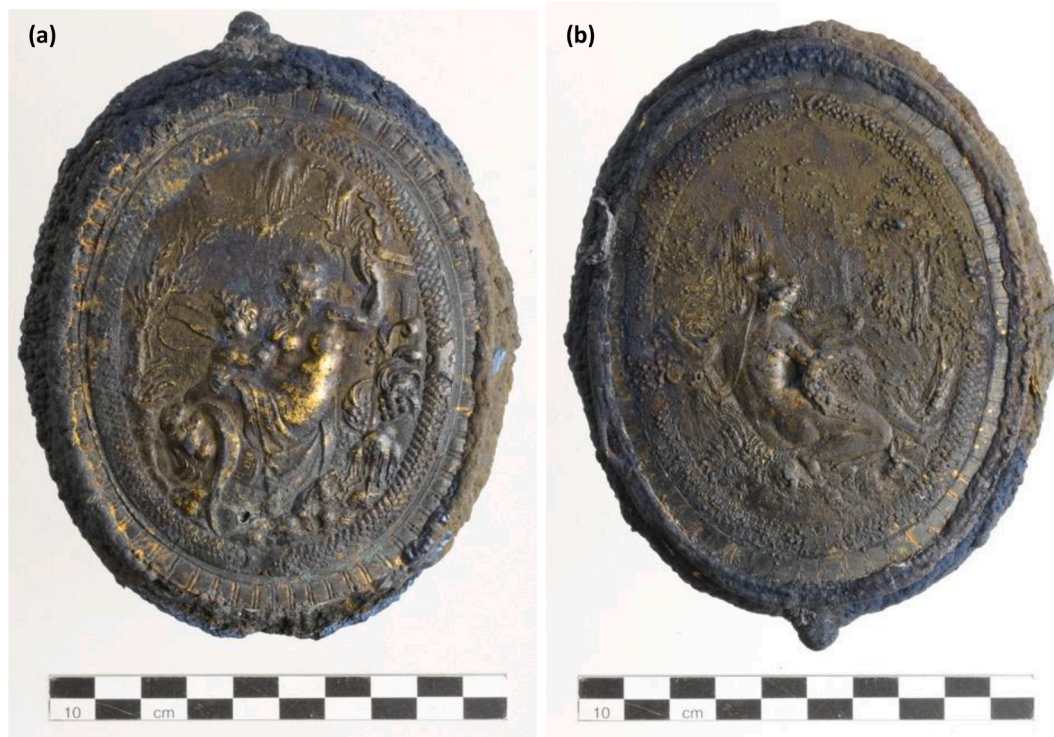
Fig. 1. Oval metal box from shipwreck BZN17. Both decorated faces are pictured, with an additional rotation of 180° for enhanced visibility: (a) Venus and Amor; (b) Leda and the swan. Images: Archeologie West-Friesland.

Previous to or during its recovery from the seabed the object was badly damaged in especially one area (Fig. 2; bottom area in Fig. 1a).
