Description of Gasket Failure in a 7 Cell PEMFC Stack

Attila Husar, Maria Serra, Cristian Kunusch*

Institut de Robòtica i Informàtica Industrial, Parc Tecnològic de Barcelona. Edifici U
C. Llorens i Artigas, 4-6, 2a planta, 08028 Barcelona, España

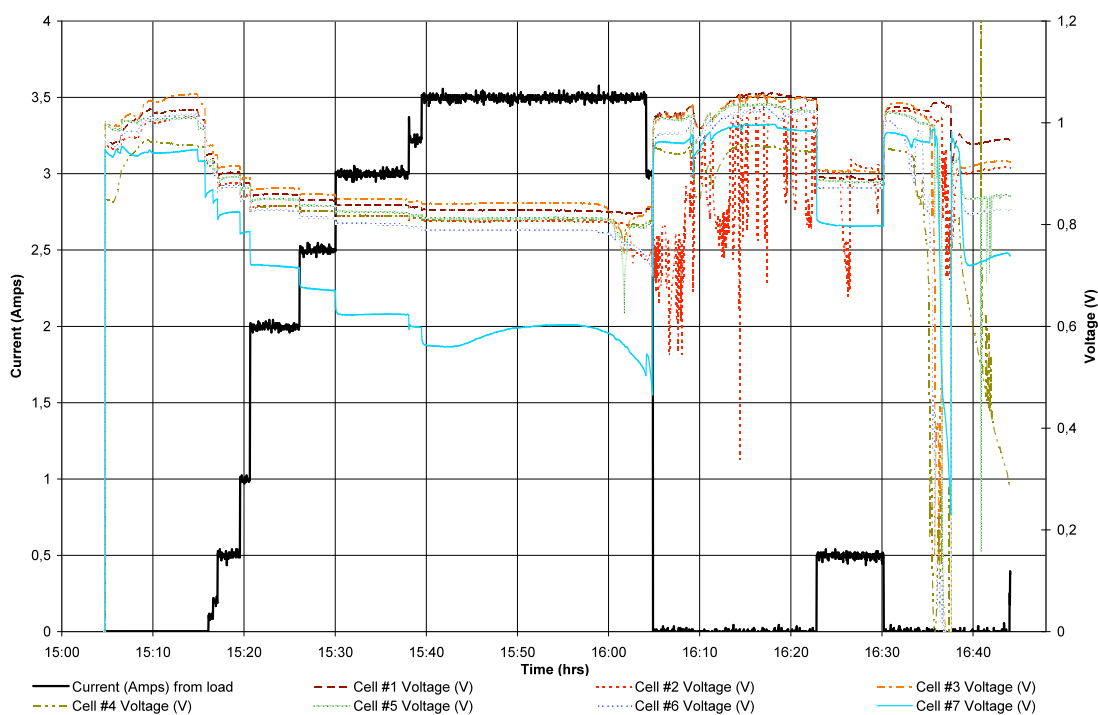
The stability of the stack over time with respect to individual cell voltage is shown in figure 2. As can be seen in this figure the stack was stable under these conditions. The variation in the cell voltage can be attributed to changes in the current due to impedance spectroscopy tests performed on the stack. Cell #7 of the stack had consistently showed a poor performance when compared to the other cells in the stack. However, this issue will not be analyzed in this work as it is unrelated to the ultimate failure of the stack.

Fig. 2. Normal voltage current response of the 7 cell stack a few days before failing, H₂/O₂, 1.02 Stoichiometry for anode and cathode, 60°C stack temperature, no humidification and a gas pressure of 4.50 bar (a) (50 psig) for both the anode and cathode
