Dhimish, Mahmoud and KETTLE, JEFF (2021) Impact of Solar Cell Cracks Caused During Potential-Induced Degradation (PID) Tests. IEEE Transactions on Electron Devices. ISSN 0018-9383

Impact of Solar Cell Cracks Caused During Potential Induced Degradation (PID) Tests

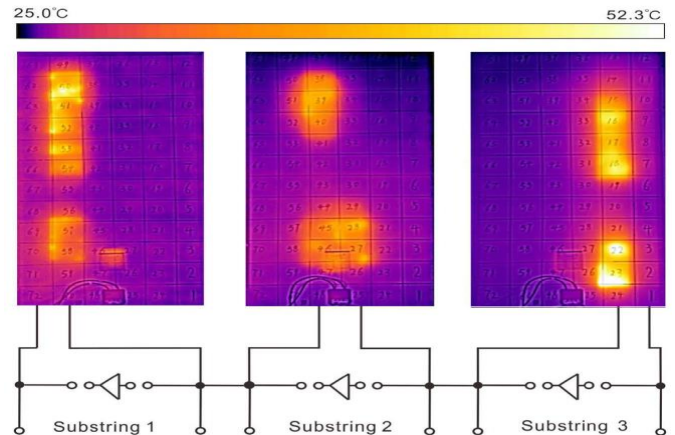
Fig. 1. Thermographic image of three substrings of module 3 under reverse 160 V bias [6].

modules, as presented in Fig. 1 for three different PV modules connected in series. This study showed that the PID resulted in a reduction of the current density and the open-circuit voltage. Improved testing has been the focus of much recent research; for example, in [7], authors have presented an approach to test the reversible and irreversible PID testing to bifacial PERC solar cells. Other researchers [8, 9] have reported that cracks in solar cells can accelerate PID due to the localized heat caused by the cracks. This work was supported by studies conducted using electroluminescence (EL) imaging before and after PID testing. This affirmed that cracks could lead to hotspots in the solar cells, and as a result, PID is expected, yet there were no discussions on the type/size of cracks and their expected impact upon PID.

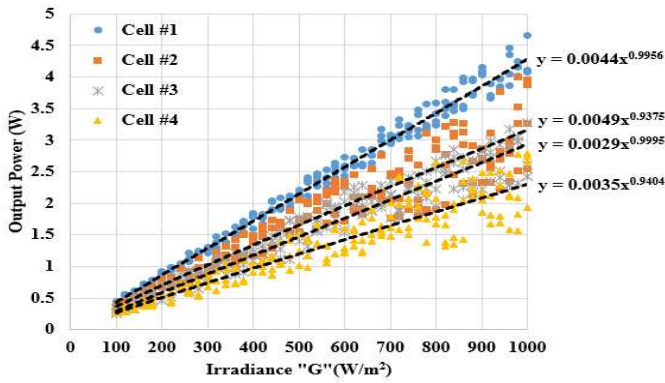
For sample #1, affected by minor cracks, the cell generated more output power, with an average power output of 2.36 W. Cells #2 and #3 show similar levels of cracking (as demonstrated by the dark areas in the EL image); so, their output averaged power at 1 Sun irradiance equals 1.81 W and 1.62, respectively. Finally, the maximum drop in the averaged power was observed for the last solar cell sample #4, which exhibited the most severe cracking and showed an output power of only 1.32 W.

Fig. 14. (a) Output power of the cells under illumination from 100 to 1000 W/m^2 , and cell temperature is 25 degrees, (b) Boxplot of the output power vs irradiance.

This data is supportive that as the crack size increases in solar cells, PID testing has a greater affect the output power performance. Furthermore, if we consider Fig. 14(b), the measured power has a more pronounced distribution away from the mean as the irradiance level increases. For example, the distribution of the measured output power at 1000 W/m^2 is $\pm 15\%$ from the actual median value, while it is only equal to $\pm 2\%$ at 100 W/m^2 .
