DAC REHABILITATION

GRAPHICAL SURVEY, DIAGNOSIS AND PROPOSALS FOR INTERVENTION OF “GUARDIA Y CUSTODIA” OF “EL POLVORÍN”

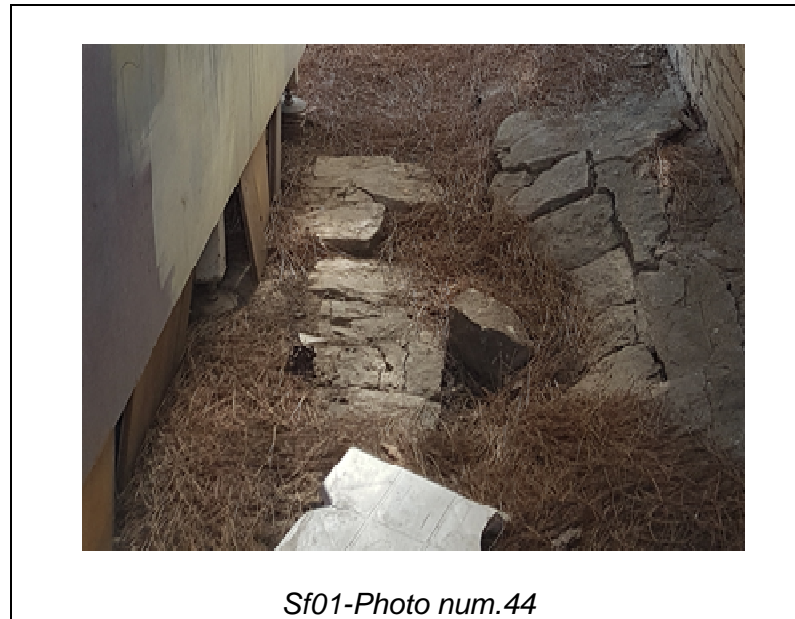
Sf01-Photo num.44

- Sagged masonry parapet, only in the zone of lateral west passage, of perimeter sidewalk that surrounds the building. (File nº1).

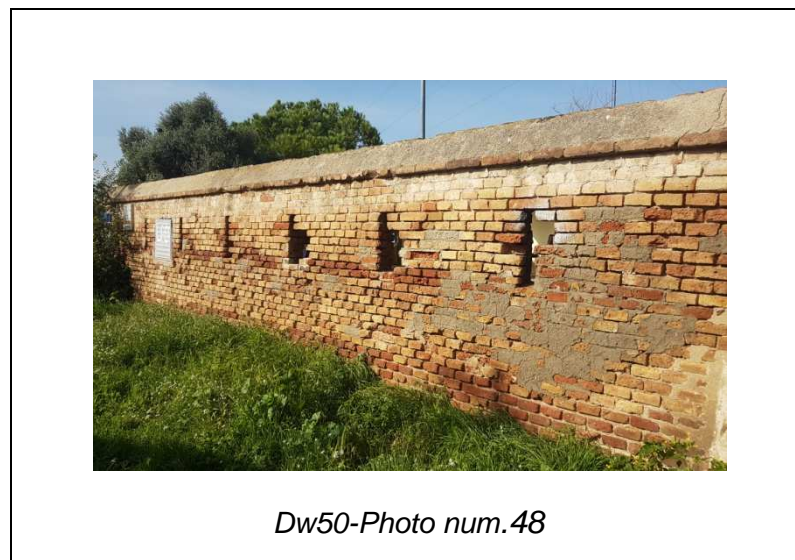
Dw50-Photo num.48

- Loophole narrow openings located throughout the section of the wall, have losses and erosion of the bricks that make them up. (File nº2).

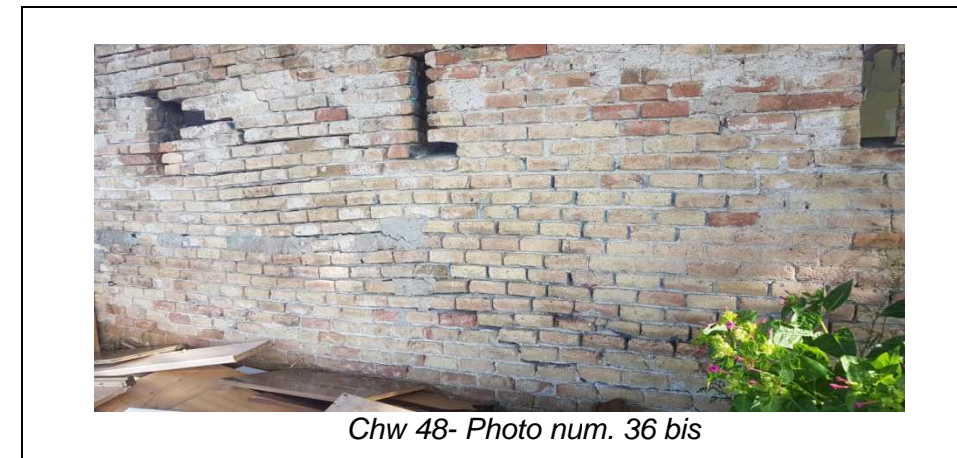
Chw 48- Photo num. 36 bis

- Wall in the southern part, has collapsed has lost its verticality. (File nº3)

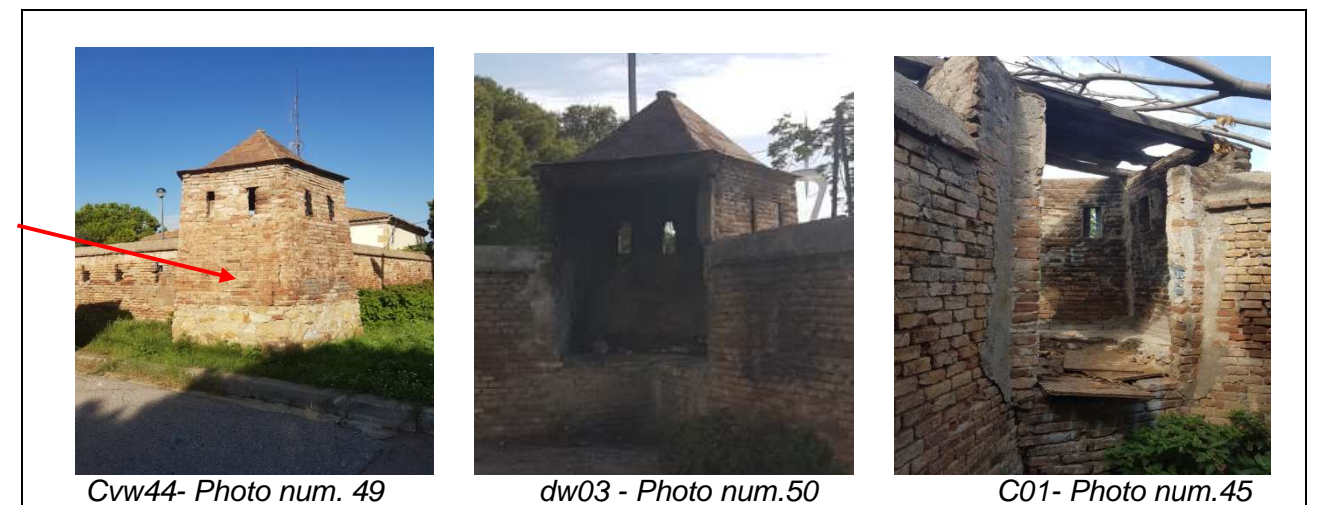
Cvw44- Photo num. 49

- The main sentry box on its outside and inside dirt on its walls and in the rear sentry box the cover has disappeared and there are debris inside (File nº4, nº5, nº6.).

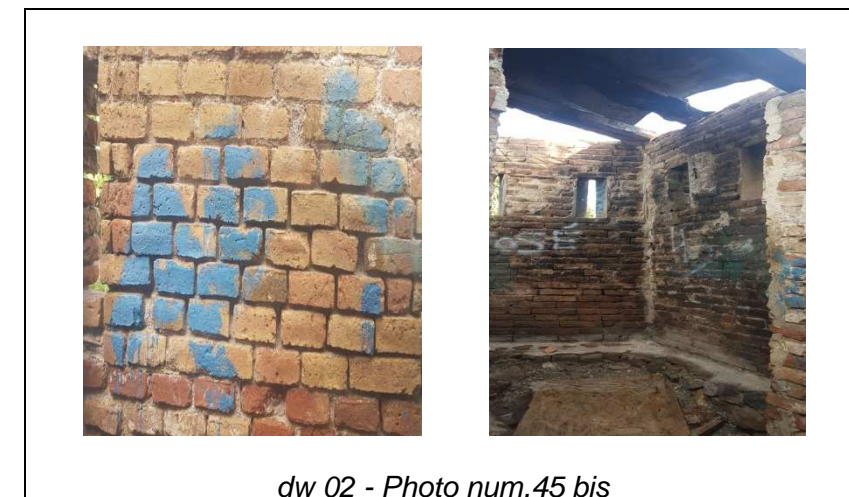
dw 02 - Photo num.45 bis

- Various painted blue and white, on the intrados of the back wall (File nº7).

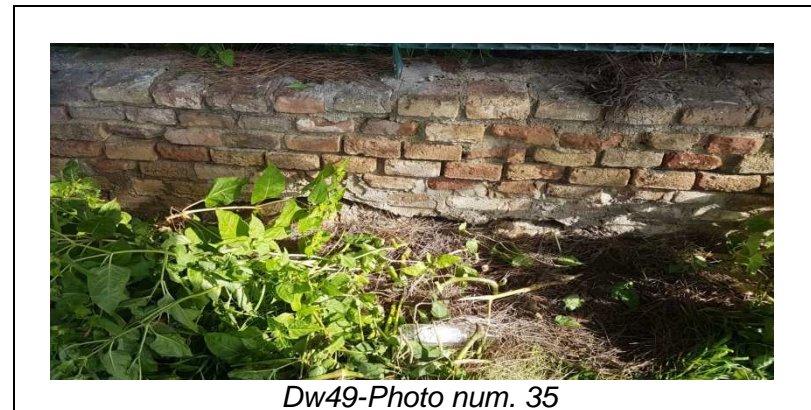
- Lost left outer wall of section in the lower part. (File nº9).

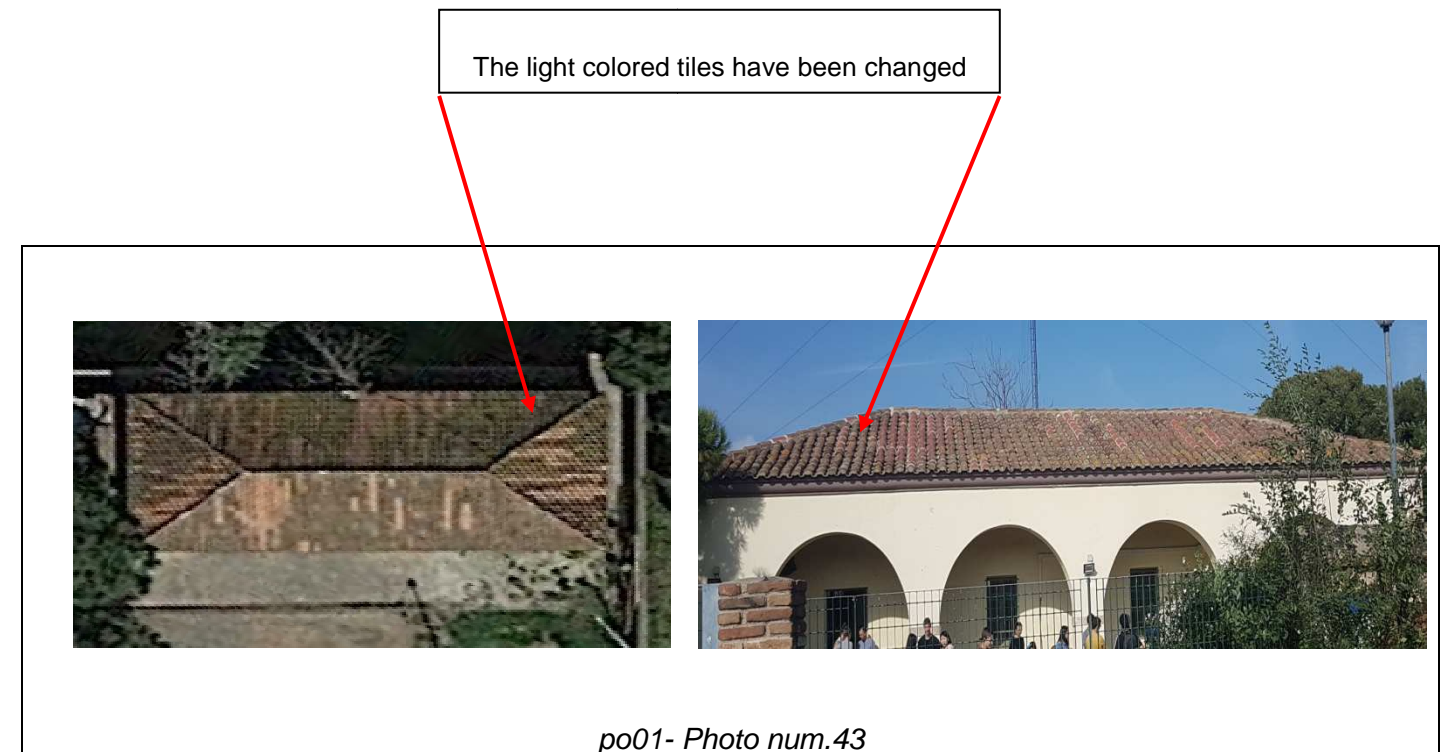
- Spots and plant organisms (mosses) located in the darkest / greenish areas throughout the cover. (File nº11).

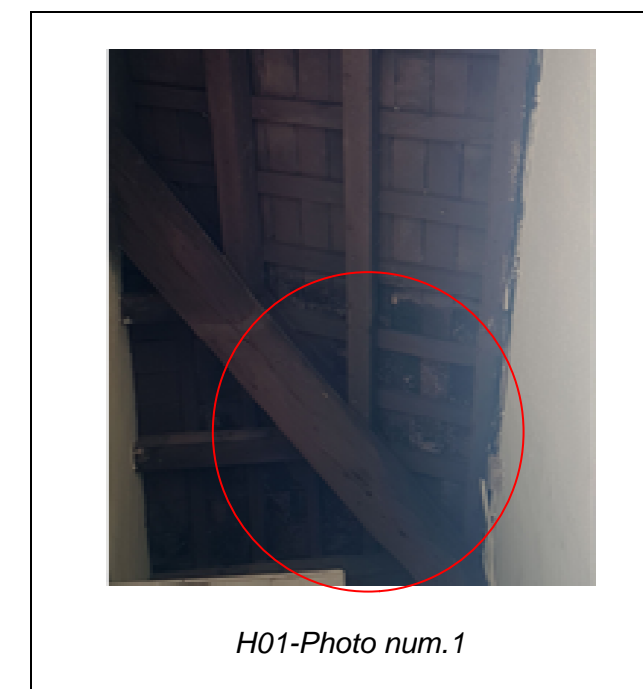
- Humidity by filtration in the wooden structure of the porch (File nº12).

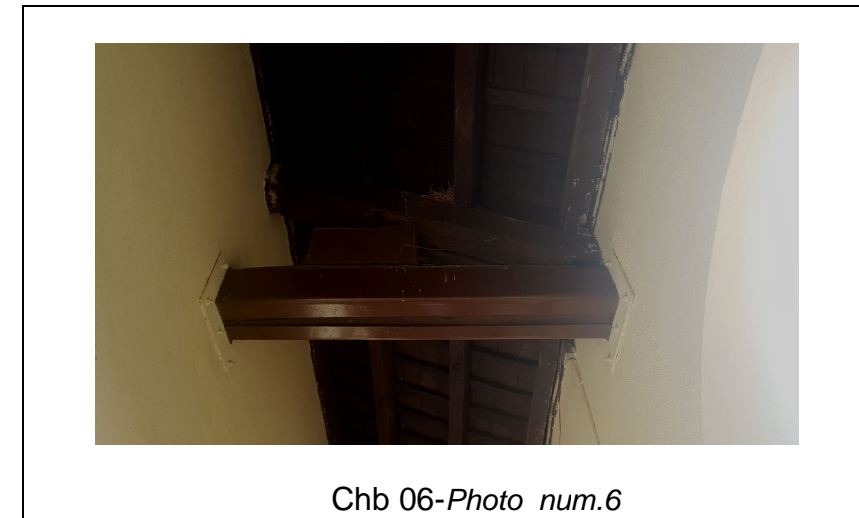
Chb 06-Photo num.6

- Longitudinal crack, which opens in the direction of the fiber, the strut of the truss already has a reinforcement along its entire length. (File nº15).

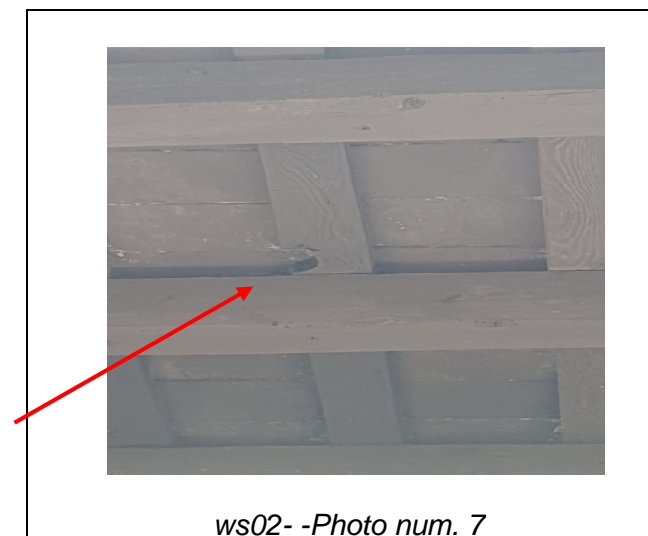
ws02- -Photo num. 7

- Jump a knot in one of the battens of the roof truss. (File nº16).

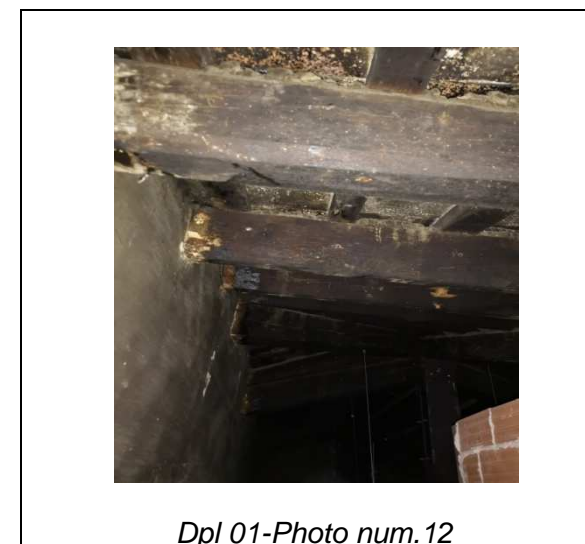
Dpl 01-Photo num.12

- Dirt in wooden battens and slats (File nº17).

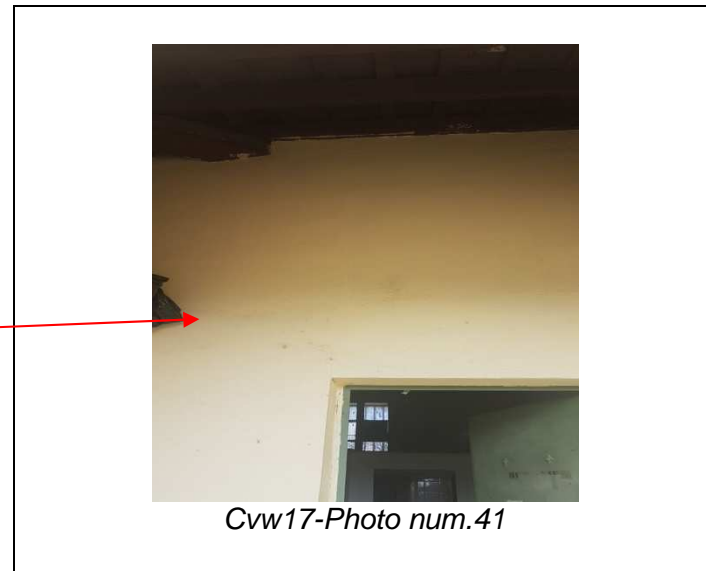
- Vertical fissure in the upper part of the door (File nº18).

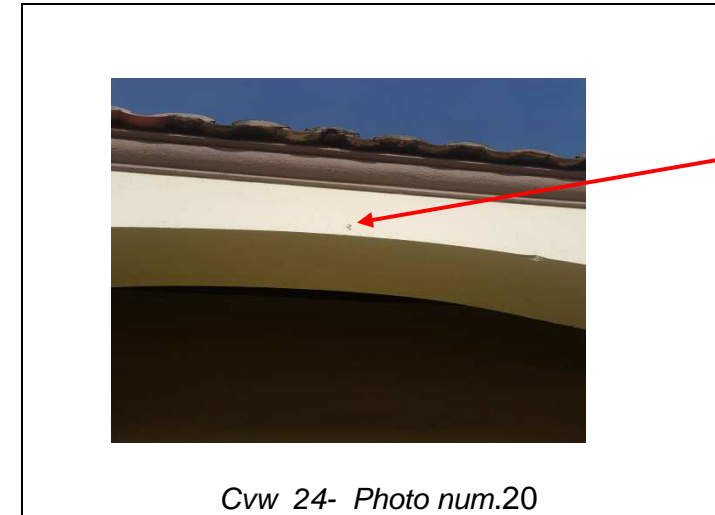
- Fissure in the center or key of the semicircular arch in the photos 19, 20 y 21 (File nº20).

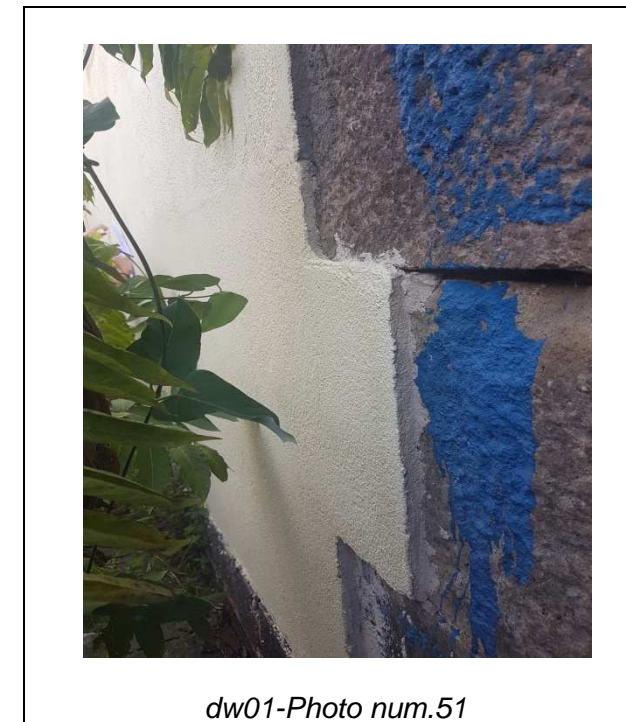
- Painting on the back facade in the corner in the stone (File nº28).

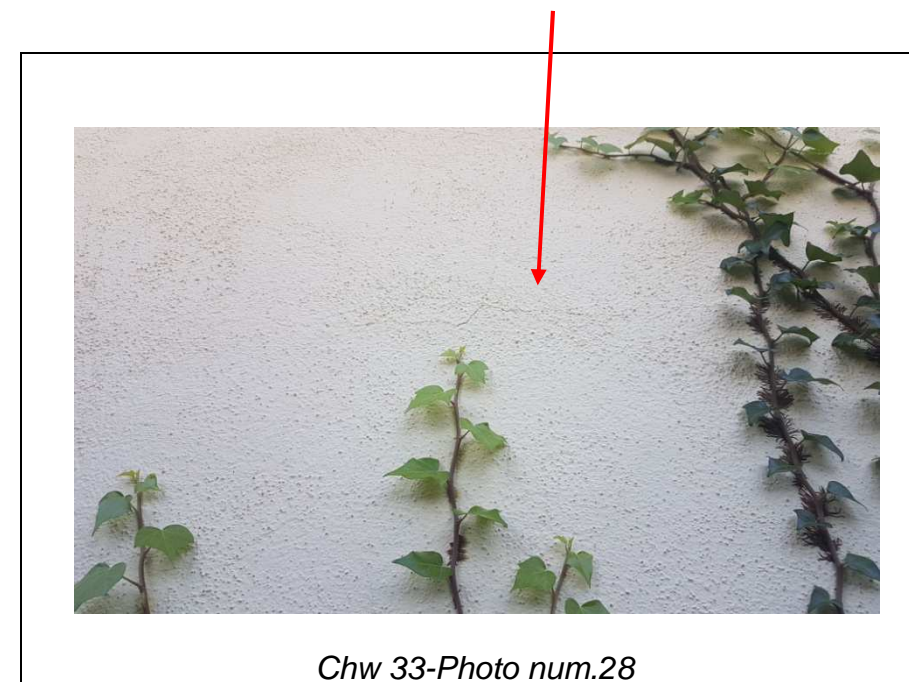
- Longitudinal fissure in the facade (File nº29).

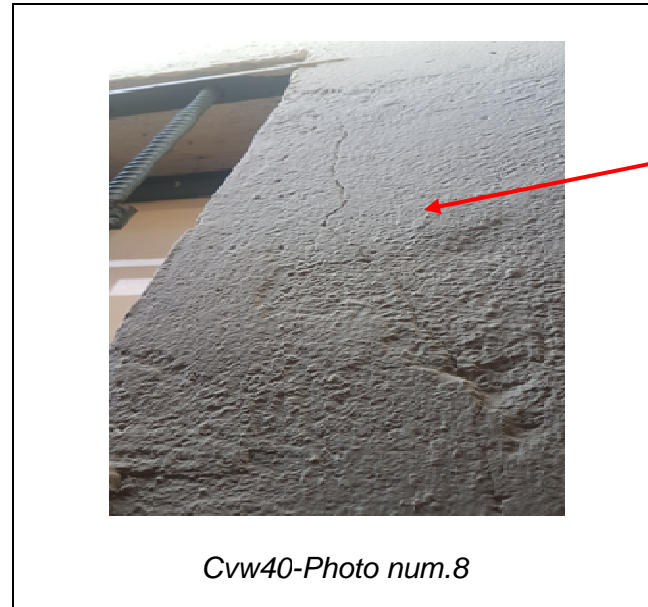
- Diagonal fissure in the wall at the top of the window in descending order, in photos 8 and 34 (File nº30)

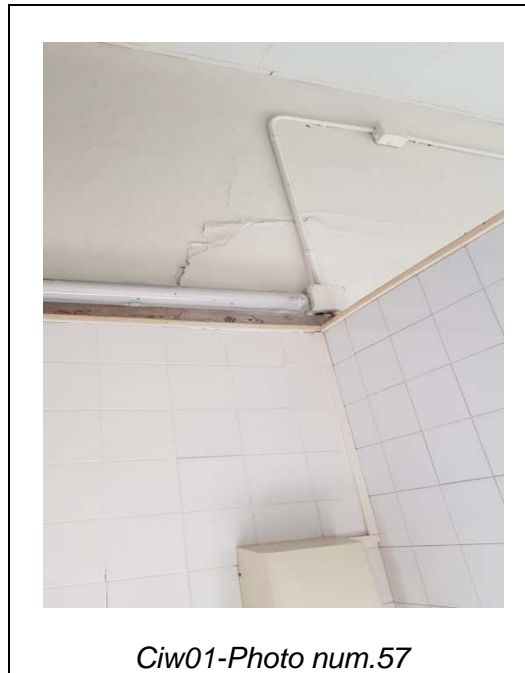
- Upward crack in vertical masonry facing that is divided into two parts. (File nº 34).

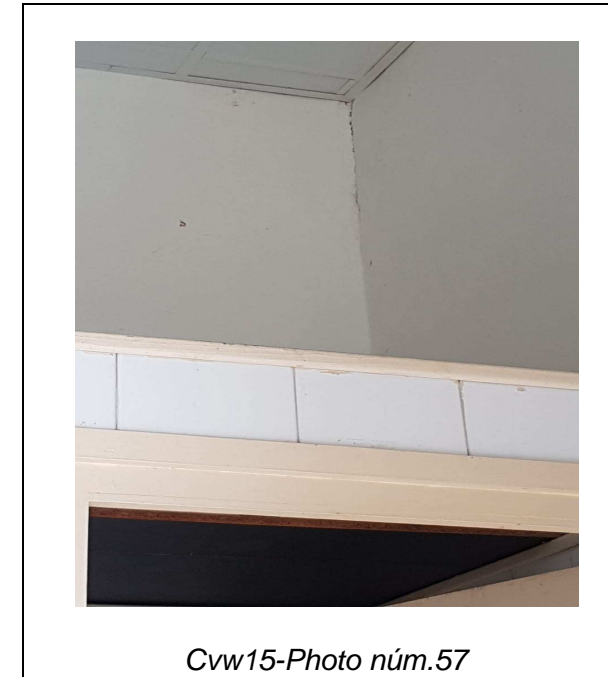
- Crack in the corner of the union of two different materials, the masonry wall and the brick dividing wall. (File nº36).

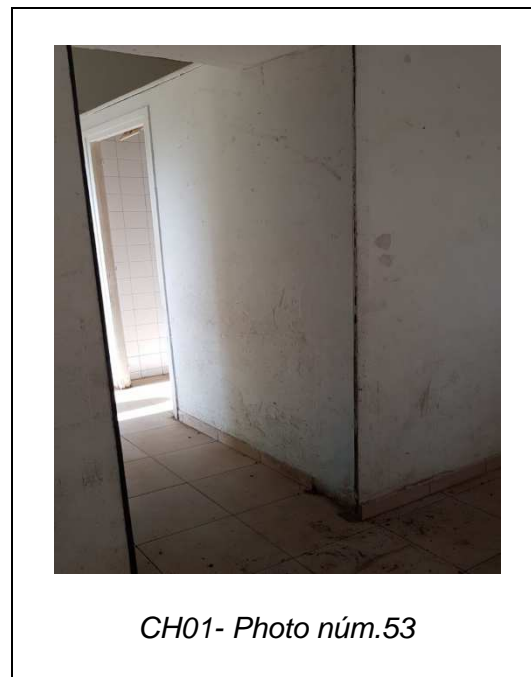
- Zone step from the open space to the services is seen as the siding has fallen leaving the wall of masonry taken with mortar. (File nº35).

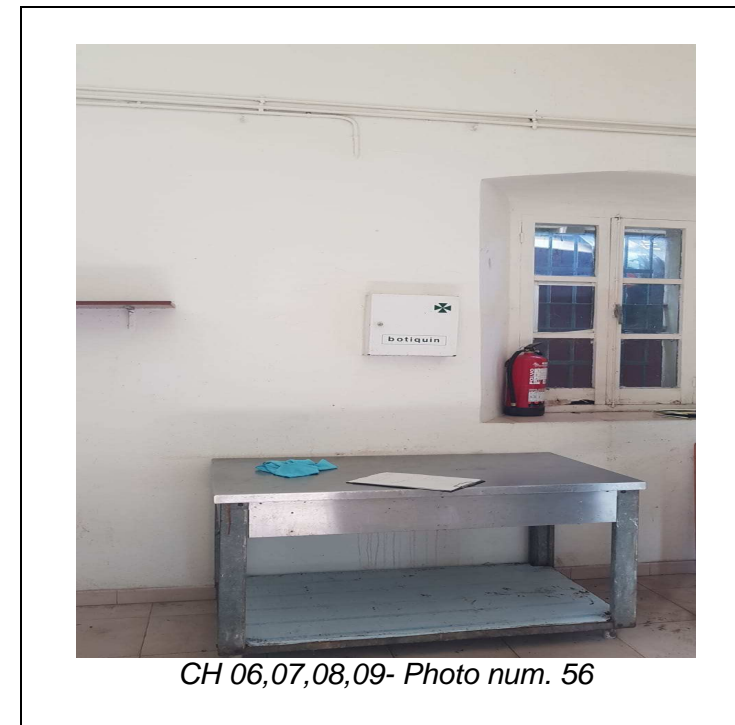
- On the inside face of the facing the covering has fallen leaving the masonry wall with mortar. (File nº.39).

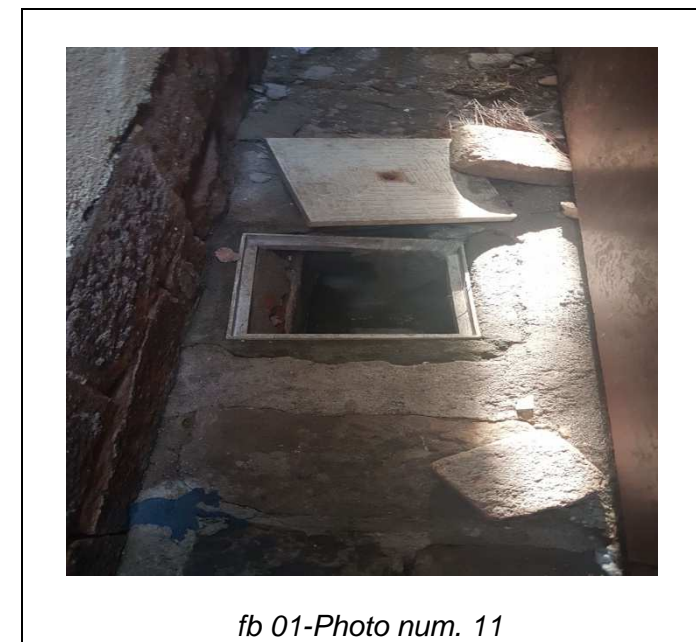
- Outer chest exterior side side broken. (File nº41).

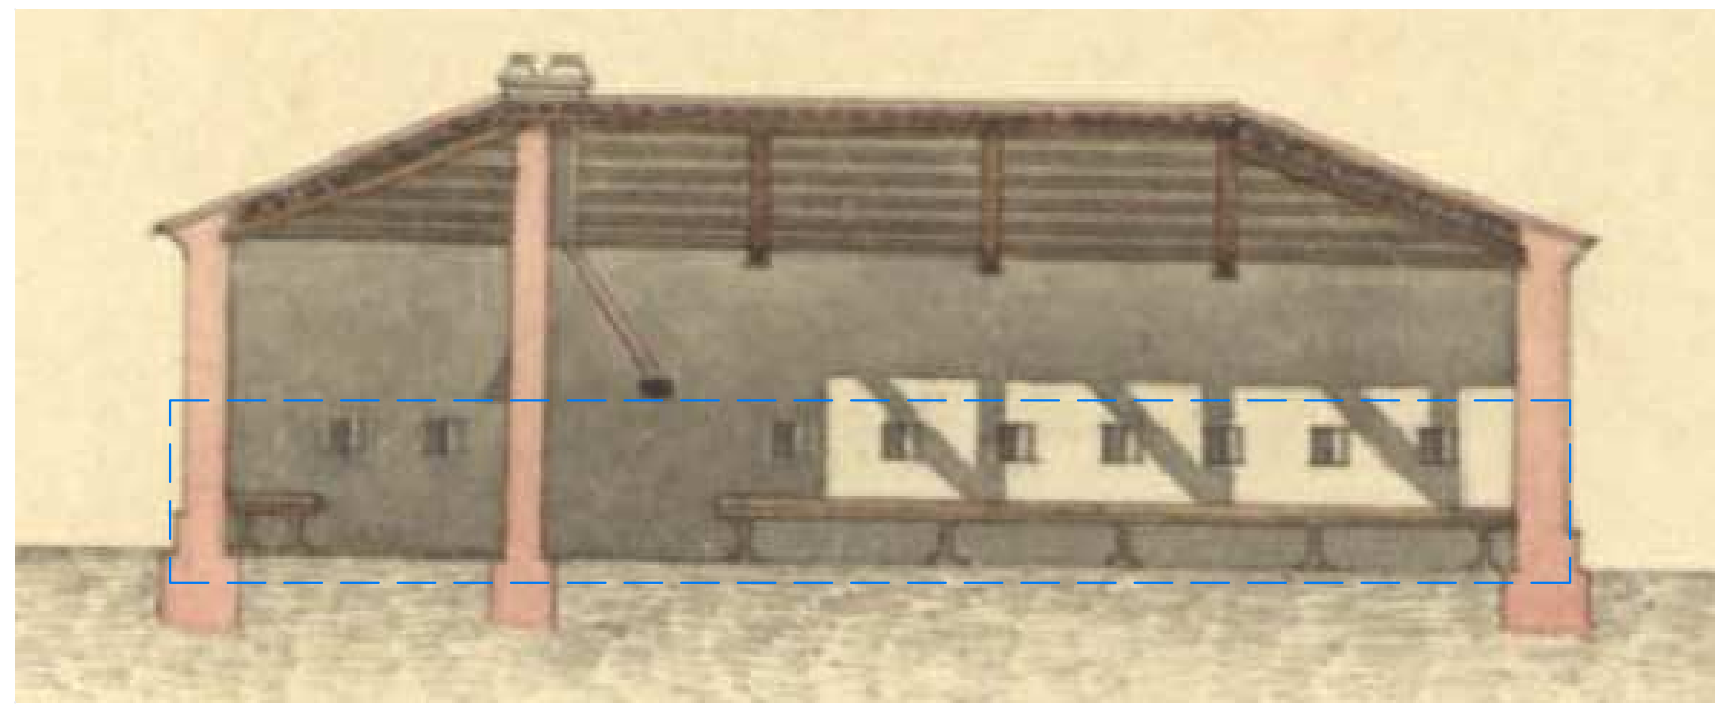
We believe that the appearance of cracks and fissures, both vertical and horizontal in the posterior facade, is caused by some old windows that in one of the modifications that were made to the building, were surely filled with other material and that provokes the Appearance of fissures and cracks due to discontinuity in the support without sufficient lock

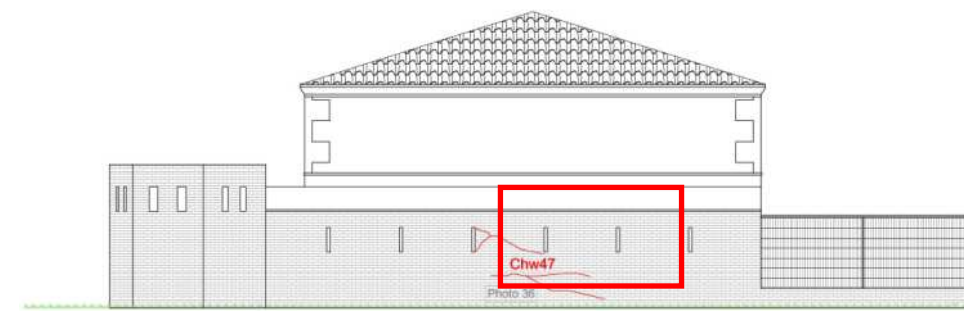
The roof will also need a new gutter in its entire perimeter to prevent humidity since there is currently no water collection element. Externally, we will reform the perimeter wall in the North-West area due to a loss of verticality caused by the roots of a nearby tree that may cause its collapse.

Our way of intervening will be to request permission to the City to move the tree, because it is the main cause of the injury, once solved, we will intervene in the wall replacing the existing damaged material by a vertical closing of laminar

glass anchored on the sides wall with a profile since it is not an original element of the building and we believe it is right that we delimit the space but at the same time we want to create a connection with the neighborhood and through this glass we can enjoy the views.

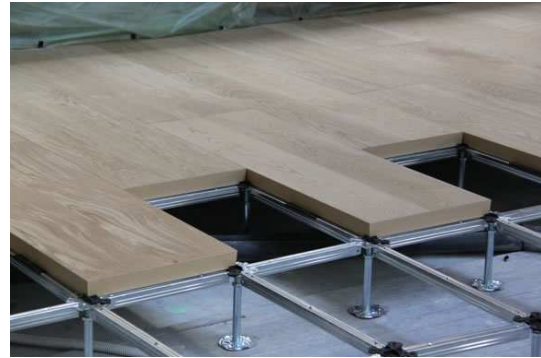
As regards the façade finishes, all the carpentry are in poor condition due to humidity and lack of maintenance, so new insulating double glazed joinery will be installed to avoid humidity and leaks.

The interior stoneware floor of the building is replaced by a wooden technical floor where all the installations can pass through its interior.

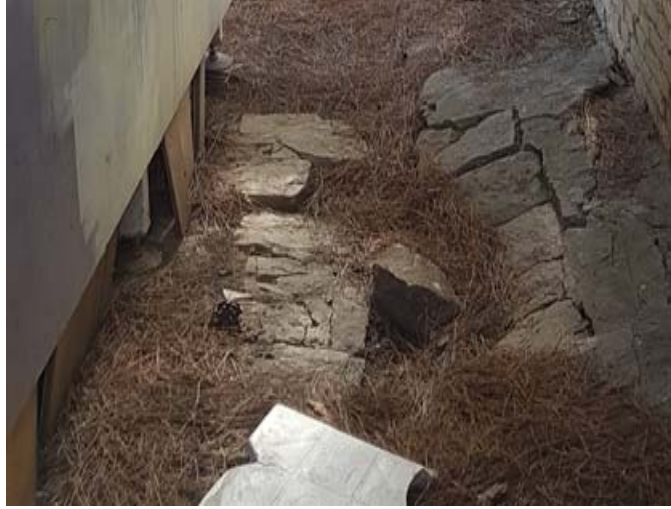
It is appreciated that the petril of sunken masonry, only in the zone of lateral step west, of perimeter sidewalk that surrounds the building.		
			Analysis and possible causes		
			The possible cause is that it has yielded the land that sustains them due to lack of drainage and vegetation.		
			Possible interventions and actions		
			The previous works will consist of cleaning, de-rubbing and the elimination of the vegetation avoiding at all times its starting to not damage the support. For the total elimination of the roots, the application of herbicides will proceed. It will also be filled with gravel (compaction behavior is excellent) and concrete (the concrete will be reinforced with a 6 cm partition mesh), leveling and placing the damaged stone.

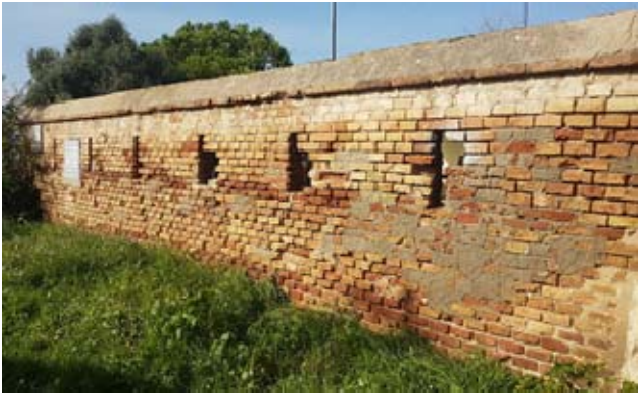
It is appreciated that the narrow openings holes located in the entire section of the wall, have losses of section and erosion of the bricks that make them up.		
			Analysis and possible causes		
			The possible cause is by physical erosion and it could also be chemical as the lack of cohesion between the materials, called decementation (brick with components of cementing bacteria) which is the loss of mass in the areas of the wall and especially by the presence of water. It could also be by segregation of the components as the type of pulverization in factory structures that is produced by the loss of the material.

Possible interventions and actions		
			The loopholes will be reconstructed with the missing bricks, differentiating the zone that is reconstructed with a brick of a different tonality and in the areas that the brick is damaged by loss of part of its section, a physical substitution of the damaged area in the which consists of the subtraction of the material of the element replacing it with the new bricks

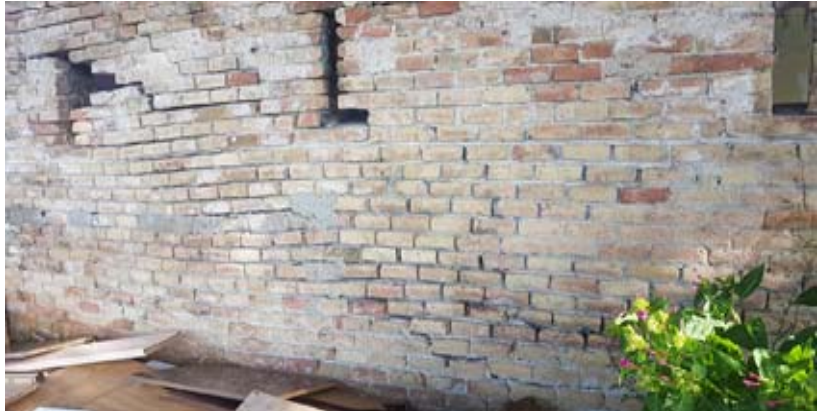
It is observed that in the outer perimeter wall in the southern part, it has collapsed and has lost its verticality.			
		Analysis and possible causes			
		The possible cause is for affections of the roots of a pine in the proximity of the wall, this type of tree develops a root system from a root where it expands very close to the surface.			
		Possible interventions and actions			
		Elimination of the problem by changing the location of the tree and in the injured area will replace the enclosure of the wall with a laminar safety glass.

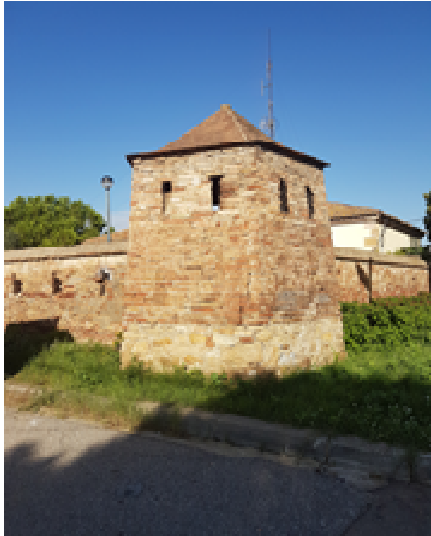
<p>It is observed that in the garita (filthy and covered) of the main entrance to the enclosure, crack in the exterior part in the brick and continues towards the lower part of the masonry of the stone of the quarry of Montjuïc, united with lime mortar.</p>		
			<p>Analysis and possible causes</p> <p>The possible causes are due to a bad initial compaction of the soil where the garita was built, the use of a filling material in the ground that was not adequate, due to the failure of the mortar to compression and / or change in the conditions of its use of its interior, as a barbecue.</p>

<p>Possible interventions and actions</p> <p>With the verification of a testimony of plaster we verify that the crack does not enlarge and we will proceed to repair the crack with a Sewn of cracks consists of interposing between the lips of the crack of the wall elements of greater resistance and rigidity as sutures, such like metal bars, pieces of brick factory, etc. Its objective is to return the lost continuity to the affected wall.</p>		
Location of the lesion

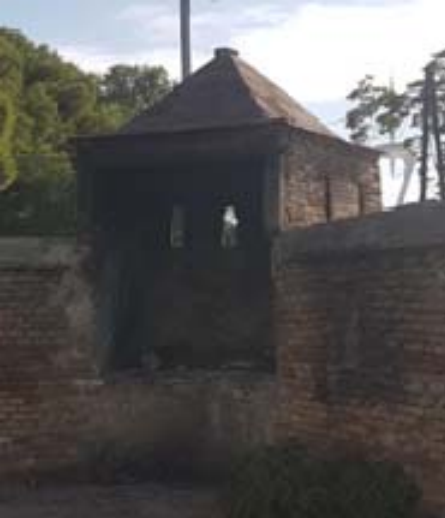
It can be seen that the bricks of the interior walls show dirt and soot in the main entrance.		
			Analysis and possible causes		
			The possible cause of soot dirt is the misuse of the sentry box since it has been used in its interior as a barbecue, which has produced thermal movements to which the materials are subjected, taking into account that these are not refractory with what movements of dilation and contraction are much greater.

Possible interventions and actions		
			We will carry out a cleaning with high pressure water to clean the soot bricks.		
Location of the lesion

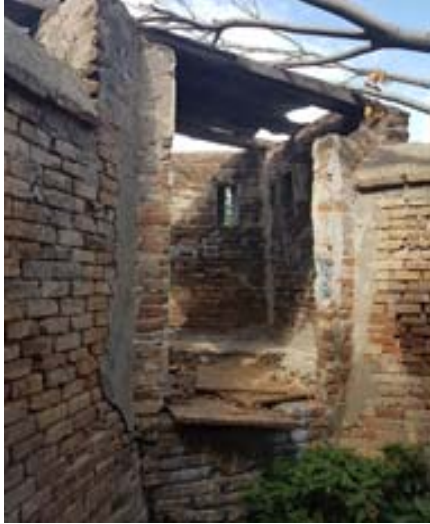
It can be seen that in the rear guard post of the exterior wall that surrounds the building, the roof has disappeared and inside it is dirty and with debris from the roof.		
			Analysis and possible causes		
			The cover is nonexistent due to collapse and the dirt in the sentry box is due to lack of maintenance and abandonment.		
			Possible interventions and actions		
			The cover of the sentry box will not be rebuilt, but the debris will be cleaned and a pressure washer will be flushed with a pressure washer to disinfect the dirt deposited on the horizontal wall.

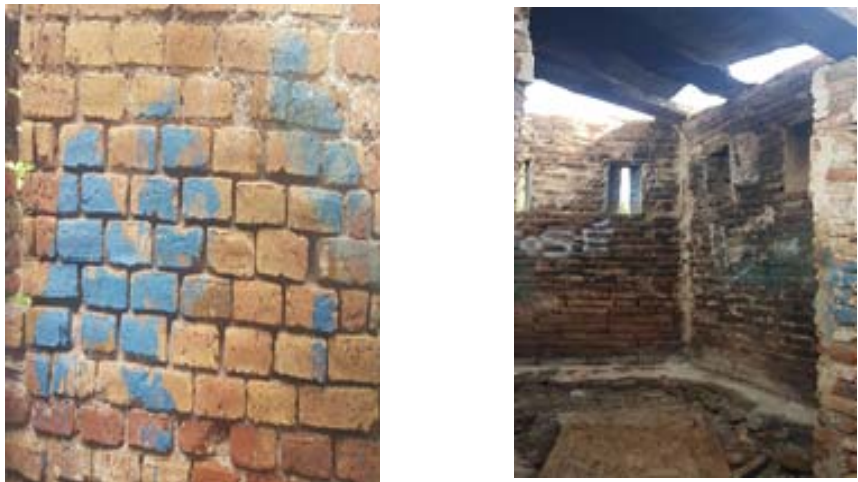
Several painted blue and white are observed, in the intrados of the rear wall and the rear sentry box.			
		Analysis and possible causes			
		The cause is lack of maintenance creating deposits of dirt on the walls and possible erosion by the paint that is part of the surface of the brick wall.			
		Possible interventions and actions			
		Cleaning with special industrial products such as anti-graffiti or removers.			
Location of the lesion

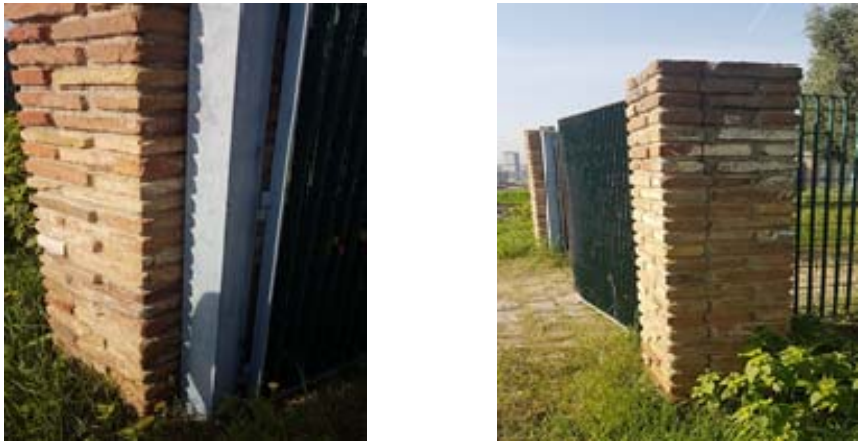
A vertical crack can be seen in each pillar of the entrance to the enclosure breaking the bricks.		
			Analysis and possible causes		
			The possible cause is the knocks and vibrations that the metallic door of the entrance to the enclosure produces.		
			Possible interventions and actions		
			We will make an intervention of injection, consists of the filling of the crack with mortar, first clean the interior and the labrios of the crack, with air under pressure. The mortar we inject must be very fluid, and it can have an expansive component and addition of epoxy resins to improve its adhesion. The injection can be done with special syringes under pressure.

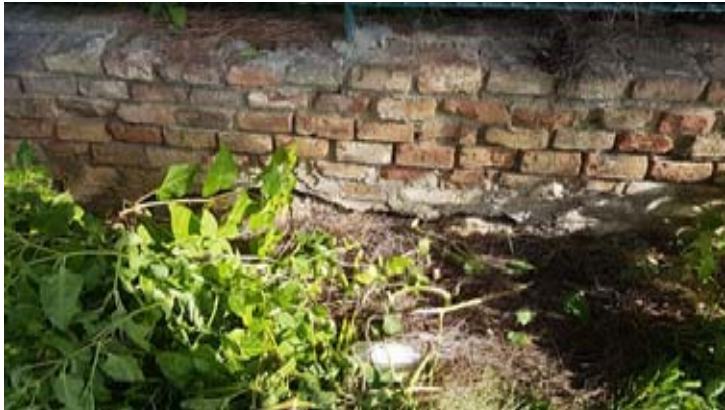
It is observed that in the left lateral exterior wall, there is loss of section in its lower part.		
			Analysis and possible causes		
			<p>The possible cause in the lack of cohesion between the materials called decemación is the loss of mass in the areas where the wall starts and above all due to the presence of water.</p> <p>It could also be by segregation of the components as the type of pulverization in factory structures that is produced by the loss of the material.</p>

Possible interventions and actions		
			A physical Substitution of the damaged area is made in which it consists of subtracting the material from the element, replacing it with the new bricks.

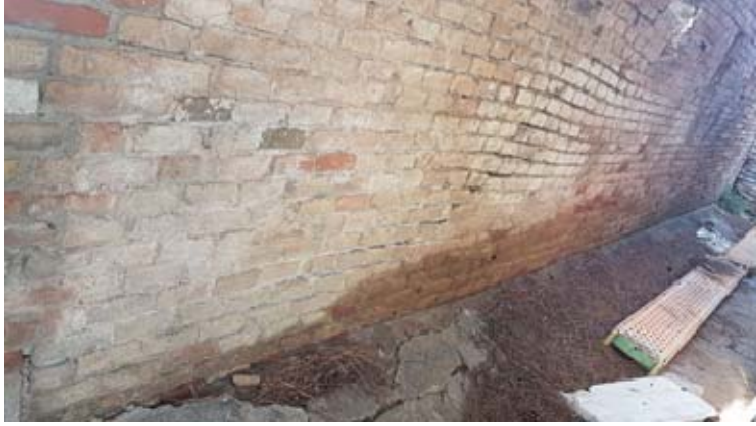
Humidities are observed in the lower part of the perimeter wall that surrounds the building on the south side in the intrados.		
			Analysis and possible causes		
			The possible cause is produced by humidity, present in the ground that rises by capillarity. It manifests with greater intensity in the winter periods and moderates during the rest of the year. The appreciable humidity stain manifests secondary lesions such as efflorescence of the brick. It does not reach much height, that depends on the porosity of the brick, evaporation and the humidity itself.

Possible interventions and actions		
			Placement of a drain that prevents the stagnation of water. The injured area will replace the wall enclosure with a safety laminar glass.		
Location of the lesion

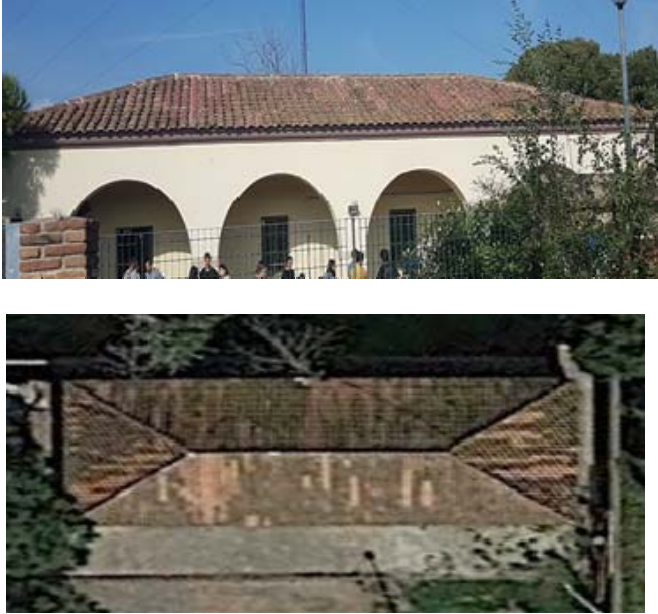
You can see spots and plant organisms (mosses) located in the darkest / greenish areas throughout the cover.		
			Analysis and possible causes		
			The possible cause is usually due to a lack of maintenance and because in shaded areas where the humidity is maintained for a longer time, it is an ideal situation for the appearance of mosses. These organisms can exert a destructive effect on the tile roof of the study building, reaching a depth of 1 cm.		
			Possible interventions and actions

In general, to eliminate the activity of organisms and vegetation on decks, a cleaning should be carried out, which due to the organic character of the lesion, needs the application of chemical products (solvents or fungicides in the case of molds). These can alter the surface of the materials where they are applied, so it is recommended to take precautionary measures.		
			As a preventive measure, to prevent the growth of plant organisms, an inspection and periodic maintenance must be carried out, performing a cleaning that prevents the accumulation of soil in gutters and water.		
Location of the lesion

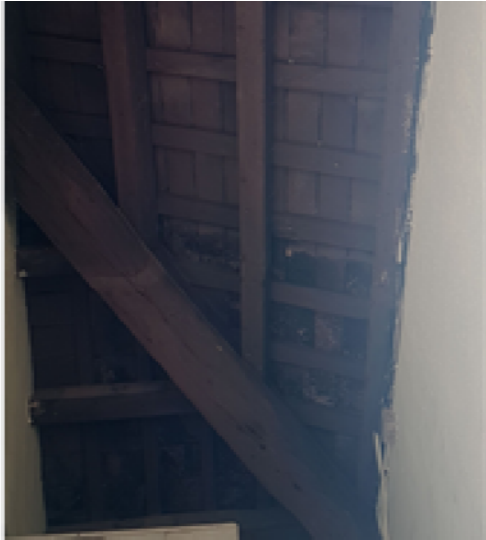
Humidities are observed by filtration in the wooden structure of the roof.		
			Analysis and possible causes		
			The possible cause of this injury is the water that gets to seep through the cover by the materials that make up the cover, and by penetration the water passes through holes, perforations, cracks or cracks caused by deterioration of the wood.		
			Possible interventions and actions		
			Seal where water is filtered and apply the new waterproofing system on the surface of clean, sanitized and dry wood.

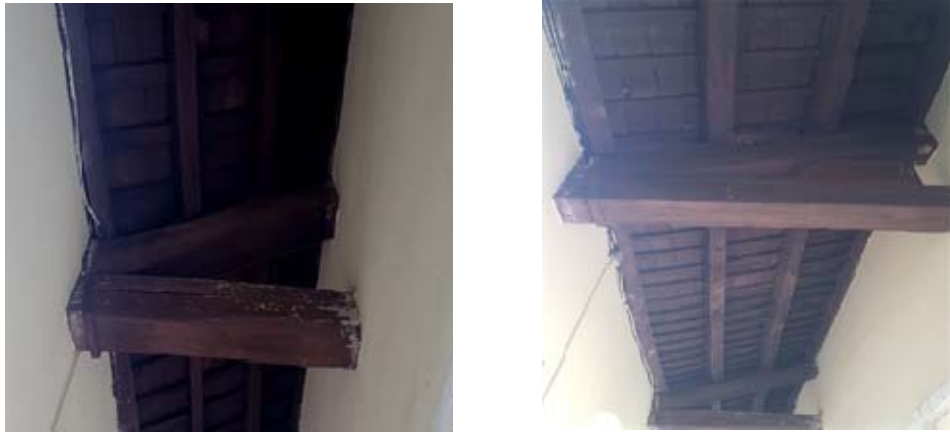
File	13	Property	Type of injury		
		Building of "guardia y custodia" of "Polvorín" - street Segura nº34 Barcelona	Physics	Chemistry	Mechanical
Location	Situation of the injury		Structural element:		
Deck	south		YES	NO	OTHERS
Plan situation	Element		Danger of stability		
Plano Nº 13	Wooden trusses		LOW	MID	HIGH
Pathology photography	Pathology reference		Intervention urgency		
4 y 2	Chb 01 y Chb0 2		LOW	MID	HIGH
Photographs			Description injury

It is observed that most of the trusses present cracks in longitudinal direction, of variable dimensions according to the truss, of different length and thickness in each one and different situation in the section.		
			Analysis and possible causes		
			The possible cause is the constant movements of dilatation, contraction and drying of the wood and another cause could be the fences present in the wood, of the trusses or slats, before placing and loading. Another cause exposure to atmospheric agents that can cause longitudinal cracking.

Possible interventions and actions		
			In this case it has been checked the mechanical characteristics of the wood and does not affect its properties. If they will affect the resistance, it would be necessary to intervene reinforcing with metal profiles.		
Location of the lesion

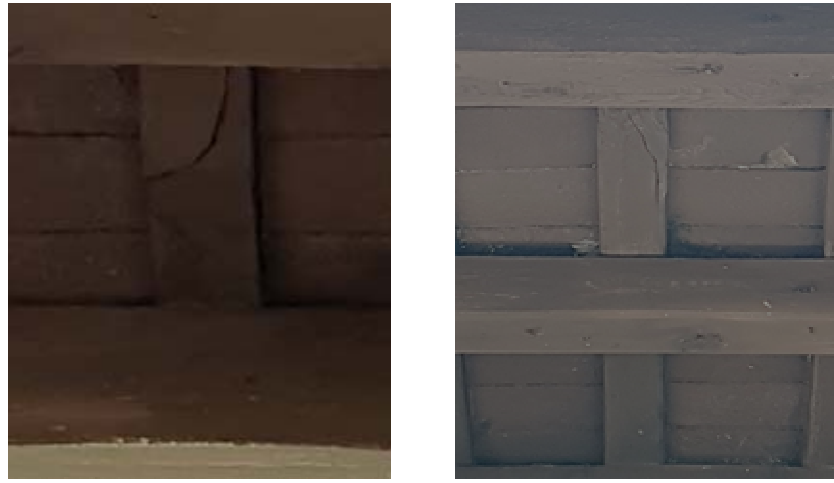
File	14	Property	Type of injury		
		Building of "guardia y custodia" of "Polvorín" - street Segura nº34 Barcelona	Physics	Chemistry	Mechanical
Location	Situation of the injury		Structural element:		
Deck	South		YES	NO	OTHERS
Plan situation	Element		Danger of stability		
Plano Nº 13	Wood paneling		LOW	MID	HIGH
Pathology photography	Pathology reference		Intervention urgency		
3 y 5	ws01 y ws02 Bis		LOW	MID	HIGH
Photographs			Description injury

Curvilinear cracks are observed between the concentric layers of the growth rings that are produced in the wooden slats of the framework (called "inlaws").		
			Analysis and possible causes		
			The possible cause is as a consequence of a defect or alteration of the growth can decrease the resistance and in case of contact it can give off splinters, which in an element seen as our injuries represents a danger.		
			Possible interventions and actions		
			<ol style="list-style-type: none"> 1. The first thing is that the surface to be repaired is clean, dry and healthy. 2. The crack will be sanded: This is done so that the surface acquires more adhesion. 3. The cracked lid putty will be placed. 4. Let it dry waiting for enough time for the putty to harden. 5. And it will be re-sanding.

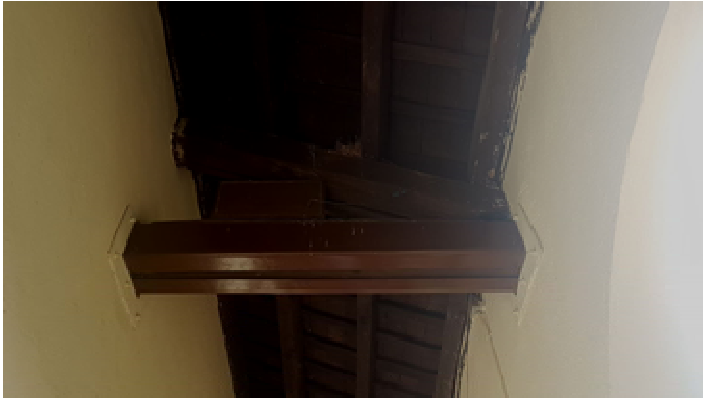
File	15	Property	Type of injury		
		Building of "guardia y custodia" of "Polvorín" - street Segura nº34 Barcelona	Physics	Chemistry	Mechanical
Location	Situation of the injury		Structural element:		
Deck	south		YES	NO	OTHERS
Plan situation	Element		Danger of stability		
Plano Nº 13	Wooden trusses		LOW	MID	HIGH
Pathology photography	Pathology reference		Intervention urgency		
6	Chb 06		LOW	MID	HIGH
Photographs			Description injury

A longitudinal crack is seen, which opens in the direction of the fiber, the strut of the truss already has a reinforcement along its entire length.		
			Analysis and possible causes		
			The possible cause is the fenda that by contraction of a layer of wood in relation to another one can not accompany it in its movement and it opens, which produces an alteration in its integrity and can modify its resistance, for that reason it carries a reinforcement throughout of your section. Another cause exposure to atmospheric agents that can cause longitudinal cracking.

Possible interventions and actions		
			A metallic reinforcement has already been placed that increases the resistant section of the element, improving the resistant capacities. We have verified that this section has not lost its resistant capacities.		
Location of the lesion

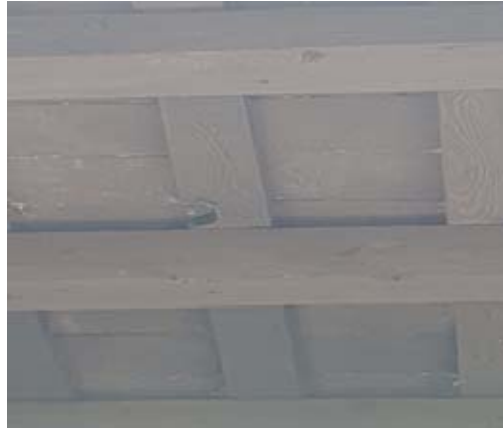
File	16	Property	Type of injury		
		Building of "guardia y custodia" of "Polvorín" - street Segura nº34 Barcelona	Physics	Chemistry	Mechanical
Location	Situation of the injury		Structural element:		
Deck	west		YES	NO	OTHERS
Plan situation	Element		Danger of stability		
Plano Nº 13	Ribbon		LOW	MID	HIGH
Pathology photography	Pathology reference		Intervention urgency		
7	ws02		LOW	MID	HIGH
Photographs			Description injury

You can see how a knot has leaped due to a tensional change, it is a discontinuity in one of the battens of the cover frame.		
			Analysis and possible causes		
			The possible cause is that the knot has fallen to dry leaving a gap, are tissues that form the branches which suffer deviations causing condensation of lignified tissue.		
			Possible interventions and actions		
			It consists of using epoxy-type resins mixed with an inert filler, for example silica sand, to recompose the damaged section. The mechanical characteristics of this mixture are very close to those of wood.

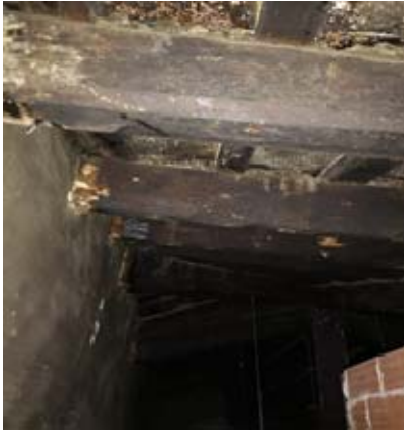
File	17	Property	Type of injury		
		Building of "guardia y custodia" of "Polvorín" - street Segura nº34 Barcelona	Physics	Chemistry	Mechanical
Location	Situation of the injury		Structural element:		
Deck	west		YES	NO	OTHERS
Plan situation	Element		Danger of stability		
Plano Nº 13	Wood lattice		LOW	MID	HIGH
Pathology photography	Pathology reference		Intervention urgency		
12	Dpl 01		LOW	MID	HIGH
Photographs			Description injury

Dirt is observed on the slats and slats of the wood frame.		
			Analysis and possible causes		
			The possible cause is dirt because of the soot, which has left it completely black, from an old fireplace that no longer exists.		
			Possible interventions and actions		
			Scratching and sanding the element without applying water because when moistening the soot the water drags the pigment inside the wood and the beam will absorb the water with pigment.

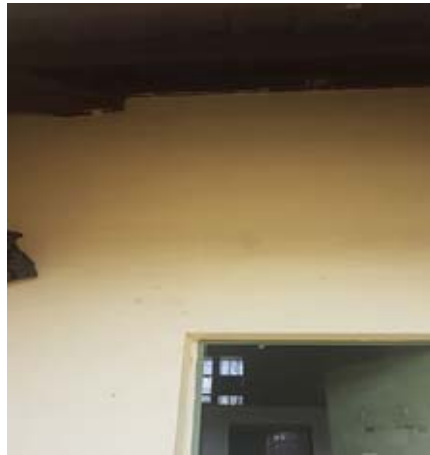
File	18	Property	Building of "guardia y custodia" of "Polvorín" - street Segura nº34 Barcelona		
Location		Situation of the injury	Type of injury		
Main facade	south		Physics	Chemistry	Mechanical
Plan situation	Element		Structural element:		
Plano Nº 14	Masonry wall		YES	NO	OTHERS
Pathology photography	Pathology reference		Danger of stability		
41	Cvw17		LOW	MID	HIGH
Photographs			Intervention urgency

Description injury		
			A vertical crack is observed in the left corner top of the door, one of the weakest point of discharge.		
			Analysis and possible causes		
			The possible causes can be due to the appearance of tensions due to material changes and another cause due to thermal origin. That is, by hygrothermal expansions and contractions.		
			Possible interventions and actions		
			We will use injections, a repair system for cracks less than 0.05 mm thick, applicable to walls of concerted masonry consisting of introducing a pressurized liquid in order to completely fill the gap between the lips of the opening. Said liquid, when hardening and adhering to the material, returns the continuity to the damaged element.

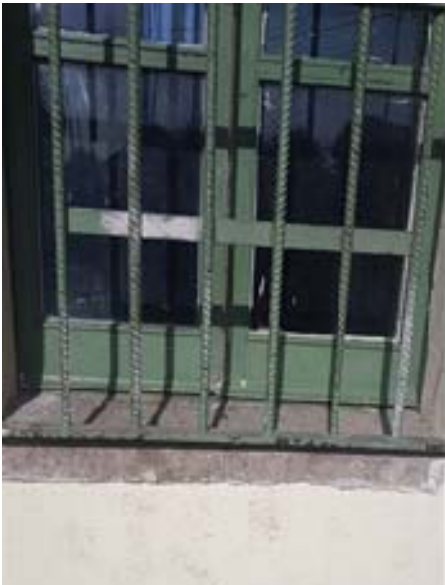
File	19	Property	Type of injury		
		Building of "guardia y custodia" of "Polvorín" - street Segura nº34 Barcelona		Physics	Chemistry
Location		Situation of the injury	Structural element:		
Main facade		south	YES	NO	OTHERS
Plan situation		Element	Danger of stability		
Plano Nº 14		ledge	LOW	MID	HIGH
Pathology photography		Pathology reference	Intervention urgency		
15		Cvw21	LOW	MID	HIGH

It is observed that there is a crack in the sill open in the middle formed by blocks of ashlar masonry.		
		Analysis and possible causes		
		The cause may be a crack of thermal origin. That is, by dilations and hygrothermal contractions, since it is on the outside and because of its orientation, the sun's rays affect the sillar of the sill.		
		Possible interventions and actions		
		Clean the open space of the crack to fill the crack of sillar labrad with epoxy.
