DAC REHABILITATION

GRAPHICAL SURVEY, DIAGNOSIS AND PROPOSALS FOR INTERVENTION OF “GUARDIA Y CUSTODIA” OF “EL POLVORÍN”

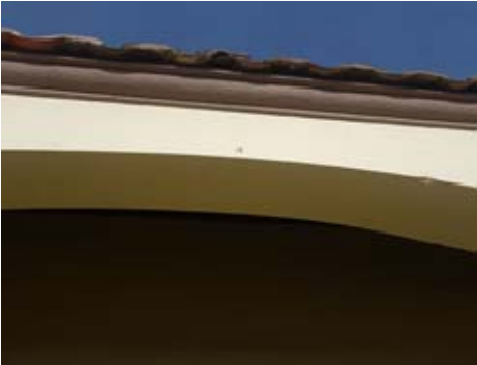
File	20	Property	Type of injury		
		Building of "guardia y custodia" of "Polvorín" - street Segura nº34 Barcelona		Physics	Chemistry
Location		Situation of the injury	Structural element:		
Main facade		south east	YES	NO	OTHERS
Plan situation		Element	Danger of stability		
Plano Nº 14		Half point arch	LOW	MID	HIGH
Pathology photography		Pathology reference	Intervention urgency		
19, 20 y 21		Cvw 24, Cvw19 y Cvw26	LOW	MID	HIGH
Photographs		Description injury

We can observe several vertical cracks that start right in the middle of several arcs of half a point and continue along the intrados of the arch.			
		Analysis and possible causes			
		The main cause can be for a specific load, in the weakest part, generated when the constructive element, in this case the masonry wall, receives a direct load that causes a too intense mechanical effort as a result the fissures appear. Other causes could be thermal origin, that is, hygrothermal expansions and contractions or the resolution of the wrong way of certain constructive joints of constructive elements with divergent loads (the trusses are not supported in the center, which is not suitable for the discharge arc.

Possible interventions and actions			
		We will use injections, a repair system for cracks less than 0.05 millimeters thick, applicable to concerted masonry walls consisting of introducing a pressurized liquid in order to completely fill the gap between the lips of the opening. Said liquid, when hardening and adhering to the material, returns the continuity to the damaged element.

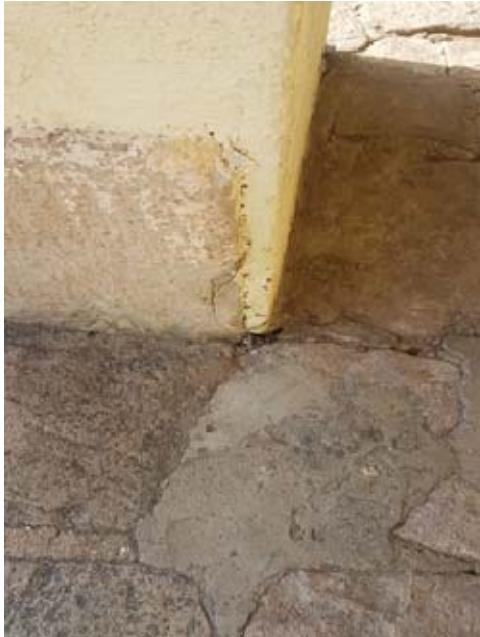
File	21	Property	Type of injury		
		Building of "guardia y custodia" of "Polvorín" - street Segura nº34 Barcelona	Physics	Chemistry	Mechanical
Location	Situation of the injury		Structural element:		
Main facade	South		YES	NO	OTHERS
Plan situation	Element		Danger of stability		
Plano Nº 14	plinth		LOW	MID	HIGH
Pathology photography	Pathology reference		Intervention urgency		
23 ,42 y 13	Cvw 21.1, Cvw 18, Cvw 18.1		LOW	MID	HIGH
Photographs			Description injury

Various vertical cracks can be seen in the pillar, in the lower part the base formed by blocks of ashlar carved by three of its faces			
		Analysis and possible causes			
		The cause may be due to a punctual load and cracks of thermal origin. That is, by hygrothermal expansions and contractions.			
		Possible interventions and actions			
		Clean the open space of the crack to fill the crack of sillar labrad with epoxy.

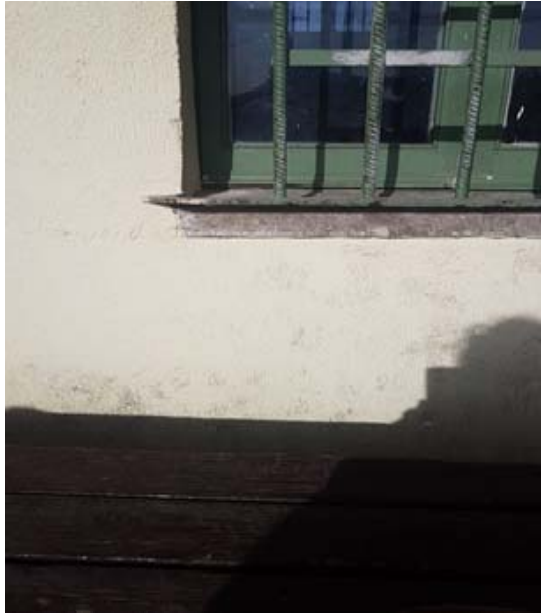
File	22	Property	Type of injury				
		Building of "guardia y custodia" of "Polvorín" - street Segura nº34 Barcelona		Physics	Chemistry	Mechanical	
Location		Situation of the injury		Structural element:			
Main facade		south		YES	NO	OTHERS	
Plan situation		Element		Danger of stability			
Plano Nº 14		Masonry wall		LOW	MID	HIGH	
Pathology photography		Pathology reference		Intervention urgency			
14		Cvw 20		LOW	MID	HIGH	
Photographs			Description injury

Various fissures are observed in singular points in the windows.				
			Analysis and possible causes			The possible causes are due to the appearance of tensions due to material changes and thermal origin, that is, hygrothermal contractions and expansions.	
			Possible interventions and actions			We will use injections, it is a repair system for cracks smaller than 0.05 millimeters in thickness, applicable to concerted masonry walls consisting of introducing a pressurized liquid in order to completely fill the gap between the lips of the opening. Said liquid, when hardening and adhering to the material, returns the continuity to the damaged element.

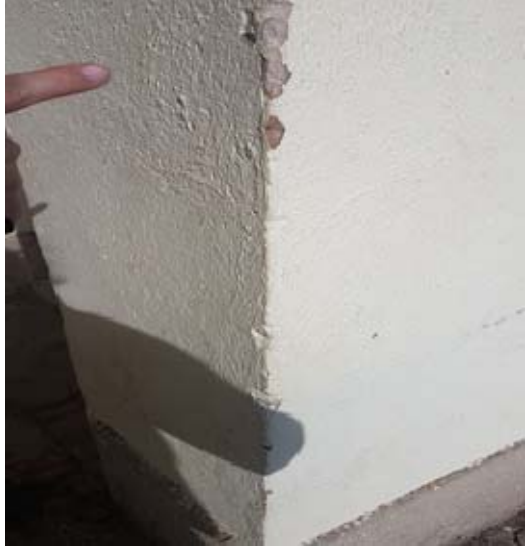
File	23	Property	Type of injury		
		Building of "guardia y custodia" of "Polvorín" - street Segura nº34 Barcelona	Physics	Chemistry	Mechanical
Location		Situation of the injury	Structural element:		
Main facade		south	YES	NO	OTHERS
Plan situation		Element	Danger of stability		
Plano Nº 14		Bottom of the semicircular arch	LOW	MID	HIGH
Pathology photography		Pathology reference	Intervention urgency		
22		CH 15	LOW	MID	HIGH
Photographs		Description injury

It is appreciated how the coating has fallen and the support material is seen in this case the masonry wall taken with mortar.			
		Analysis and possible causes			
		The possible causes can be for the friction continued in the time, the bad quality of the material or when being exposed the facade in the outside the atmospheric agents can cause a deterioration of the coating.			
		Possible interventions and actions			
		We can not act on the friction produced by the passage of people, tools or animals, but we can try to choose a suitable material for a specific transit and also these are usually exposed to wear by abrasion, friction and bumps. They are materials that need more maintenance and must be replaced with a certain frequency. Before applying the material to be coated, it will be repeated until the support is clean and a base mortar will be applied.

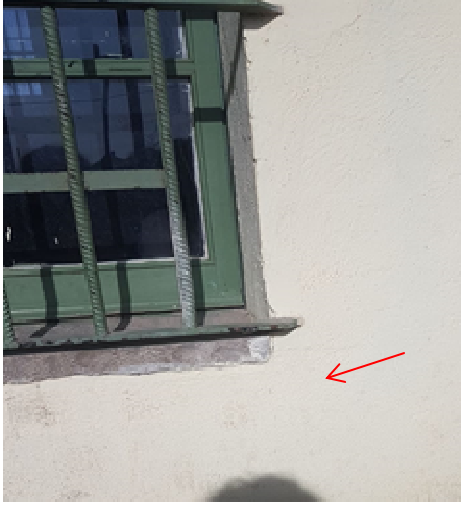
File	24	Property	Building of "guardia y custodia" of "Polvorín" - street Segura nº34 Barcelona		
Location		Situation of the injury		Type of injury	
Main facade	south	YES		Chemistry	Mechanical
Plan situation	Element	DANGER OF STABILITY		OTHERS	
Plano Nº 14	Masonry wall	LOW	MID	HIGH	
Pathology photography	Pathology reference	Intervention urgency			
23 bis	Cvw1.2	LOW	MID	HIGH	
Photographs			Description injury

A crack is observed that comes out at the weakest point of discharge that is the bottom window, at the corner one of the weakest points.		
			Analysis and possible causes		
			The possible causes are due to the appearance of tensions due to material changes and thermal origin, that is, hygrothermal contractions and expansions.		
			Possible interventions and actions		
			We will make a seam of the crack: it consists of drilling holes on both sides of the crack and inserting U-shaped metal elements. Then they must be secured with mortar. It is necessary to reinforce the adjacent sections, since when sewing a crack, the structure tends to become more rigid, and this can increase the global restriction of the structure causing the appearance of cracks in other parts of the concrete. Holes are drilled on both sides of the crack. The holes are cleaned and the legs of the staples are anchored in them, using a mortar or an adhesive system based on epoxy resin. Staples must vary in length and orientation

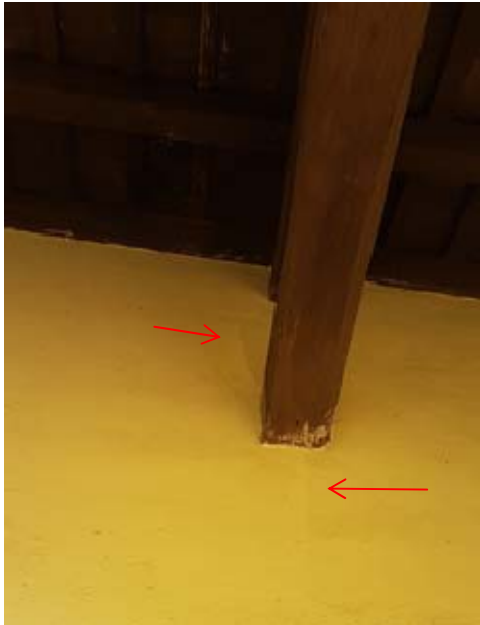
File	25	Property	Type of injury		
		Building of "guardia y custodia" of "Polvorín" - street Segura nº34 Barcelona	Physics	Chemistry	Mechanical
Location	Situation of the injury		Structural element:		
Main facade	south		YES	NO	OTHERS
Plan situation	Element		Danger of stability		
Plano Nº 14	Masonry wall		LOW	MID	HIGH
Pathology photography	Pathology reference		Intervention urgency		
23 y 25	Cvw 23 , Cvw 25		LOW	MID	HIGH
Photographs			Description injury

<p>It is observed several fissures and cracks in descending sense that leave the union of the truss, with the tie and the pair, and that affect the vertical paramento producing a loss of verticality.</p>		
			<p>Analysis and possible causes</p> <p>The possible cause is produced when the wooden beam is supported by a masonry load wall. We are matching two structural materials of very different characteristics. Thus, wood is much more resistant than masonry. Then, the load of the beam is transmitted over a very small area. The wall is almost always wider than the wing of the beam. Due to the above, it is easy for the wall not to resist the tension that will produce the beam, appearing cracks and / or cracks. Another cause may be due to the exhaustion of the material that supports the beam.</p>

<p>Possible interventions and actions</p> <p>Intervention on the causes in this case is to prop up the heads, we will repeat their support in such a way that we will make a concrete die with some measures that we calculate so that it can support the loads of the beam. Once the cause is solved we can solve the injury by repeating the fissured area and we will re-coat it.</p>		
			<p>Location of the lesion</p>

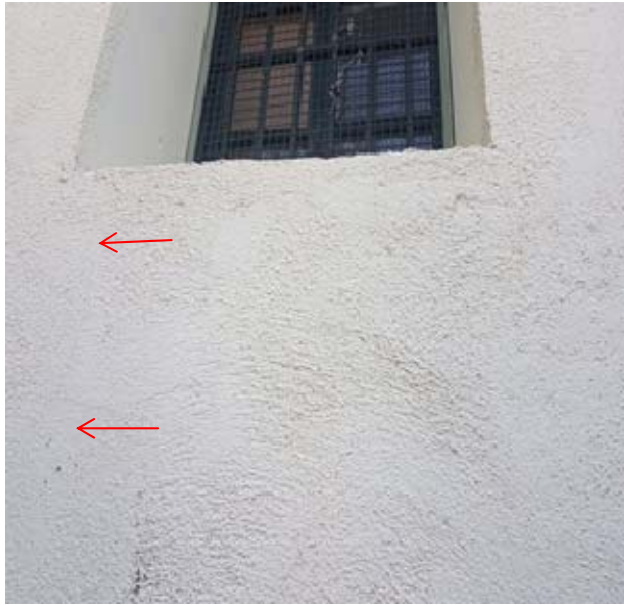
Several descending cracks are observed in the rear façade below the windows.		
			Analysis and possible causes		
			<p>The possible causes are due to the appearance of tensions due to changes in the material, also due to the jambs when there is some movement in the structure and it tends to fall causing a fissure in the lower part of the window.</p> <p>Another possible cause could be of thermal origin, that is, by hygrothermal expansions and contractions.</p>

Possible interventions and actions		
			<p>Before we would have to solve the cause and then we could act on the injury with this intervention: Injections, a repair system for cracks smaller than 0.05 millimeters in thickness, applicable to concerted masonry walls consisting of introducing a pressurized liquid in order to completely fill the gap between the lips of the opening. Said liquid, when hardening and adhering to the material, returns the continuity to the damaged element.</p>		
Location of the lesion

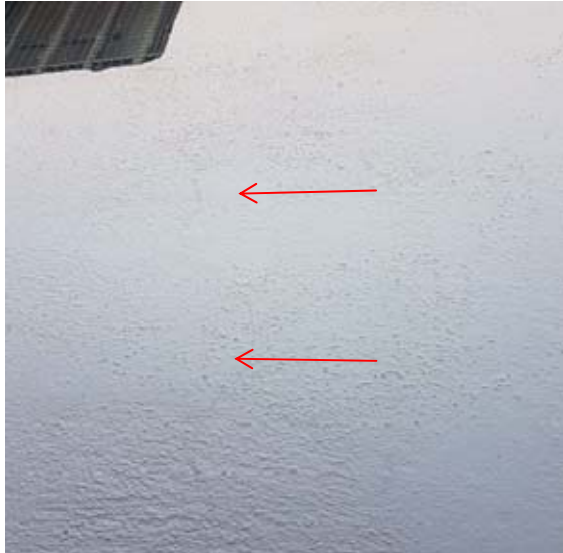
Multiple vertical cracks are seen on the inside of the entire façade.		
			Analysis and possible causes		
			<p>The deformability that presents the mortar against the masonry pieces, produces an elongation of the same in the direction perpendicular to that of the application of the load. Under excessive vertical loads, the mortar is crushed, subjected to local tractions to the pieces in horizontal direction, and produce their vertical cracking.</p>

Possible interventions and actions		
			<p>Before we would have to solve the cause and then we could act on the injury with this intervention: With injections is a repair system for cracks less than 0.05 millimeters thick, applicable to walls of concerted masonry consisting of introducing a pressurized liquid in order to completely fill the gap between the lips of the opening. Said liquid, when hardening and adhering to the material, returns the continuity to the damaged element.</p>		
Location of the lesion

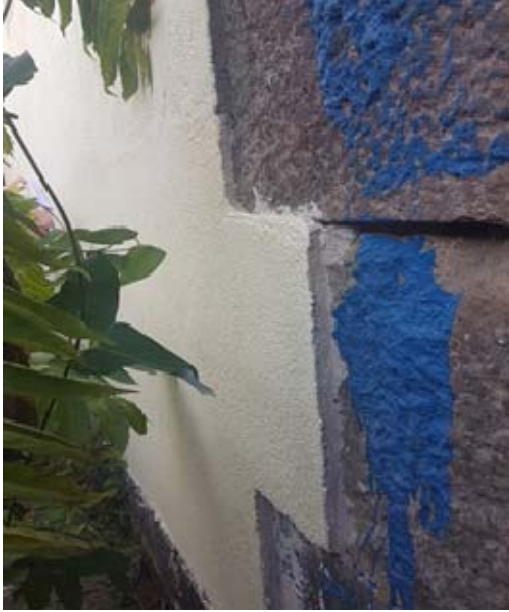
We observe how there is paint on the back façade in the corner in the carved ashlar, in ashlars two and three starting at the bottom.		
			Analysis and possible causes		
			The cause is by a physical action that can produce an erosion in the carved ashlar.		
			Possible interventions and actions		
			Projection of a jet of water under pressure, which may or may not contain an abrasive product, depending on the finish intended to be given to the stone.		
Location of the lesion

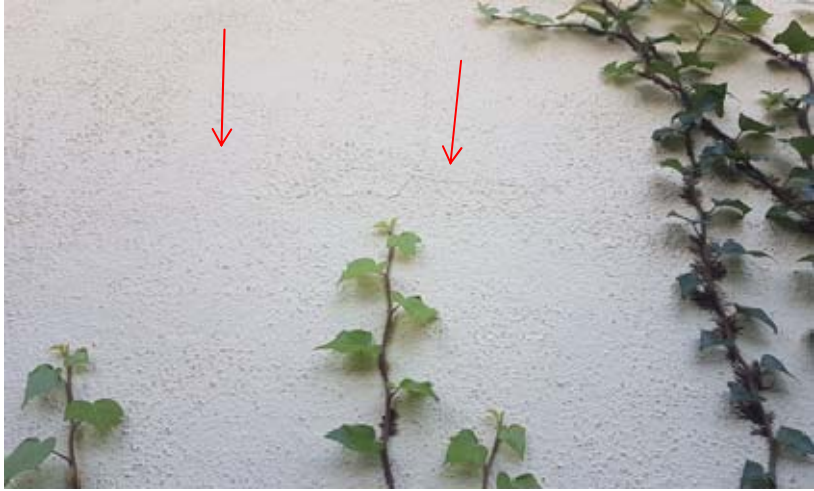
Two longitudinal cracks are observed in the lateral face of the façade.		
			Analysis and possible causes		
			The possible causes are due to the appearance of tensions due to material changes and thermal origin, that is, hygrothermal contractions and expansions. We have also found that in the 1849 plans on this façade there was an embrasure all over it and many of these fissures coincide with these old openings.		
			Possible interventions and actions

Location of the lesion			Before we would have to solve the cause and then we could act on the injury with this intervention: With injections is a repair system for cracks less than 0.05 millimeters thick, applicable to walls of concerted masonry consisting of introducing a pressurized liquid in order to completely fill the gap between the lips of the opening. Said liquid, when hardening and adhering to the material, returns the continuity to the damaged element.

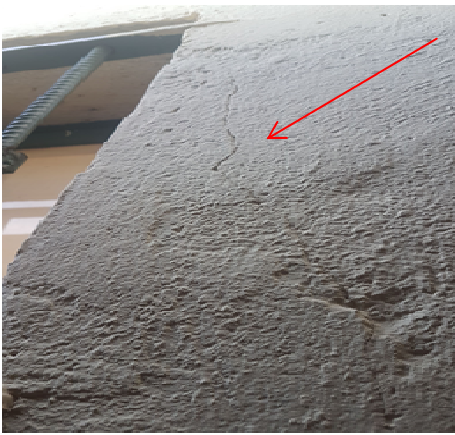
A diagonal fissure is observed in the wall at the top of the window in a descending manner.		
			Analysis and possible causes		
			The possible causes are due to the appearance of tensions due to material changes and thermal origin, that is, hygrothermal contractions and expansions.		
			Possible interventions and actions		
			Before we would have to solve the cause and then we could act on the injury with this intervention: With injections is a repair system for cracks less than 0.05 millimeters thick, applicable to walls of concerted masonry consisting of introducing a pressurized liquid in order to completely fill the gap between the lips of the opening. Said liquid, when hardening and adhering to the material, returns the continuity to the damaged element.

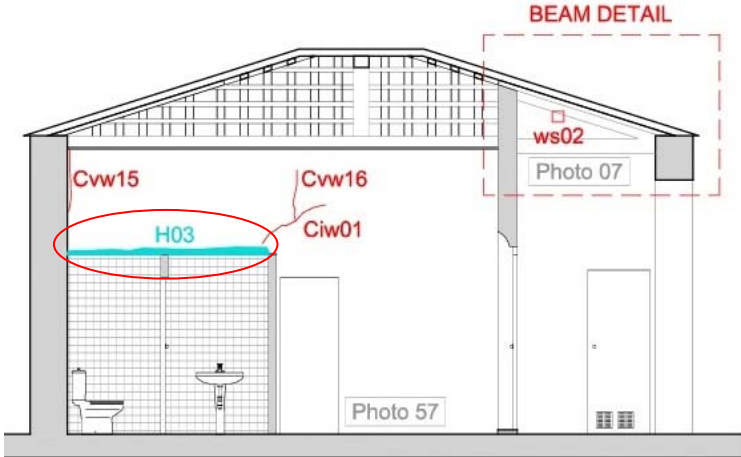
Accidental humidity is observed in a linear and horizontal way in the vertical wall, of the structural wall in washbasins.		
			Analysis and possible causes		
			The possible cause is the loss of water through pores in the pressure pipe and also affects the volume changes of the wall, causing local failures and loss of the load capacity of the mortar..		
			Possible interventions and actions		
			The first thing will be to change the broken piece. The introduction of slack is fundamental in the encounter with structural elements.

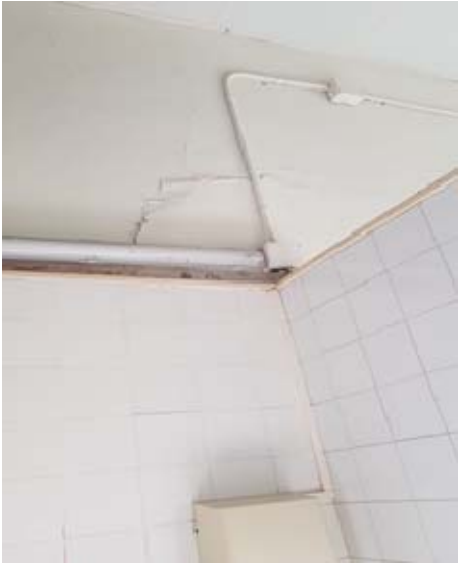
It is observed in the vertical facing of masonry, an ascending crack that is divided in two parts.		
			Analysis and possible causes		
			The possible cause is caused by the filtration of water from the pipe that softens the wall and cracks. That is to say, that the damages have been caused by the rupture of a pipe, that causes damages by the accumulation of water in the facing.		
			Possible interventions and actions		
			Once the pipeline has been solved, we will intervene: Withdrawing those materials that have lost cohesion or are disintegrated and redoing them again and if not have lost their properties we will make a seam of cracks: it consists of drilling holes on both sides of the crack and insert metal elements in a U. Then they must be secured with mortar. It is necessary to reinforce the adjacent sections, since when sewing a crack, the structure tends to become more rigid, and this can increase the global restriction of the structure causing the appearance of cracks in other parts of the concrete. Holes are drilled on both sides of the crack. The holes are cleaned and the legs of the staples are anchored in them, using a mortar or an adhesive system based on epoxy resin. Staples must vary in length and orientation.

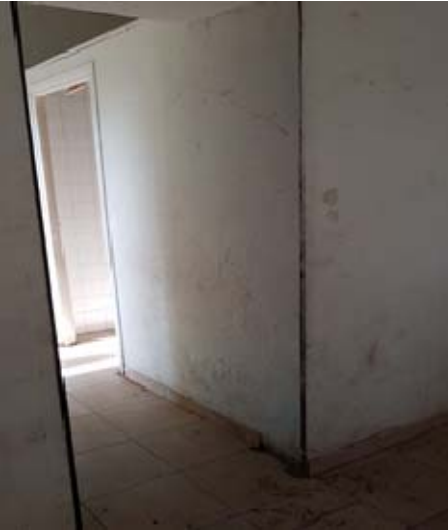
It is observed that in the zone, the passage from the open space to the services is seen as the covering has fallen, leaving the masonry facing taken with mortar.		
			Analysis and possible causes		
			The possible causes can be for the friction continued in time and another for the quality of the material.		
			Possible interventions and actions		
			We can not act on the friction produced by the passage of people, tools or animals, but we can try to choose a suitable material for a specific transit and also these are usually exposed to wear by abrasion, friction and bumps. They are materials that need more maintenance and must be replaced with a certain frequency. Before applying the material to be coated, it will be repeated until the support is clean and a base mortar will be applied.

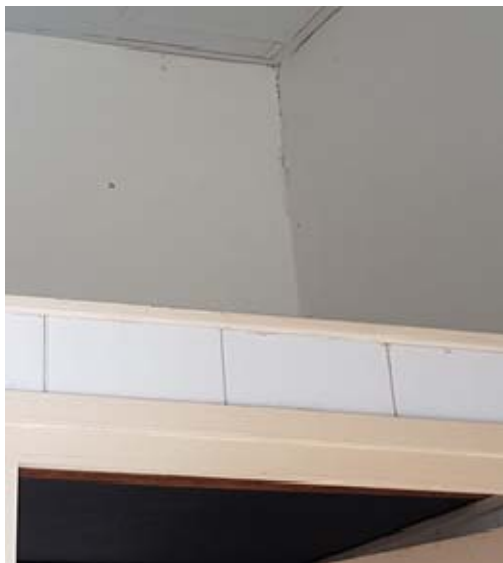
There is a crack in the corner of the junction of two different materials, the masonry wall and the brick dividing wall.			
		Analysis and possible causes			
		The cause is the inability to adapt to deformations the wall are cut by the partition and we also have shear stresses due to the difference of the loading conditions of both walls could be the cause of the crack.			
		Possible interventions and actions			
		We will make a crack seam: it consists of drilling holes on both sides of the crack and inserting U-shaped metal elements. Then they must be secured with mortar. It is necessary to reinforce the adjacent sections, since when sewing a crack, the structure tends to become more rigid, and this can increase the global restriction of the structure causing the appearance of cracks in other parts of the concrete. Holes are drilled on both sides of the crack. The holes are cleaned and the legs of the staples are anchored in them, using a mortar or an adhesive system based on epoxy resin. Staples must vary in length and orientation.

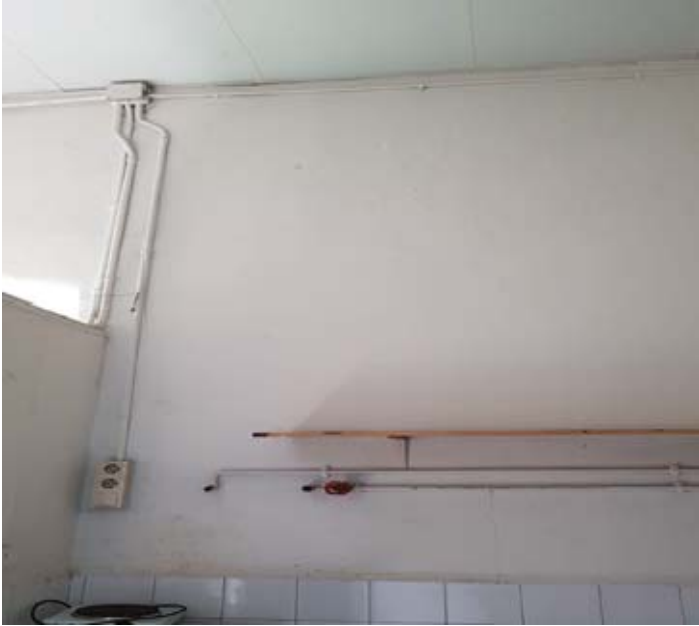
It can be seen how the inside face of the wall has fallen, leaving the masonry wall visible.		
			Analysis and possible causes		
			The cause is differential dilatations, thrusts in the same direction but in the opposite direction of the coating with the facing that involves the displacement of these causing the separation of the two.		
			Possible interventions and actions		
			We will try to choose a suitable material for a specific traffic and also these are usually exposed to abrasion, friction and shock wear. They are materials that need more maintenance and must be replaced with a certain frequency.

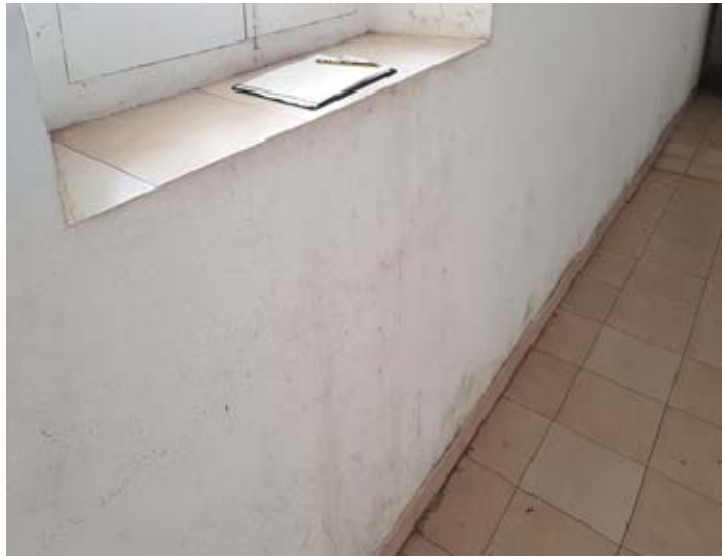
They are observed as in the interior face of the wall there are different fissures in the lower part of the window in the masonry wall.		LOW	
		Analysis and possible causes		MID	
		The possible causes are due to the appearance of tensions due to material changes and thermal origin, that is, hygrothermal contractions and expansions.		HIGH	
		Possible interventions and actions		Intervention urgency	
		Before we would have to solve the cause and then we could act on the injury with this intervention: With injections is a repair system for cracks less than 0.05 millimeters thick applicable to walls of concerted masonry consisting of introducing a liquid under pressure in order to entirely fill the gap between the lips of the opening. Said liquid, when hardening and adhering to the material, returns the continuity to the damaged element.		LOW

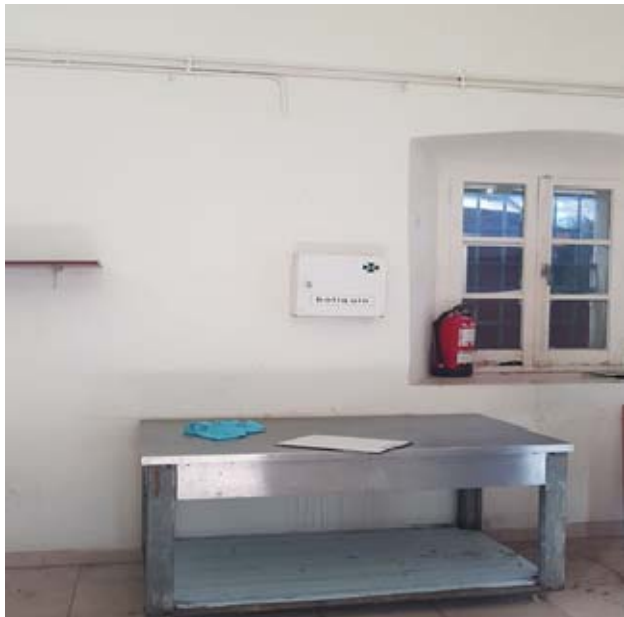
It is observed how the interior face of the wall has fallen the siding leaving the masonry wall with mortar.			
		Analysis and possible causes			
		The cause is differential dilatations, thrusts in the same direction but in the opposite direction of the coating with the facing that involves the displacement of these causing the separation of the two.			
		Possible interventions and actions			
		Before applying the material, the coating should be repeated until the support is clean and a base mortar will be applied. We will try to choose a suitable material for the kitchen and also these are usually exposed to wear by abrasion, friction and shock. They are materials that need more maintenance and must be replaced with a certain frequency.

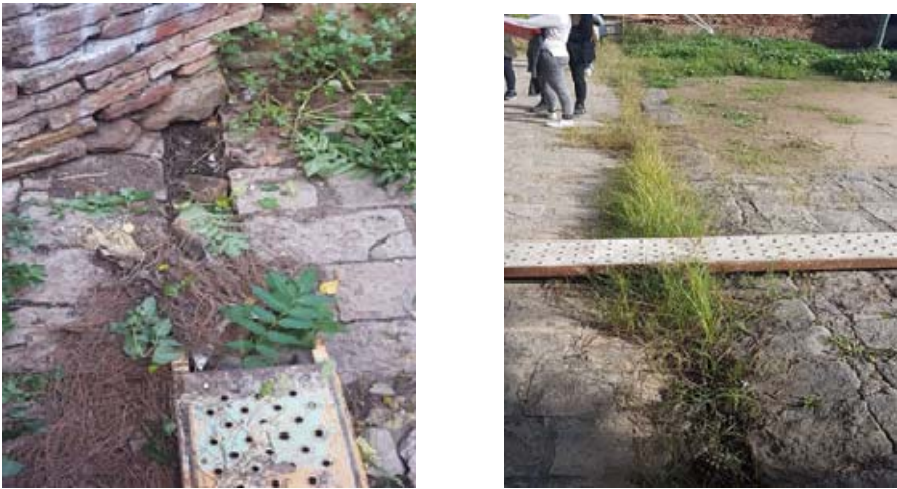
Canalización exterior obstruida por plantas y tierra, no se drena.				
	Analysis and possible causes				
	The cause is the lack of maintenance and it is not drained by the obstruction of the canal because it has been filled with soil and plants.				
Possible interventions and actions					
A new drainage installation will be made.

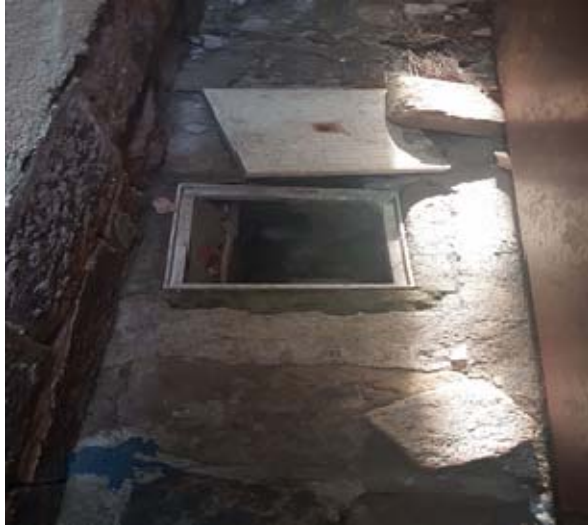
We appreciate that the outer side chest of the south side is broken.		
			Analysis and possible causes		
			The possible cause is the lack of maintenance.		
			Possible interventions and actions		
			A new lid will be placed and its interior cleaned.		
Location of the lesion

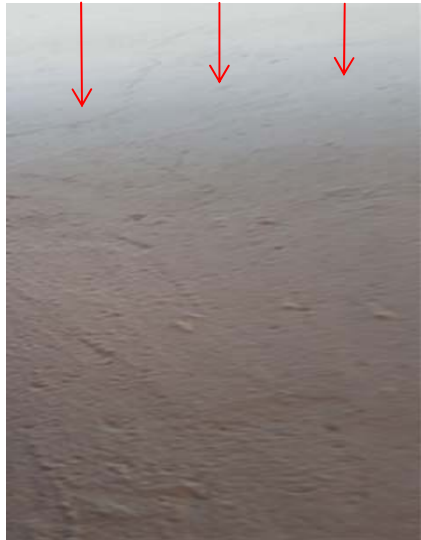
A horizontal crack can be seen in the masonry wall in the middle zone in the exterior lateral face of the façade.		
			Analysis and possible causes		
			The possible cause is an accidental humidity of the water pipe that is in the facing of the inner face, as the material softens cracks in the exterior side of the wall, following the extension of the humidity, in this case horizontally .		
			Possible interventions and actions		
			Once the pipeline has been solved, we will intervene: With injections is a repair system for cracks less than 0.05 millimeters thick, applicable to walls of concerted masonry consisting of introducing a pressurized liquid in order to completely fill the gap between the lips of the opening. Said liquid, when hardening and adhering to the material, returns the continuity to the damaged element.
