Engineering Failure Analysis

Failure investigation of a solar tracker due to wind-induced torsional galloping

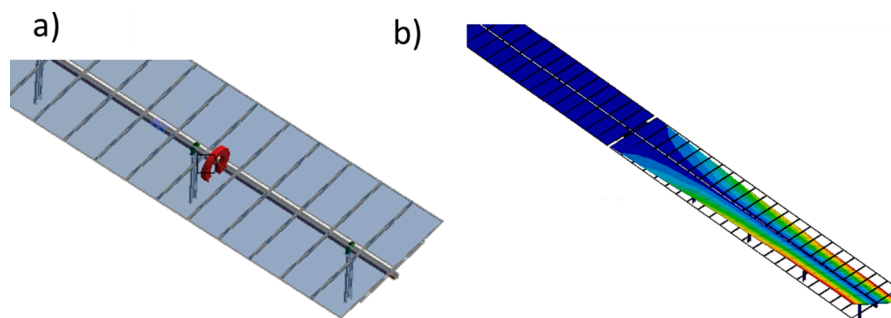
Fig. 10. a) Moment applied to the structure. b) Deformation of the structure due to the moment. Normalized displacement (Red maximum, blue minimum).

A stress analysis was conducted to find the location of the maximum stresses in the structure when it is subjected to a high load due to the wind. A torque moment was applied on the axis of rotation of the structure as it is observed in Fig. 10. The amplitude of this torque was set to 10 kNm, according to [22] for a wind speed of 60 km/h.
