ANALYSIS OF VALVE AND VALVE SEAT INSERT DAMAGE MORPHOLOGY OBSERVED AFTER DIFFERENT ENGINE TEST

A. Zuleta Durango^{1(*)}, F. Mazuco¹, A. Sinatora¹, D.K. Tanaka¹

¹ Surface Phenomena Laboratory, Mechanical Engineering Department, University of Sao Paulo, Sao Paulo, SP, Brazil

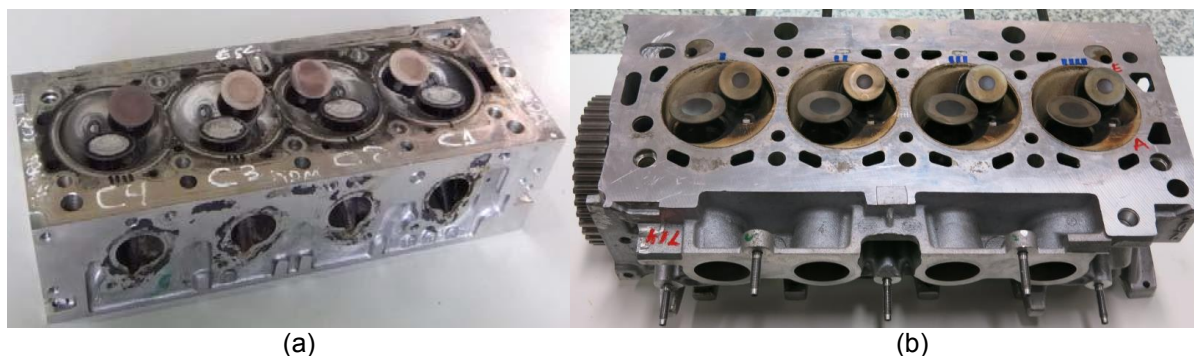
The valves and valve seats surface wear damages were evaluated through visual examination of the valve surface in contact with valve seat using a low-magnification Nikon SMZ800 model stereo-microscope with Nikon 1200F digital camera. The combustion chambers of both engine heads are shown in Figure 1 and were identified as C1 to C4, from right to left for MT-1 and I to IIII for MT-2.

Figure 1. Cylinder head of 8-valve engines. Combustion chambers engine (a) MT-1 (b) MT-2.

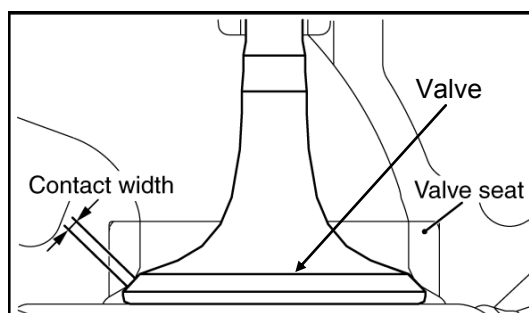
The analyses of wear were conducted on the intake and exhaust valves and valve seats, as can be seen in Figure 3a and 3b. The region analyzed in this work is identified in Figure 2 as "contact width".

Figure 2. Contact width between valve and valve seat of engine.

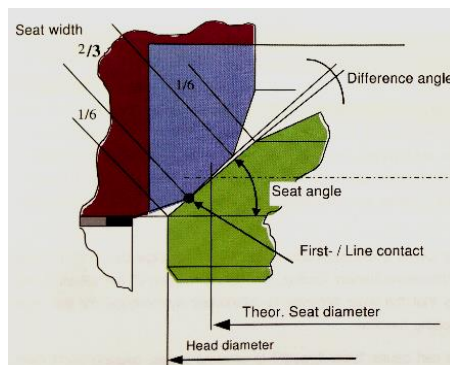
The surface of the exhaust valve seat of the engine MT-2 shown in Figure 12 was divided into three regions with different aspects and coloring. Region 1 is characterized by having surface with less roughness than the others regions closer to the inner edge (region 3), characterized by the circumferential machining scratches and deposits. Region 2 has a transition characteristic between regions 1 and 3. This fact indicates that the region 1 suffered more severe wear (as explained in Figure 13).

The wear was more severe possibly due to the higher contact pressure that occurs at the outer edge, indicating that wear increases from the inner edge to the outer edge of contact surface. This may occur due to the project recommendation between valve

and valve seat, in which is desirable that the first line of contact occur in the region close to the outer edge, in order to ensure the sealing of the contact, as shown in Figure 13.

Figure 13. Contact scheme in the design of valves – valve seats.
