SURVEY OF DAMAGE MECHANISMS ON PVD COATED HSS HOBS USED IN SWEDISH GEAR MANUFACTURING INDUSTRY

ABSTRACT

This work presents a survey of wear as observed on today's state of the art hobs used by Swedish gear manufactures. It aims to identify damage mechanisms and the common problems in order to enable future production of more reliable hobs. The tools were temporarily borrowed from the production and the analyses were made non-destructively using optical microscopes. This was complemented by destructive cross-sectional analysis on two of the hobs.

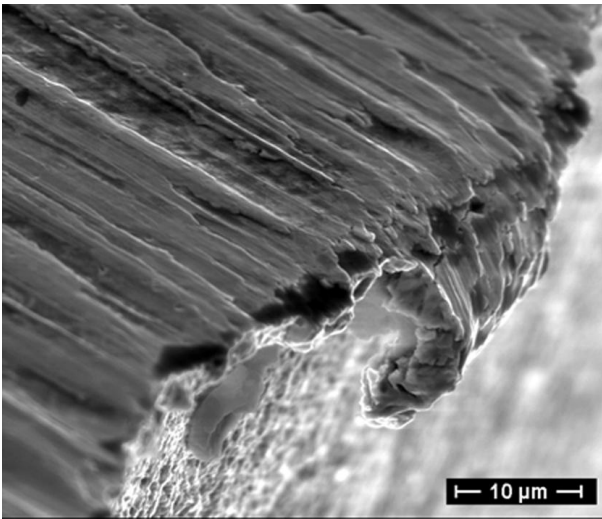
Discrete coating detachment can have a number of causes. The preparation of the tool surface is one critical stage when trying to avoid this. Industrial grinding processes more or less always result in burrs at the edges and, on a smaller scale, along the ridges on the ground surface as exemplified in Fig. 4. The burrs can be described as thin flakes of severely deformed material. When such burrs are present under a hard, brittle coating they will function as initiation points for cracking and are sure to be broken off almost immediately when the tool is exposed to external stress, leaving areas of unprotected substrate. It is therefore important to remove these burrs from the substrate surface before the coating is deposited.

Figure 4. Scanning electron microscope image showing an example of a large burr hanging by over the edge of the ground surface. Burrs are also seen on ridges on top of the ground surface.
