TRAFFIC ENGINEERING
DEMONSTRATION PROJECT ON
U.S. 52 BYPASS
INVENTORY, ANALYSIS AND RECOMMENDATIONS

by
G.A. SHUNK
AND
H.L. MICHAEL

PURDUE UNIVERSITY
LAFAYETTE INDIANA

Progress Report

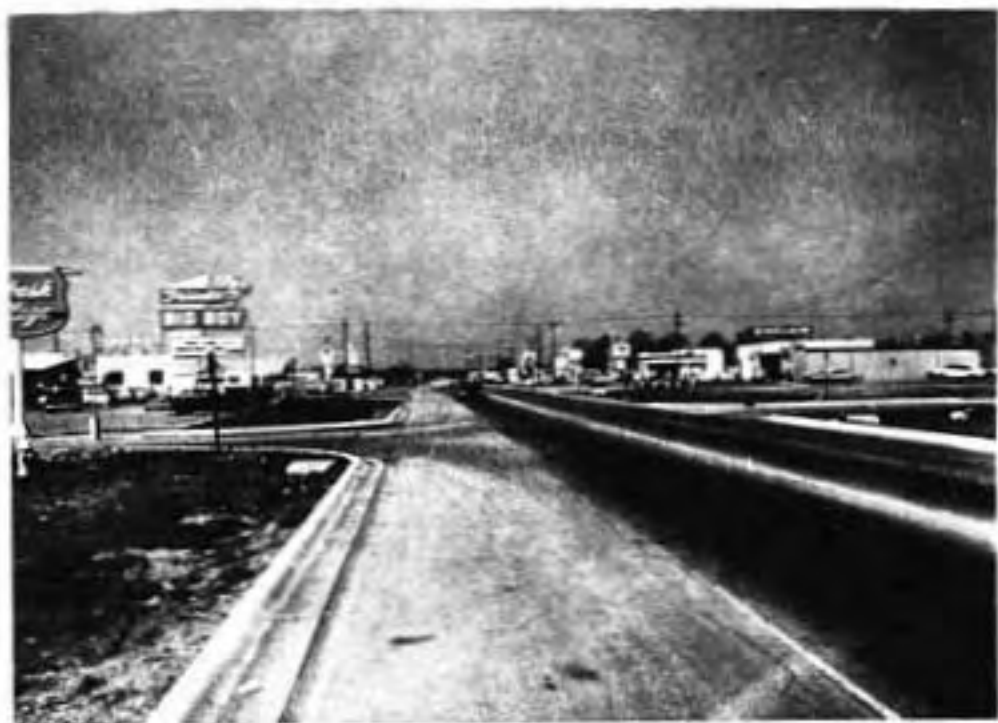
FIGURE 12 GOOD DRIVEWAY DELIMITATION AND RECOVERY LANE

- d. Require precise delimitation of all existing entrances and improvement of acceleration lanes. Figure 12 shows an example of good driveway definition.

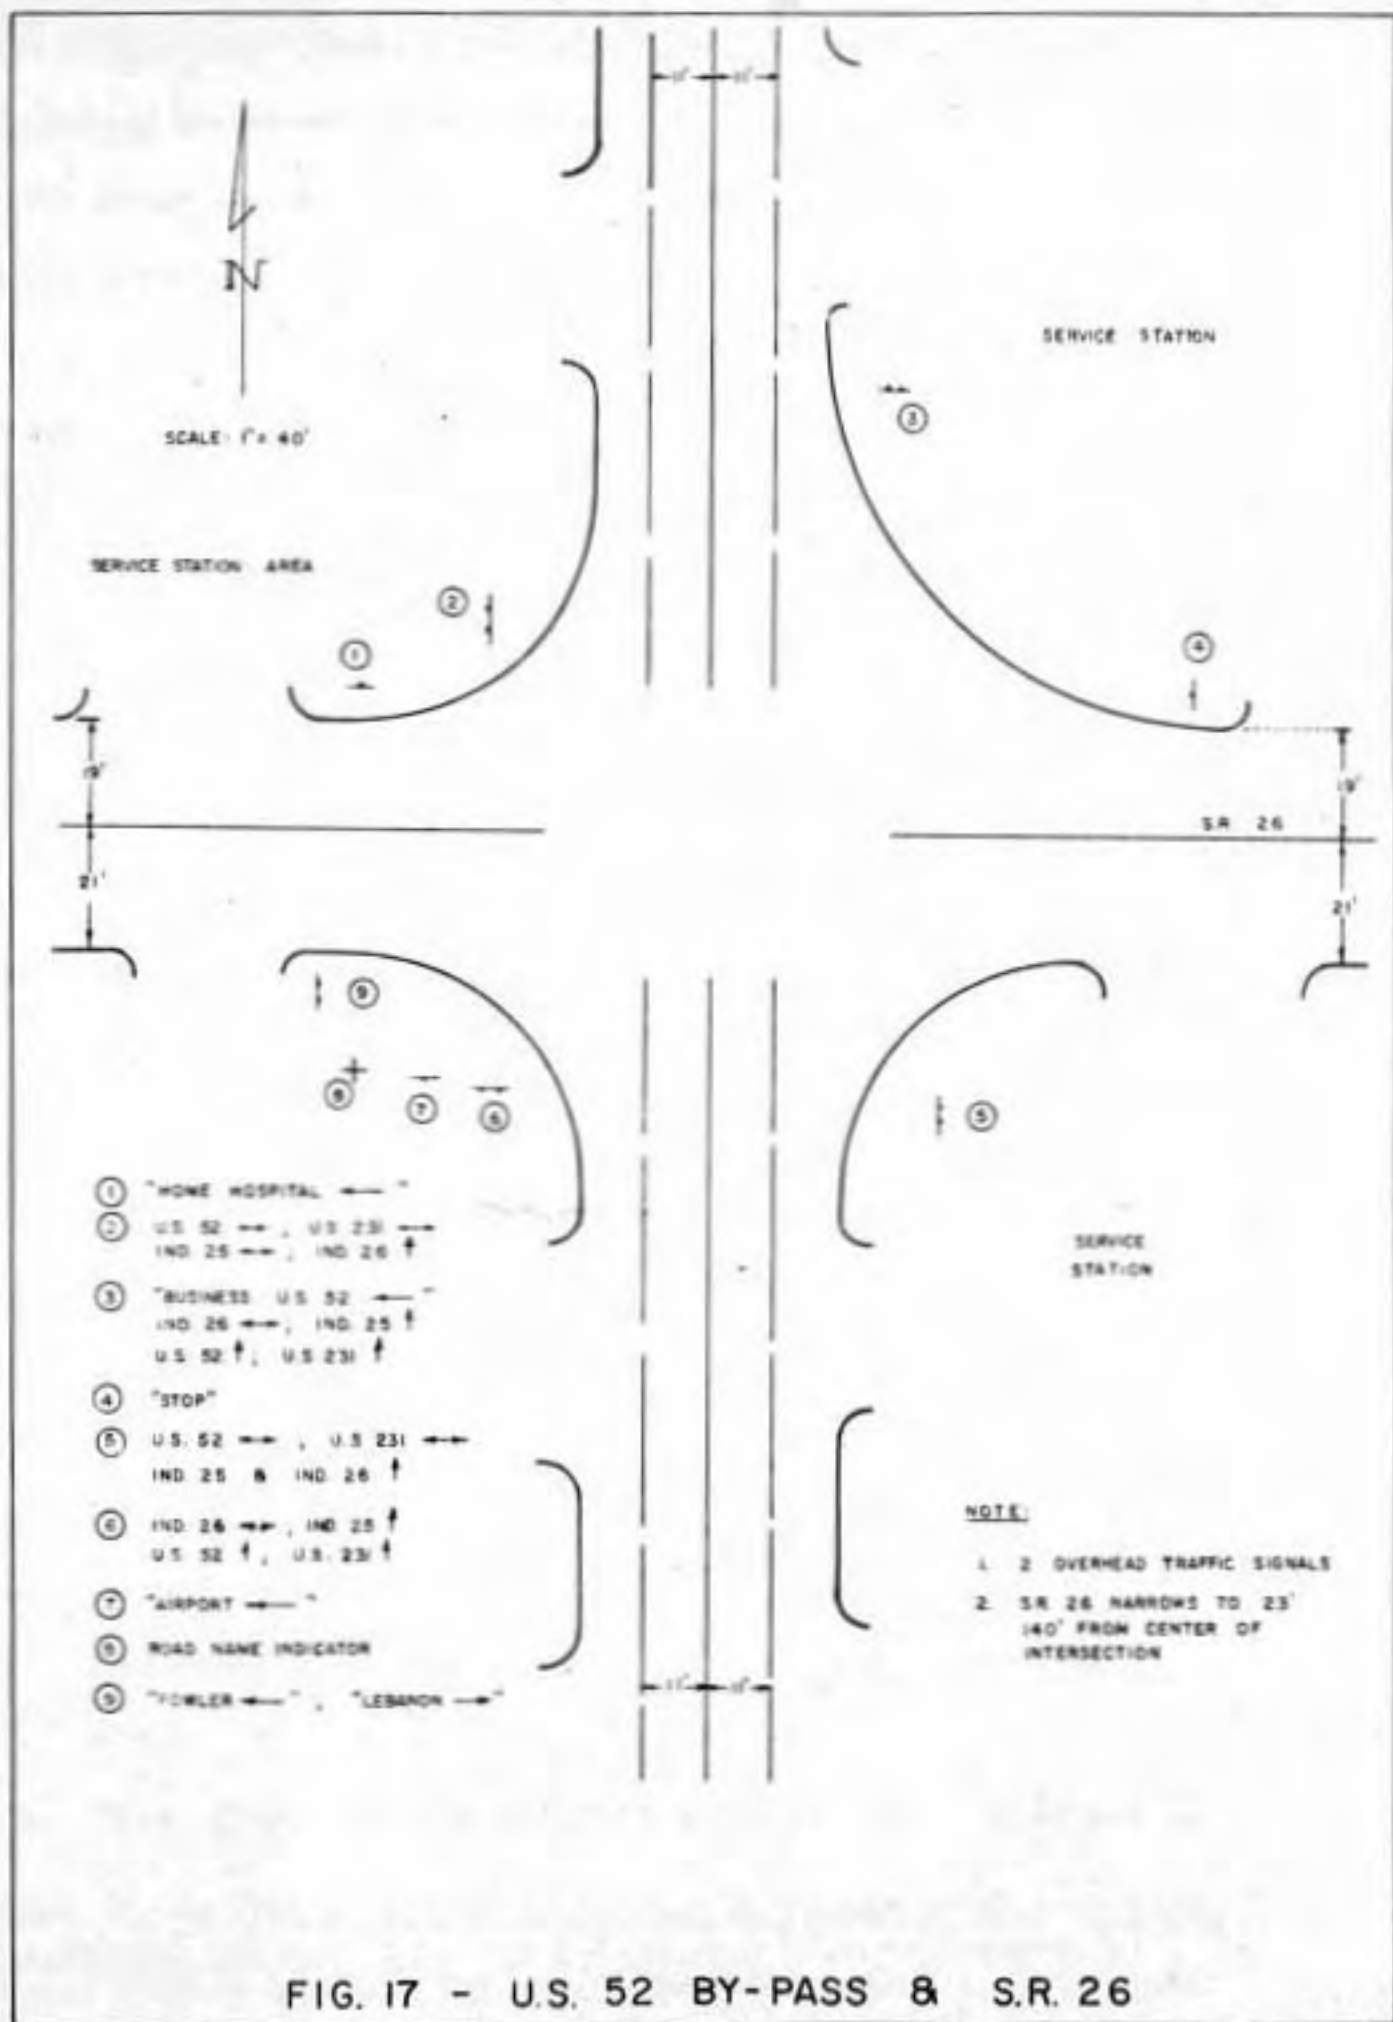
FIG. 17 - U.S. 52 BY-PASS & S.R. 26

This is the principal access route to the Bypass from Lafayette and a well traveled highway in its own right. It handles the heaviest volume of any intersection studied and ranks second in accident occurrence. These accidents were not as severe as elsewhere and were principally of the rear-end and left-turn types. There were also a few lane-

change collisions. These types of accidents occur where unprotected left-turning movements exist. There are heavy left-turn movements from the south and west approaches. A heavy right-turn movement exists from the north approach; the left-turn here is not a large proportion but is a heavy volume. Recent studies have indicated a definite need for left-turn relief at this location.* The existing outer lanes on the north and south approaches are woefully inadequate for the volume, speed, and weight of vehicles using them to bypass left-turners. The present signal cycle is very long and heavily favors the Bypass; no separate left-turn phases are included. As a result, all traffic, especially left-turns, from the cross street is delayed excessively. There is confusion over proper lane use and interference from nearby driveways in all quadrants. Sign encroachment on the right-of-way is prevalent here (Figure 11).

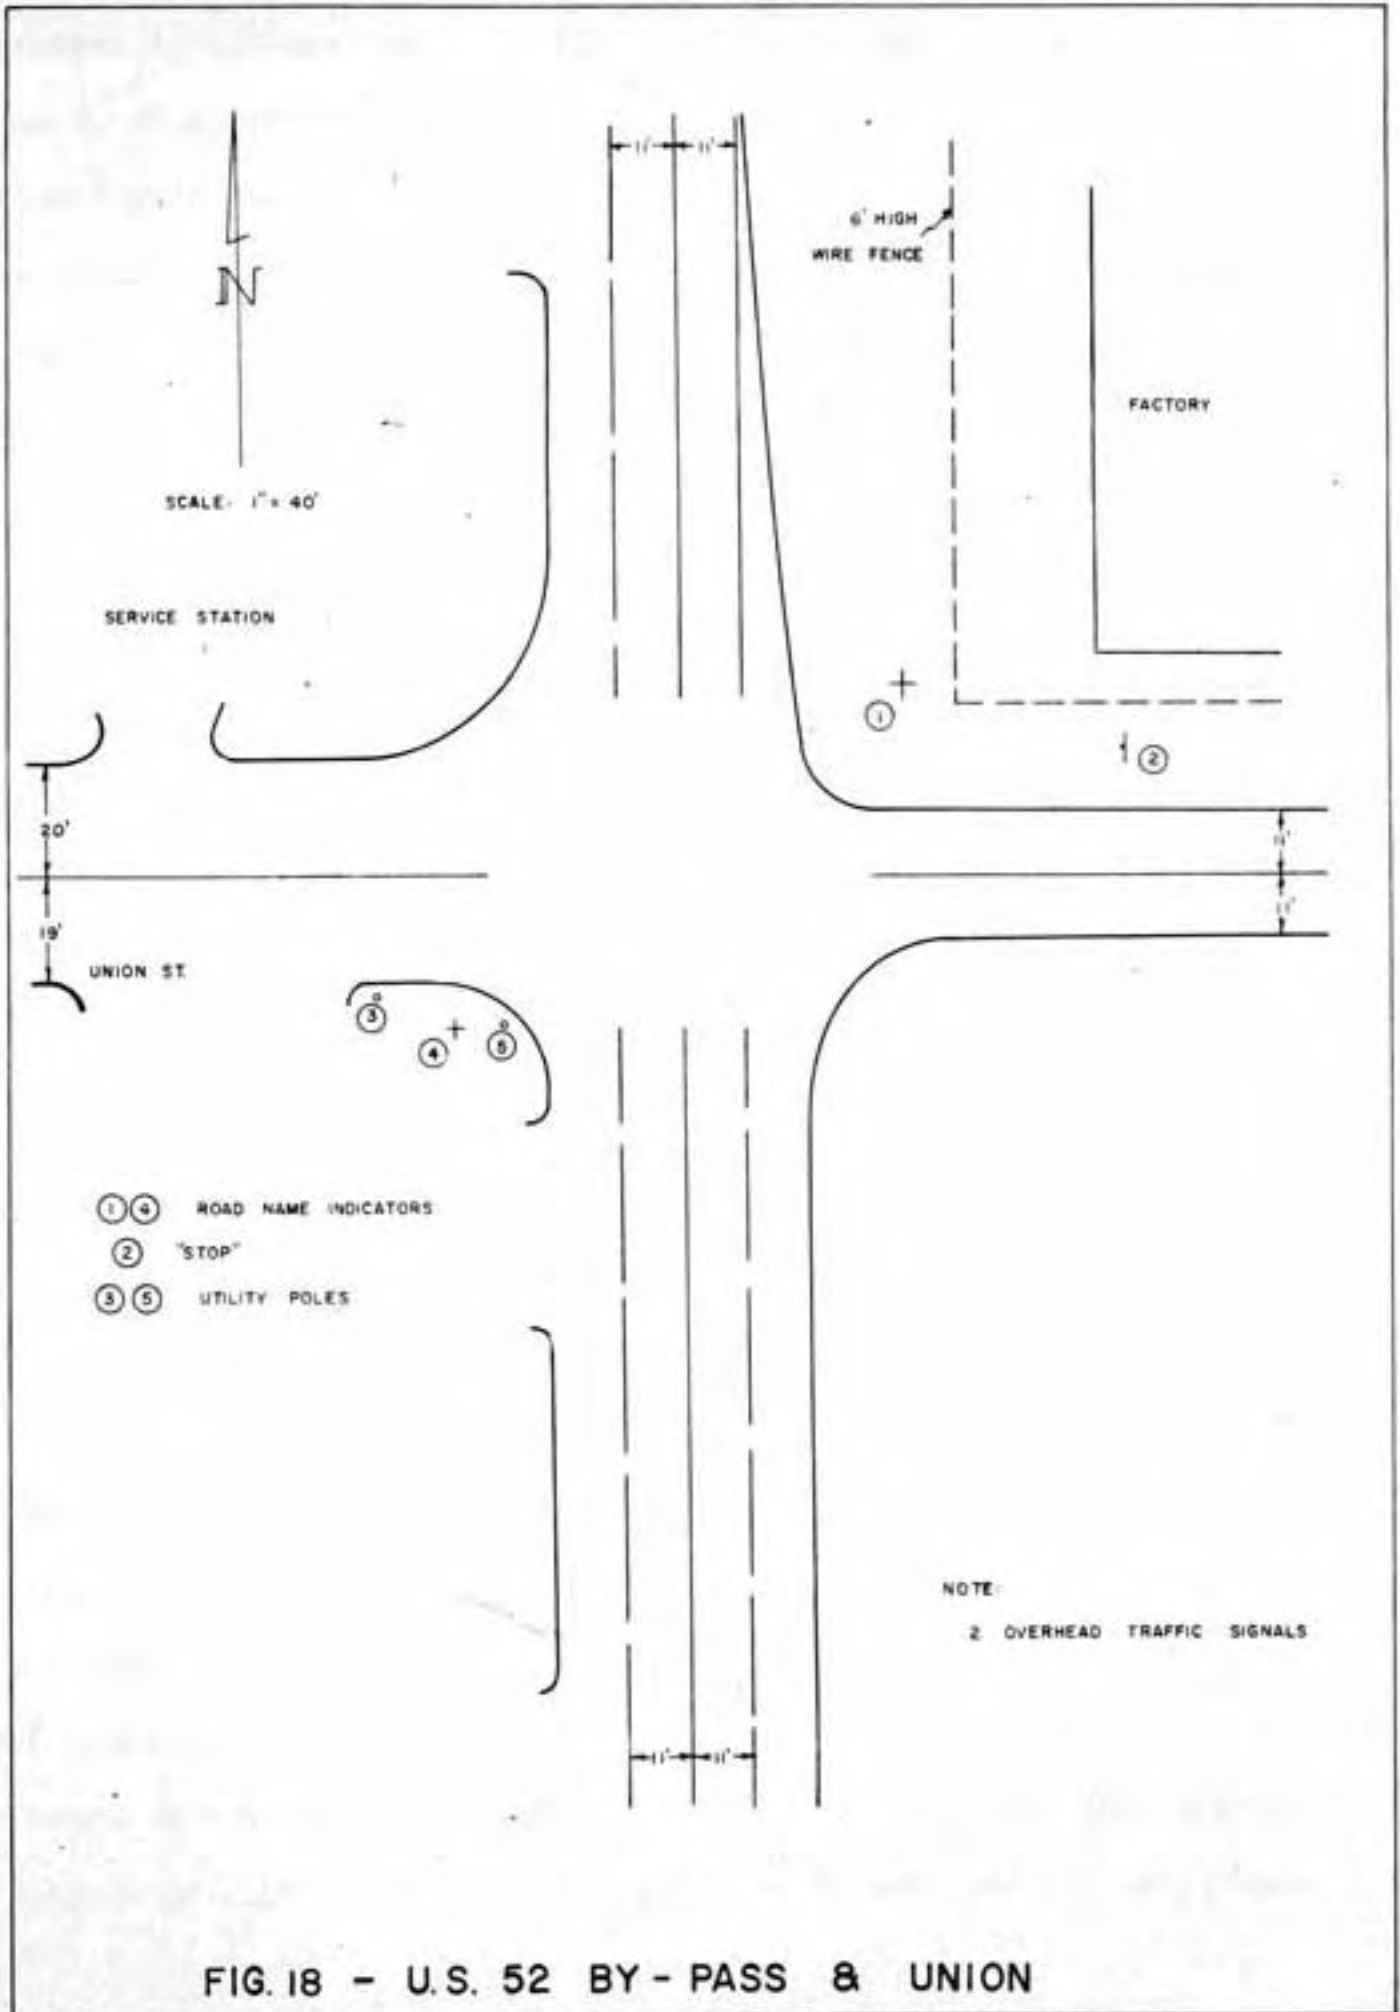
FIG. 18 - U.S. 52 BY - PASS & UNION

This intersection serves commercial and residential areas and is a direct connector to West Lafayette. The north approach is on a grade and commercial development on the west side of both Bypass approaches is intensive. Passing and recovery lanes are worse than at any other location. Minor street cross traffic is relatively light. Once again, as at all other signalized intersections, rear-end, lane-change, and left-turn accidents dominated, involving primarily Bypass traffic. Left-turns from the north approach are insignificant; those from the south are very heavy. The cross-street approach from the west is very good; the approach from the east is in poor condition

but carries little traffic. Significant delay to southbound traffic was due to slow starting of trucks stopped on the grade. Faster vehicles try to pass the slow starters, and this leads to conflicts in the outside approach lane and the recovery lane. Passing left-turners in the northbound stream can also cause trouble because of the very short recovery lane (75 foot taper) next to which is a ditch and a soft unimproved shoulder.

- a. Increase the length, width, and surface quality of outer approach and recovery lanes. This is especially necessary for the recovery lane on the south side in order to permit smooth merging without hazard. Mark the outer lane on the south approach for right-turn-and-through; mark the center lane for left-turn-only.
- b. Eliminate right-of-way encroachment of signs and mail boxes on the west side of the Bypass. Close the two entrances nearest the intersection from each service station.
- c. An exclusive left-turn phase for the south and north approaches combined with right-turns from the east and west would be desirable.
- d. Remove the bus stop in the southeast quadrant.

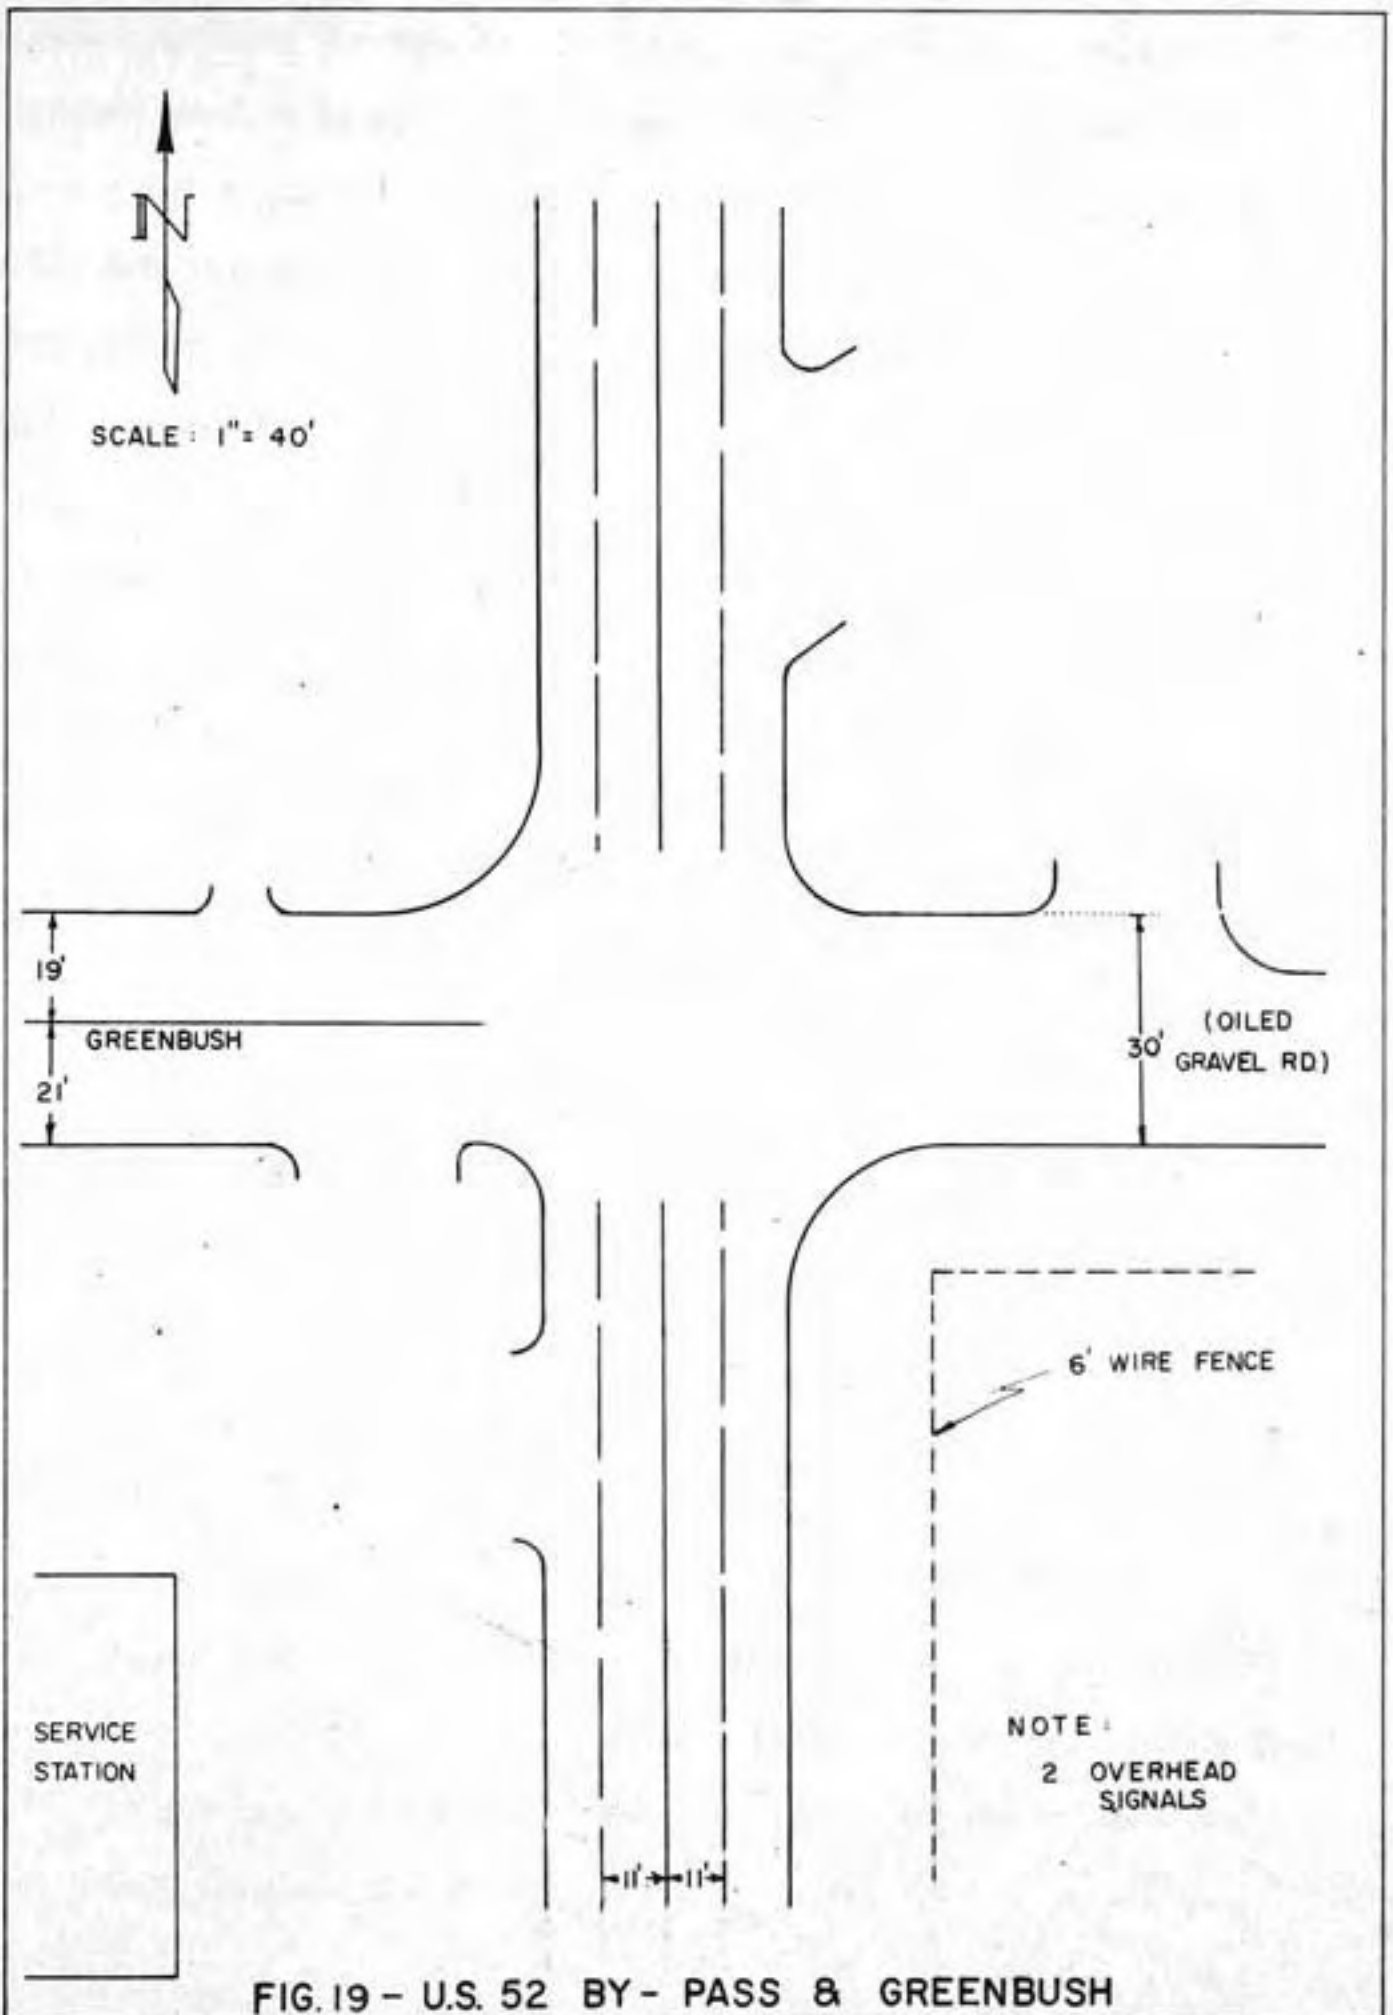
FIG. 19 - U.S. 52 BY-PASS & GREENBUSH

This is currently a low volume street serving established residential and commercial areas west of the Bypass. A large residential area currently being developed to the east can be expected to increase traffic on the east approach substantially over the presently low volume. The accidents are typical of signalized locations, principally rear-end and lane-change.

The recovery lanes for Bypass traffic are again very poor, that for southbound traffic being extremely short due to a right-of-way constrict-ion. A crest vertical curve through the intersection flattens to the south. Substantial delay here can be attributed to slow acceleration of stopped commercial vehicles at the traffic signal and the protected left-turn phase for the south approach. The left-turn movement here is here is not as heavy as at the two previously discussed locations. The special phase is questionably warranted and is a severe detriment to operation of the intersection. The very need for the signal is questionable at present, but will surely exist soon due to the new residential development.

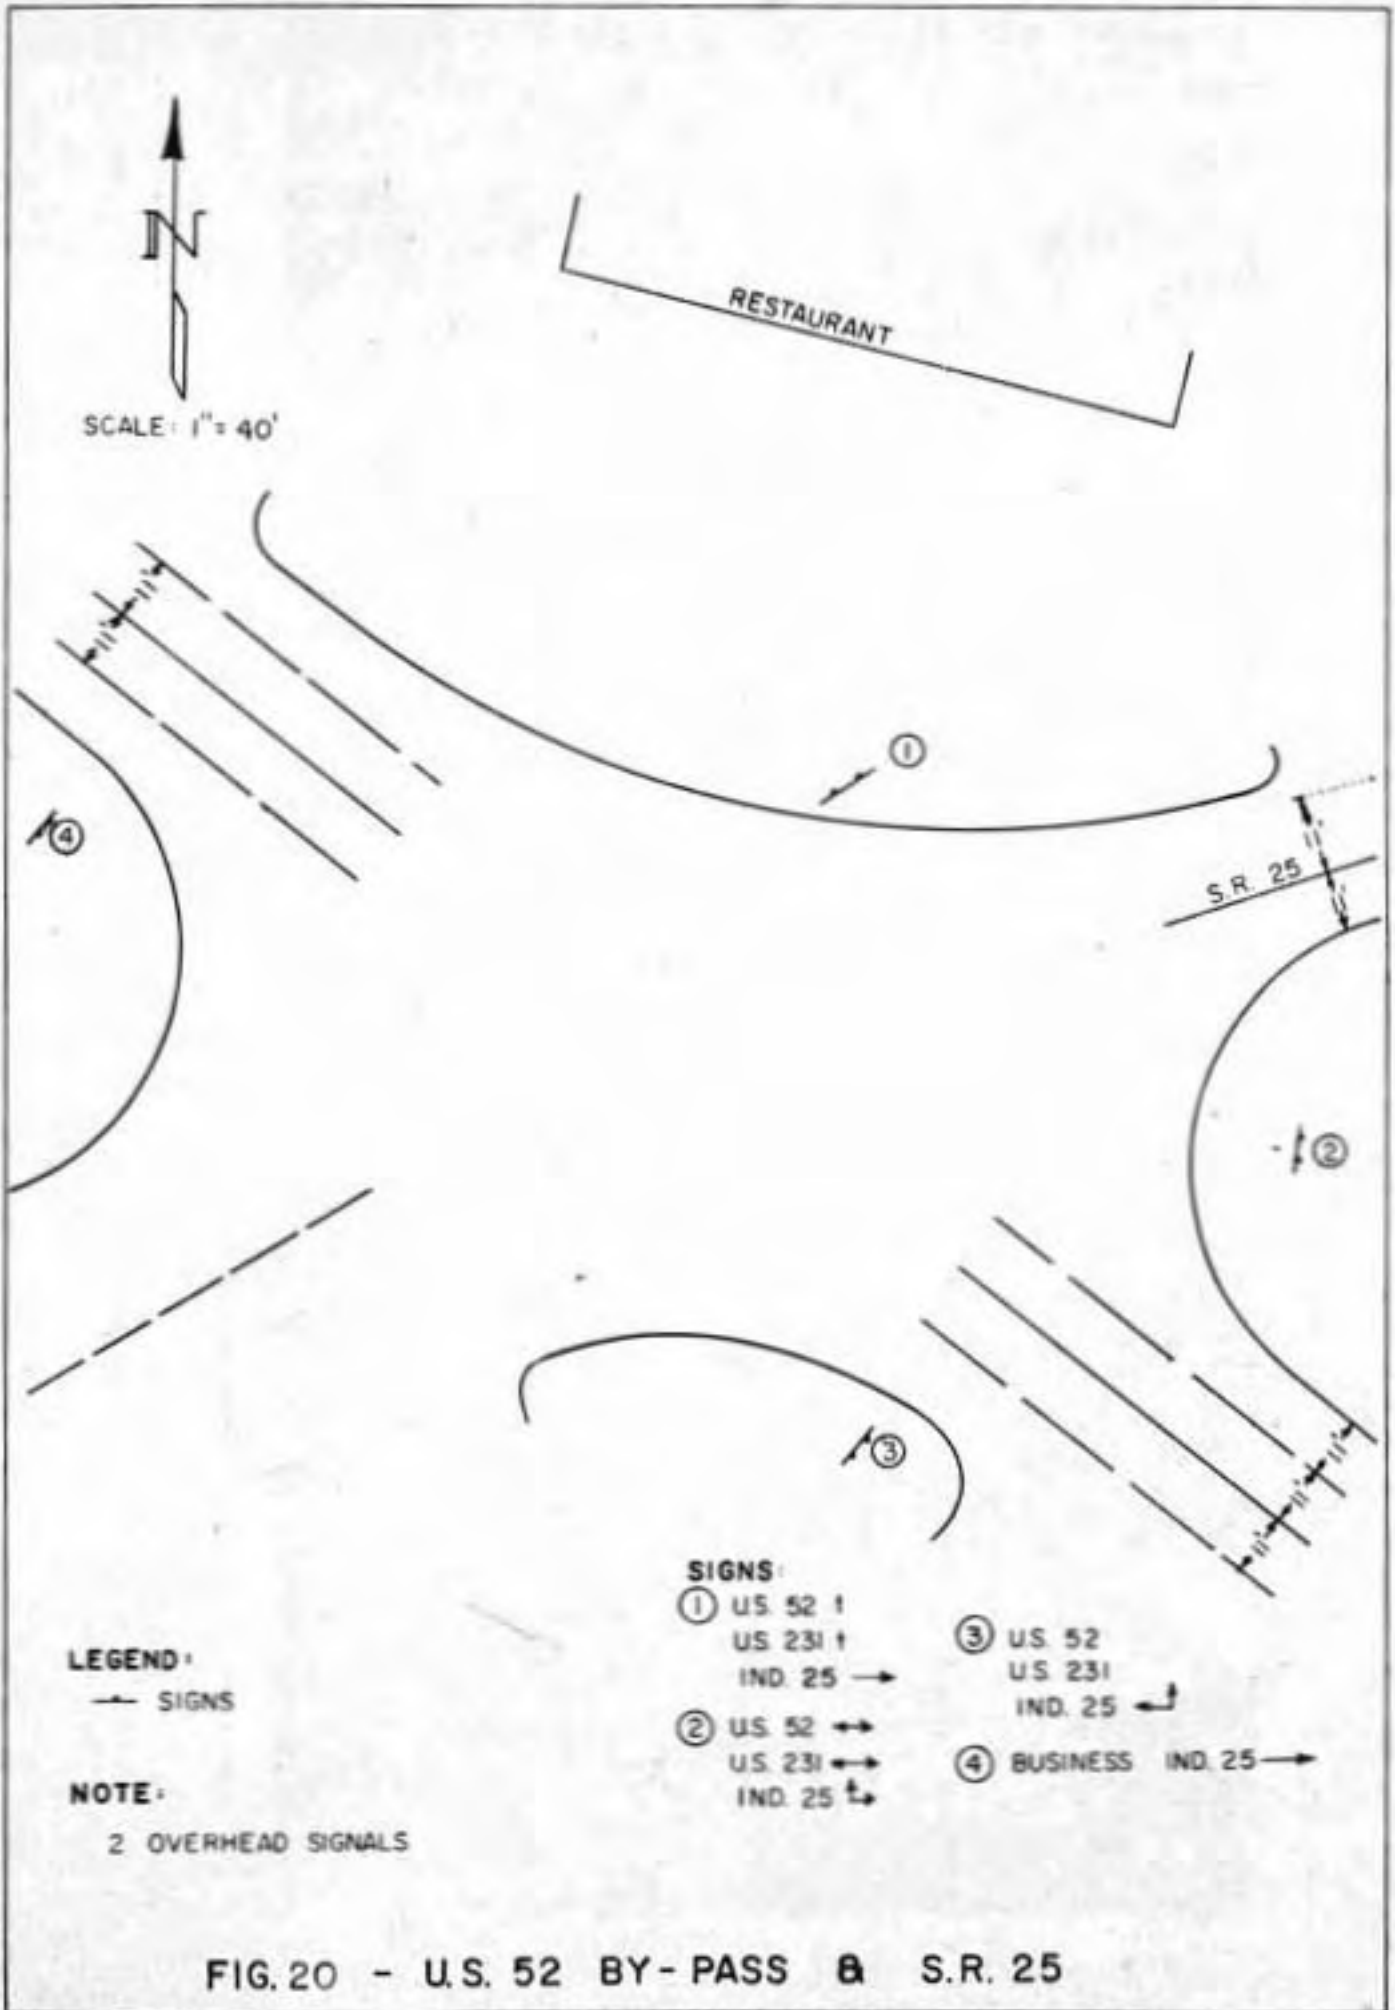
FIG. 20 - U.S. 52 BY-PASS @ S.R. 25

This rural highway is a main route to northeastern Indiana from Lafayette. All Lafayette-bound traffic on Indiana 25 continues on Schuyler to the center of the city. Most Bypass traffic uses this street to reach areas on the city's north side. The intersection ranks third in accidents per million vehicles. One third of these were a result of improper lane usage or lane-changes. There were also nine right-angle collisions and thirteen of the rear-end type. Delays are not especially excessive here since the intersection is level and has sufficient area to permit maneuvering around waiting vehicles. A very hazardous situation exists in both western quadrants due to termination of city streets at the Bypass (Figure 21 and 22). Driveways in the northeastern quadrant are very poorly defined (Figure 23).

- a. The vast open area of the intersection calls for extensive channelization. This should be done in coordination with widening and lane assignment as indicated in Figure 24.
- b. Close openings onto the Bypass from Stillwell and Monon Streets, and of 24th, 25th, and 26th Streets (Figure 25). These can all be served readily from the 24th Street entrances to Schuyler. The present condition causes apprehension for southbound drivers ascending the hill to the north approach and leaving the intersection on the south approach.
- c. Cooperation with the Devon Plaza Motel should be sought to erect a barrier to prevent cross-cutting of their parking lot to reach 26th Street (Figure 25). The driveways in the northeast

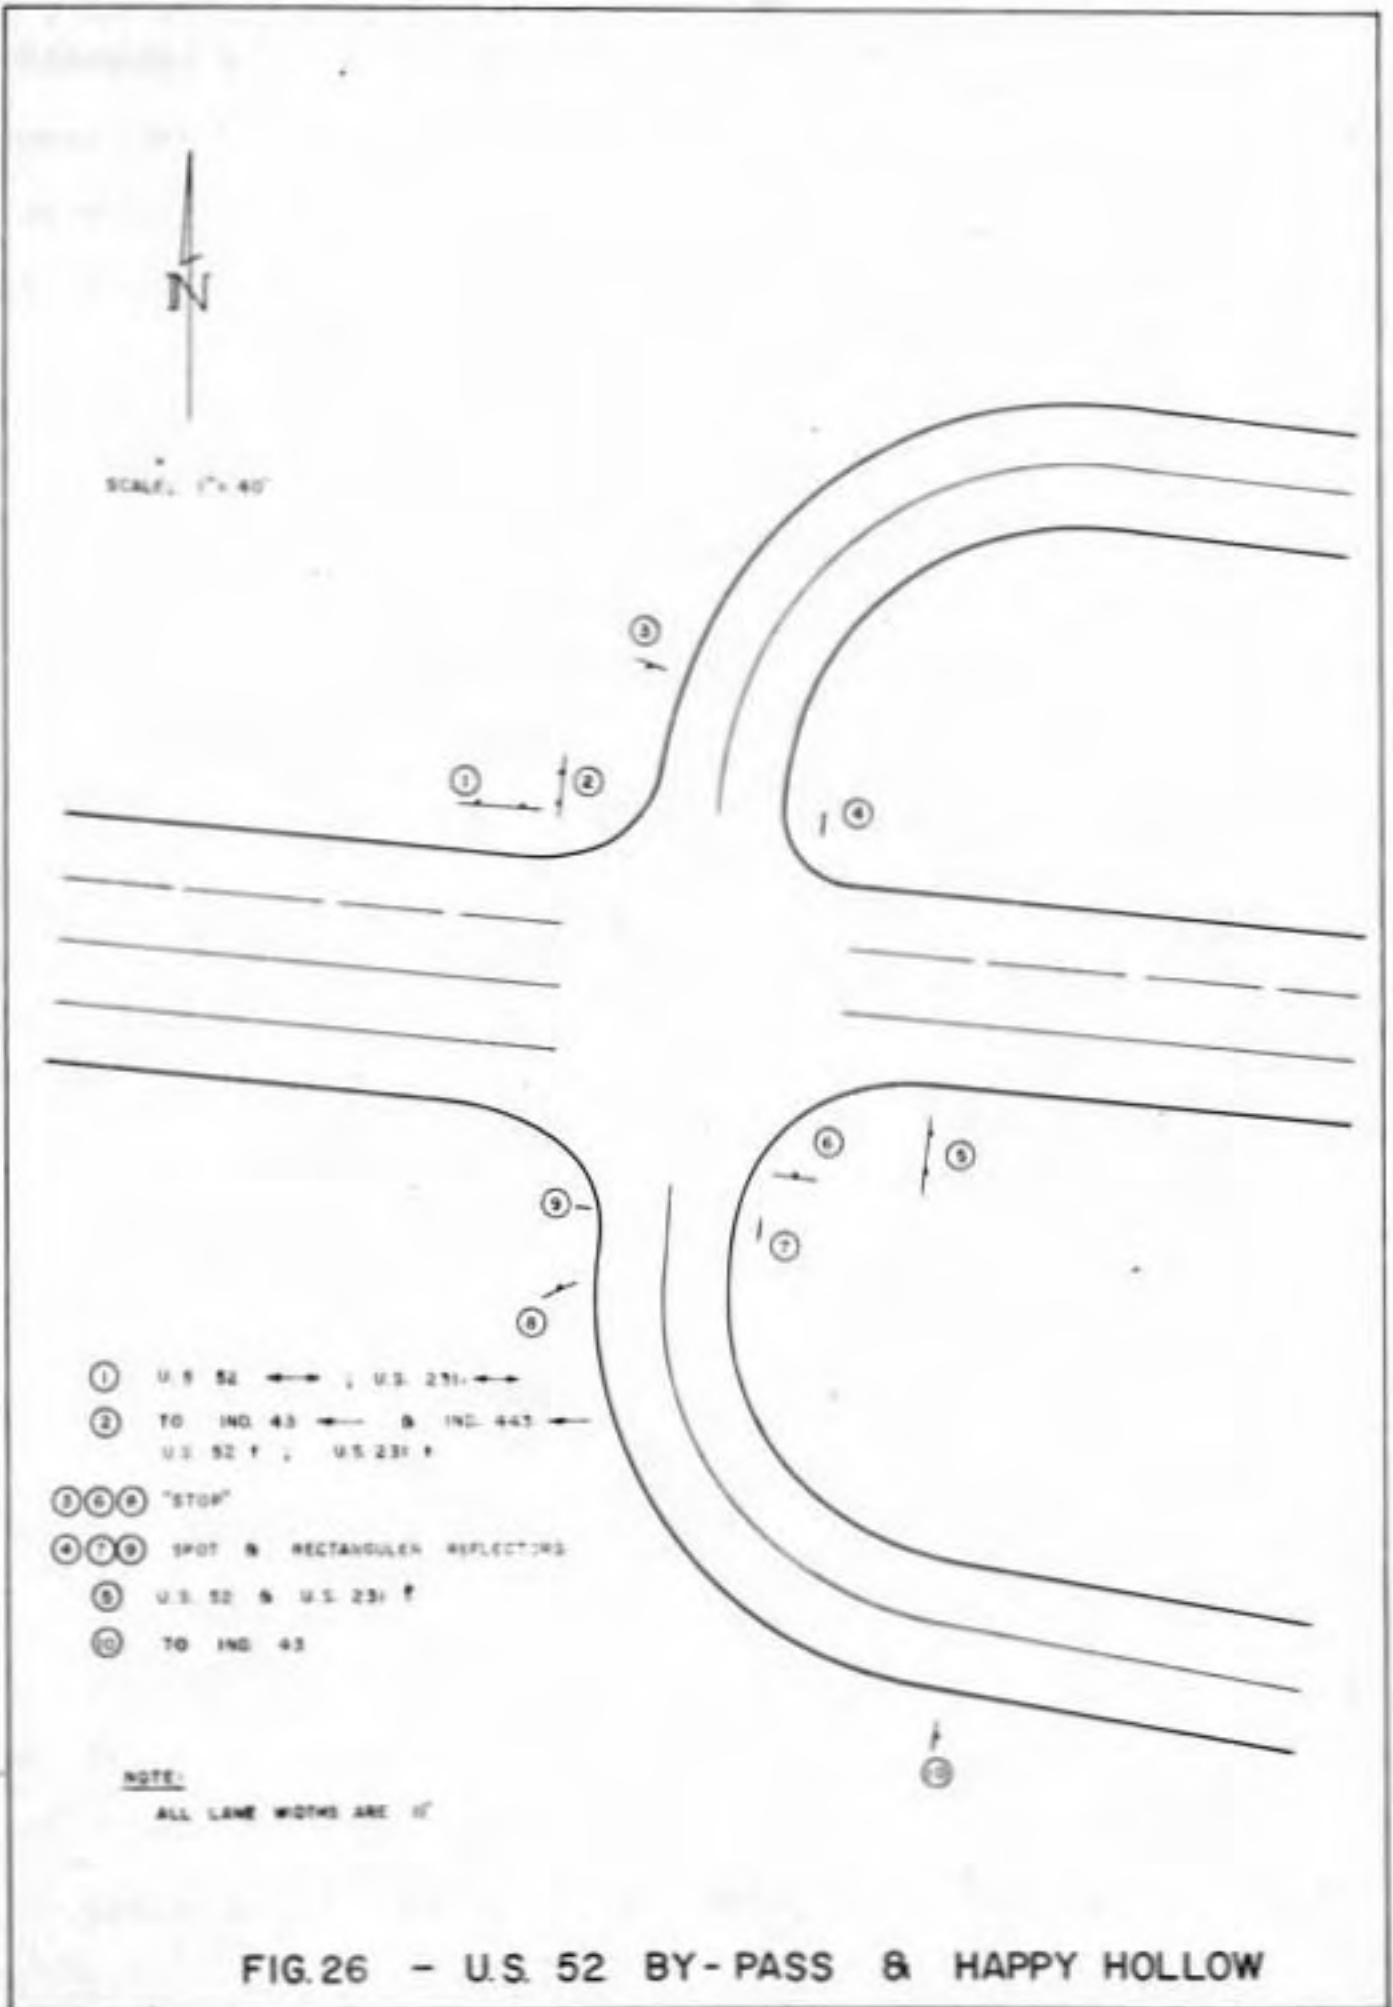
This intersection poses one of the worst problems on the Bypass because of topographic effects on design, operation and sight distance. The intersection is atop a long down-grade to the east on which there are a "humpback" and a truck climbing lane. This route is the only currently feasible means of access to the urban area from mushroom-

ing residential developments to the north. The principal movements are left turns from the cross street approaches and the returning right turns of this traffic. There is a new commercial establishment immediately west of the intersection. Accidents here were nearly 50 per cent right-angle. One third were rear-end collisions, most involving Bypass traffic waiting to turn onto the cross street. About 75 per cent of the accidents involved westbound Bypass vehicles, for and of whom sight distance is severely restricted by the humpback. Delays to cross-street traffic are severe due to driver reluctance to accept gaps because of the sight distance situation. The recovery lane for southbound Bypass traffic is poor, causing delay to people reluctant to bypass turners and slowing those who do. The situation here will be impossible to solve in a satisfactory manner without substantial construction. The most effective recommendations are those in Stage II.

- a. Extend and improve the recovery lane for southbound Bypass traffic.
- b. Broaden the north approach of Soldiers' Home Road and construct a longer taper on the Bypass to act as an acceleration lane for right-turning vehicles.
- c. On both cross-street approaches mark lane lines and lane use designations. Place stop-lines sufficiently far out to permit good sight distance but prevent interference with Bypass traffic.
- d. Mark the right-turn lane from the west Bypass approach. Also improve lane use markings on the hill climbing lane near the top of the hill for northbound traffic on the Bypass.

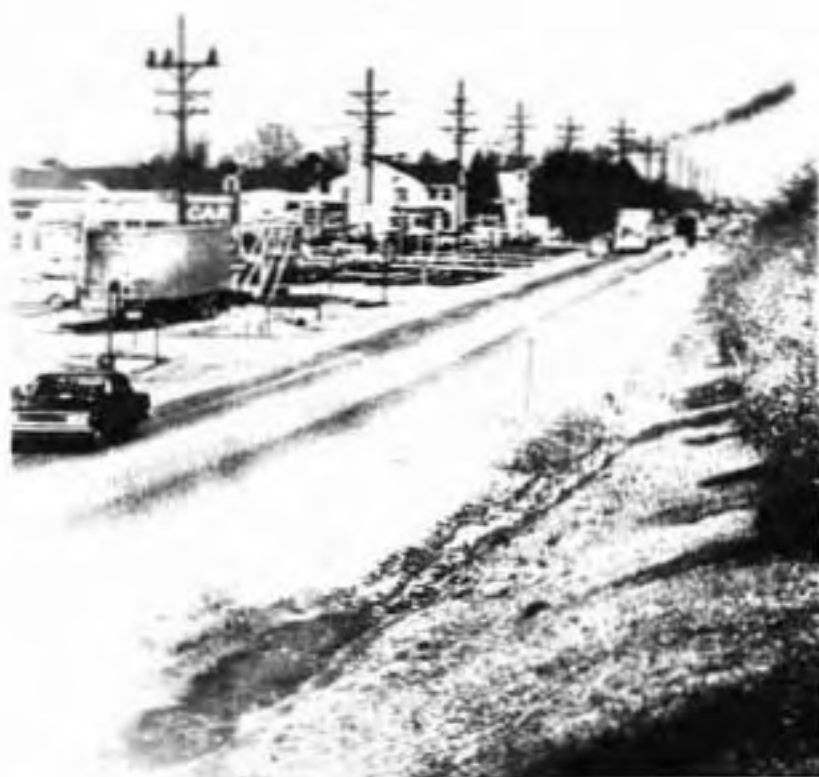
FIGURE 29 EXAMPLE OF POOR DRIVEWAY DELIMITATION

1. Trader Horn Commercial Complex-Station 37 + 40L; Figure 29

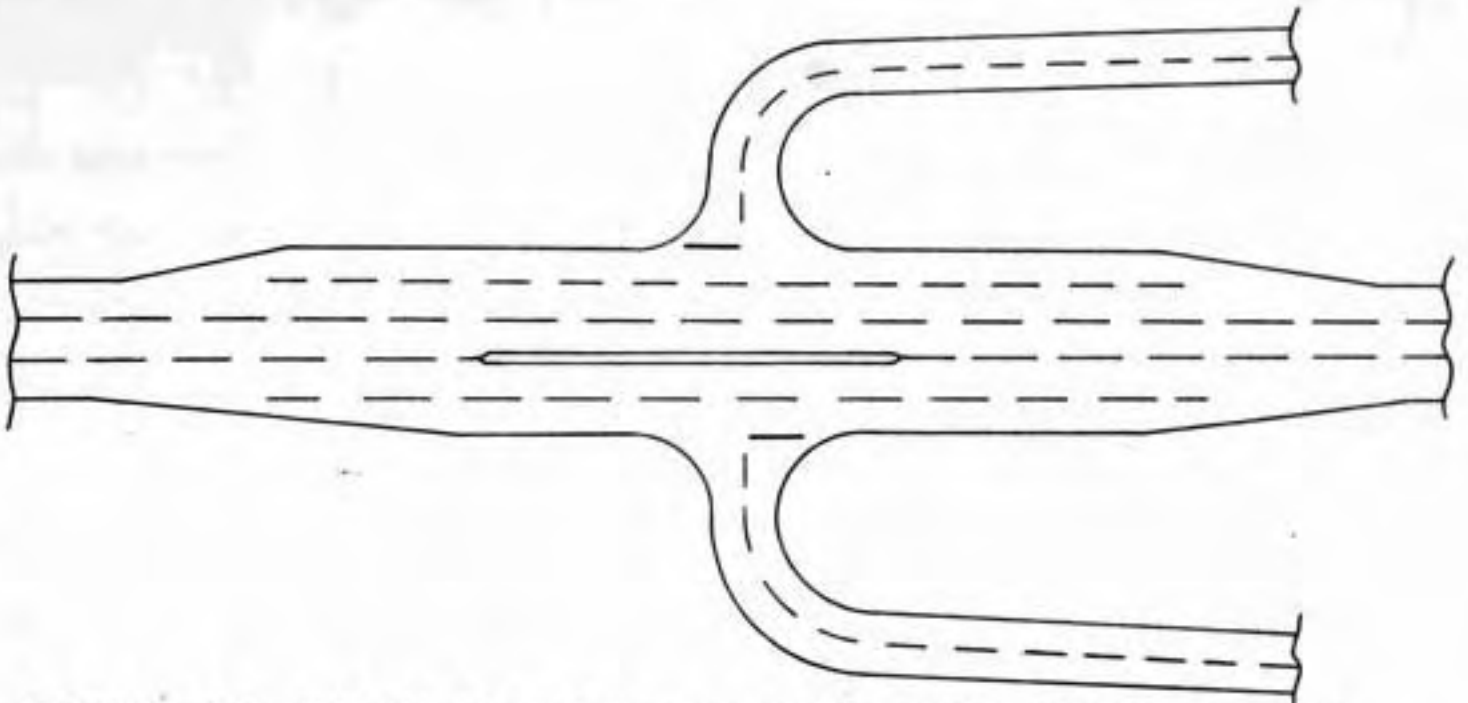
FIGURE 32 HAPPY HOLLOW - SOLDIERS HOME ROAD INTERSECTION WITH U.S. 52 BYPASS; STAGE 2 RECOMMENDED MODIFICATIONS

The problems here concern the steep down-grade immediately east of the intersection. If the intersection could be moved to a more nearly level area the sight distance and commercial vehicle acceleration problems would be reduced and installation of a signal would be feasible. It is recommended that the intersection be moved west of its present location to near Station 54+00, location of a recently granted point of access.

This location would have sufficient stopping sight distance for vehicles on the east approach to permit installation of a traffic signal. The current intersection would be terminated completely and the cross-road approaches extended on frontage roads to the point of intersection (Figure 32). The automobile sales establishment at Station 66+73 would have access to the frontage road only. Bypass approaches would be four lanes each to match the cross section at the Salisbury intersection (1900 feet west) and carrying through the truck climbing lane from the hill. The outside southbound lane would be tapered for a reasonable recovery distance to meet the present situation on the hill.

There is sufficient right-of-way available for 20 foot frontage roads on either side of four 11 foot lanes on the Bypass, allowing also for a marginal divider between the Bypass and the frontage roads. The frontage road on the south side should be constructed on the alignment which the southbound roadway will follow when the Bypass is widened and realigned in this area. The frontage road on the north side within the current right-of-way could still be used subsequent to the Stage II work. The cross-street approaches should have three lanes each to permit easy right-turns and through movements.
