Impact Fatigue Behaviour of Flapper Valve Steel

IMPACT FATIGUE BEHAVIOUR OF FLAPPER VALVE STEEL

Akemi Futakawa, Dr. Eng., Manager and Koji Namura, Engineer
Central Research Laboratory, Mitsubishi Electric Corporation,
Amagasaki, Hyogo, Japan

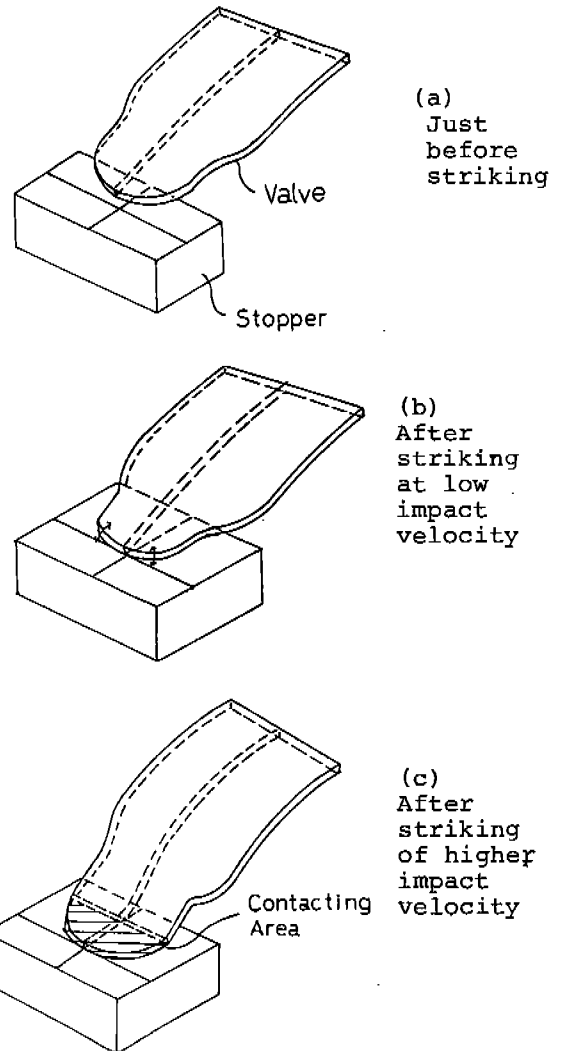
Fig. 13 Illustration of dynamic deformation

On the bases of the evidence obtained through the various analysis procedures described above, some considerations are taken on the impact fatigue failure mechanism of a suction valve when it hits repeatedly a valve stopper during suction stroke. Figs. 13 (a) to (c) show illustration of the dynamic deformation when the suction valve hits a valve stopper. Fig. 13 (a) shows the valve deformation just before striking. Fig. 13 (b) and (c) show the valve deformation after striking at low impact velocity and higher impact velocity, respectively.

At the early stage during suction stroke, the tip of the suction valve moves to a valve stopper deforming as shown in Fig. 13 (a). In the case where the impact

velocity is low, fluctuated vibration mode with very high frequency will be produced at the tip portion of the suction valve as shown with arrows in Fig. 13 (b) immediately after striking. As a result, large repeated bending stress might be applied to the suction valve, followed by impact fatigue failure initiated from the corner of the center edge on the seat side. When the impact velocity is much higher, the tip portion of the suction valve might contact to the valve stopper with comparatively large area as shown in Fig. 13 (c), accompanying with high frequency vibration in the circumferential and radial directions. Accordingly, large impact stresses, which are caused by not only bending deformation in the circumferential direction but also that in the longitudinal direction, are produced along the circumferential edge of the suction valve. These stresses might rule the impact fatigue failure with a lot of cracks along the circumferential edge.
