**EROSION MITIGATION AT FORT HASE BEACH
AND AT PYRAMID ROCK RECREATIONAL AREAS**

**U.S. MARINE CORPS BASE HAWAII, KANEOHE BAY
KANEOHE, OAHU, HAWAII**

FINAL REPORT
May 31, 2000

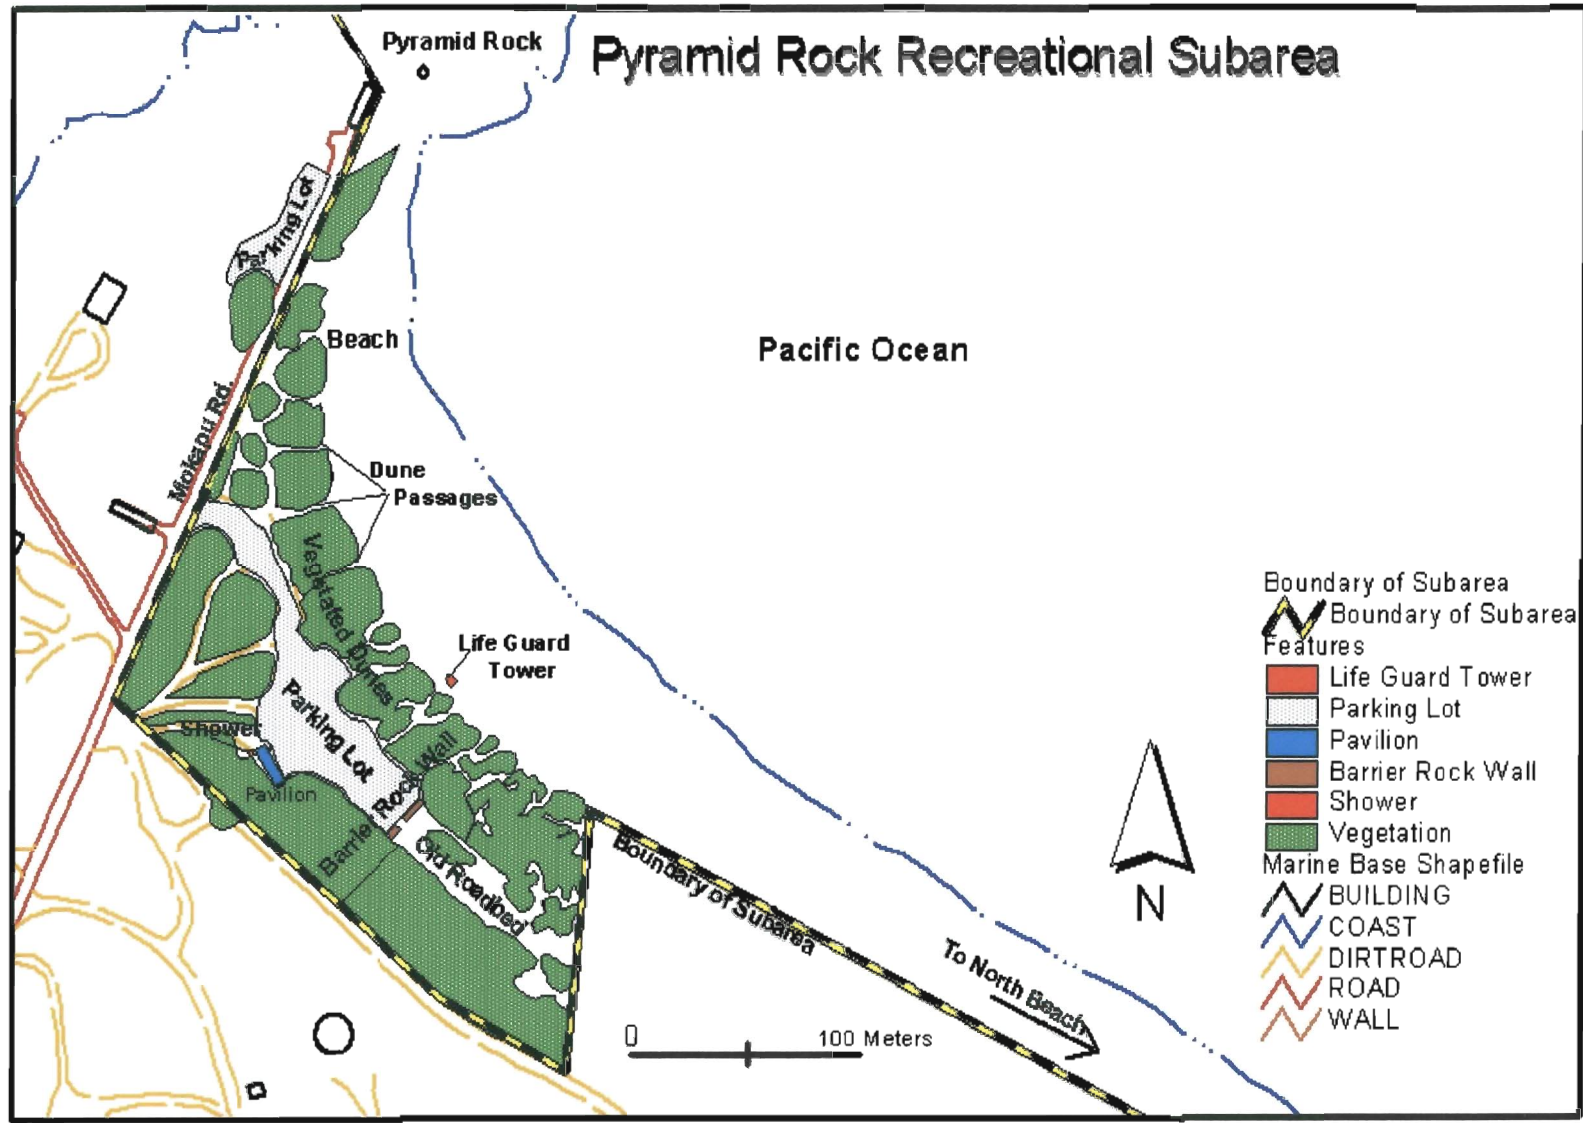
The parking lot is an unpaved open area set just behind the lower dune area (Figure 6). It is located on excavated sand dunes and is surfaced with crushed coral and other fill material. There are no marked stalls. It has a capacity of approximately 50 cars. Concrete stops are placed along the edge of the lot bordering the lower dune area. The parking lot is on a slight grade that rises from northwest to southeast. A part of the upper lot, nearest the lower sand dunes, is covered by several inches to over a foot of sand blown back from the beach. Cars parking in this area have become stuck in the sand due to loss of traction.

The recreational pavilion and shower stall are located on the southern boundary of the parking lot (Figure 6). The pavilion is a roofed over concrete slab with a picnic table and benches. The shower is located adjacent to the pavilion and contains a single showerhead over a concrete slab. There are several portable toilets located near the pavilion and shower stall.

Figure 6. Pyramid Rock Recreational Subarea. Note location of parking lot, vegetated dunes, beach passageways, shower, picnic pavilion, and barrier rock wall.

The dunes fronting the parking lot have at least eight passageways to the beach. The passages are generally straight and parallel to each other. Near the eastern end of the parking lot there are a series of three passageways to the beach that are connected by lateral trails. Past the end of the parking lot and on the other side of the low wall are a dozen trails, many with perpendicular branching connections (Figure 6). The vegetative cover has been worn away in these areas by pedestrian traffic to the beach.

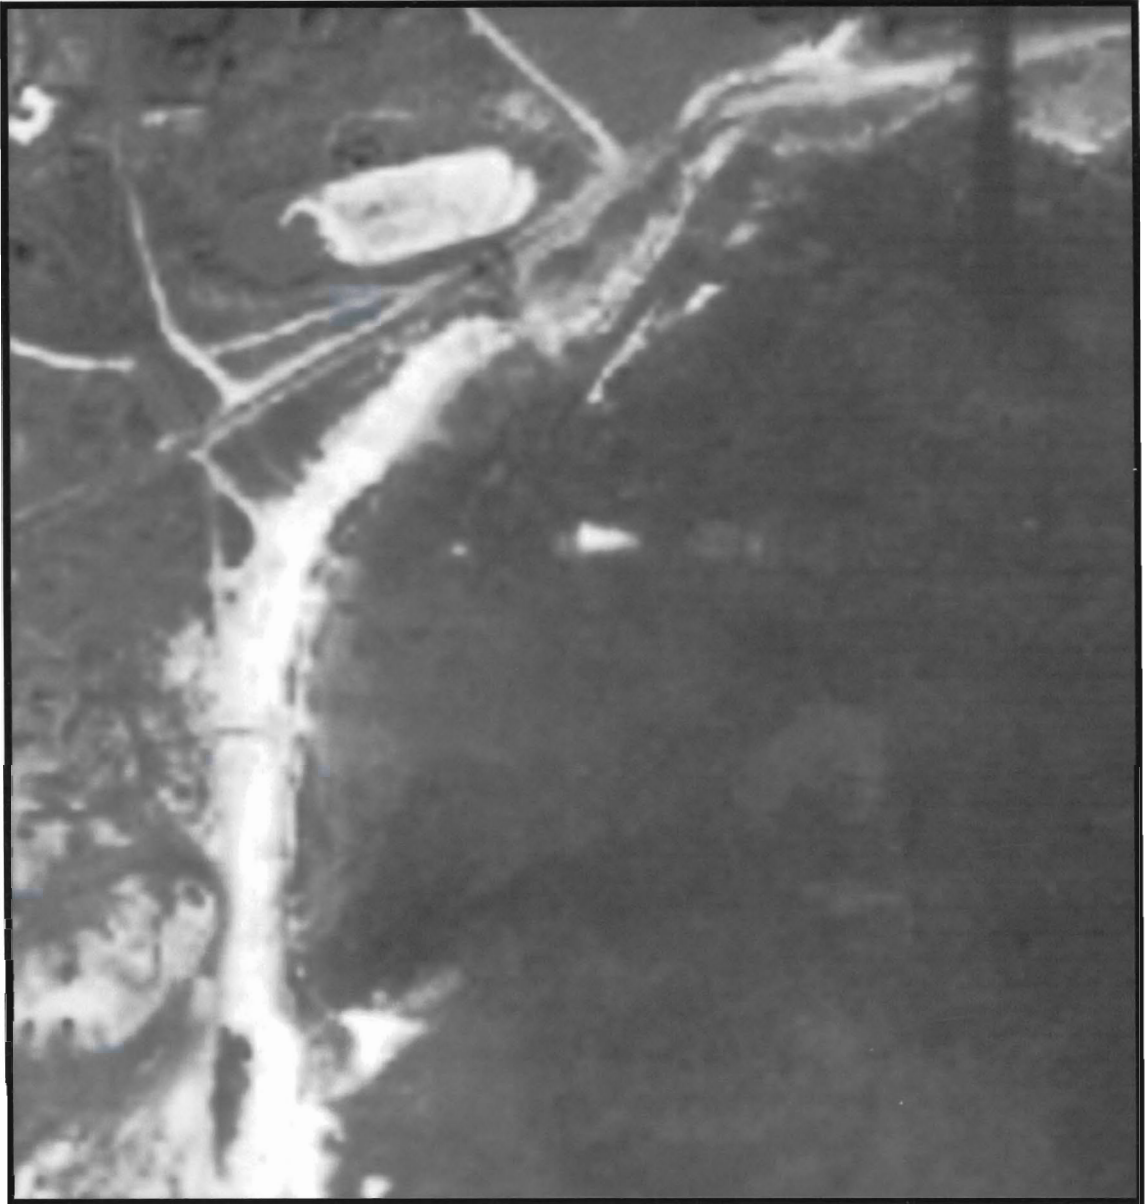
Figure 10. Fort Hase Beach Recreational Area. Aerial photograph taken by Air Survey Hawaii in 1963. Note tracks across dunes to beach.

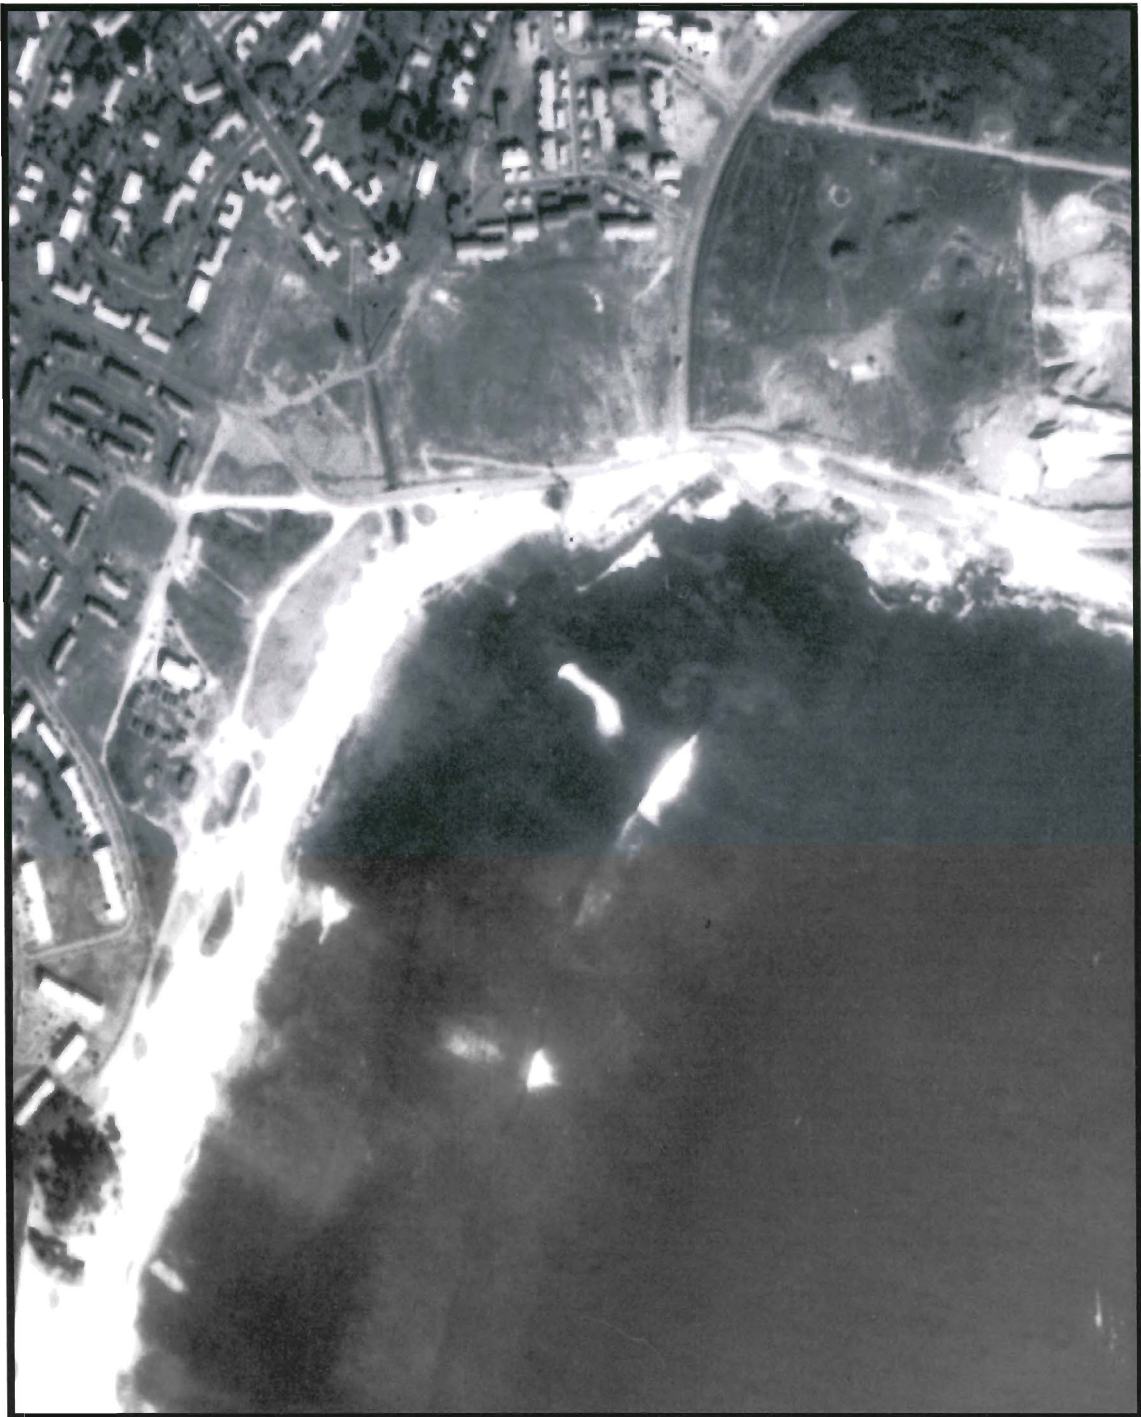
Figure 11. Fort Hase Beach Recreational Area. Aerial photograph taken by Air Survey Hawaii in 1993. Note increasing development in the back-dune area and in the number of tracks across dunes to beach.

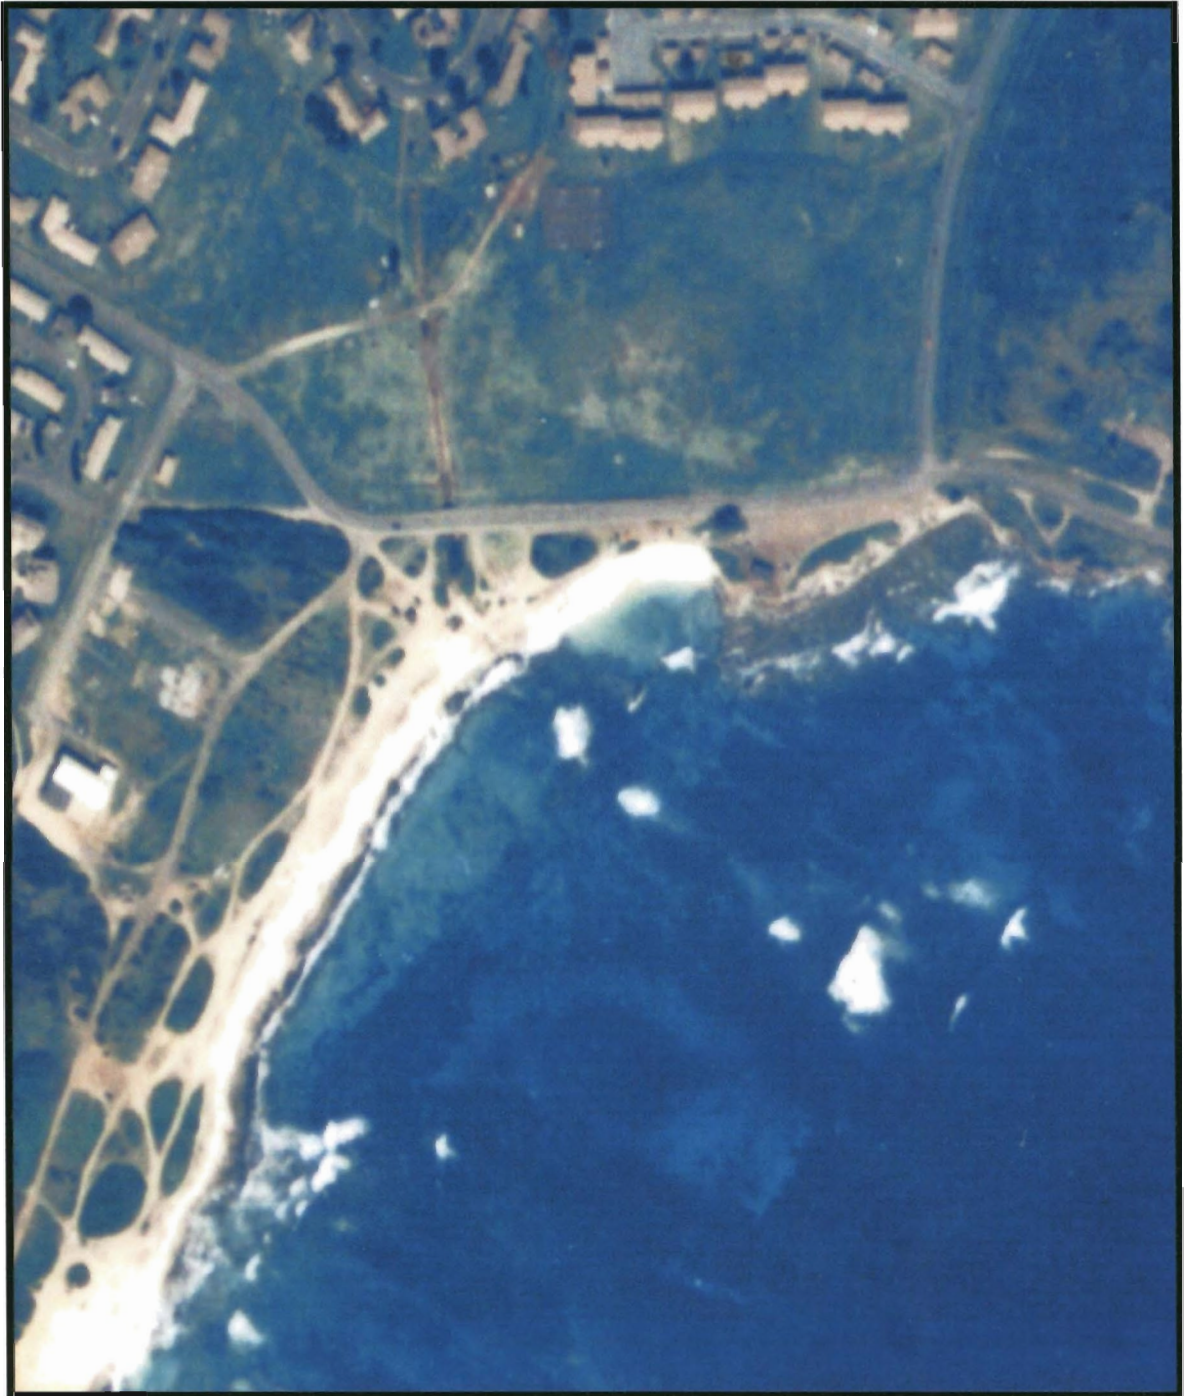
Figure 12. Fort Hase Beach Recreational Area. Aerial photograph courtesy of Air Survey Hawaii, taken in January 2000. Note tracks across dunes to beach and overall development in the back-dune area.

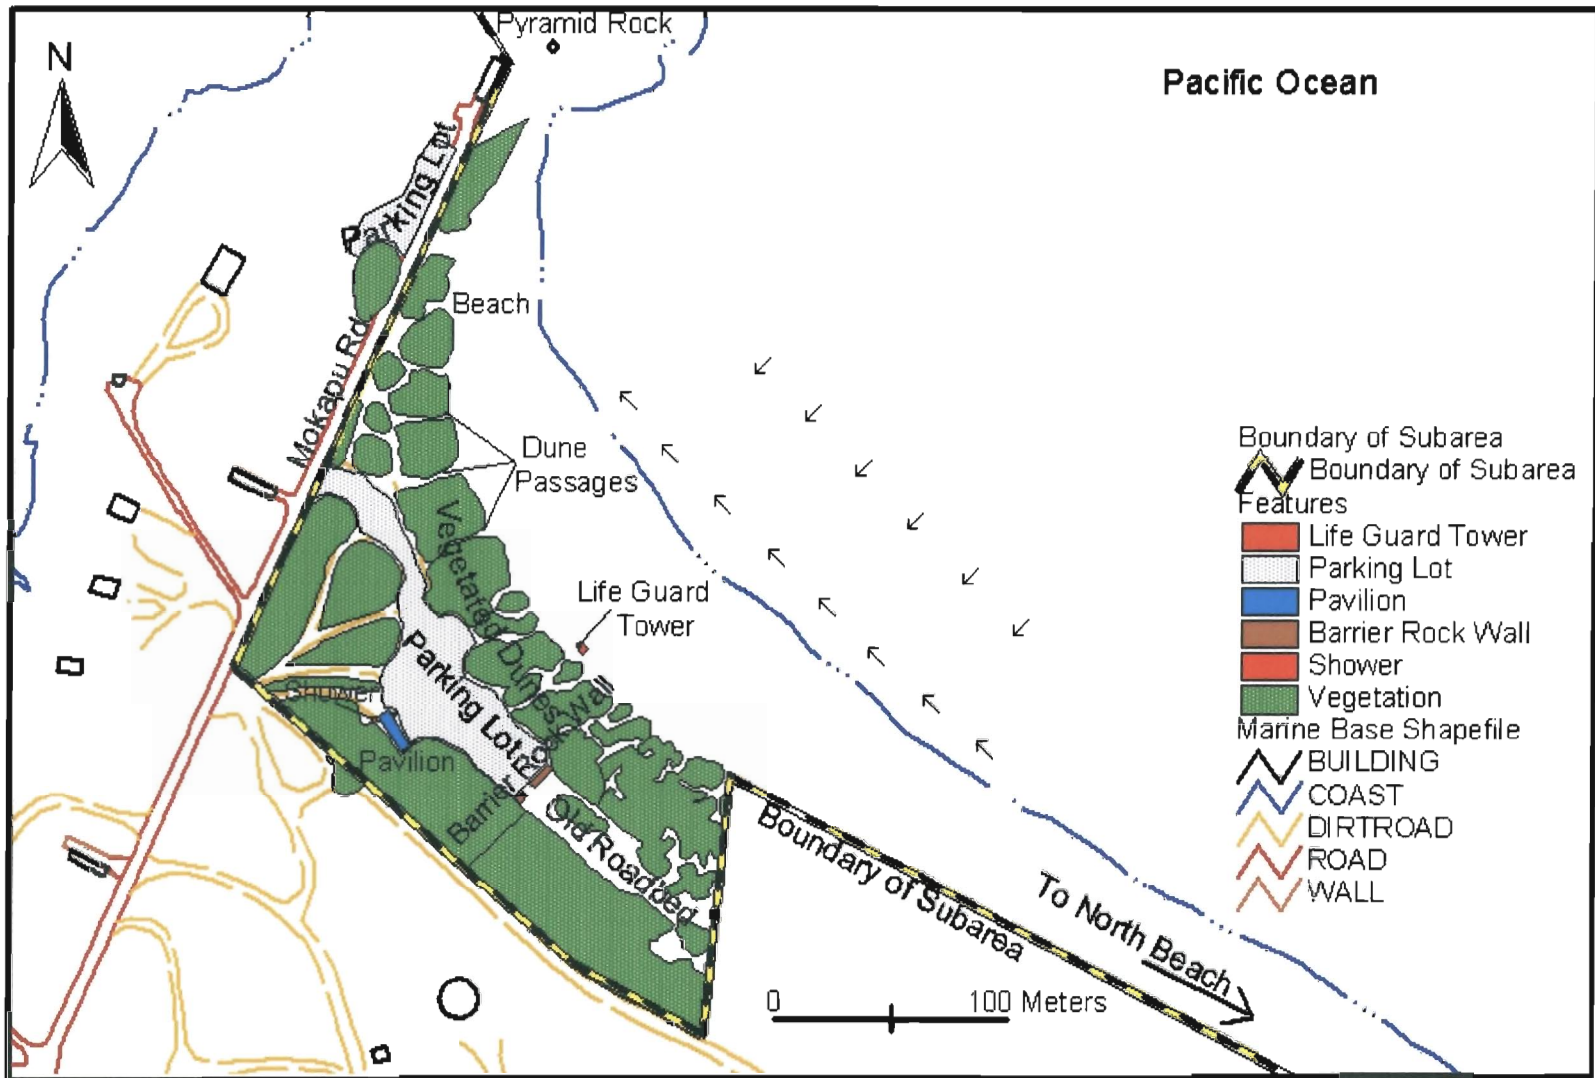
Beaches accrete when the harsh storm waves are replaced by less steep waves. These conditions occur during the summer months when the winter surf has diminished and tradewind swell waves dominate. The summer waves transport sediment toward shore and the beach gradually widens as the sand is distributed along the beach (Figure 14).

Figure 14. Pyramid Rock Recreational Subarea. Figure illustrates direction of coastal sediment transport under summer wave conditions.

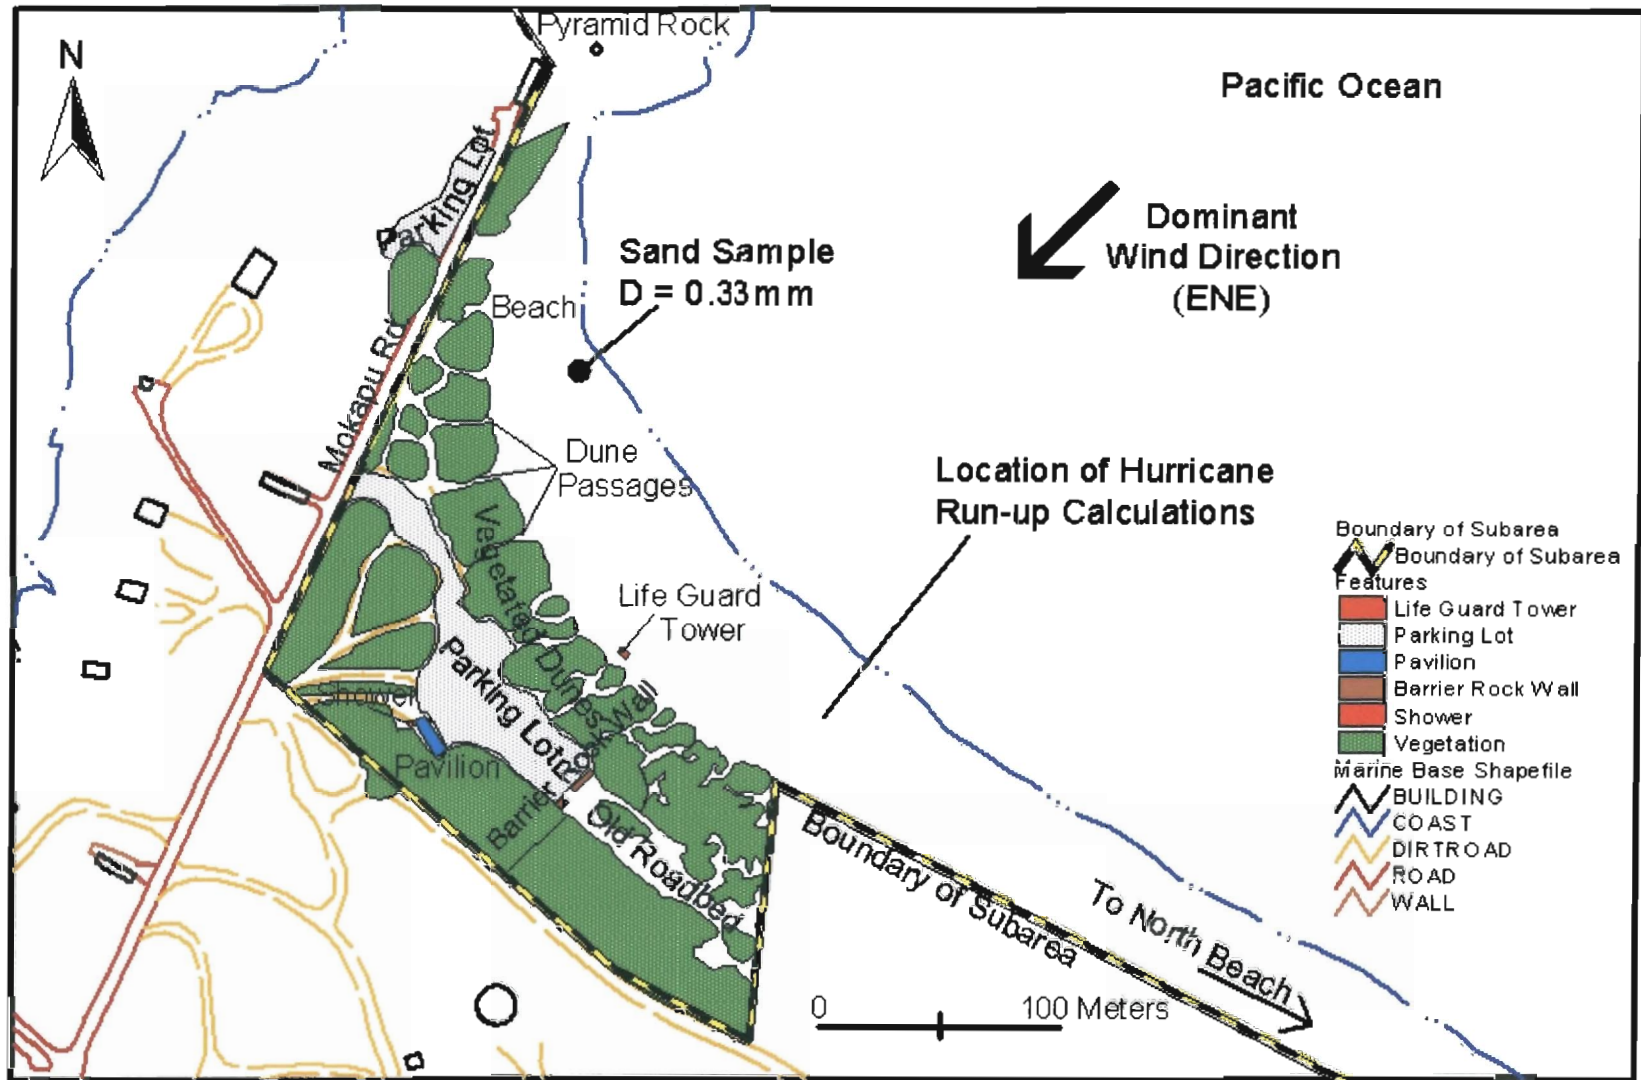
The winds are also a factor in sediment transport at Pyramid Rock Beach. The nearly direct onshore winds transport beach sand landward. Between the beach parking lot and the airport runway, a number of distinct dune lines can be seen (Figure 16). The dunes serve as a supply of sand that can gradually and naturally be released to the beach during periods of substantial, and usually temporary, beach loss. Dunes can also serve to protect landward property from flooding. Wind analysis and rough extrapolation from the present locations of the dune lines indicates that the dunes extended toward Pyramid Rock and once existed at the present location of the pavilion and parking lot. This conclusion is supported by the accumulation of sand in the parking lot.

The model hurricane approaching from the East to Southeast had maximum sustained wind speeds of 65 knots at the shoreline. The flooding potential was assessed and the associated wave inundation reached an elevation of +10.1 feet above Mean Sea Level (MSL), corresponding to a distance of 108 feet from the shoreline. The location of the transect can be seen in Figure 16. The direction of approach and local topography suggests that the run-up will be approximately the same in the vicinity of the parking lot. The associated flooding is expected to extend as far as the vegetation, but not endanger the parking lot.

Figure 16. Pyramid Rock Recreational Subarea. Figure illustrates direction of dominant wind direction (ENE) and location of the hurricane run-up transect as calculated from model studies.

1. The parking lots at both beaches should be surfaced with a porous, non-compacting material such as crushed rock or gravel that will eliminate or significantly reduce sheet flow.
2. The shower facility at Pyramid Rock Beach should be moved to an existing lower level (Figure 16) there, its waste water can be controlled and recycled for use in irrigating landscaping in the vicinity.
3. Passageways to the beach from the parking lots should be limited to 3 or 4 at each site.
4. The remaining multiple walkways should be temporarily barricaded with educational signage so that re-vegetation of these excess walkways can be initiated.

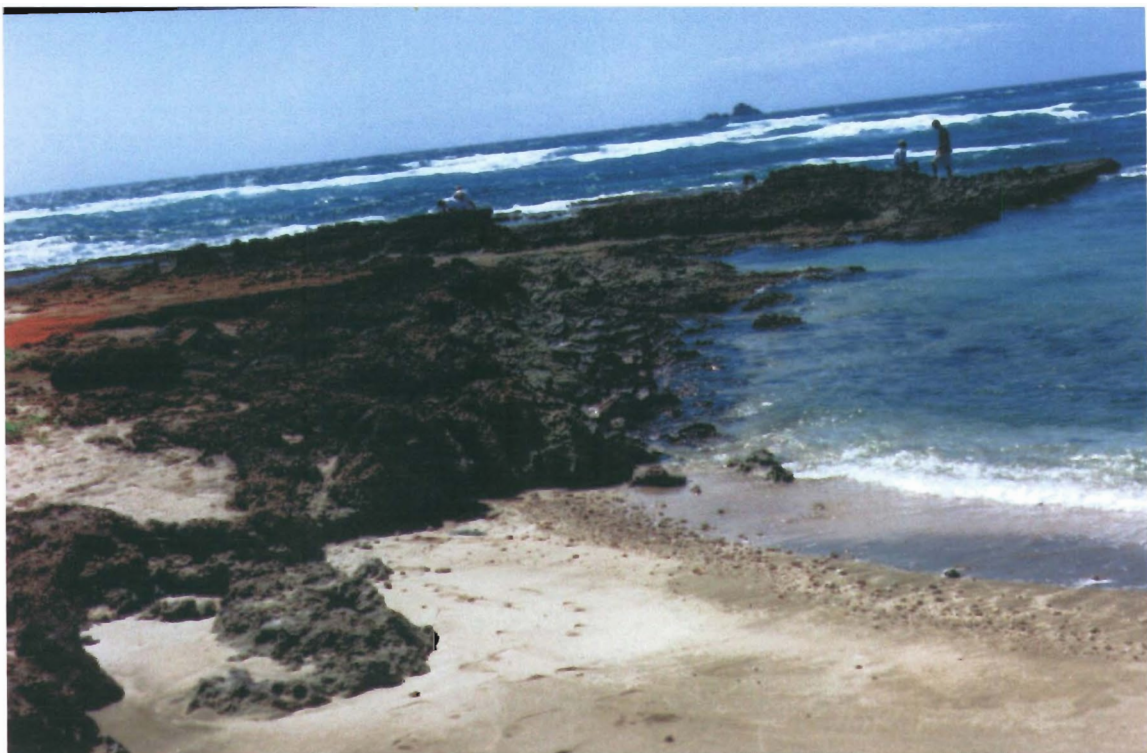
Photo 2. Rocky shoreline and small pocket beach at north side of Fort Hase Beach Recreational Area just seaward of the Picnic Pavillion shown above.

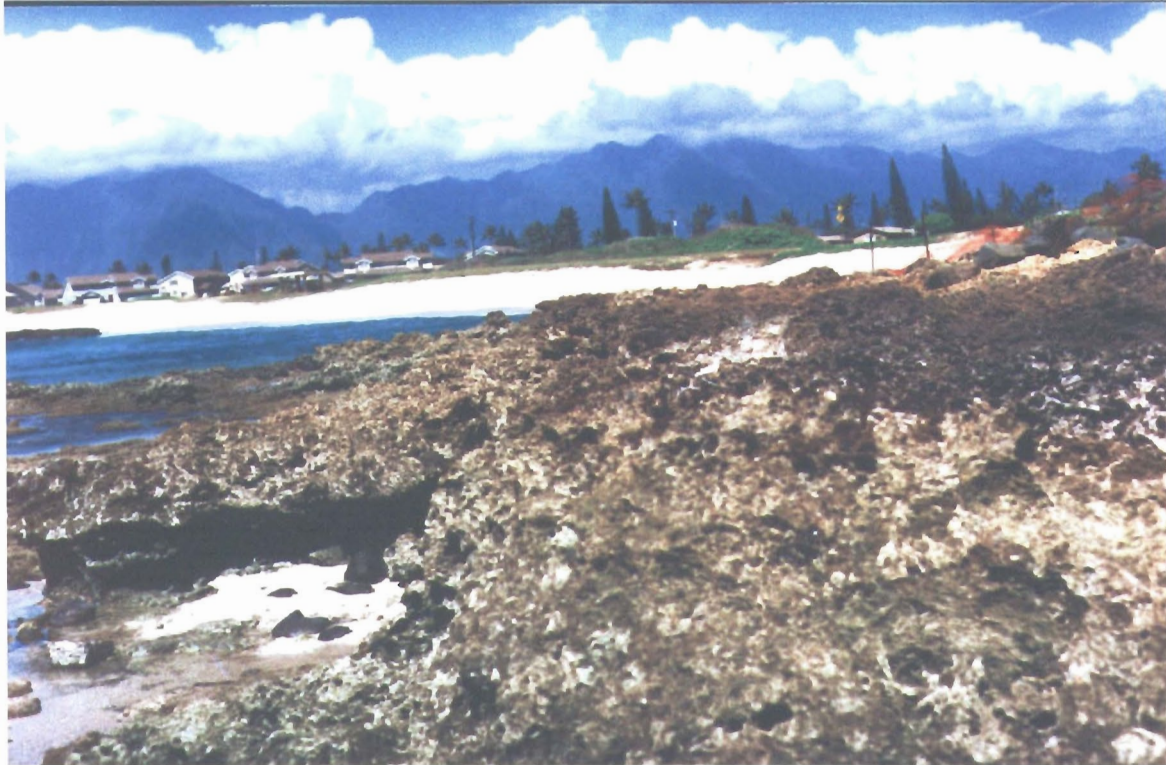
Photo 3. Fort Hase Beach Recreational Area. Exposed reef and rocky shoreline at northern limit of the beach park.

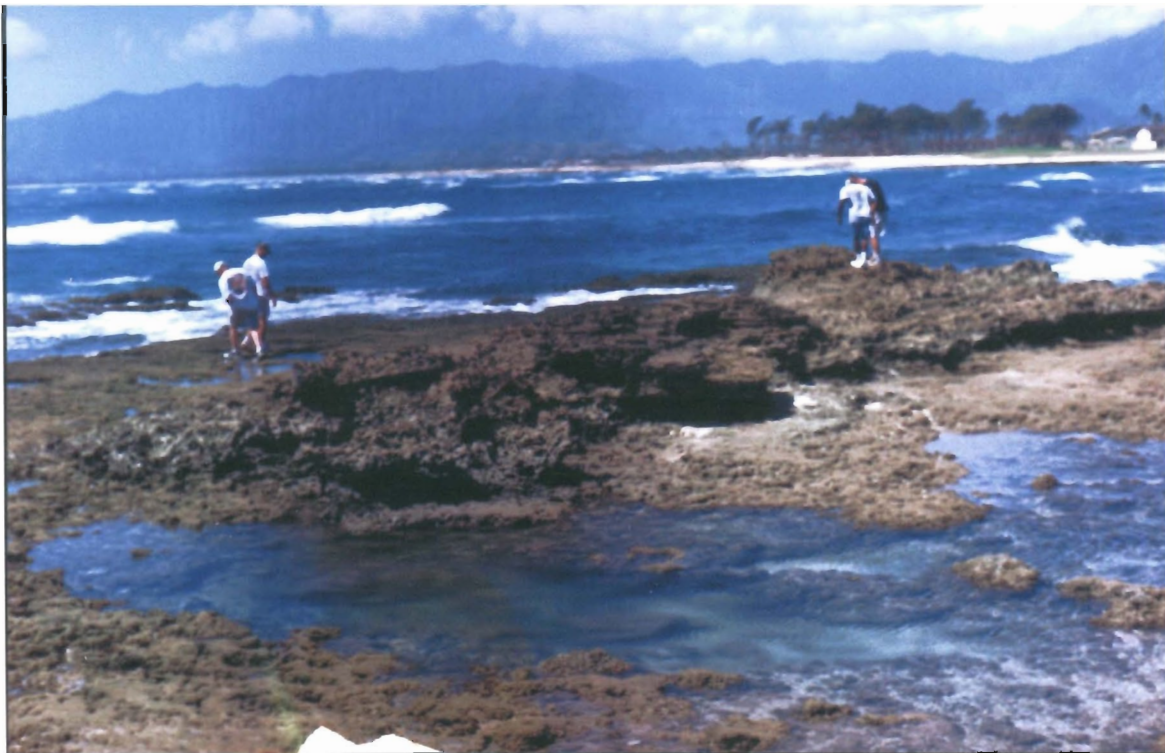
Photo 4. Fort Hase Beach Recreational Area. Tide pools just seaward of the picnic pavilion and exposed archaeological site. Note rocky substratum. Photo taken at moderately low tide.

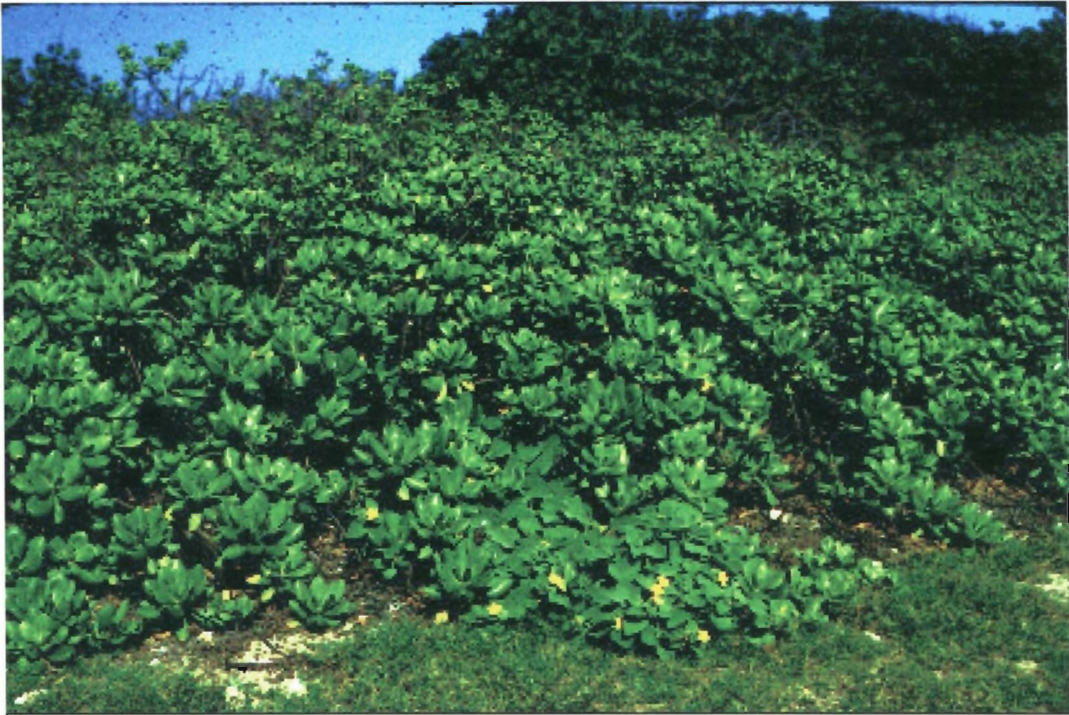
Photo 10. Pyramid Rock Recreational Subarea. Vigorous stand of beach Naupaka and akiaki grass in the foreground covering the back beach dune area.

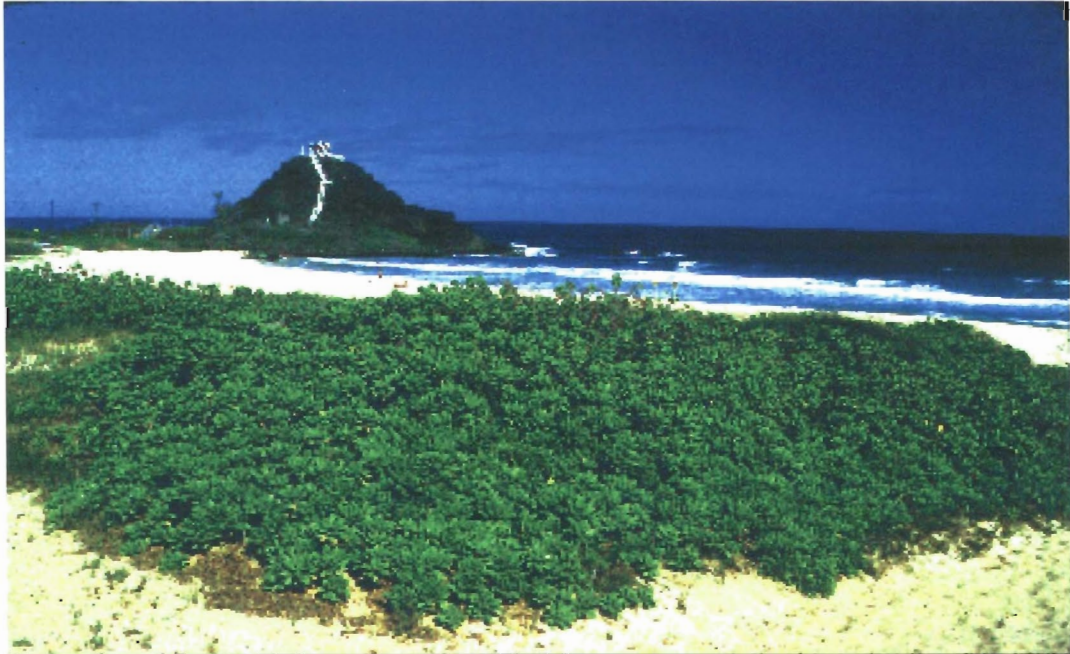
Photo 11. Pyramid Rock Recreational Subarea. Note sand beach between upper dune and shoreline. Substantial growth of beach Naupaka in the foreground. "Pyramid Rock" is shown in the distance.

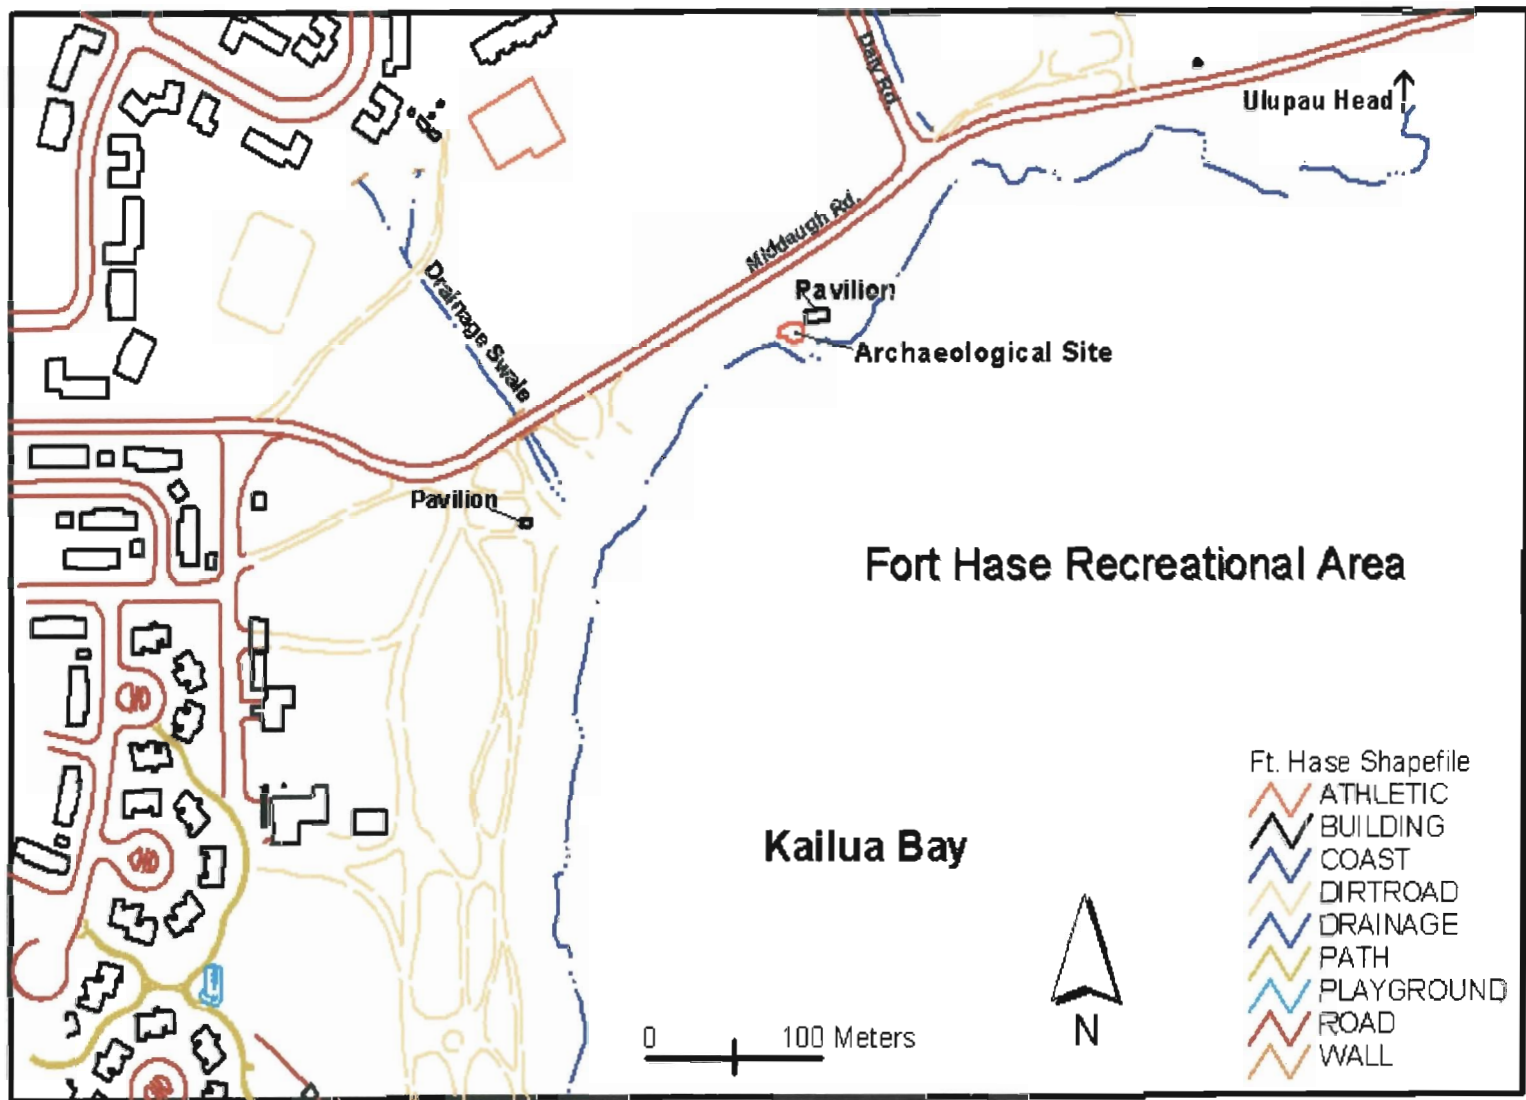
Archaeological remains have been identified and are currently being mapped at the northeastern corner of the Fort Hase Beach Park (Anderson, 2000) (Figure 2). These remains consist of shell, coral, and charcoal fragments in an approximately 1 meter high, shore side escarpment. This escarpment is just inland from a rocky coastline and is subject to erosion from high surf and is also just seaward of a public recreational picnic shelter, hence it receives considerable foot traffic from park users going to and from the shoreline. Pyramid Rock Beach recreational parking lots are located within the Archaeological Zone 1 area and the Fort Hase Beach parking lots are designated as a Historic Property.

Figure 2. Fort Hase Beach Recreational Area. Note drainage swale and proximity of archaeological site to picnic pavilion.
