Review

Analysis of Renovation Works in Cappuccinelli Social Housing District in Trapani

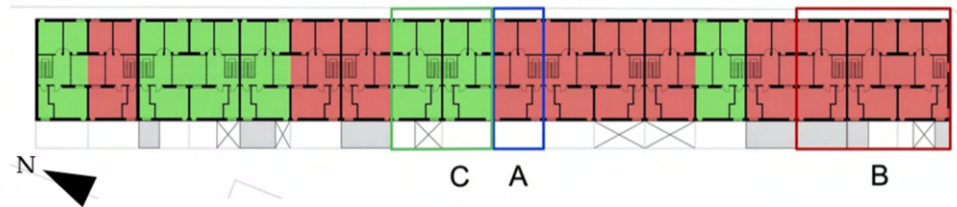
A public body (IACP) currently owns seven of the 18 dwellings in block “L” (Figure 4). The only apartment not altered from the project by Valori is owned by a private party and suffers from more severe degradation than the other apartments in the building. Both the geometric and material features of this dwelling have been analyzed.

Figure 4. Ground floor of “L” block. Dwellings still owned by IACP are shown in green and private dwellings are shown in red. The blue rectangle identifies the apartment where the project by Valori has not been altered. Source: Archive IACP Trapani.
