# Experimental procedure for studying the degradation and alteration of limestone slabs applied on exterior cladding

V. Pires<sup>1</sup> · P. M. Amaral<sup>2</sup> · J. A. R. Simão<sup>3</sup> · C. Galhano<sup>3</sup>

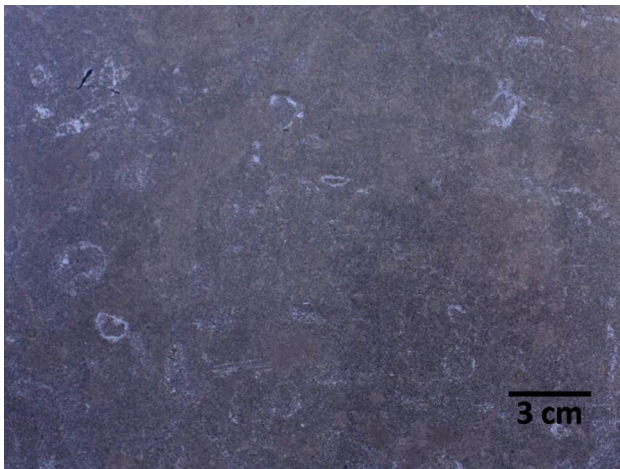
**Fig. 2** Macroscopic aspect of a sound sample of AV limestone

The most common finishing stages of external surfaces are honed and polished and, in this case, the rock color becomes grayish or grayish brown (Casal Moura 2009). The macroscopic appearance of the rock can be observed in Fig. 2.
