Traditional Structures in Turkey and Greece in 30 October 2020 Aegean Sea Earthquake: Field Observations and Empirical Fragility Assessment

Yasemin D Aktas^{1*}, Ioanna Ioannou¹, Fatma Sevil Malcioglu², Ahsana Parammal Vatteri¹, Maria Kontoe¹, Kokcan Donmez², Jacob Black³, Danaï Kazantzidou-Firtinidou⁴, Panagiotis Dermanis⁵ and Filiz Diri-Akyildiz^{1,6}

Aktas YD, Ioannou I, Malcioglu FS, Vatteri AP, Kontoe M, Donmez K, Black J, Kazantzidou-Firtinidou D, Dermanis P and Diri-Akyildiz F (2022) Traditional Structures in Turkey and Greece in 30 October 2020 Aegean Sea Earthquake: Field Observations and Empirical Fragility Assessment. *Front. Built Environ.* 8:840159. doi: 10.3389/fbuil.2022.840159

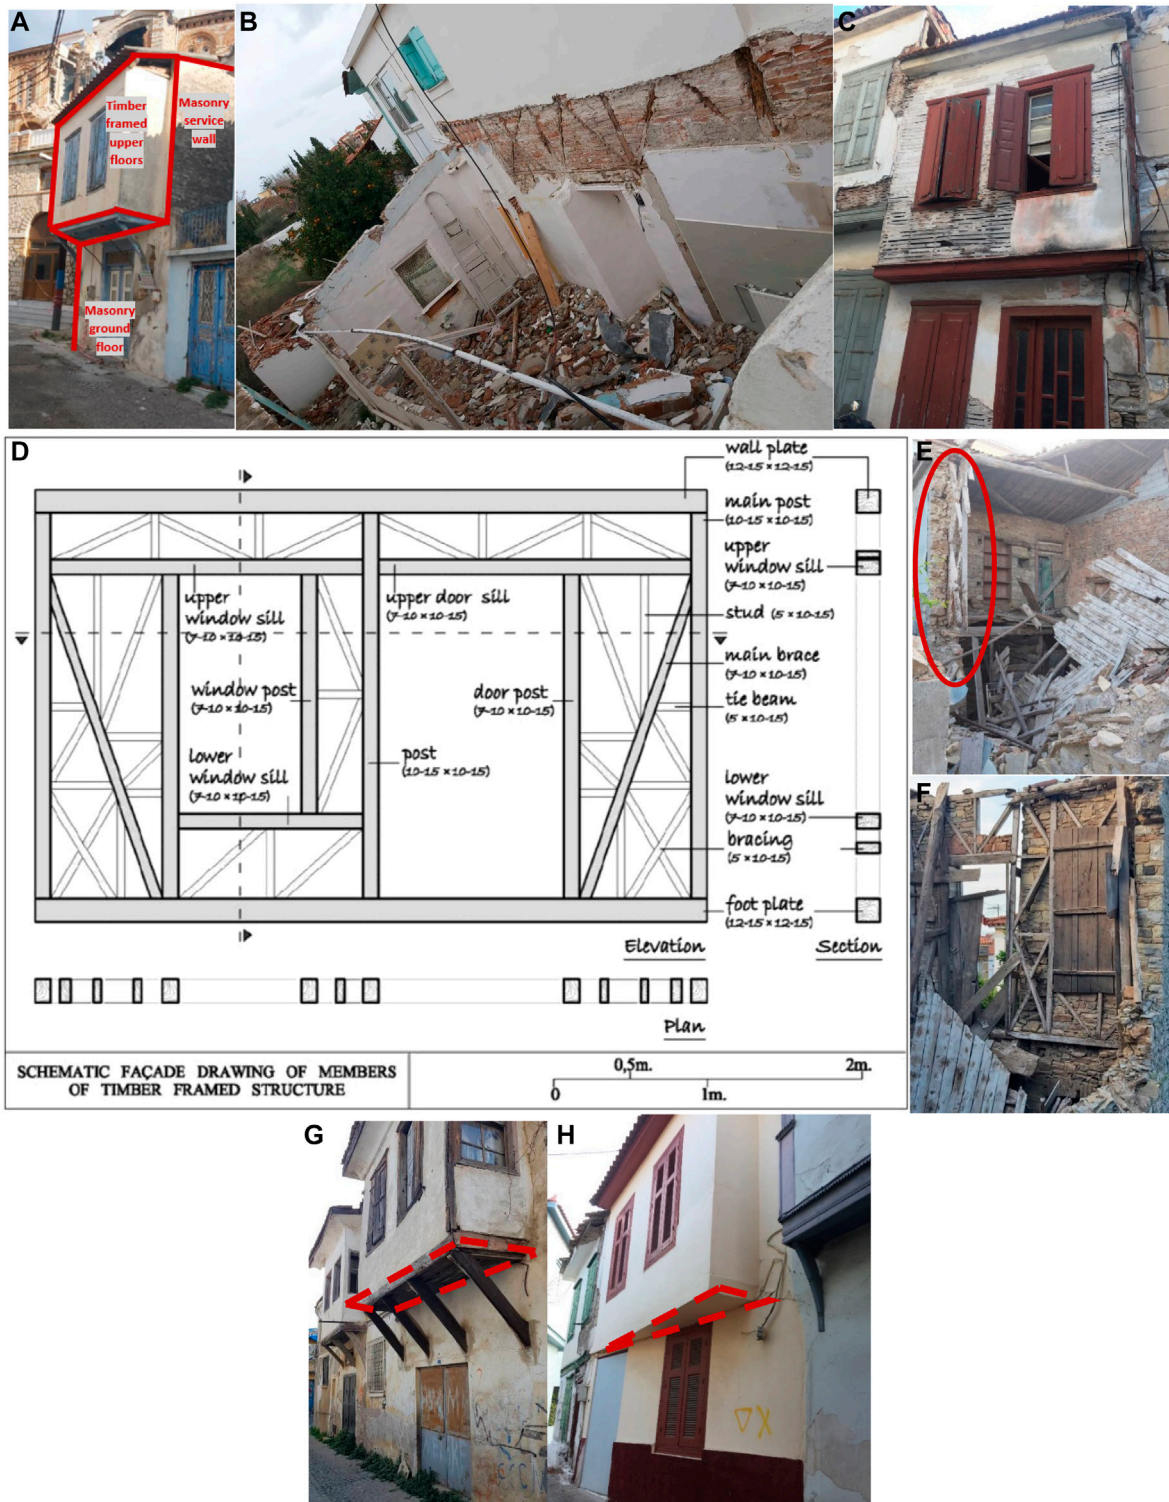
The timber-masonry structures are characterised by hybrid or “dual” construction system, composed of a masonry ground floor and timber frame upper floors (**Figure 1A**), with infill or cladding (**Figure 1B,C**, respectively). In certain cases, a masonry service wall with the chimney may carry on in the upper floors. The overall construction characteristics and structural principles of this hybrid typology which is common in Turkey, Greece and the Balkans, definitely since early 16th century if not earlier, are pretty well established, with however very rich variations in detailing, material selection and implementation from region to region (see Sahin-Guchan, 2018 for a systematic review of typologies based in Turkey; see (Dutu et al., 2018) for the Romanian examples (Papaioannou, 1961); specifically for Samos). They are often 2-3 storey buildings, where the construction materials and details of both the masonry ground floor and the braced timber frame upper floors can be extremely diverse: brick, stone, brick + stone or adobe masonry with or without tie-beams and/or timber posts at the ground floor are coupled with timber frames with brick, stone, brick + stone, adobe or timber infill or cladding. In the infilled typologies, the masonry infill is confined in small compartments created within the timber framing through diagonals and secondary members, to minimise the shear failure and maximise energy dissipation (**Figure 1D**; Aktas et al., 2014). Timber frames are occasionally accompanied by an additional external layer of masonry (**Figure 1E,F**). In the cladded typologies, mostly 3–4 cm wide laths are nailed onto the inner and outer surfaces of the timber frame, creating a very lightweight structure with a good diaphragm action. The connections are almost exclusively made of nails, which improve energy dissipation under seismic loading for enhanced ductility—the carpentry joints are existent, but are rare and simple. Metal connectors between masonry and timber floors are a regional variation intrinsic to Lefkas (Vintzileou et al., 2007). Jetties (projections) are an optional but dominant feature of these houses, which can be built simply in the form of a cantilever or can be braced (Aktas, 2017). These are often used to have a better street view (**Figure 1G**) and occasionally also to “correct” the irregular ground floor plan (**Figure 1H**).

FIGURE 1 | (A) General construction features of hybrid timber-masonry structures (in Samos, Greece) with examples to **(B)** infilled and **(C)** cladded typologies (in Samos, Greece); **(D)** The schematic showing the general timber frame organization based on a Western Anatolian case, Turkey (Diri, 2010) **(E,F)** Examples of timber framed walls with an additional external layer of masonry (in Samos, Greece); **(G)** a regular braced jetty (in Seferihisar, Turkey); **(H)** an irregular cantilever jetty (in Samos, Greece).

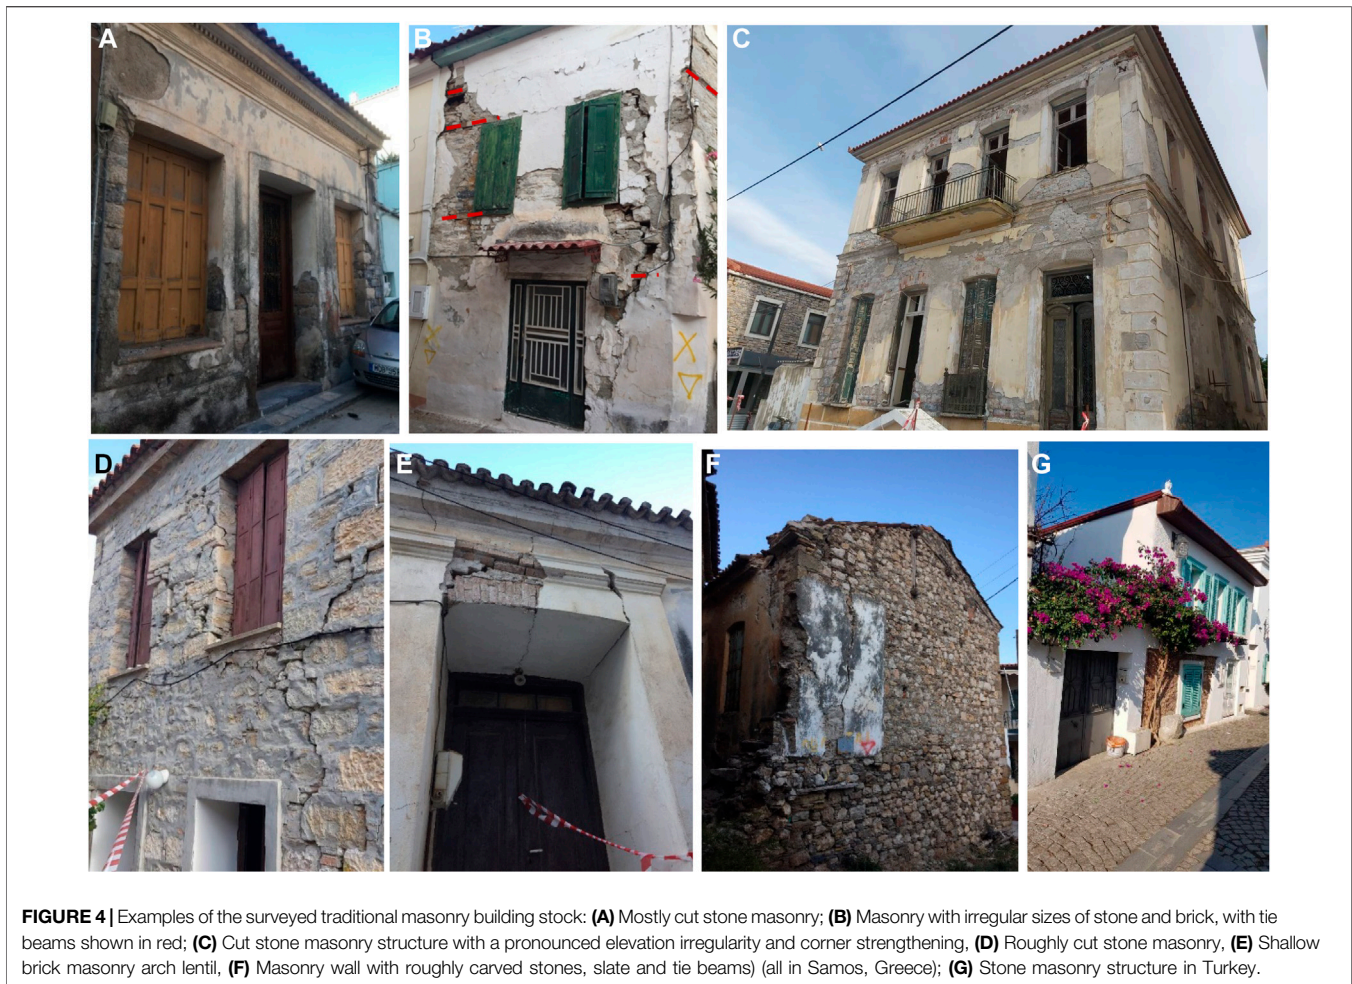
FIGURE 4 | Examples of the surveyed traditional masonry building stock: **(A)** Mostly cut stone masonry; **(B)** Masonry with irregular sizes of stone and brick, with tie beams shown in red; **(C)** Cut stone masonry structure with a pronounced elevation irregularity and corner strengthening, **(D)** Roughly cut stone masonry, **(E)** Shallow brick masonry arch lintel, **(F)** Masonry wall with roughly carved stones, slate and tie beams (all in Samos, Greece); **(G)** Stone masonry structure in Turkey.

morphological features, and have a timber roof structure (**Figure 4**). Most commonly, these are made of roughly cut large stones and lime mortar, with thin slates or smaller pieces of stone, occasionally round pebbles, also inserted to fill in the gaps. There are cases where mud-mortar is observed, or the apparent multi-leaf masonry walls evident after the failure. Tie-beams are commonly used to strengthen the masonry. Additionally, the use of bricks in the lintels is quite common (**Figure 4E**). Traditional masonry structures in Turkey are almost exclusively plastered from outside, making it difficult to read the details of the construction system (**Figure 4G**). Around 17% of them is single storey and 70% is two storey. The most common irregularity we observe in >1 storey examples of these structures was the variation of floor heights, with the ground floor being higher. Change in stiffness due to structures attached to the main building is also common.

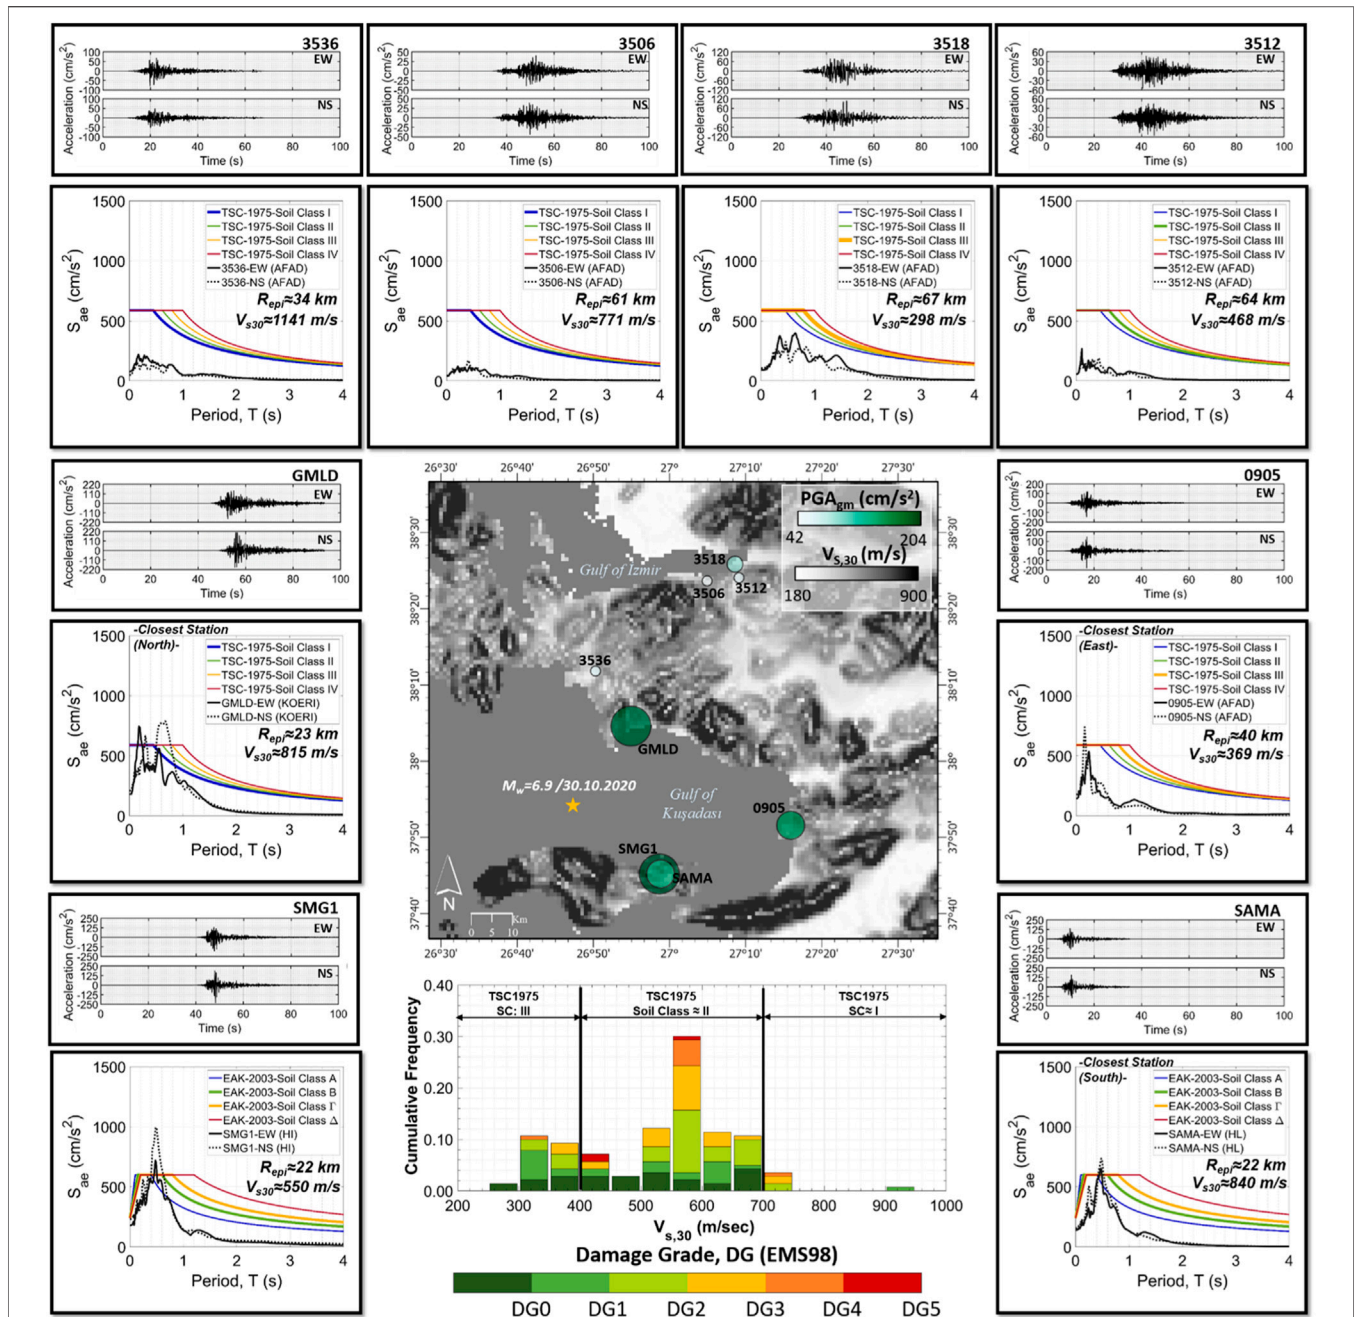
FIGURE 8 | The map of USGS topography based V_{s30} values together with the geometrical mean of recorded PGAs of several stations that are close to the examined buildings in the database, their strong ground motion time histories of horizontal components and their response spectra (5% of damping ratio) compared to design spectra (EAK2003 for Greece and Turkish seismic provision, 1975 for Turkey). The histogram shows the distribution of V_{s30} values of the inspected buildings with respect to their damage grades. (PGA_{gm} = Geometrical mean of peak ground acceleration; V_{s30} = average shear wave velocities for the upper 30 m depth; R_{epi} = Epicentral distance).

The geometrical mean of recorded PGAs designated on the map reveals that the closest station, SMG1, have been produced the highest PGA ($PGA_{SMG1} \approx 204 \text{ cm/s}^2$). The PGA recorded in

station SAMA, which is roughly at the same epicentral distance as SMG1, is lower than the PGA of the latter. This lower PGA in SAMA may be associated with the fact that SAMA has been deployed on the stiffer soil ($V_{s30,SAMA} \approx 840 \text{ m/s}$). Moreover, there exist several buildings, whose damage grades are higher than DG2, around SMG1 while the damage grade of all

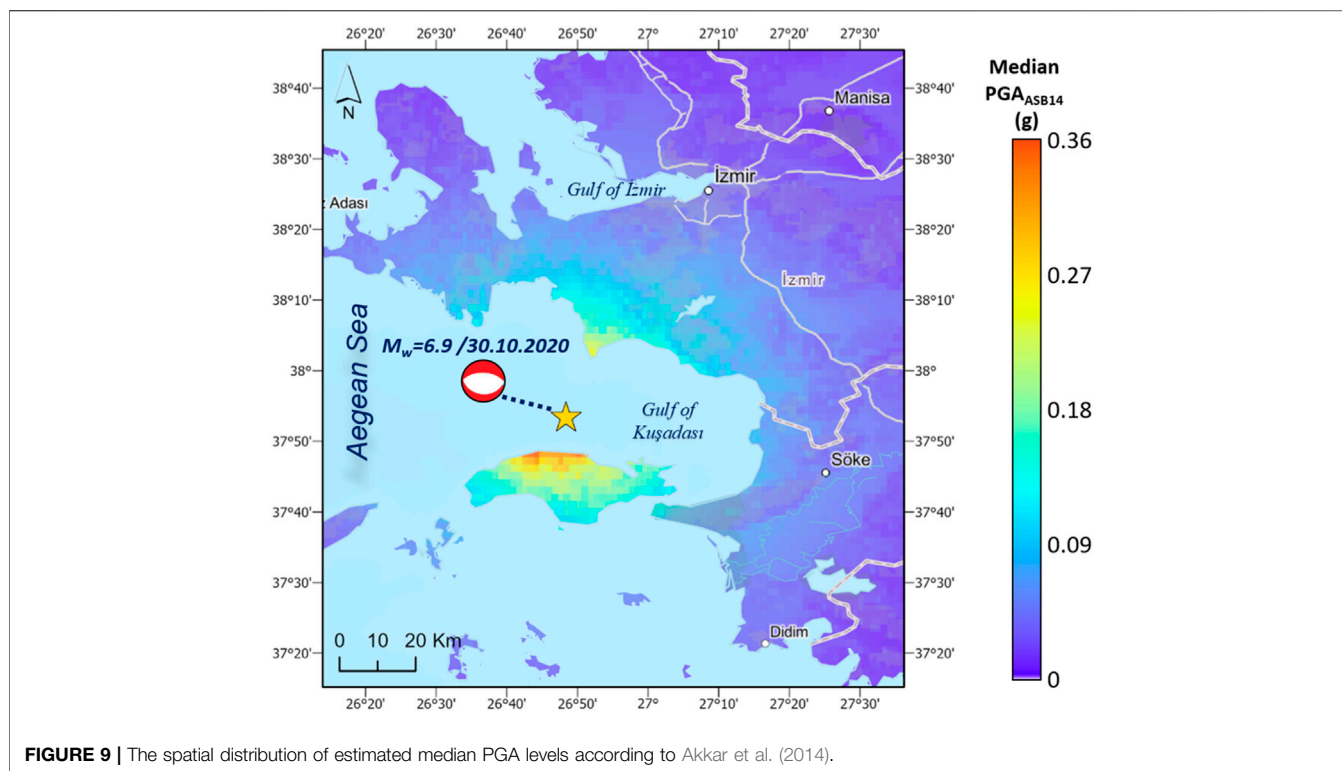
FIGURE 9 | The spatial distribution of estimated median PGA levels according to Akkar et al. (2014).

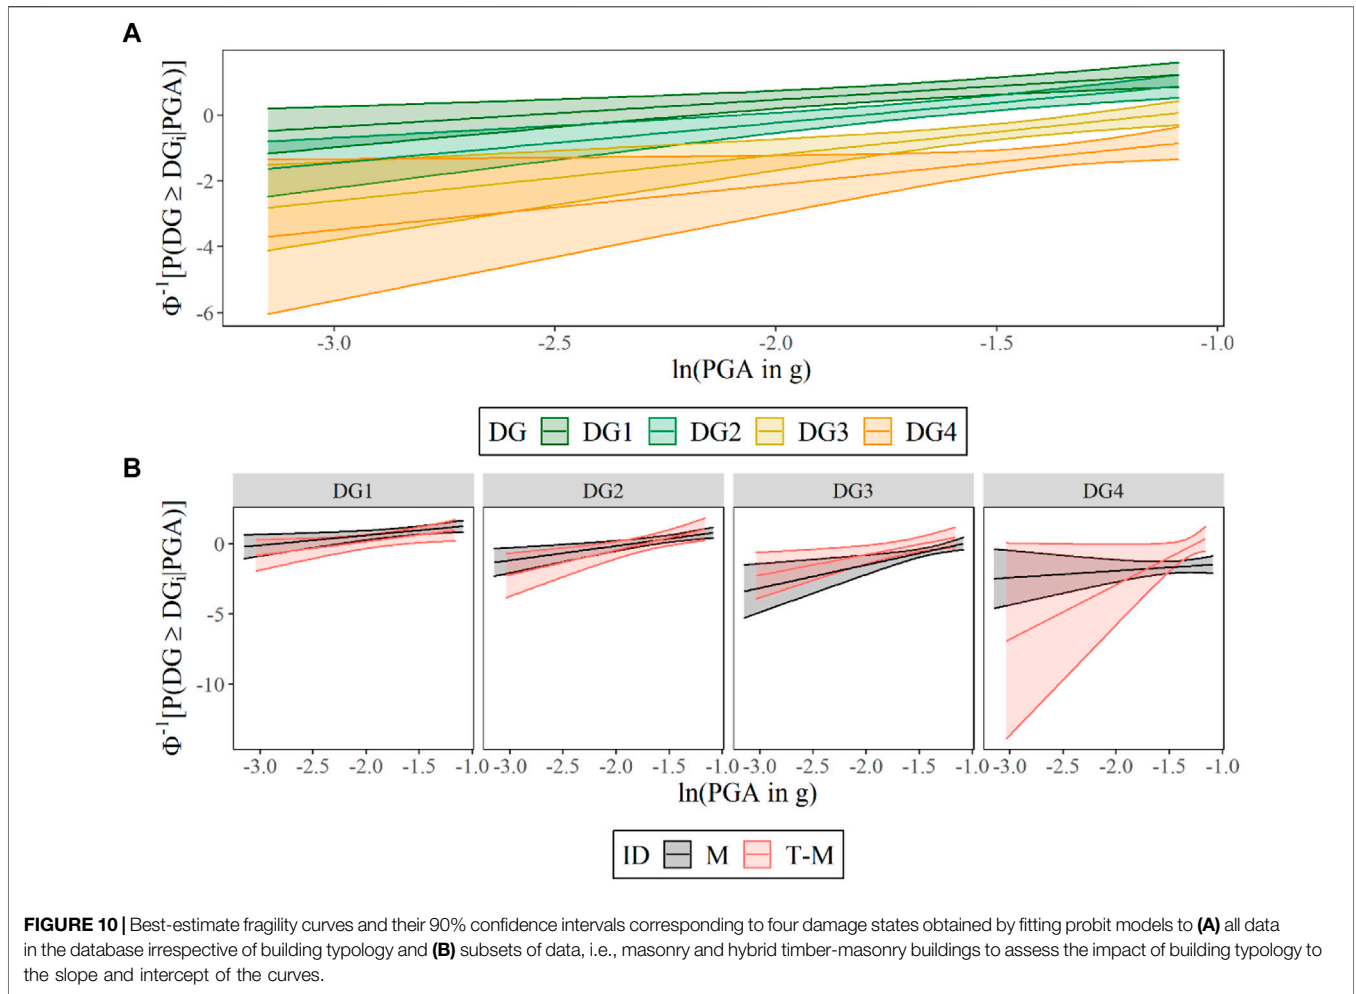
The framework presented in Section 3 is adopted here in order to empirically construct the fragility curves for the traditional buildings. As part of the exploratory analysis, a GLM probit model is fitted to the data and the results are depicted in Figure 10. By comparing the best-estimate fragility curves, it can be noted that the likelihood of damage increases with the increase in the PGA level for all damage states. Apart from the intercept, the slope also appears to vary for the various damage

states, indicating the need to take this into account to the final model. With regard to the uncertainty expressed in terms of the 90% confidence intervals around the best-estimate fragility curves, the uncertainty appears to be reasonably well-constrained around each damage state with the exception of DG4. The partial overlapping of the confidence intervals can be mainly attributed to the small sample size and part of it could be attributed to the uncertain seismic behavior of vulnerable masonry buildings which are the majority of the buildings in the database. For this damage state, the uncertainty is notable and can be attributed to the very few buildings which sustained heavy damage or were destroyed.

A probit model is also fitted to subsets of data in order to construct curves for masonry and hybrid timber-masonry buildings. In **Figure 10B**, it can be noted that the fragility curves for the latter building class have very large confidence intervals which include substantially the ones for masonry buildings for all four damage states. The rather wide intervals can be attributed to the very small sample size for the hybrid buildings, and for this reason, there is not enough information to draw meaningful conclusions on whether the hybrid timber-masonry buildings behaved better than their masonry counterparts. For this reason, the final statistical model considers only the masonry buildings.

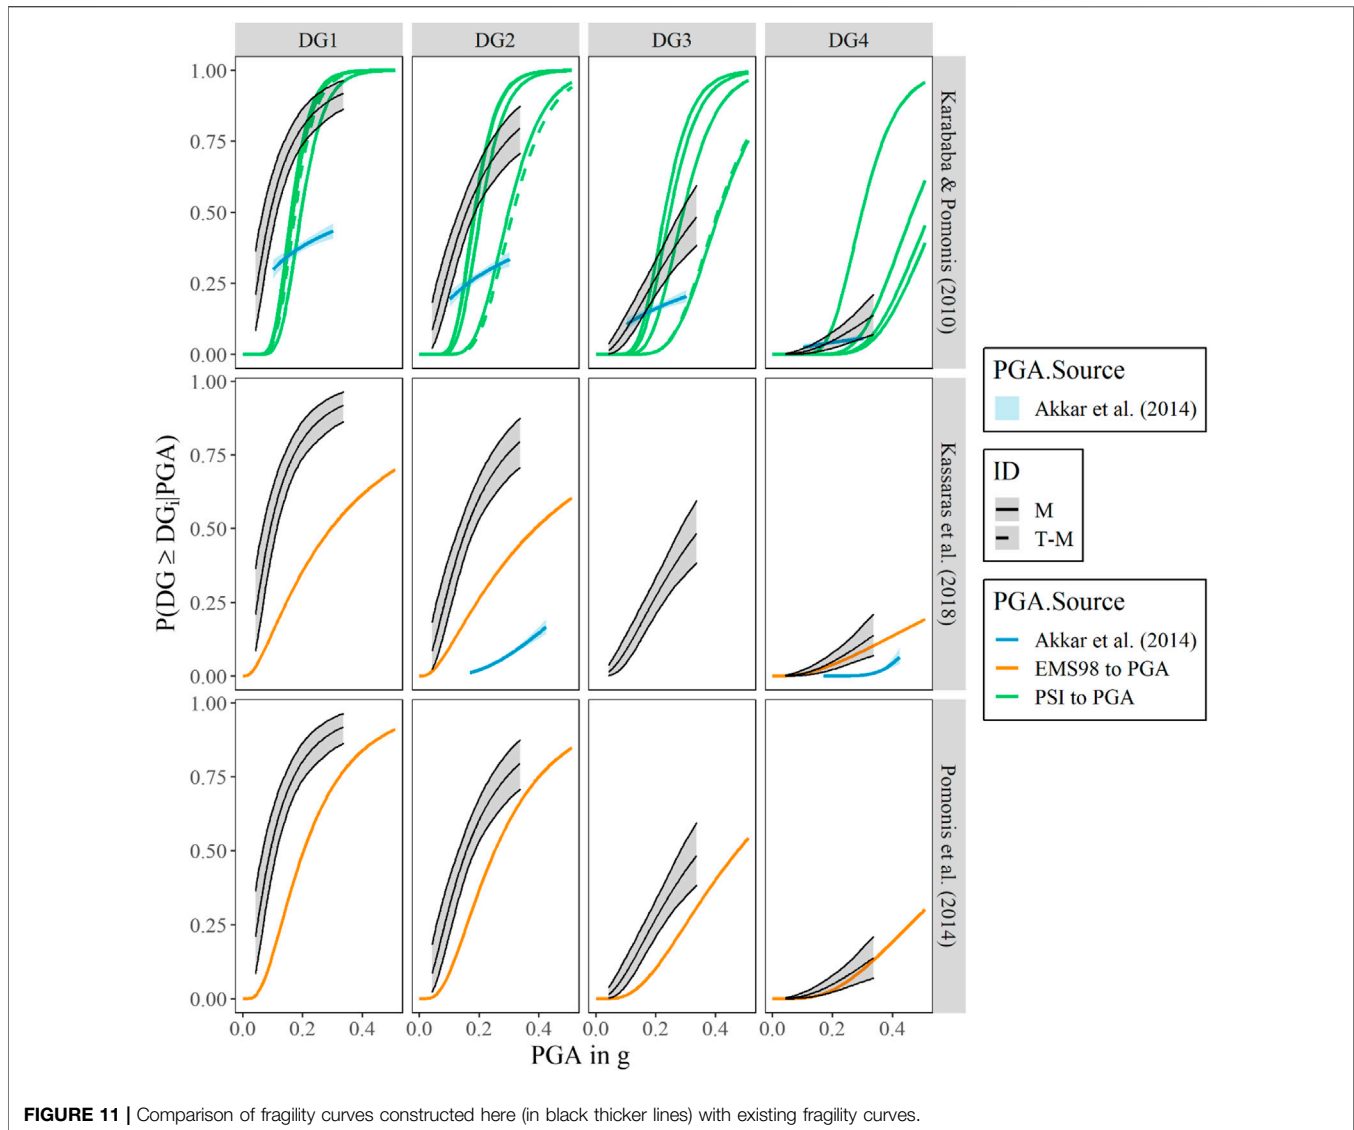
measures. Thus, to make them comparable with the curves produced in this study, their macroseismic intensity was transformed to PGA using appropriate equations found in the literature (Spence et al., 1991; Tselentis and Danciu, 2008). The fragility curves in terms of PGA are plotted in **Figure 11**. The comparison of the curves based exclusively from data from the 2003 Lefkada event (Karababa and Pomonis, 2011), shows that the curves for the hybrid timber-masonry buildings behave approximately the same as good quality masonry buildings and this further reinforces the approach adopted in this study which constructed fragility curves for traditional building and did not exclude the hybrid timber-masonry ones. It can also be noted that the curves based on the 2020 Aegean reconnaissance mission data compare well with these curves. Furthermore, the masonry buildings based on (Karababa and Pomonis, 2011) appear, in **Figure 11**, to be more vulnerable than the masonry buildings based on data from the 2003 as well as the 2015 Lefkada earthquakes (Kassaras et al., 2020). This is in line with findings by Kassaras et al. (2020) and can be attributed to the large number of retrofitted masonry buildings in the aftermath of the 2003 event. Interestingly, the curves (Pomonis et al., 2014) constructed for three Greek events (i.e., dominated by the data from the 2003 Lefkada event) also appear to be flatter and shifted to the right than the curves developed by Karababa and Pomonis

FIGURE 11 | Comparison of fragility curves constructed here (in black thicker lines) with existing fragility curves.

(2011) (as well as the curves constructed in this study). The significance of this difference is difficult to assess without the presence of confidence intervals. It could be attributed to the sensitivity of the results to the transformation from one ground motion intensity measure to another, which is associated with considerable uncertainty. The differences in the shape of the fragility curves raises questions regarding the reliability of the transformed curves in terms of PGA.
