Hybrid Reconnaissance Mission to the 30 October 2020 Aegean Sea Earthquake and Tsunami (Izmir, Turkey & Samos, Greece): Description of Data Collection Methods and Damage

On 30 October 2020, an earthquake of M_w 6.9 hit the Aegean coasts of Turkey and Greece. The epicentre was some 14 km northeast of Avlaxia on Samos Island, and 25 km southwest of Seferihisar, Turkey, triggering also a tsunami. The event has been followed by >4,000 aftershocks up to M_w 5.2 The Earthquake Engineering Field Investigation Team (EEFIT) has immediately gathered a team to conduct a hybrid reconnaissance study, bringing together remote and field investigation techniques. The mission took place between 16 November and 17 December, inclusive of three sets of field study carried out by the field crews for building damage assessment in the affected areas in Turkey and Greece under the coordination of the remote team. The mission also aimed to assess the viability of alternative data sources for an appraisal of the future viability of hybrid missions. This paper summarises the mission setup and findings, and discusses the benefits of and difficulties encountered during this hybrid reconnaissance activity.

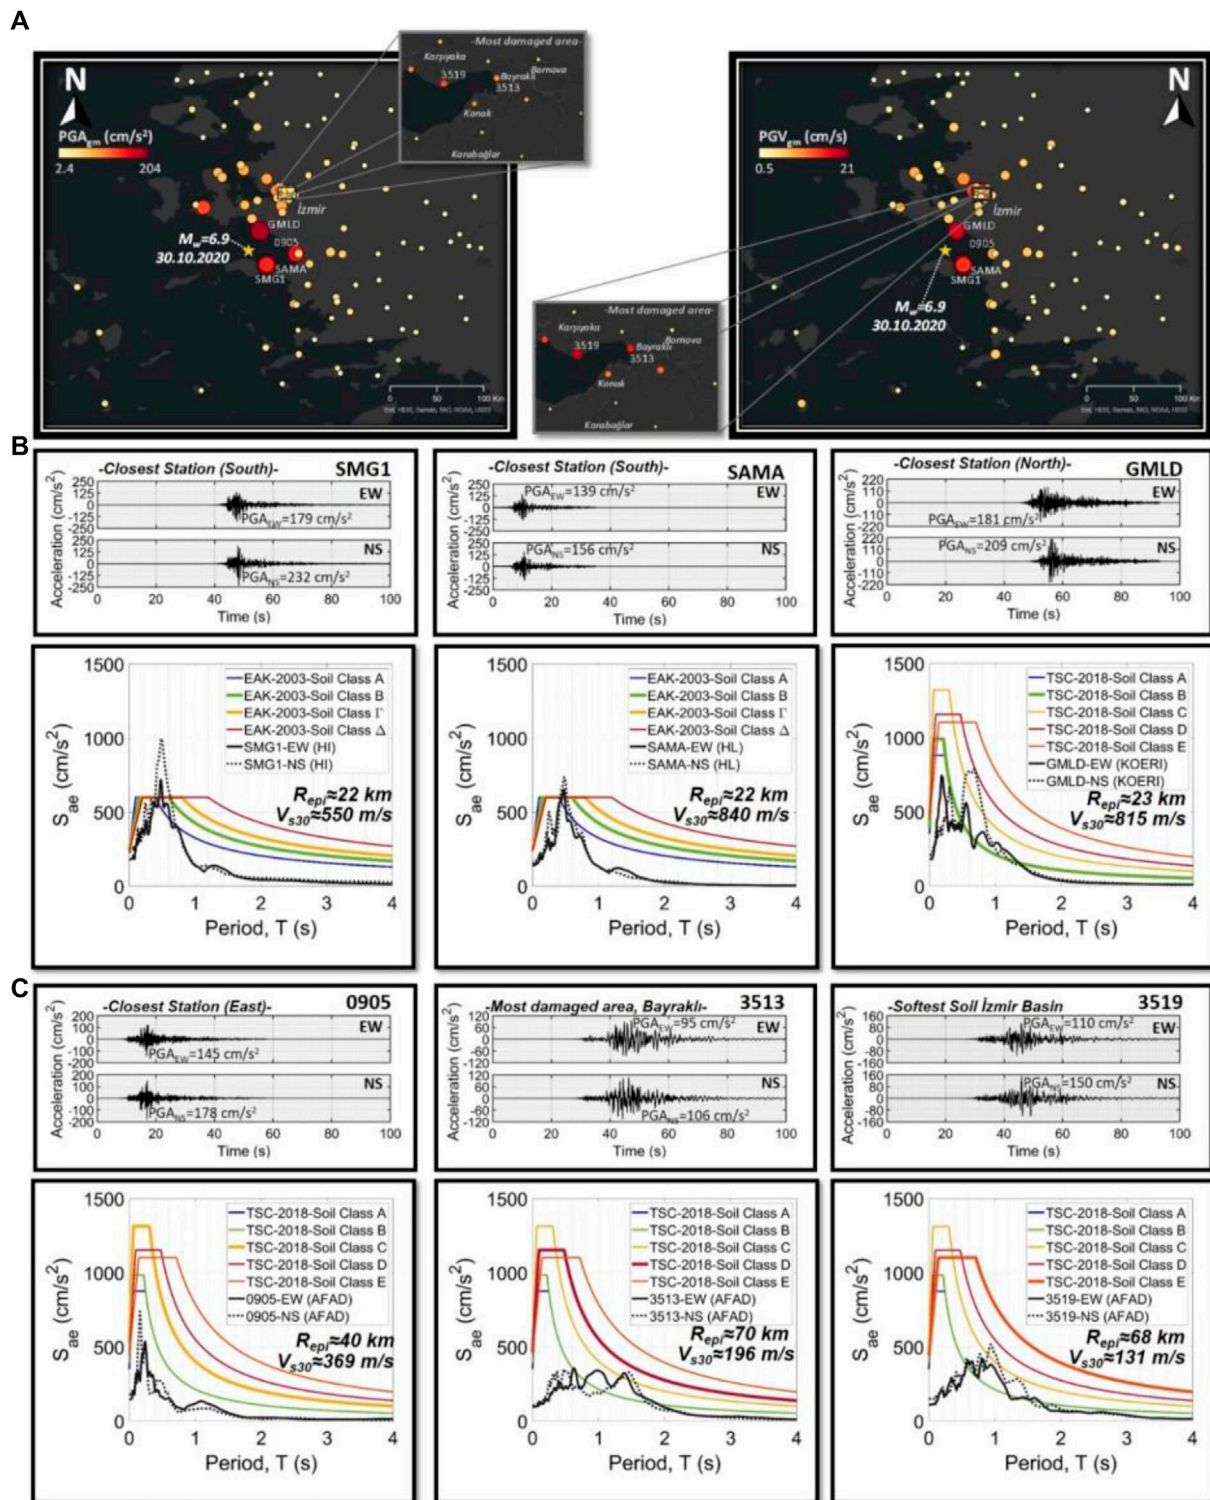
FIGURE 7 | (A) Spatial distribution of the observed PGAs and PGVs with a focus view on the significantly damaged region: Bayrakli, **(B)** Acceleration-time histories and response spectra of two horizontal components belonging to closest stations on South (SMG1 and SAMA) and North (GMLD) of the epicentre, **(C)** those belonging to the closest station on East (0905) and two stations in Bayrakli (3513 and 3519).

The top panel of **Figure 7** illustrates the spatial distribution of peak ground accelerations (PGA) and peak ground velocities (PGV). As expected, the highest peak ground acceleration (PGA) has been measured in NS component of one (SMG1) of two stations in the east of Samos Island, which are the closest territory to the earthquake epicentre, at about 0.24 g (232 cm/s²). This value is slightly smaller than the expected PGA value of the Greece zonation map (2003) for a 475- year return period. In Turkish territories, while a station in Gümüldür produced a maximum PGA (≈ 0.21 g), the softest soil station in İzmir Basin-

the most damaged area—recorded 0.15 g, which is below the expected PGAs of the recent Turkish earthquake hazard map (TSHM, 2018) for the design basis earthquake. However, PGVs of soft soil stations (3513 and 3519) in the İzmir Basin is about as high as those of the nearest stations.

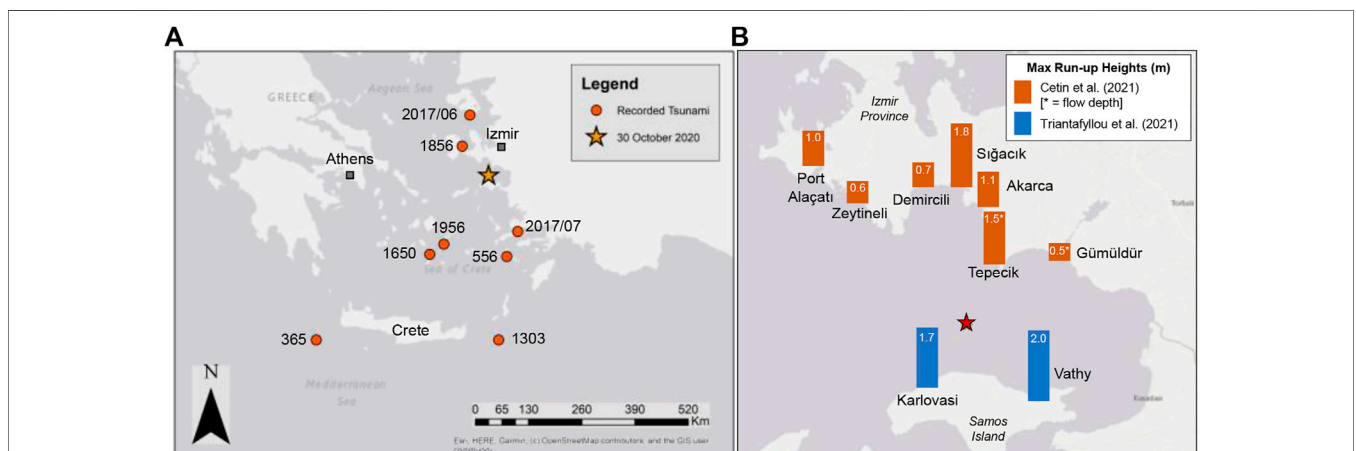
FIGURE 16 | (A) Recorded major tsunami events in the Aegean Sea (B) Measurements of maximum tsunami run-up heights in m for the most-affected locations by the tsunami along the coast of Izmir Province and Samos Island, according to Cetin et al. (2021) and Triantafyllou et al. (2021).

The 30 October 2020 Aegean earthquake was accompanied by a tsunami, which is not an uncommon phenomenon in the region (**Figure 16A**). The tsunami waves reached up to 2.0 m in this particular event (**Figure 16B**). Therefore, the EEFIT mission also systematically investigated the tsunamic impact on buildings and infrastructure, through a set of questions embedded in the data acquisition system specifically to reflect typical damage mechanisms due to tsunami hydrodynamic effects on buildings. These being: the number and types of openings, particularly at ground floor level; the presence of a basement; assessment of surroundings, including perimeter walls and presence of debris; details of foundation type and damage (if that is visible); and evidence of water marks on the building. Some of these attributes were included in the damage assessment form developed in the 2018 EEFIT mission in Palu (Rossetto et al., 2019), which has been adopted for the damage assessment carried out in this mission. By the time our field crews visited site however, it was already 1 month after the event, and all debris was cleared and no substantial structural and non-structural damage was found despite significant inundation in some localities. In certain cases, water marks were visible on buildings (**Figure 17**).
