Importance of periodic CPCP revisions in the evaluation and improvement of the program

NetJets Europe: a perspective from a business jet operator

Dissertação para obtenção do Grau de Mestre em
Engenharia Aeronáutica
(ciclo de estudos integrado)

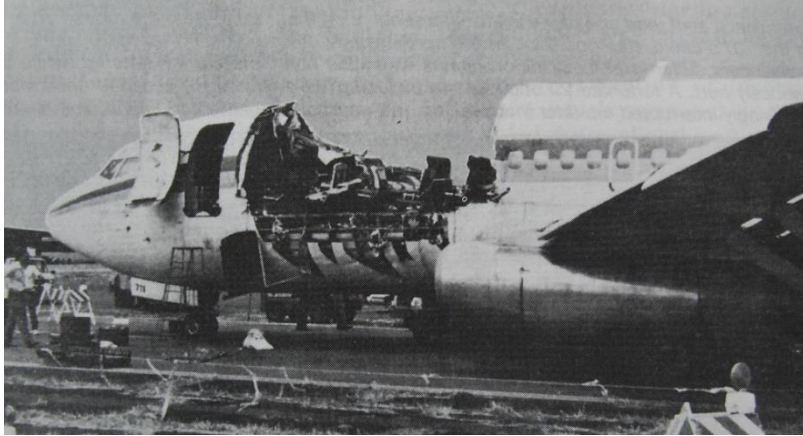
Figure 3.2: Aloha Airlines Boeing 737-297 without a portion of the fuselage structure [17].

On 28 April 1988, the Boeing 737-297 from Aloha Airlines, flight 243, departed from Hilo Int'l Airport, Hawaii, USA, en route to Honolulu Int'l Airport, Hawaii, US, when a segment on the left side of the upper fuselage (roof), ruptured from the front of the aircraft (Figure 3.2), forcing an emergency landing on Kahului Airport, Hawaii, US [17].

This event “initiated with the structural separation of the pressurized fuselage skin. As a result of this separation, an explosive decompression occurred, and a large portion of the airplane cabin structure comprising the upper portion of section 43 was lost” [17].

The investigation showed some factors of concern in the Aloha Airlines aircraft maintenance program [17, 18]:

- High accumulation of flight cycles between structural inspections;
- Extended intervals between inspections, allowing the effects of lap joint disbond, corrosion, and fatigue to accumulate;

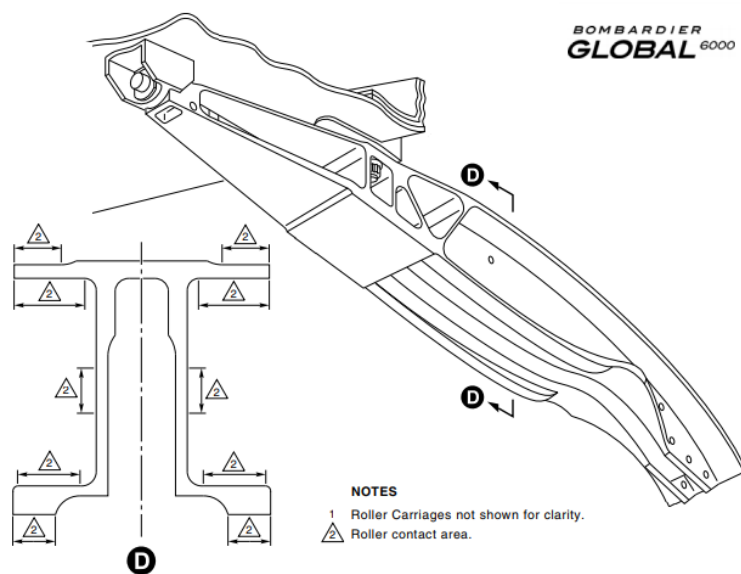
Figure 4.7: Flap track areas of contact with the rollers [55].

This mechanical abrasion causes the nickel plate protection to wear out, and thus starts flaking (Figure 4.6-A). Without the nickel plate, the areas of bare metal (Figure 4.6-B), corresponding to the areas of contact of the track with the rollers (Figure 4.7), are exposed to any corrosive agent present in the environment, which in turn will lead to corrosion of the track surface.

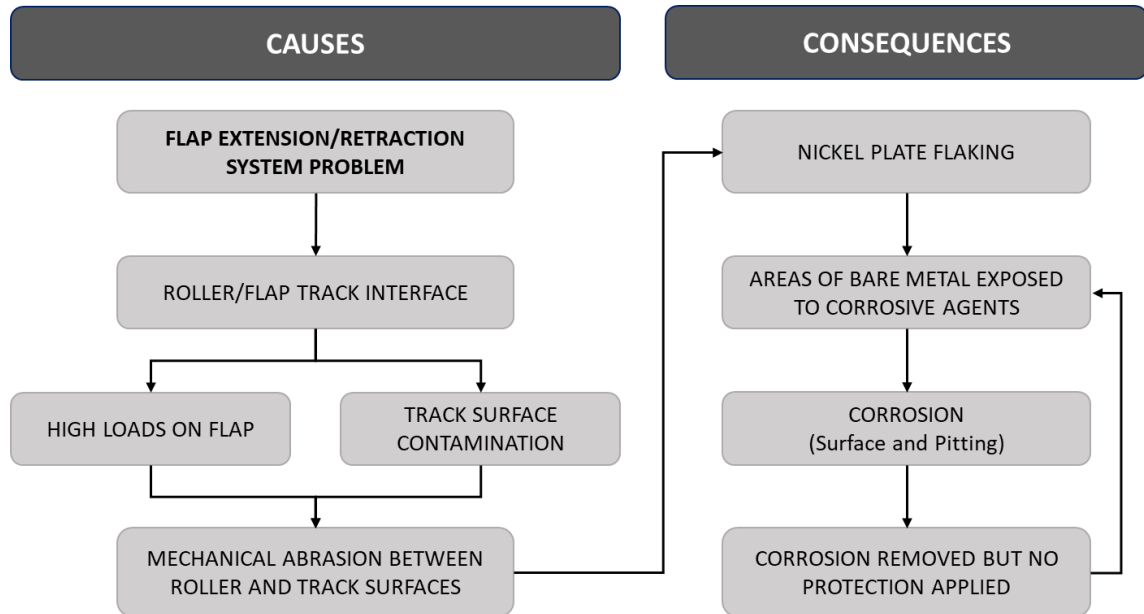
Figure 4.10: Flap track corrosion problem diagram.

By OEM recommendation, no type of protection or product can be applied to the affected areas (contact areas of track surface with the rollers), since there are no studies available about the

effect of these products in the normal movement of the flaps. Thus, these areas are left unprotected, and the bare metal is exposed again to the environment, as the aircraft return to service. In time, this state will lead to corrosion reappearance in the flap tracks (Figure 4.10). Another limitation imposed by the OEM is that, the reapplication of nickel plate to the track surface cannot be performed by any company or institution other than the OEM, since, if not performed following right standards, it can lead to the appearance of nickel plate flakes in the rollers, disabling the normal movement of the flaps.

From the aircraft manufacturer, it is known that this problem does not only affect the Global 6000 aircraft, but the entire Global family. Also, until the moment, no flap track was replaced due to track material thickness removal exceeded the limits for a serviceable component.

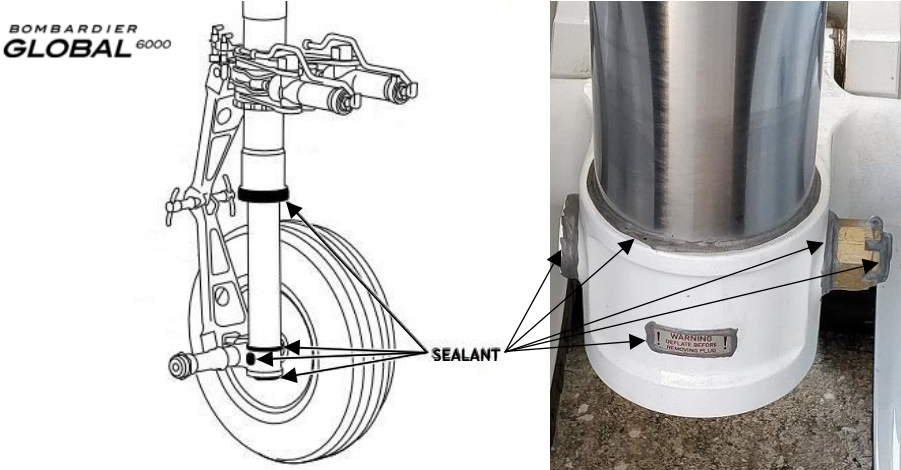
Investigating maintenance reports, related to the MPD task “General Visual Inspection of the Nose Landing Gear” achieved every 450 landings, in which an inspection of the seals condition in the nose landing gear is performed, it was possible to find that in two of these inspections (Table 4.6), the sealants in the surroundings of the axle/sliding tube were found either damaged or missing.

The absence of the sealant could have allowed corrosive agents, such as water from rain or washes, or runway de-icing products, to enter through the spaces of damaged or missing sealant.

Figure 4.17: Location of the nose landing gear sealants (adapted) [54].

The presented proposal for this problem focuses on the inspection of the nose landing gear sealants. In addition to the existent MPD task “General Visual Inspection of the Nose Landing Gear”, where the sealants are currently inspected every 450 landings, it was proposed the introduction of the procedure “Inspection of the general condition of the sealant for signs of peeling or cracks” (Figure 4.17) to the MPD task “Lubrication of the Nose Landing Gear (NLG) and Components”, performed every 250 flight hours. This addition allows better control and monitoring of the sealants condition, important to prevent the entry of corrosive agents in the affected areas. This proposal, like the one presented for the flap tracks, could also signify a total or partial coverage of the inspection costs by the operator, but with less cost and downtime impact, since this proposal only involves a general visual inspection of the sealants.

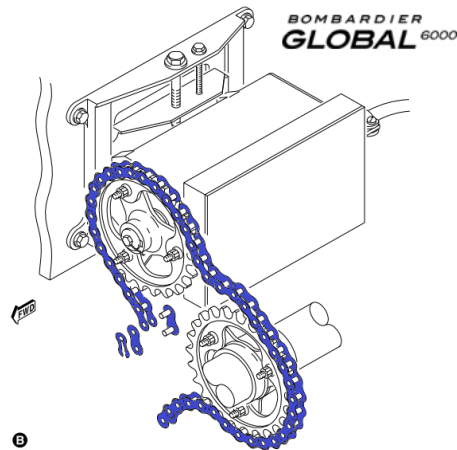
The corrosion problem was found in the chain (Figure 4.20) that connects two sprockets, one attached to the actuator and the other attached to a rod. The movement of the chain, generated by the electrical actuator, between the two sprockets, allows the door to open or close.

Figure 4.20: Passenger door actuator chain (in blue) (adapted) [56].

According to OEM documentation, the chain is supplied with a coating of heavy petroleum grease, adequate for slow and light load applications, such as this one. However, due to a high frequency of use of NetJets Europe aircraft, the multiple times that the door is opened and closed may be affecting the condition of the coating, allowing corrosion to develop.

Corrosion on the actuator chain was found at the 60-month inspection. There are no maintenance tasks involved, such as cleaning or re-protection of the component, since in both cases (aircraft #1 and aircraft #2) the chain had to be replaced.

To solve this problem, the chain should be re-protected from time to time, allowing the service life of the component to be extended. When contacting the OEM about this situation, it was recommended the lubrication of the chain, with an SAE 30 (Oil Viscosity VG100) lubricant, applied with an aerosol.

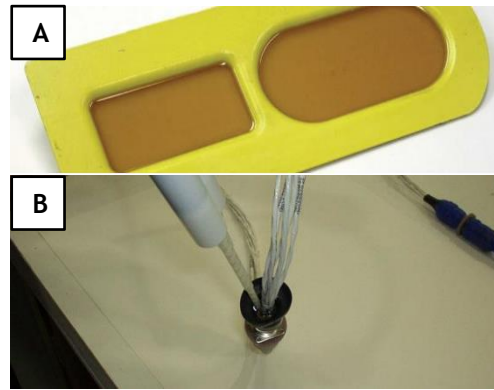
Figure 4.26: Recommended protective coating (A - TS1228 coating; B - application method) (adapted) [39].

In order to find an appropriate and improved protective coating, the case was presented to Av-DEC, a specialized company in aircraft corrosion prevention. After reviewing the case, Av-DEC recommended the application of an improved protective coating (Figure 4.26-A): Tuff Stuff™ (TS1228). A two-component polyurethane material, designed for use as a weather-tight, self-leveling, rigid sealant [39]. This coating is an injectable sealant (Figure 4.26-B), easy to remove and install, with excellent adhesion to itself after repair or inspection and provides a high degree of environmental protection with maximum sealing [39].

The application of Av-DEC protective coating is the proposed measure for this case study, but before the product can be applied, the same tests will need to be conducted to find the exhaust stream temperature (temperature not mentioned in the aircraft or engine manuals), to verify if the coating withstands this operating temperature.

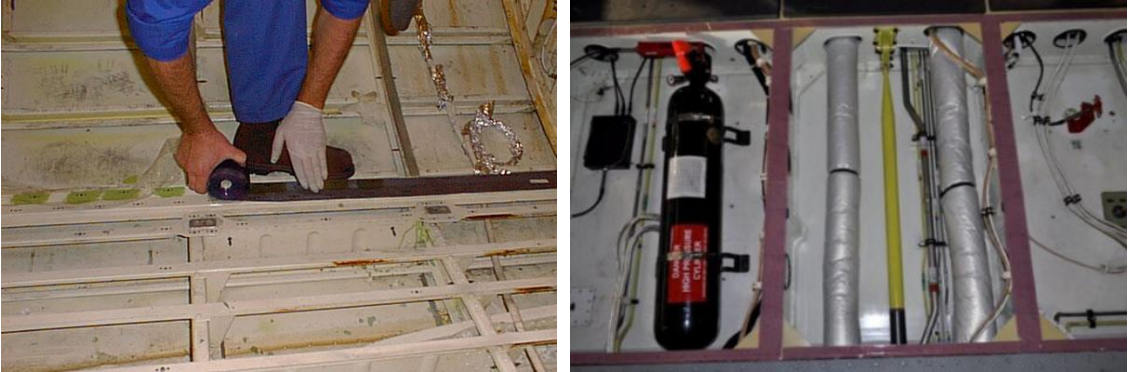
Figure 4.34: Av-DEC corrosion prevention tapes (left: HT3000; right: HT3935-7) [42, 43].

No solution to this problem was available in aircraft manufacturer documentation at the time of this revision. To get around this problem, much like the problem found in the thrust reverser, the beam case was also presented to the corrosion prevention company, Av-DEC. After reviewing the case, Av-DEC recommended the use of one of two corrosion prevention tapes (Figure 4.34): TufSeal® (HT3000) or HI-TAK® Tape (HT3935-7).

The first is a pre-cured polyurethane tape sealant with a fiberglass carrier and polytetrafluoroethylene (PTFE) backing for one-sided sealing [42]. The second is also pre-cured polyurethane tape sealant but has a fiberglass carrier providing two-sided sealing [43].

Nevertheless, the two tapes were designed for sealing and moisture-proofing irregular surfaces, commonly used in this type of location (fuselage beams under floorboards) [42, 43]. Ease of installation and removal, these tapes are efficient in preventing corrosion development in the affected area.
