## **Case studies and analysis of mine shafts incidents in Europe**

A. Lecomte & R. Salmon (Institut national de l'environnement industriel et des risques)

### **Abstract**

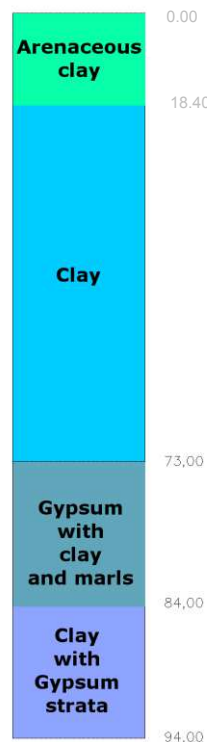
*Figure 12 : Geological cross-section in the area of catastrophe occurrence*

The Carboniferous formations are composed of strata of argillaceous shales, arenaceous shales and sandstones, among which coal seams with a thickness of up to 4.5 m occur. A fragment of geological cross-section along shaft V is presented in *Figure 12*. It represents the geological setting in the area of the catastrophe.

On 4 September 2008 at 4.35 o'clock a catastrophe took place which resulted in shaft lining damage up to a depth of circa 70 m, and afterwards the shaft was spontaneously filled with overburden soil material. This caused that a large crater came into being at the surface that in turn caused damage of building facilities present in its impact zone.

The primary cause of the accident at the shaft was damage to its lining at a depth of 61 m – 67 m. The damage was a consequence of:

1. Irregular mining repeatedly performed in the neighborhood of the safety pillar of the shaft which influenced hydrogeological conditions which in turn destroyed building-engineering stability of the ground-lining system.

## 2. Poor technical condition of the lining of shaft V.

Empty spaces in the shaft section where the lining damage took place up to the crater bottom were filled with a binder characterised by compression strength of not less than 15 MPa. The spaces were filled after building stoppings at levels 450 m and 350 m. The filling material was supplied through holes drilled from the ground surface in the direction to the shaft at 10 m distance one to another. Before they set to injection, an exploration borehole was drilled to assess the crater's range and scope of damage. Locations of the injection boreholes and the exploration hole are presented in *Figure 14*.
