# SEISMIC DAMAGE OBSERVATIONS OF PRECAST HOLLOW-CORE FLOORS FROM TWO FULL-SCALE SUPER-ASSEMBLY TESTS

Büker, F.<sup>1\*</sup>, Parr, M.<sup>2</sup>, De Francesco, G.<sup>3</sup>, Hogan, L.S.<sup>4</sup>, Bull, D.K.<sup>5</sup>, Elwood, K.J.<sup>6</sup>, Liu, A.<sup>7</sup>, Sullivan, T.J.<sup>8</sup>

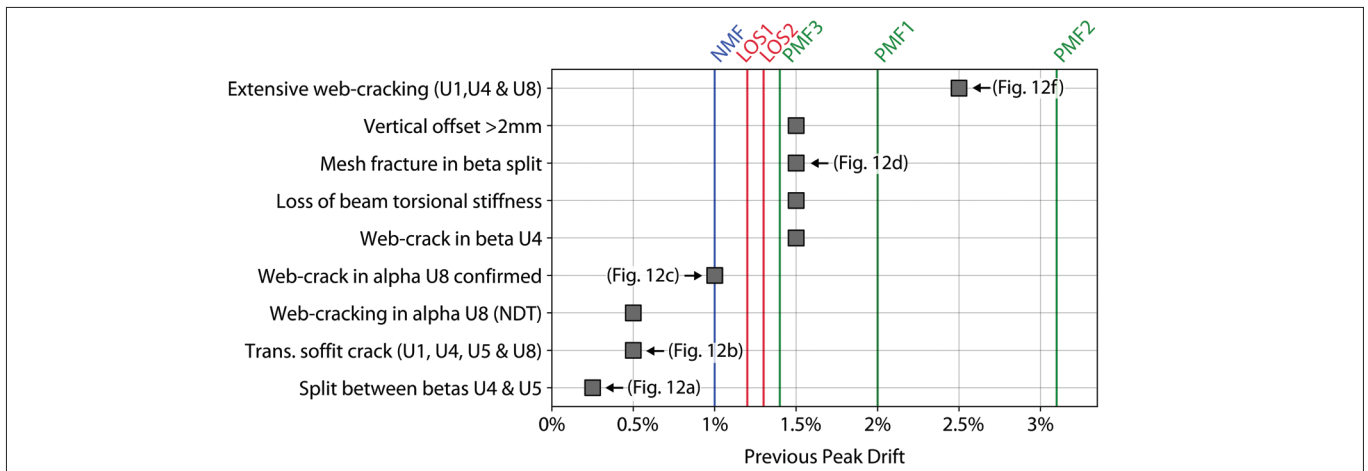
**Figure 11: Summary of damage observed in first experiment (refer to Section 2.4 for the definition of failure modes)**

From the borescope inspections conducted during the 2.5% drift cycles it was concluded that web cracking was present in multiple locations, as indicated in Figure 12f. Only alpha and beta units exhibited web cracking in this first test. The majority of detected web cracks were an extension of the soffit cracks and propagated at an angle of 45° or steeper in the direction of the gravity shear, which is consistent with the positive moment crack propagation observations from Matthews’ super-assembly experiment (2003, see Figure 2).

The first experiment was terminated after finishing the 3% drift cycles due to an actuator control error.

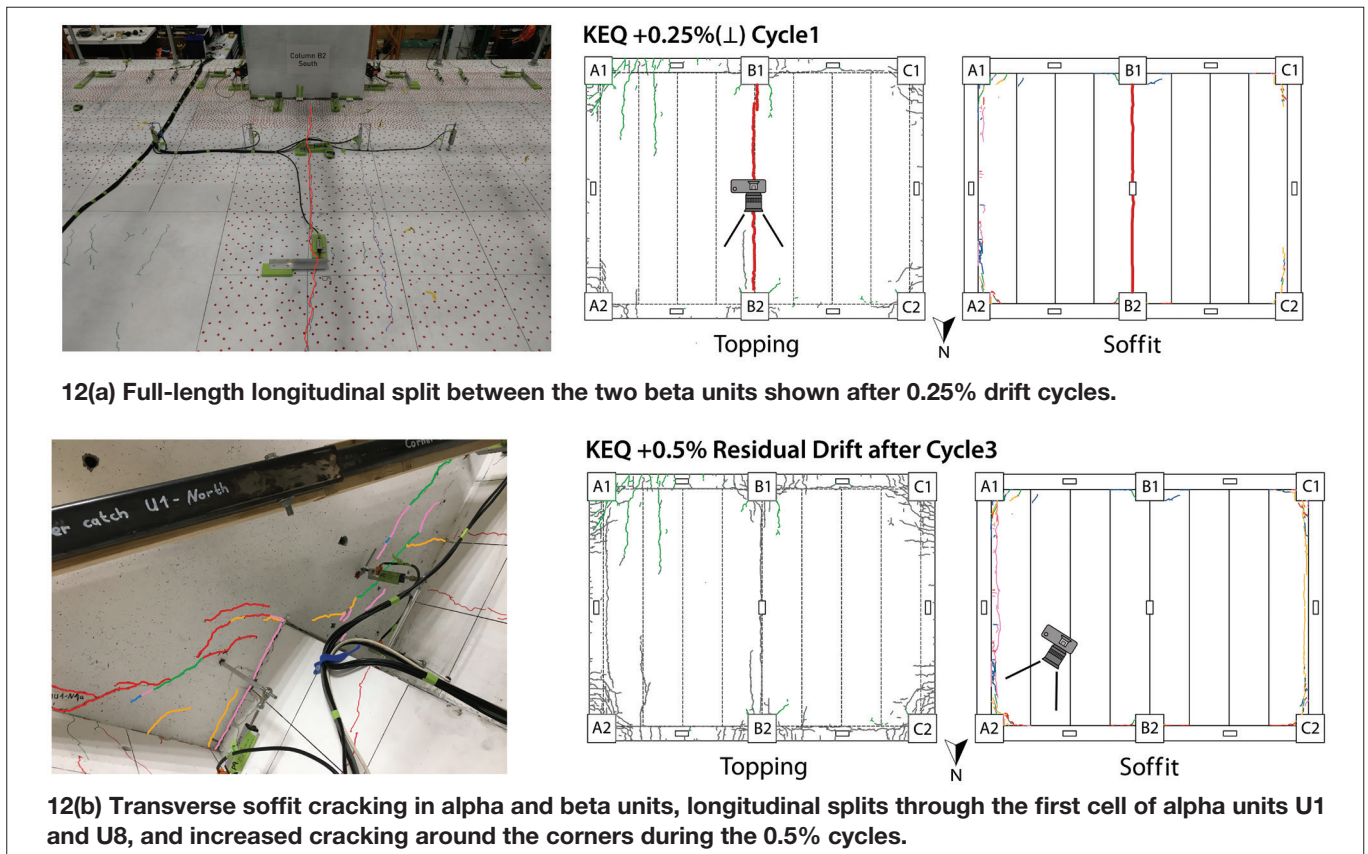
Figure 12: Floor damage observed in Test 1

During loading the first sign of floor damage occurred at +0.25% (L) inter-storey drift when a longitudinal split (0.4 mm wide) formed between the beta units U4 and

During the load cycles to 0.5% drift, a substantial amount of new cracking occurred with three main locations of cracking. Firstly, longitudinal splits formed down the first cell of the alpha units U1 and U8 while loading to  $\pm 0.5\%$  ( $\perp$ ) drifts. Secondly, transverse soffit cracks along the seating ledge of the support beams in alpha and beta units occurred when loading to  $\pm 0.5\%$  ( $\parallel$ ) drift. Lastly, the warping deformations due to the simultaneous bi-directional loading generated cracks around the columns in the soffit and top of the floor (refer to Figure 12b).

(12c) Web crack in alpha unit U8 at +1.0% (||) (where at 0.5% drift a web crack was detected via acoustic testing)

(12d) Widened longitudinal split between beta units after rupture of mesh reinforcement shown after 1.5% drift cycles

(12e) Extensive spalling and splitting cracks at 2.5%

(12f) Extensive web cracking in multiple hollow-core unit ends at 2.5%

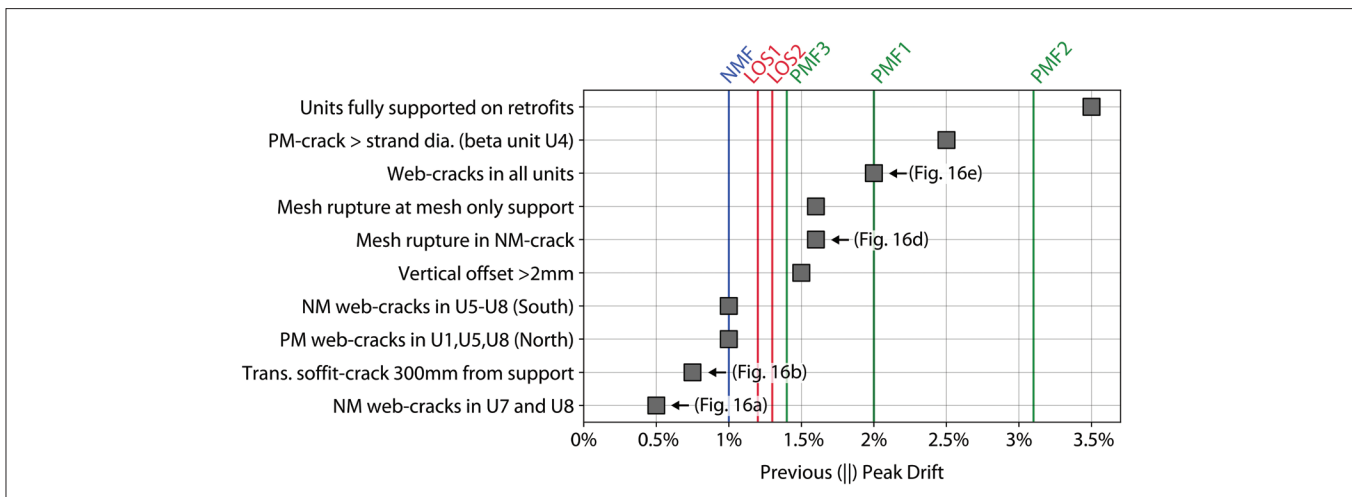
Figure 15: Summary of damage progression of Test 2 (refer to Section 2.4 for the definition of failure modes)

The second specimen was loaded with a pulse-type motion from the 1994 Northridge Earthquake, followed by progressively increasing drifts (Figure 7b). The progression of damage is described below and summarised in Figure 15.

The first pulse to -2.0% (||) drift, as part of the 1994 Northridge earthquake loading, caused extensive damage to the floor. When the pulse reached -0.35% (||) drift, a negative moment crack formed in the saw-cut at the end of the starters along beam B1 C1. The detailing along this support beam (Figure 6b) was intentionally designed to be particularly critical for negative moment failure.

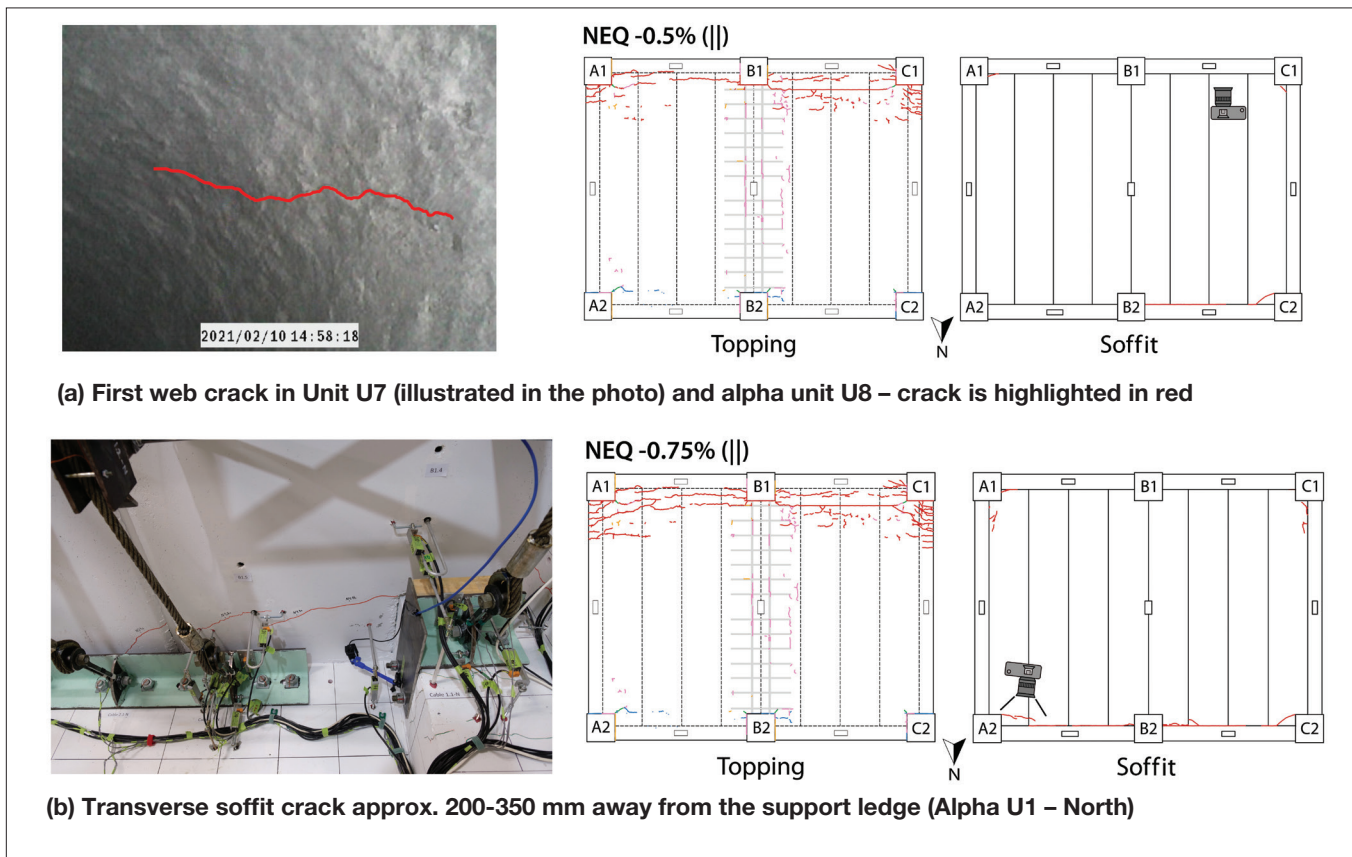
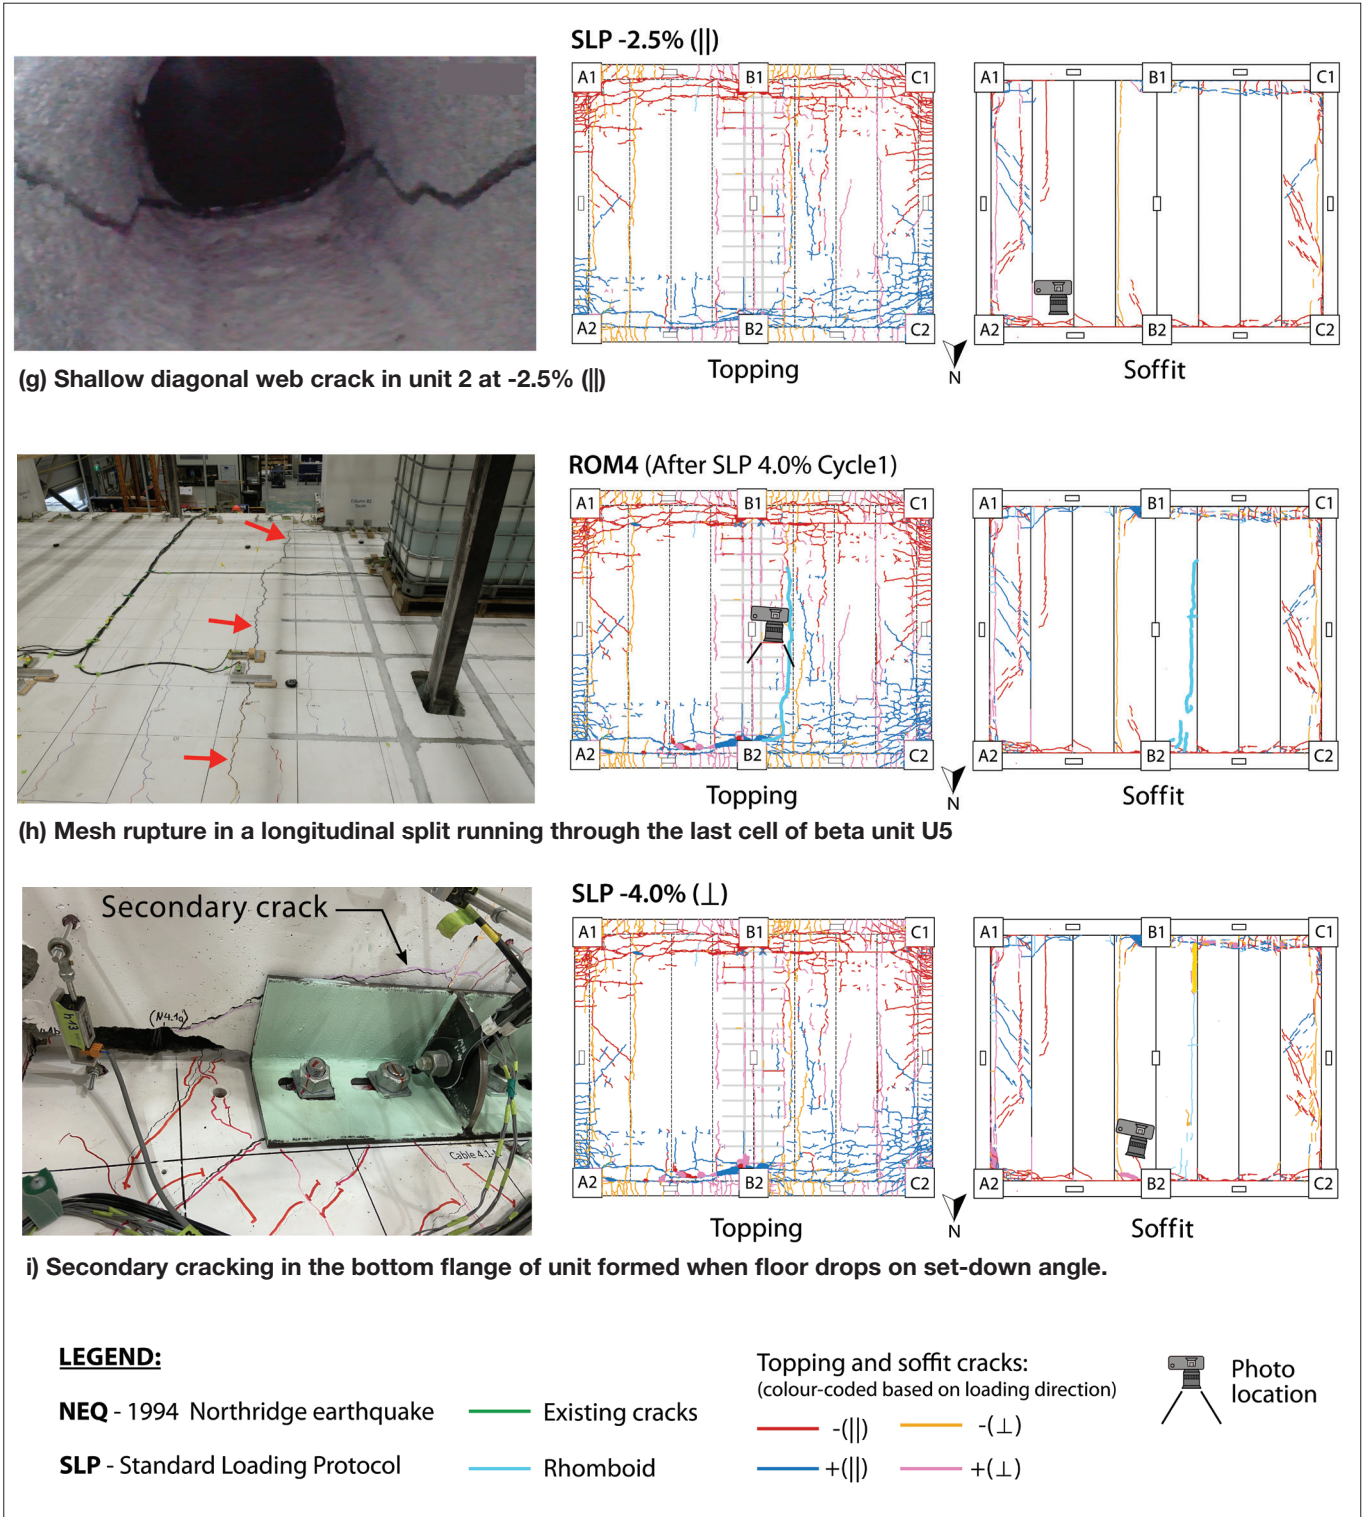
Figure 16: Floor damage observed in Test 2

Subsequently the first web cracking was detected at -0.5% (||) drift in units U7 and U8 (North end), as shown in Figure 16a. Although the detected web cracks were an extension of the aforementioned negative moment crack, the low drift at which these web cracks formed highlighted the fragility of the unreinforced webs. The detection of such narrow web cracks with a borescope camera was difficult due to the challenging navigation of the borescopes and poor lighting conditions in the voids. Furthermore there was no indication of the web crack through damage on the underside of the floor because the web crack was an extension of the negative moment cracking that initiated at the top of the floor.

The first transverse soffit cracking occurred along the north support at -0.5% (||) and additional soffit cracks formed while loading to -0.75% (||) drift. Most notably a transverse soffit crack formed 200-350 mm away from the support in alpha unit U1 (Figure 16b). Although the soffit crack only measured 0.3 mm in width, it propagated internally as a diagonal web crack in the direction of the gravity shear towards the top of the unit. This soffit crack had initiated at

the corner of the notch that was cut into the unit to fit the alpha unit around the precast columns. Thereby, this crack demonstrated how the notches acted as a stress raiser that promoted soffit and web cracking away from the support. Similarly the presence of the stitching bars that were installed transversely along the column ties acted as a stress raiser, promoting a negative moment crack near the end of the starter bars along support A1-B1 (see topping crack map in Figure 16b).

At -1.0% (||) drift a vertical offset of 1.3 mm across the soffit crack at the north support of beta unit U5 was measured. During the loading to -1.5% (||) drift the vertical offset across the now 3 mm wide soffit crack increased to 2.6 mm and thus exceeded the vertical offset benchmark of 2 mm, which indicates a loss of reliable load path (Corney et al. 2021). The vertical offset measured across the soffit crack in beta unit U4 (north end) was even more pronounced, measuring 3.7 mm. This soffit crack formed approximately 100 mm from the support beam ledge and propagated internally as a shallow web crack approximately 400-500 mm towards mid-span, as shown in Figure 16c.

The presence of web cracking in every hollow-core unit was confirmed at the peak of the first pulse (-2.0% (||) drift) as indicated in Figure 16e. Furthermore additional vertical offsets across the transverse cracks in the soffit of beta units U4 and U5 were recorded, with a magnitude of 6 mm and 4.5 mm respectively. Figure 16f illustrates the extent of the vertical offset in beta unit U5. It should be noted that further vertical offset of beta unit U5 was prevented by the strongback retrofits, but the cable-catch retrofit under beta unit U4 allowed for additional vertical offset.

formed when the floor engaged with the angle, which was intentionally set down by 40 mm (Figure 16j). The collapse of the hollow-core unit was prevented by the cable-catch system that was anchored back to the seating angle. Nonetheless, this crack highlights the fragility of hollow-core units that have sustained shallow web cracking and indicates that seating angle retrofits may not be suitable solutions to address this damage (Brooke et al. 2022; SESOC et al. 2021).

(c) Web cracking in beta unit U4 (North support)

(f) Vertical offset in beta unit at -2.0% (||)
