**STRUCTURAL MECHANISMS CONTRIBUTING TO
LARGE-SCALE HANGINGWALL INSTABILITIES ON THE
UG2 REEF HORIZON**

MSc Mining

UNIVERSITY OF PRETORIA

2019

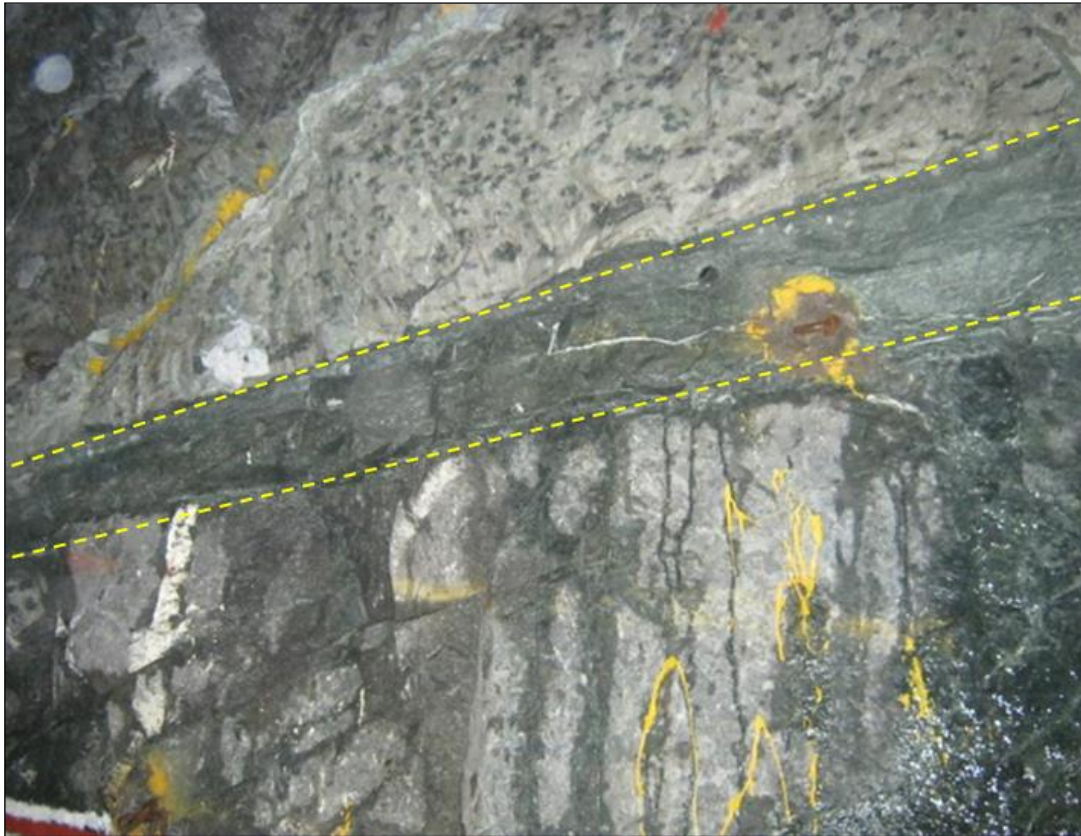
Figure 1.4: Footwall 5/6 shear exposed in an off-reef development excavation (a decline) at an Eastern Platinum Limited Shaft.

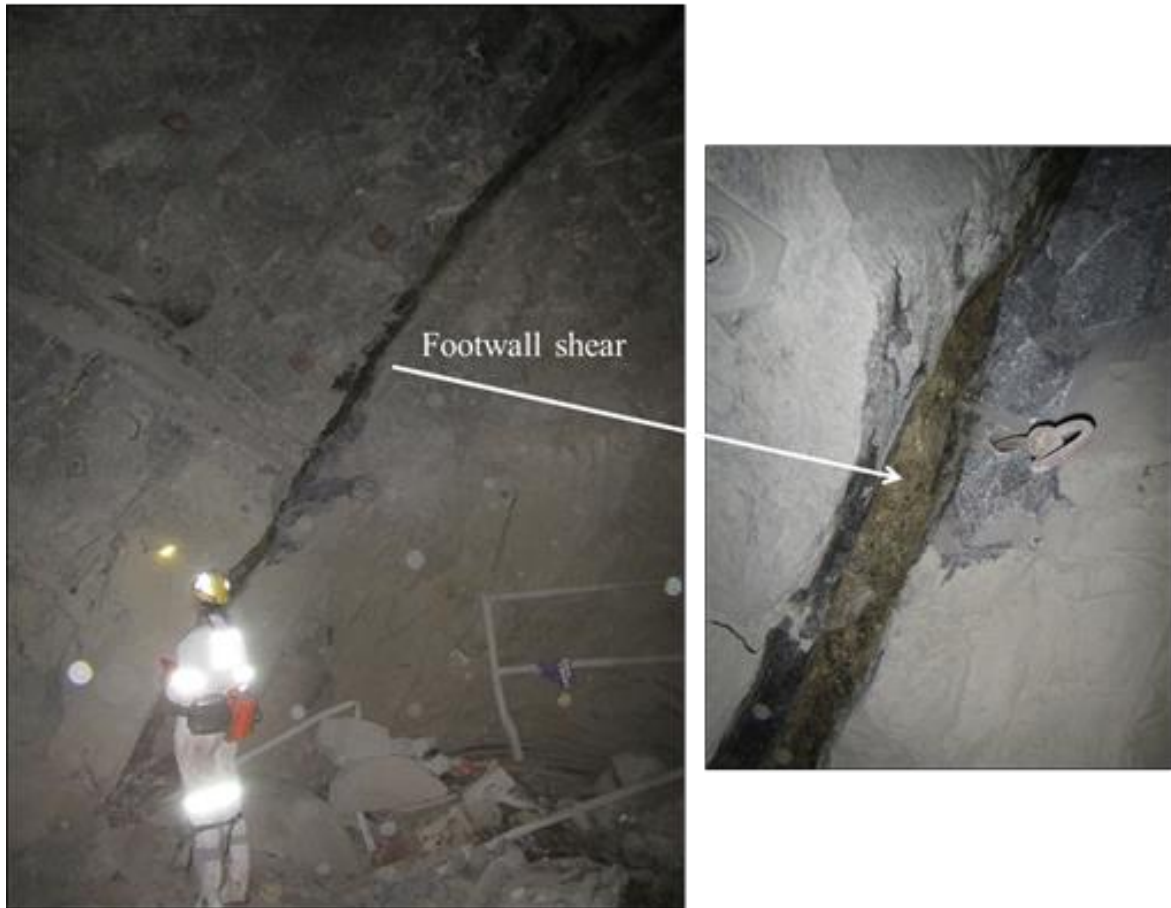
Figure 1.5: Footwall shear exposed in off-reef development (a decline) at a shaft in the Bushveld Complex where the stratigraphic layers are steeply dipping.

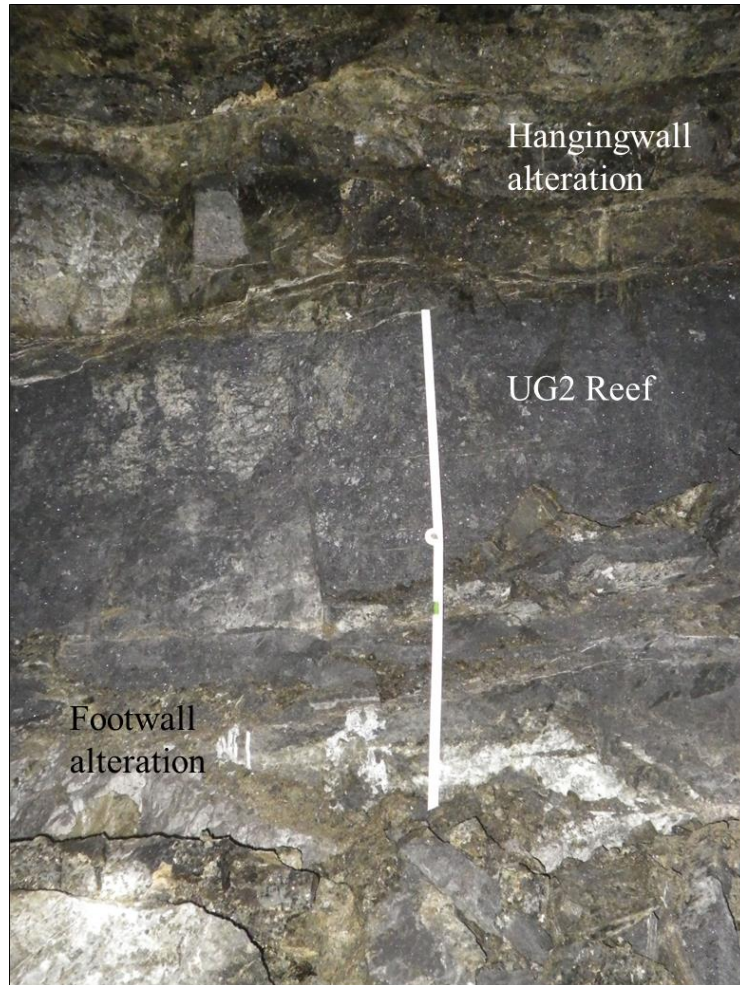
Figure 1.6: Alteration zones along the hangingwall and footwall pyroxenite units of the UG2 Reef.

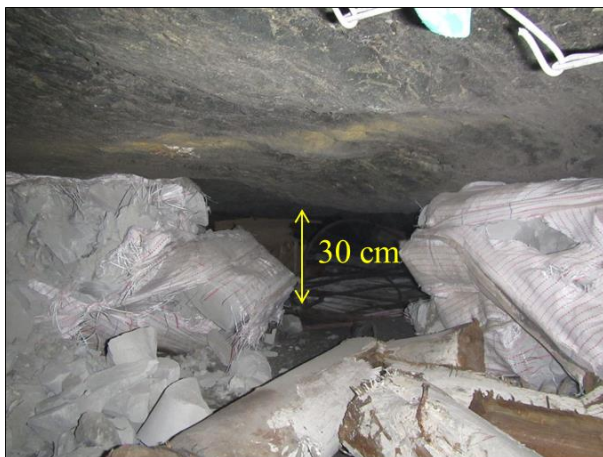
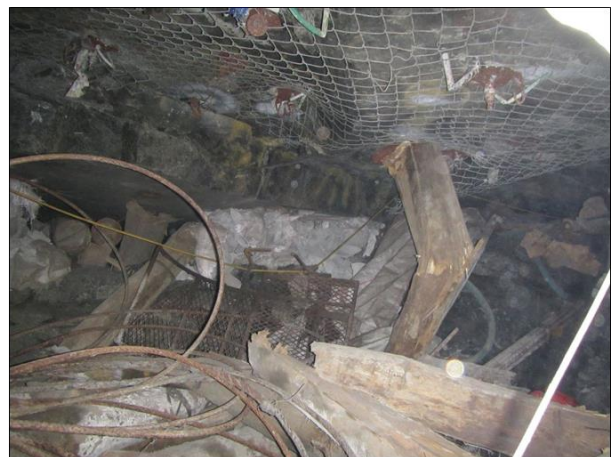
Figure 1.7: Separation in the hangingwall caused instabilities. Crushed grout packs and buckling of timber elongates can be observed. The stope width (1.2 m) was reduced to 30 cm.

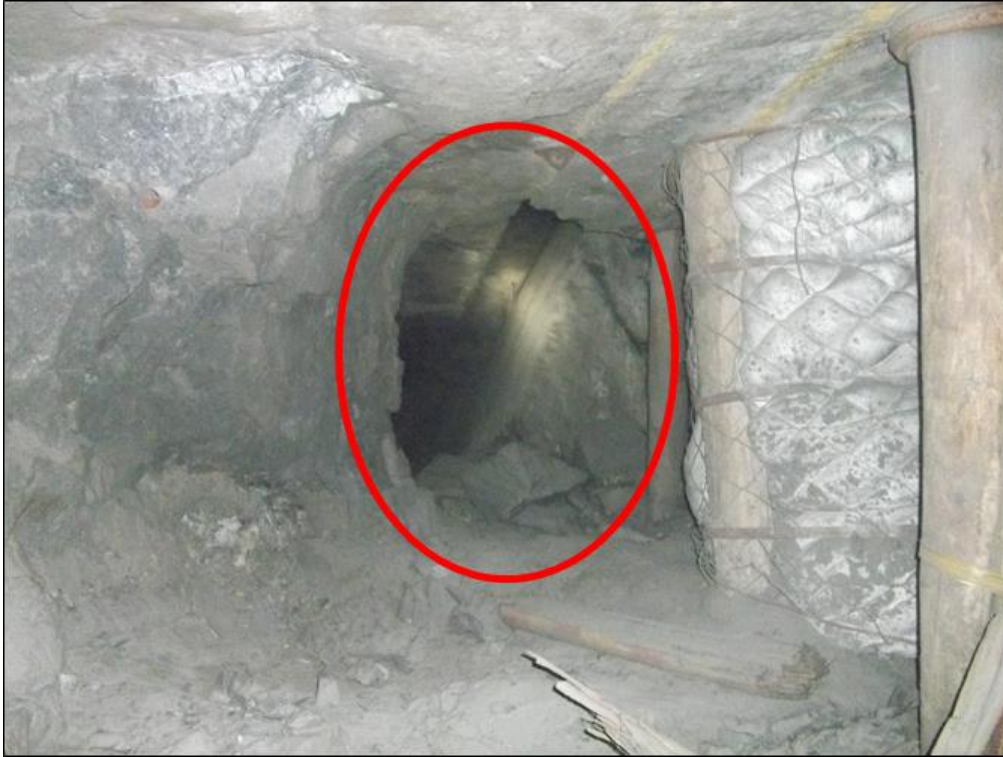
Figure 1.9: Panel instability shown in the red ellipse. The entire panel was affected along a regional large-scale WNW-ESE trending fault structure. Separation occurred at approximately 12 – 15 m in the hangingwall (along the hangingwall 1A/hangingwall 2 contact). The panel had to be re-established.

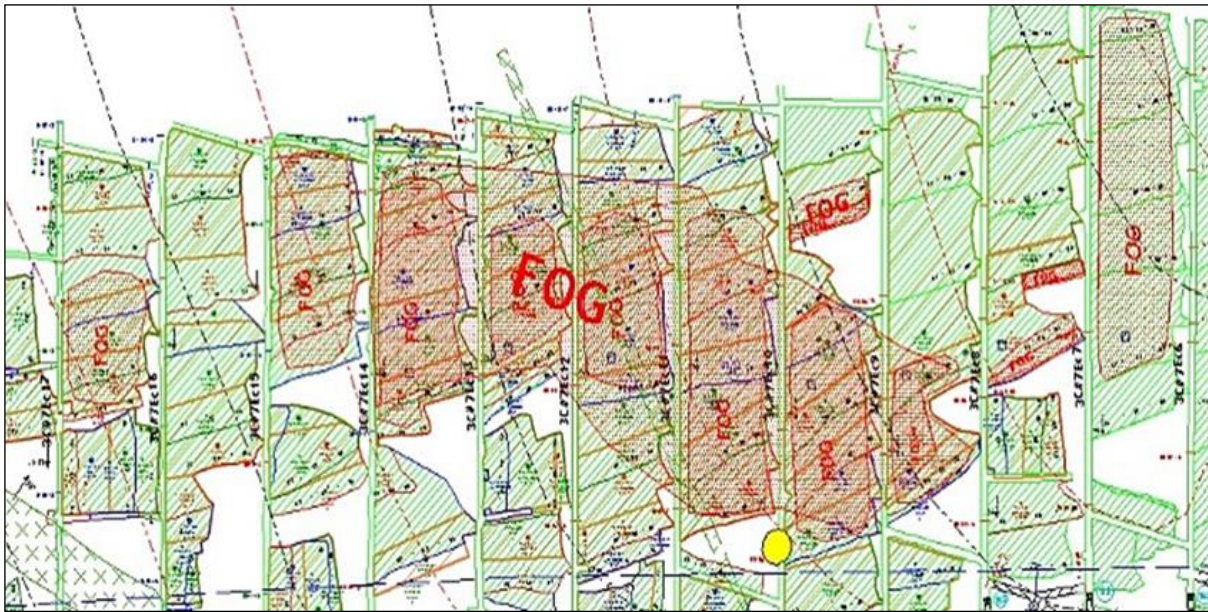
In 2003, spalling along the top corner of a 15 m wide crown pillar was reported at a depth of 220 meters below surface at Eastern Platinum Limited 3 Shaft (Figure 1.2). Inspection of the working places that were mined out revealed that a large-scale collapse had occurred (Figure 2.13) with a size of approximately 360 m on strike and 130 m on dip (More O’Ferrall and Du Plessis, 2017). A non-yield pillar layout was implemented and the in-stope support consisted of timber elongates intended to ensure the stability of the

Figure 2.13: Falls of ground extending 360 m on strike and 130 m on dip at Eastern Platinum Limited 3 Shaft.

As an immediate remedial action, the mining spans were reduced and cementitious grout packs were introduced in the support design strategy to prevent the secondary effect of unravelling in the back area.

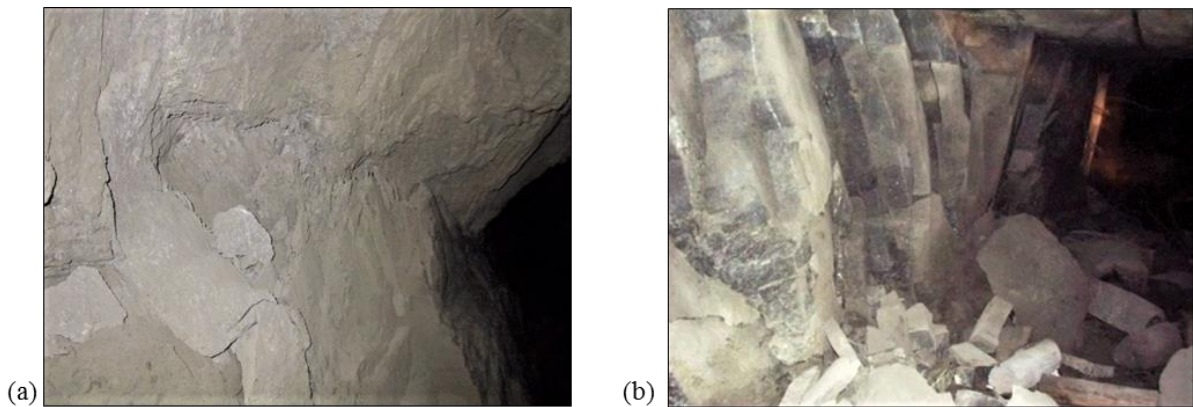
Figure 2.14a shows the onset of fracturing experienced close to the hangingwall contact of the UG2 Reef. In many instances, pillar slabbing (Figure 2.14b) was observed and in other instances total pillar failure had occurred. It was noticed during the investigations that the timber elongates were failing in compression. Prominent joint planes were open and dripping water was observed in the surrounding areas where the falls of ground had occurred.

Figure 2.14: (a) Stress fracturing of the pillar; (b) pillar slabbing.

The detached blocks could not be supported by the timber elongate in-stope support, which was subsequently overloaded. This resulted in the collapse of the beam in the middle of the panel strike span (Figure 2.15b). Two types of pillar behaviour were identified. This included stress fracturing (Figure 2.14a) where no infilling (alteration) occurred at the UG2 Reef and hangingwall 1B pyroxenite contact, as well as pillar slabbing where a thin altered layer was present at the top reef contact (Figure 2.14b).

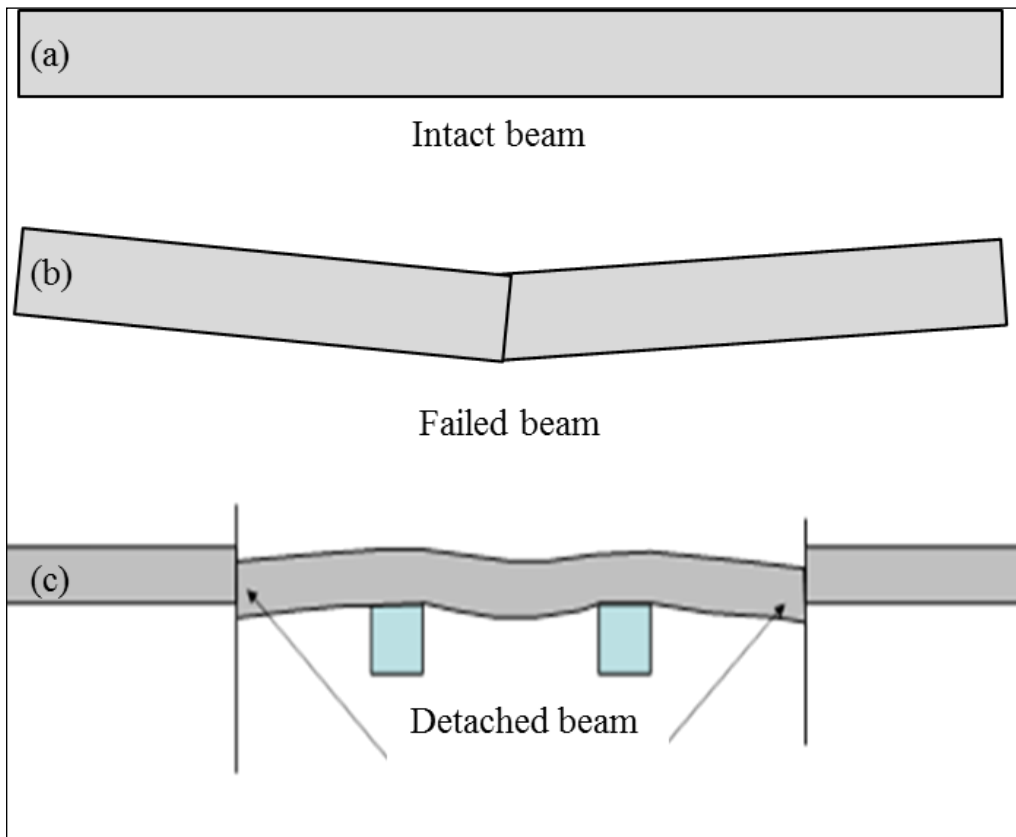
More O’Ferrall and Du Plessis (2017) believed that the instability was caused by the failure of the entire hangingwall1 beam (hangingwall 1B, UG2A markers and hangingwall 1A) where the panels stripped along major, vertical dykes, striking approximately NNW-SSE. The possibility exist that the contact of the hangingwall 1A and hangingwall 2, in close proximity to the dyke on Eastern Platinum Limited 3 Shaft was weathered (altered). This resulted in a beam thickness of 13 m that was only supported by the timber elongates.

Figure 2.15: (a) Intact beam, no geologic structures; (b) Failed beam, near-vertical geologic structures, absence of low-angle structures and (c) Detached beam (modified after Du Plessis, 2010).

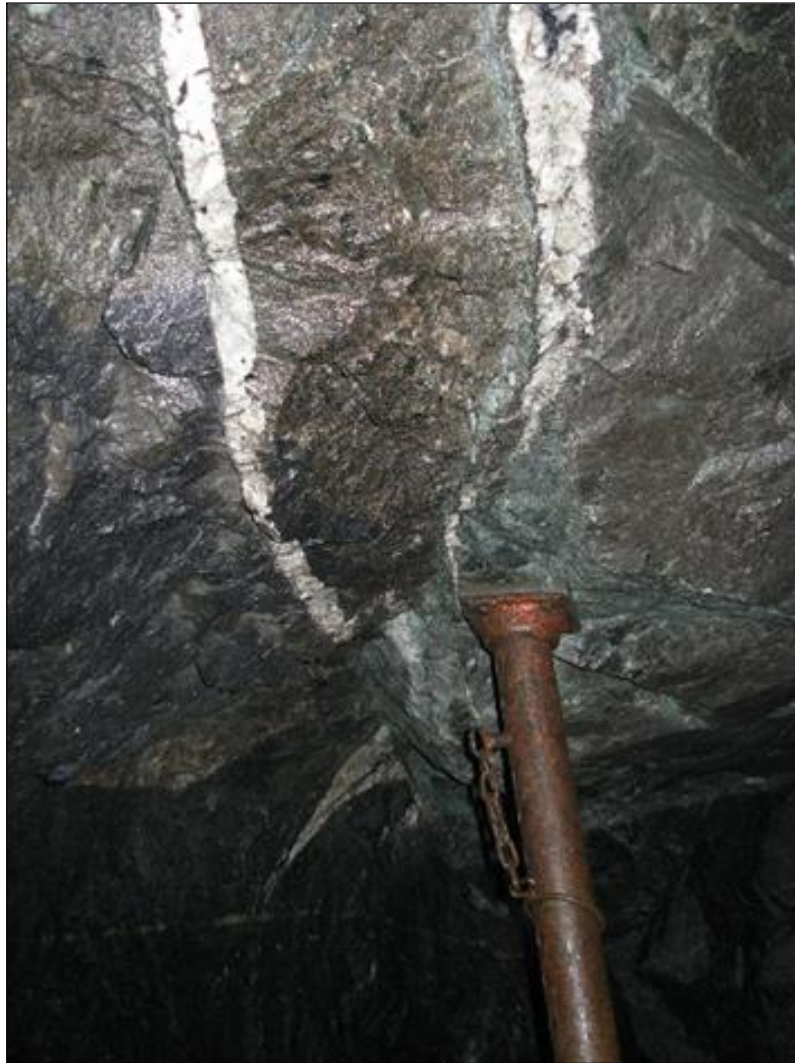
Figure 2.16: Underground image of a WNW-ESE striking, regional low-angle structure with pegmatite infill. These structures have been termed the Marikana structures in this study.

These structures were historically associated with major instability in the stoping panels as it traverses the entire hangingwall 1 pyroxenite package. Where these Marikana structures intersect the mining area, the hangingwall beam is cut off at one end (Figure 2.15c) and is simplified by some authors as a possible cantilever effect as shown in Figure 2.17 (Du Plessis, 2009). The detached beam reaches a critical span after which the convergence sustained by the deflecting rock cannot be absorbed by the timber elongates (Figure 2.17). Van der Merwe and Madden (2002) discussed the calculations to determine the deflection (δ), by applying equation 1, and the stress (σ_v), by applying equation 2.

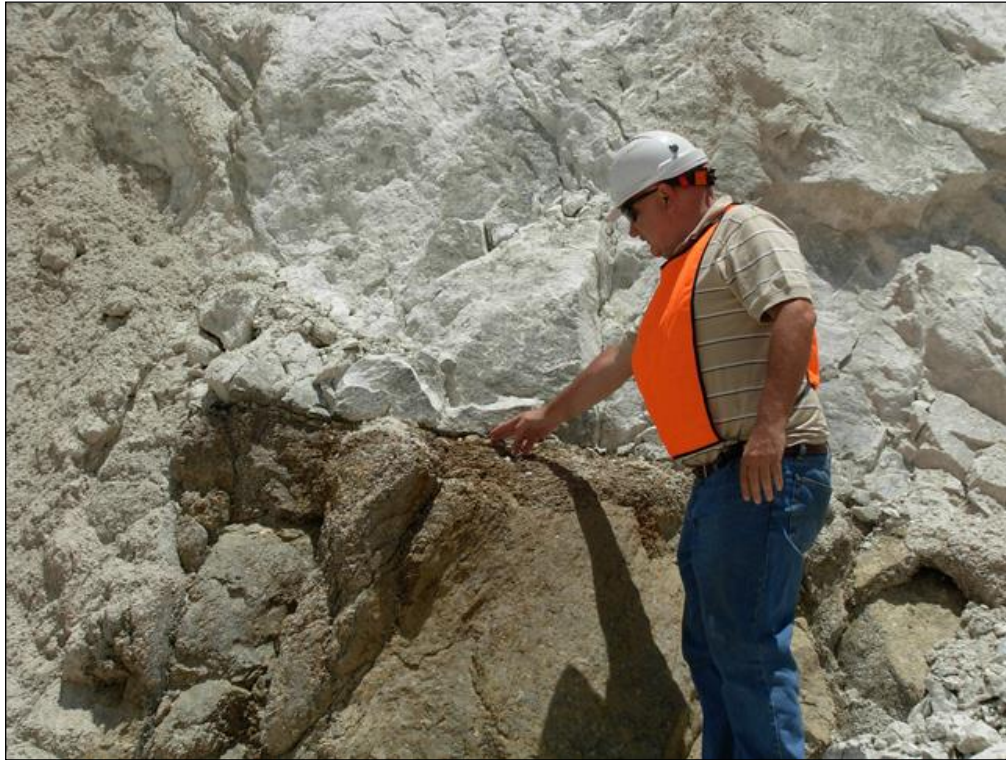
During the 2009 study, an investigation in the open pit directly up-dip of Eastern Platinum Limited 3 Shaft revealed that an alteration zone exists at the hangingwall 1A/hangingwall 2 contact (Figure 2.18). This contact can also consist of a thin chromitite layer and it acts as a natural parting plane. This confirmed the findings that a weak contact exists at the hangingwall 1A/hangingwall 2 contact.

Figure 2.18: Open pit, up-dip of Eastern Platinum Limited 3 Shaft showing the alteration zone at the hangingwall 1A/hangingwall 2 contact.

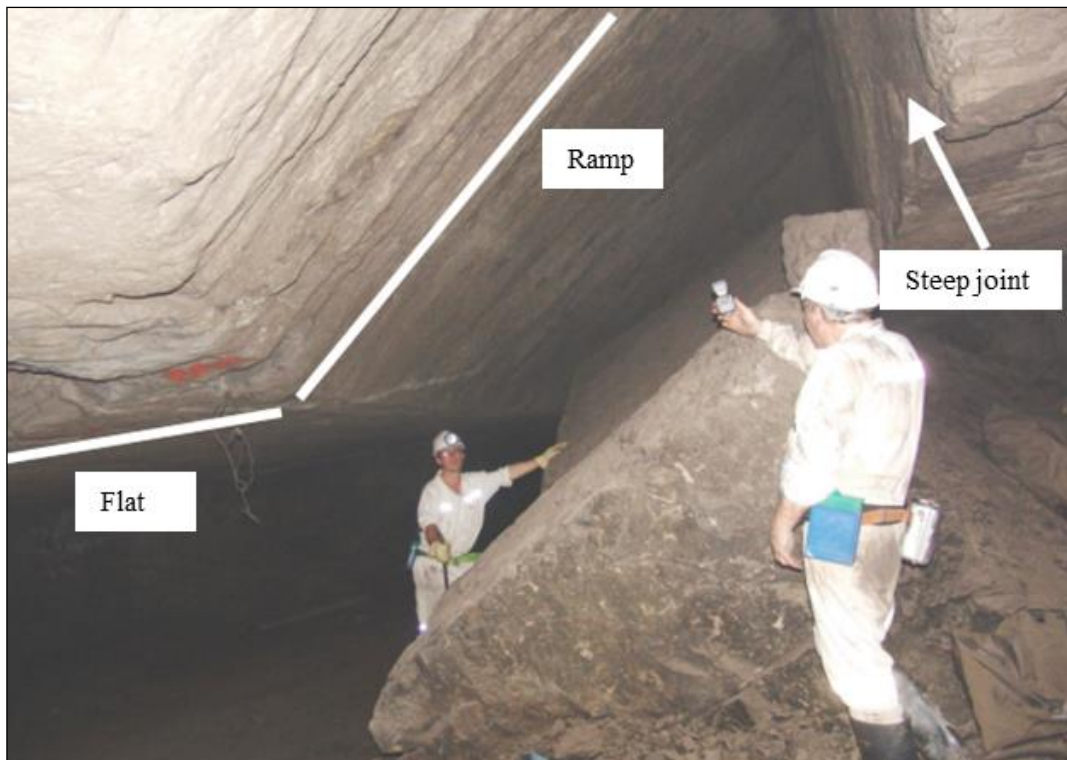
A large number of falls of ground fatalities in the platinum industry (especially on the UG2 Reef horizon) have been caused by the intersection of low-angle structures with steeply dipping joints, faults or pegmatite veins. Figure 2.23 show a fall of ground in a bord and pillar mine. Roberts and Clark-Mostert (2010) recommended that flexural slip thrust faults can be controlled by installing 4 m long, 400 kN cable anchors in a systematic pattern of 1.5 m x 1.5 m. This provides a support resistance of more than 200 kN/m². The bord widths in this environment can also be decreased. The visual identification of the low-angled structures nevertheless remains a challenge. Some mines have implemented the use of ground penetrating radar (GPR) and borehole cameras in an attempt to early identify flexural slip thrust faults, low-angle ramp structures, also referred to as deformation event 1 in Table 2.1. Roberts and Clark-Mostert (2010) found that the

Figure 2.23: Flexural slip thrust fault (ramp structure) intersecting a steeply dipping joint (Roberts and Clark-Mostert, 2010).

application of grout packs in Bushveld Complex platinum conventional mines proved to be an effective support system to prevent falls of ground associated with these structures.

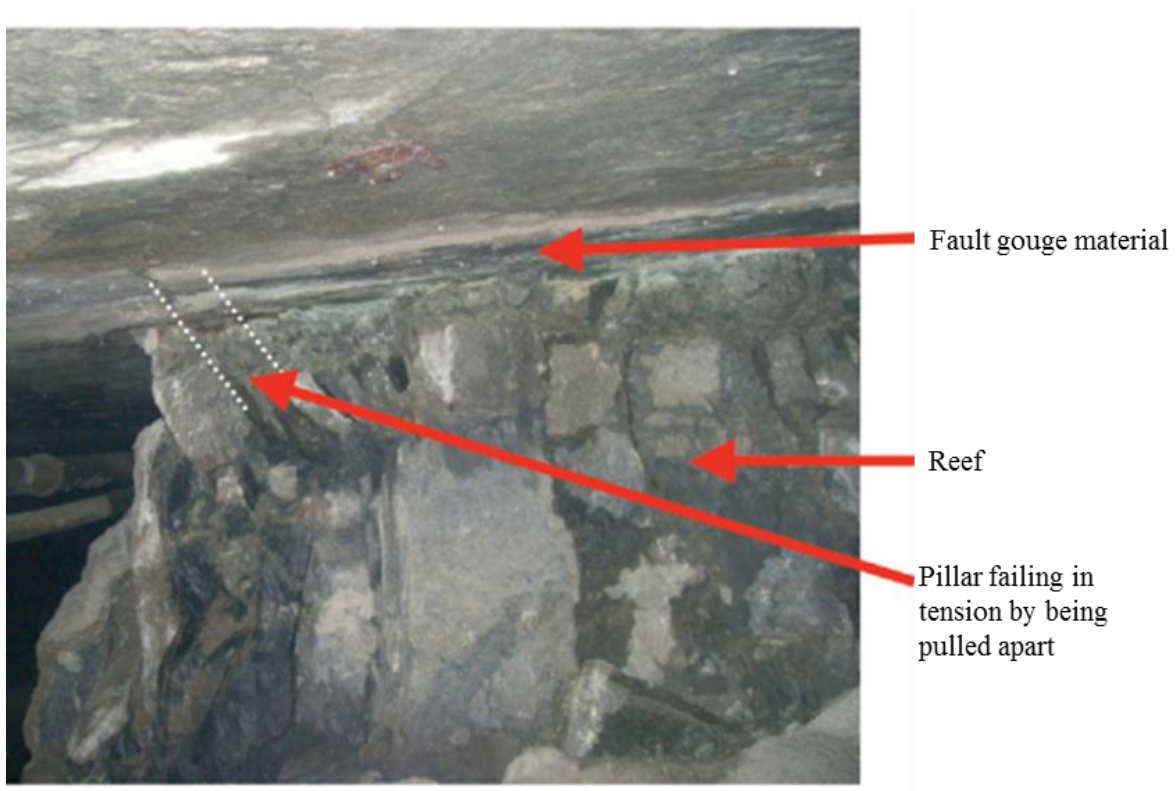
Roberts and Clark-Mostert (2010) believed that the pillar instabilities occurred as a result of the fault gouge being compressed, deforming the material and failing the pillars in tension (Figure 2.24). The pillars were effectively pulled apart. Consequently, when extensive pillar failure occurred, unravelling of the hangingwall was initiated and this led to widespread collapses. This failure mechanism is further investigated in Chapter 4.

Figure 2.24: Pillar failure due to the deformation of the fault gouge material (after Roberts and Clark-Mostert, 2010).

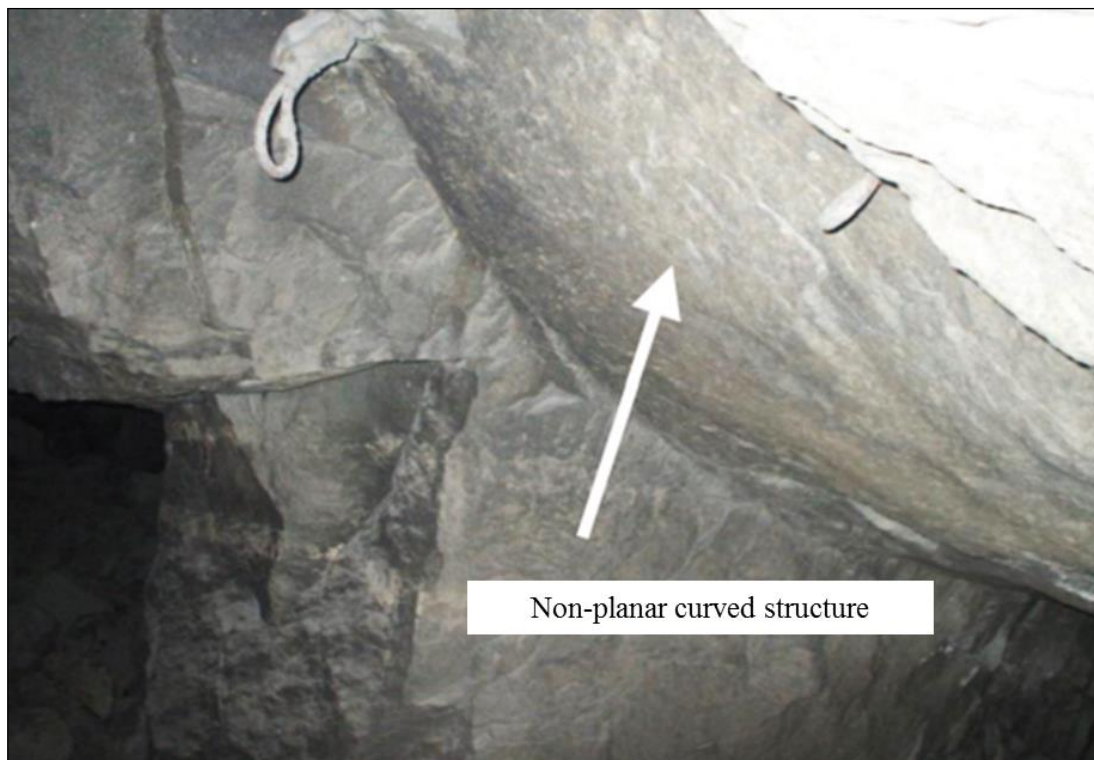
Some mining operations in the Great Dyke have excellent ground conditions where the bord spans (bord and pillar mining method) is 15 m and minimal support is installed. Mining is more challenging where the joint density increases and non-planar curved structures (Figure 2.25) are exposed. This results in a decrease of the bord widths (Roberts and Clark-Mostert, 2010).

Roberts and Clark-Mostert (2010) noted that the presence of curved structures presented a similar risk to the ramps of the flexural slip thrust faults observed in the Bushveld Complex sites. Also, slickensides were visible on the planes, indicating thrust movement. These structures have tentatively been identified as flexural slip thrust faults (ramp structures). These structures have not been recorded everywhere in the Great Dyke and no fault gouge was present along these curved structures.

Figure 2.25: A non-planar curved structure (ramp structure) in a mine of the Great Dyke (Roberts and Clark-Mostert, 2010).

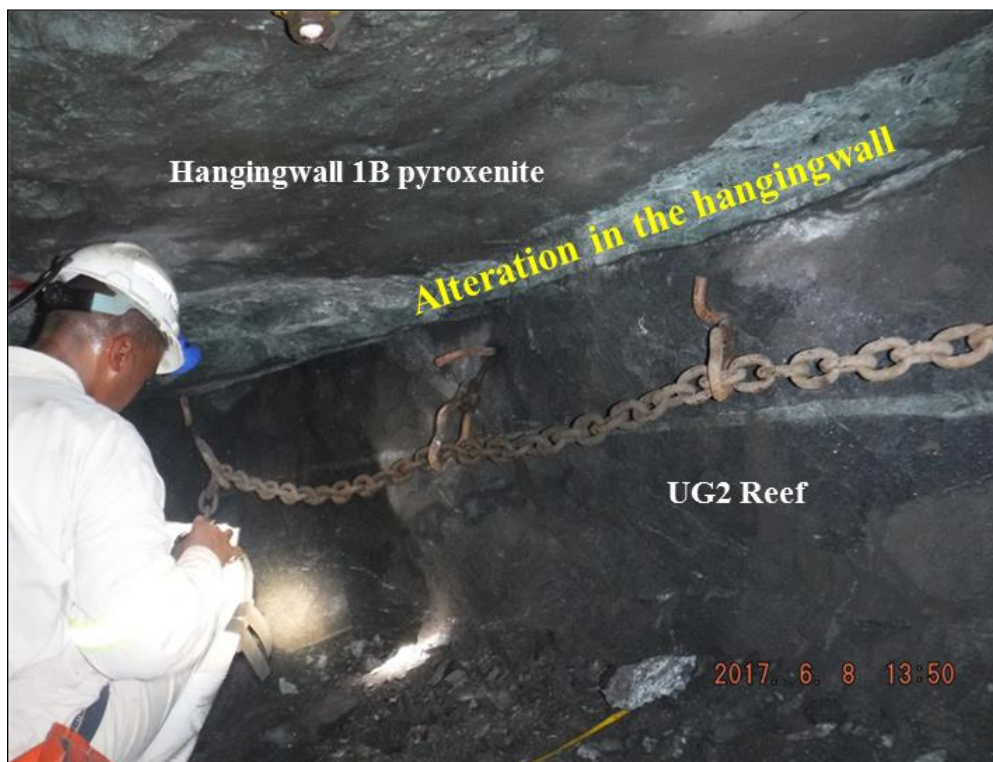
When these alteration layers are present, it poses a fall of ground risk as the rock may unravel around installed support units and it can also result in anomalous pillar behaviour. The occurrence of the weak contacts can easily be overlooked in geotechnical drill holes, due to the alteration material being washed out during the drilling process. The presence of alteration zones may also not be correctly identified by underground staff. Therefore, its presence may not be reported and the behaviour of these structures not necessarily recorded unless there was significant associated instability.

Figure 2.26: An alteration zone present at the top contact of the UG2 Reef.

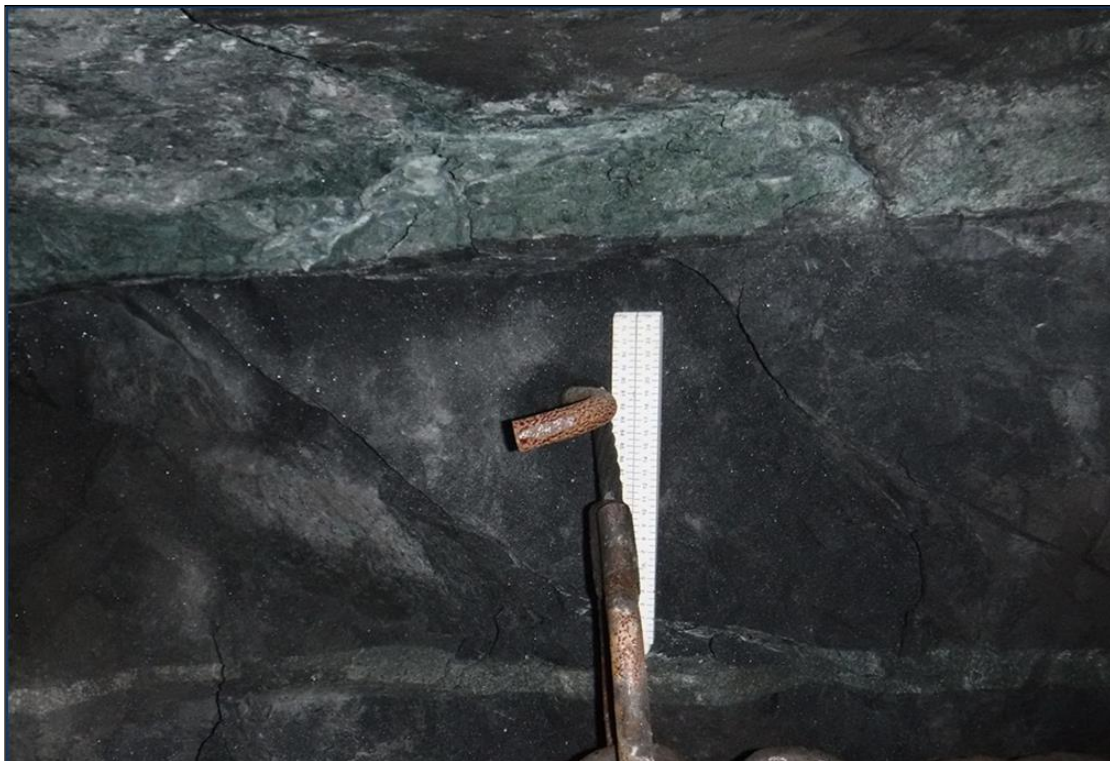
Knipe (2016) indicated that several layer parallel shears (Figure 2.28) are observed on the shaft and tend to follow geologic contacts. These shears are best developed in specific stratigraphic positions (Figure 1.3) which is similar to the findings at other sites. The footwall 6 shear which occurs on the footwall 5/footwall 6 contact is approximately 42 m below the reef and is not exposed in the normal mining operations, except where decline systems are developed in this location. A second footwall shear is also known to occur towards the top of footwall 5 at the Eastern Platinum Limited Shafts, but it is only observed in the shallower operations. Here it can be very brittle with open fractures or is completely weathered (referred to as a ‘mud layer’ by Lyons and Du Plooy, 2002).

Figure 2.28: Occurrence of the alteration zone in the vicinity of the UG2 Reef.

The alteration zones (Figure 2.28) were also identified at the hangingwall 1A/hangingwall 2 contact, at the top UG2 Reef contact and / or at the UG2A markers (approximately 8 - 13 m above the top contact of the UG2 Reef). Recent alteration and possible brecciation was also observed at the bottom of the hangingwall 2 mottled anorthosite, directly west of ‘Aqua Zone 1’ (19 to 20 Level West in Figure 2.20). Relatively close to this area on 19 and 20 Level East, grout packs were observed to have failed (Figure 2.20). The presence of the alteration zone at the hangingwall 1A/hangingwall 2 contact could explain the failure of the grout packs. A thorough understanding of the alteration zones and deformation events at the bottom of hangingwall 2 and delineation of the affected area is essential.

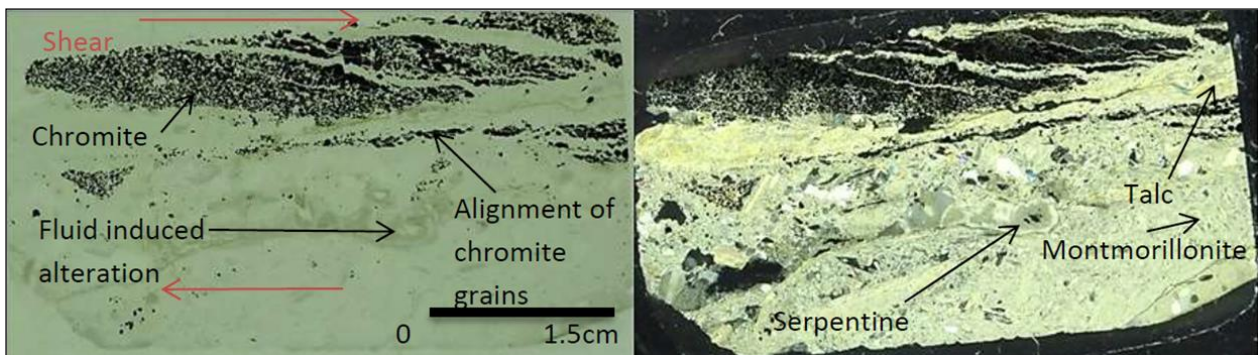
Figure 2.29: Images of the thin sections at the top contact of the UG2 Reef. The shearing caused the top contact to be fractured.

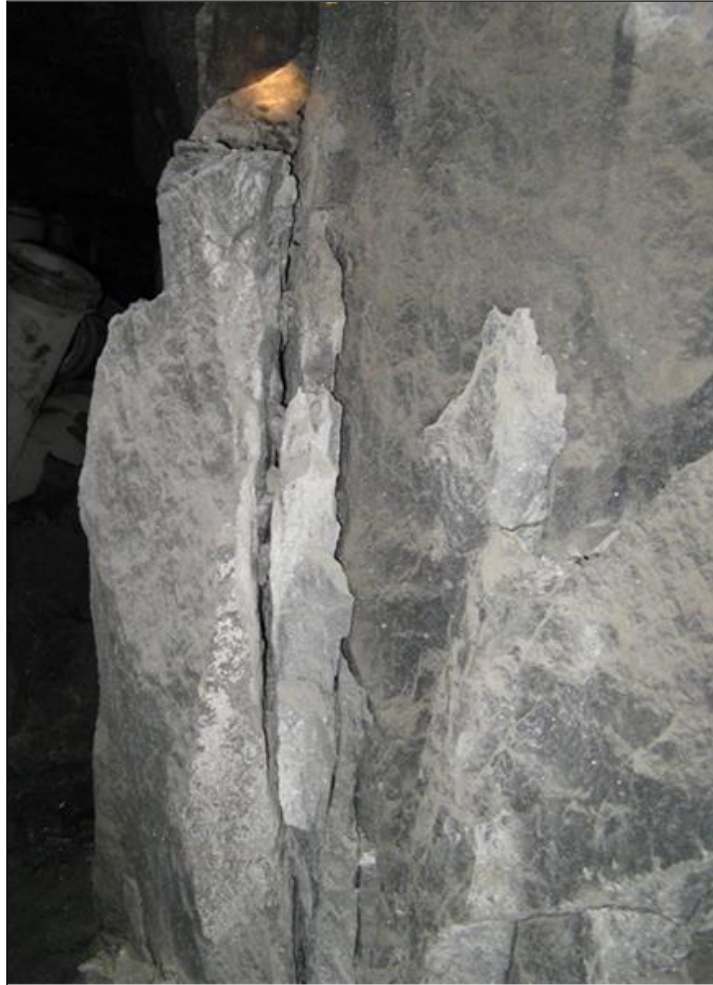
Pillar slabbing (Figure 2.30) was studied by Malan (2008) at Hossy Shaft. Unexpected and abnormal pillar behaviour was observed on both Hossy and Saffy Shafts where pillar slabbing was observed for non-yield pillars. It was thought that this only occurred on pillars that were cut smaller than the specified size (possible over loading). It was suggested by Malan (2008) that the major contributing factor to the pillar slabbing was the very weak contact present between the hangingwall and UG2 pillars (Figures 2.31 and 2.32). Numerical modelling indicated that the impacted pillars had very high pillar stress (> 150 MPa). Malan (2008) suggested limiting the pillar stress to < 130 MPa and to apply a factor of safety > 2 to ensure that the unravelling pillars (slabbing phenomena) is accommodated. It will also ensure that the pillar does not fail and mine stability is ensured. Additional slabbing of the pillars in the back area could therefore possibly occur and routine observations in these areas would be required to identify potential instability.

Figure 2.30: Slabbing noted at the edge of a pillar. The slabs are defined by joint planes which are mobilised by alteration zones along the pyroxenite and chromitite contacts (i.e. Figure 2.31).

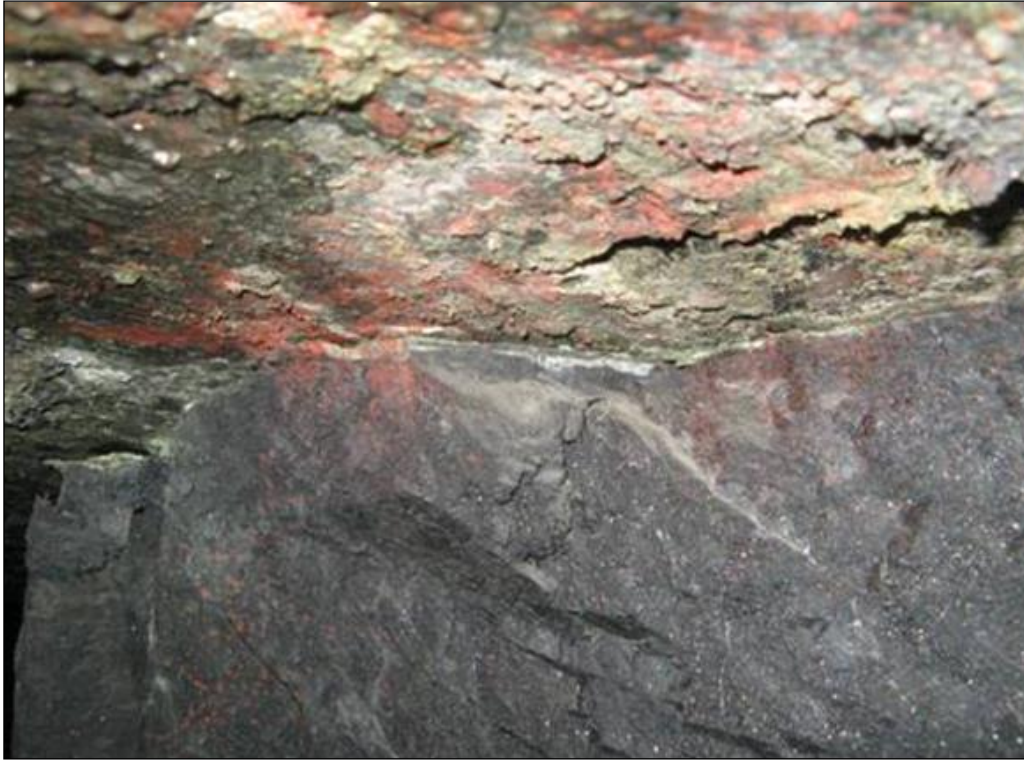
Figure 2.31: The alteration zone at the contact between the UG2 Reef and the hangingwall.

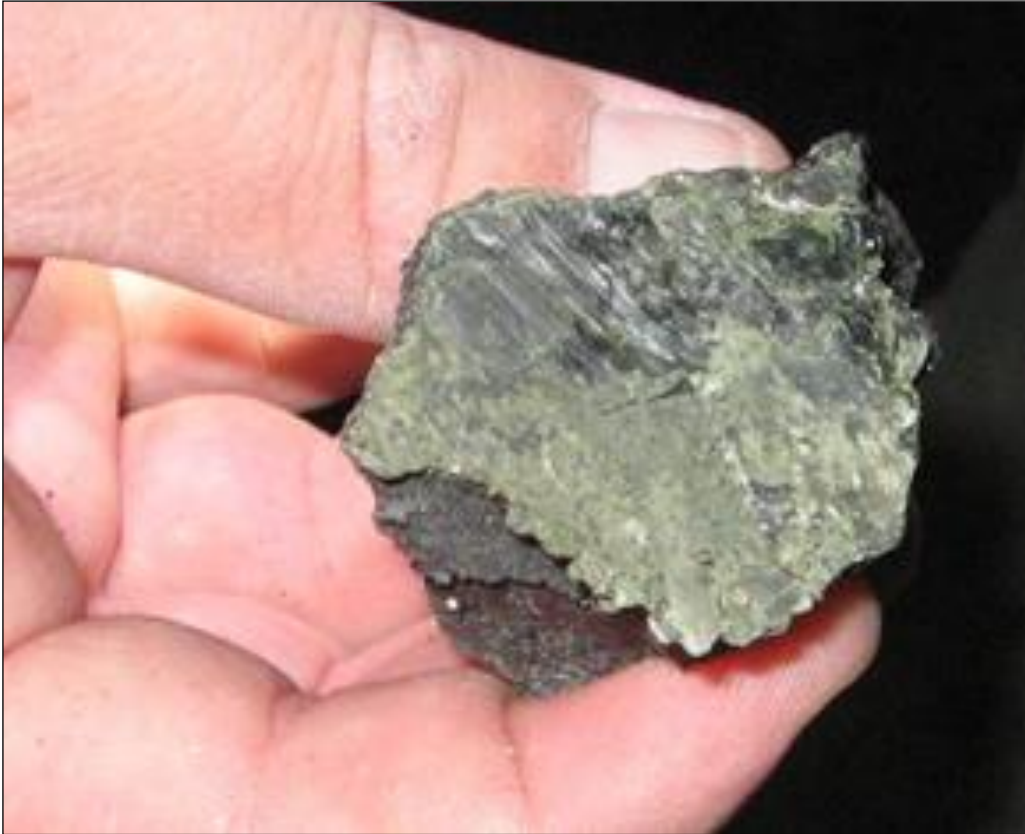
Figure 2.32: A fragment illustrating the alteration zone between the UG2 Reef and the hangingwall. Note the slickensided surfaces which indicate that movement has occurred along the top reef contact.

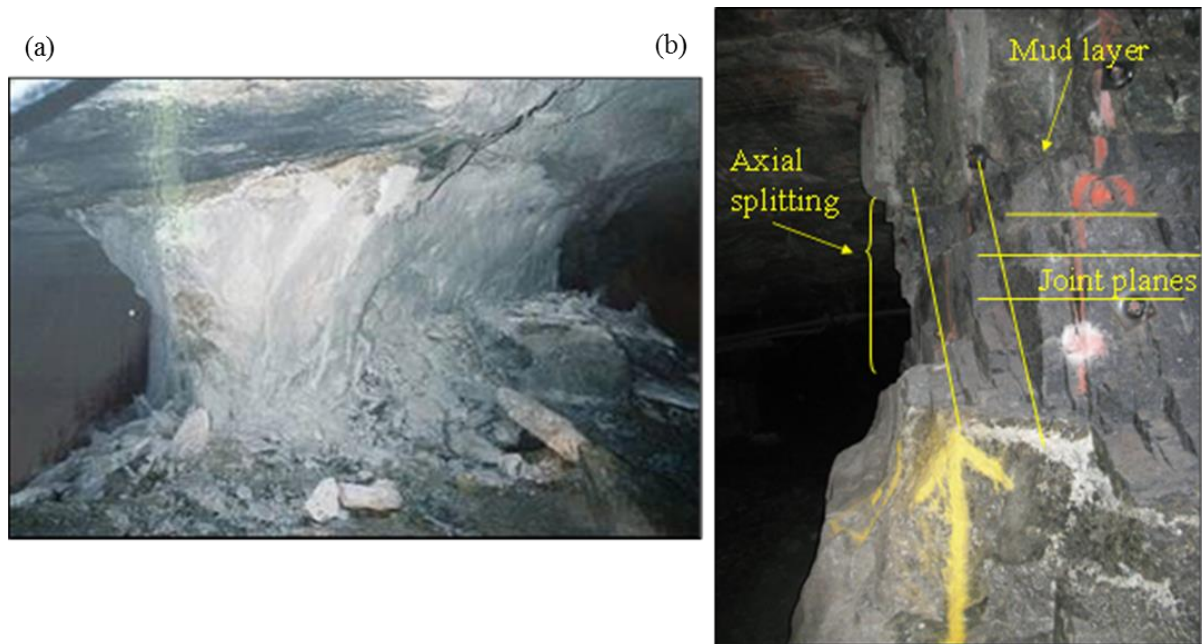
The pillar strength will significantly decrease when an alteration zone is present at the pillar and hangingwall contact. Laboratory experiments were done by Peng (1978) and he concluded that the strength can vary by up to 100% depending on the conditions at the interface of the rock-sample testing machine. Wagner (1980) confirmed this result and his tests indicated that if a soft layer is present at the rock / platen interface, the strength is reduced and the mode of failure changed. The mode of failure changes from 'hour glassing' (Figure 2.33a) and scaling on the edges for the higher friction angles to axial splitting (Figure 2.33b) for the lower contact friction angles.

Figure 2.33: (a) Examples of pillar scaling in areas where no alteration zone is present at the interface between the pillar and the hangingwall. The typical ‘hour glass’ failure mode is evident (Malan, 2008); (b) Axial splitting is evident where an alteration zone is present along the top reef contact.

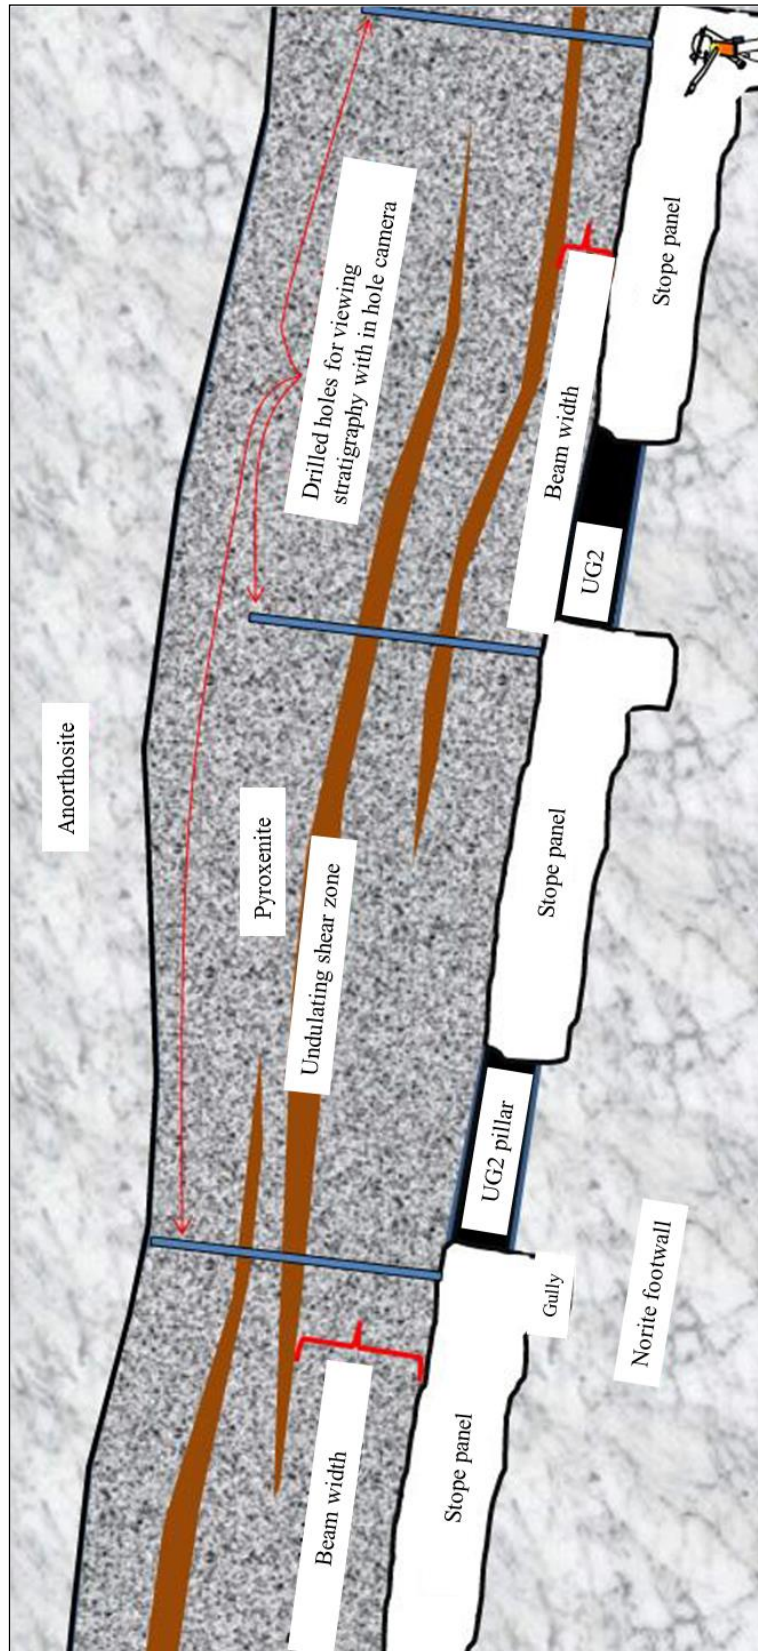
Lombard (2018) created an illustration (Figure 2.34) of the location of the alteration zones from core that was drilled across a mine in the Western Limb of the Bushveld Complex. In most instances, the altered material washed out and it was not captured during the core logging process and the weakening effect was not incorporated into the support design.

In the case where the alteration zone is located along the top reef contact, it will be a challenge to support this material as it unravels between and around the installed support units. Areal coverage will have to be considered. The unravelling of this material during blasting causes dilution (increase in stoping width) and if the grade is too low, mining will not be economically viable. It will also have an impact on the pillar behaviour.

In the case that the alteration zones are located within the hangingwall units, it contributes to a decrease in the friction angle of the alteration zones and other contacts. Large-scale instabilities can then occur. Stiff, active grout packs will be required to support to the highest possible parting plane.

Figure 2.34: An illustration of the undulating nature of the hangingwall alteration zone and its potential effect on stope hangingwall beam stability as well as the in-stope support. The alteration zone may be more continuous as suggested by the picture (Lombard, 2018).

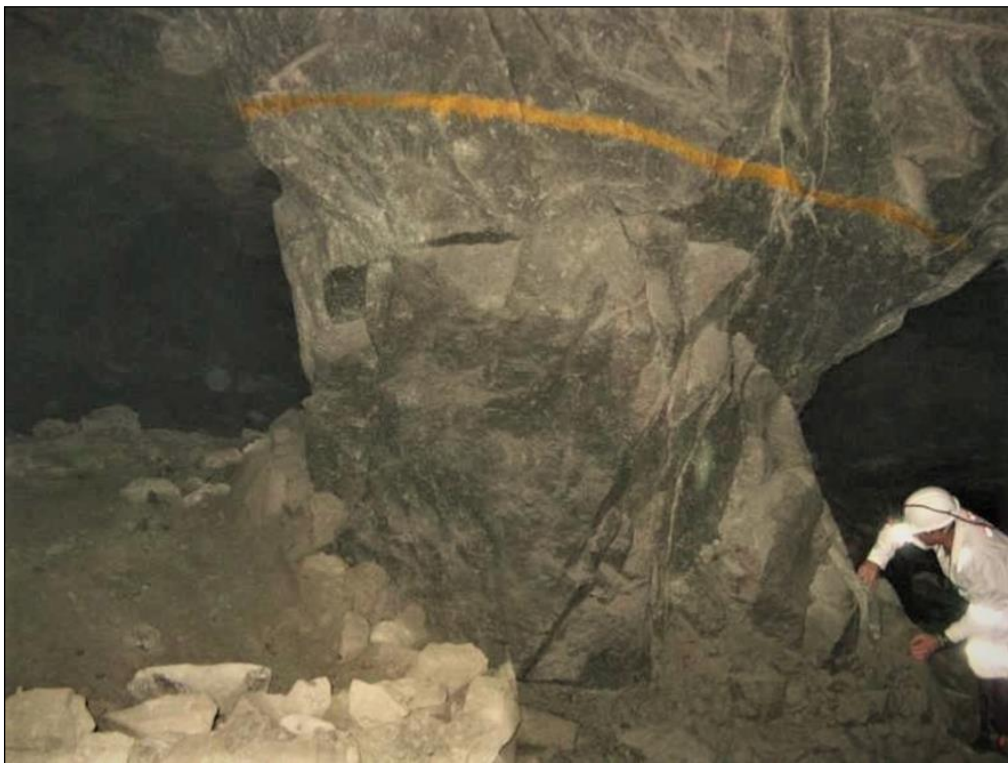
At this site, mechanised mining was conducted in a room and pillar layout. The mining height was approximately 2.25 m and pillar dimensions varied according to ground class. A large number of joint sets and possible shear zone configurations existed. The nature of the problem was therefore extremely complex. Regional and local stability was provided by non-yield pillars which support the load up to surface. In the shallow part of the operation, footwall heave and unravelling of blocks along joints from the pillar walls was observed (Figure 2.35).

Figure 2.35: Unravelling caused by joint planes in the pillar (More O’Ferrall and Du Plessis, 2017).

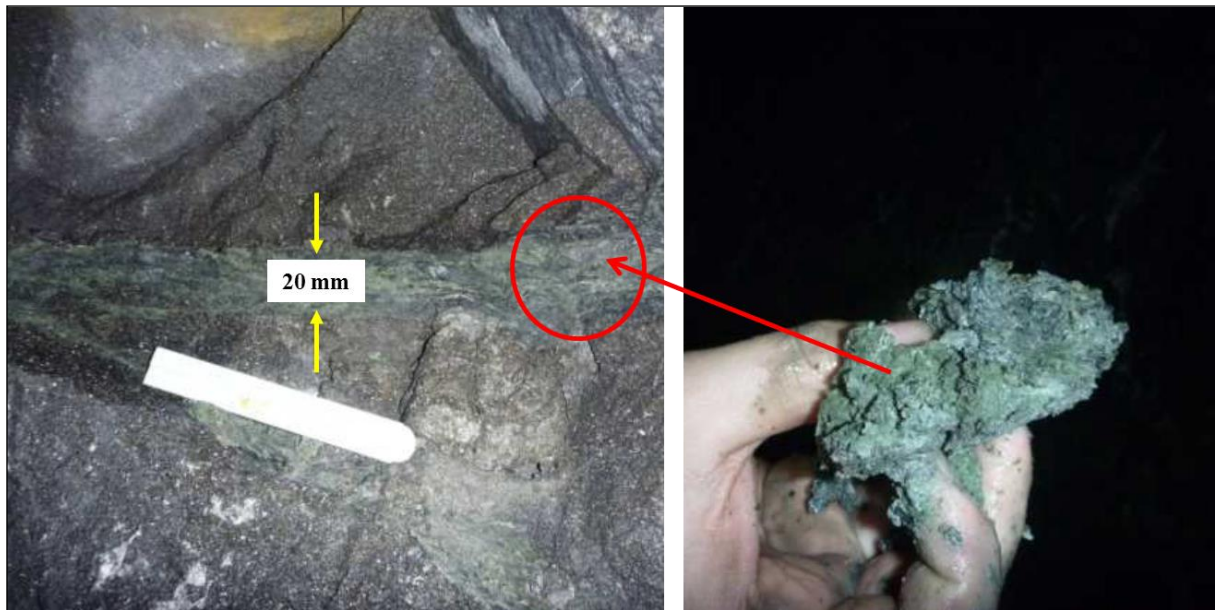
In the deeper section of the mine, the Mutambara shear (a few mm to 50 mm thick) was exposed along the hangingwall or within the pillars. Where exposed in the pillars, slabbing of the pillar walls, both above and below this shear layer, (Figure 2.36) occurred. The challenge was that this shear zone was not always identified in the borehole core logging. Additional logging of some boreholes indicated that the shear zone

Figure 2.36: The mylonitic shear layer (Mutambara shear) within a pillar at Bimha Mine (More O’Ferrall and Du Plessis, 2017).
