**STRUCTURAL MECHANISMS CONTRIBUTING TO
LARGE-SCALE HANGINGWALL INSTABILITIES ON THE
UG2 REEF HORIZON**

MSc Mining

UNIVERSITY OF PRETORIA

2019

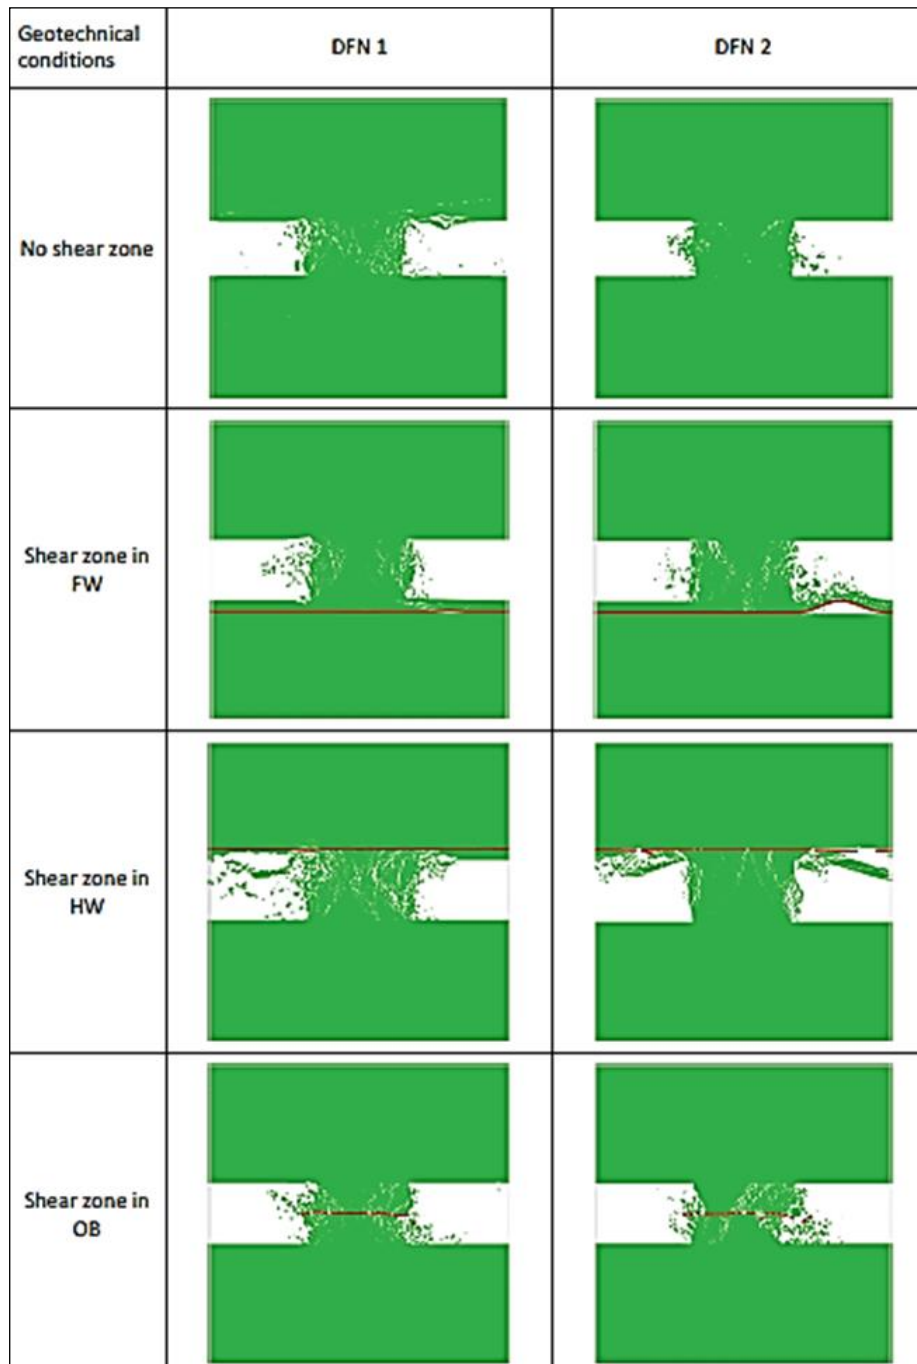
program 3DEC was used to generate stochastically 3D DFNs from which 2D sections were cut and imported into the 2D program, UDEC. Owing to time constraints, only two DFNs (DFN 1 and DFN 2) were examined and were selected such that DFN 1 incorporated a low-angle random joint set. Four shear zone configurations were examined for each DFN including, shear in the footwall, in the hangingwall, in the orebody and a case without a shear structure (Figure 2.37).

Figure 2.37: Simulated failure mechanisms in the pillars at Bimha Mine (after Muaka *et al.*, 2017) No shear zone, shear zone in the hangingwall (HW), footwall (FW) and within the reef (OB).

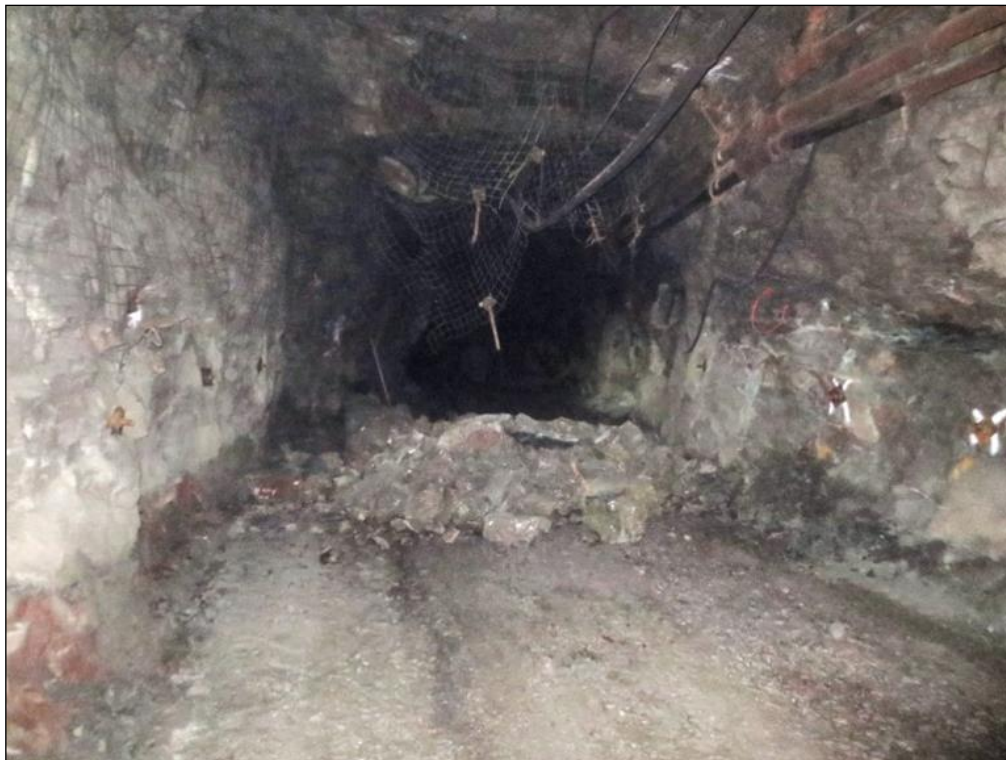
Figure 2.38: Localised fall of ground (More O’Ferrall and Du Plessis, 2017).

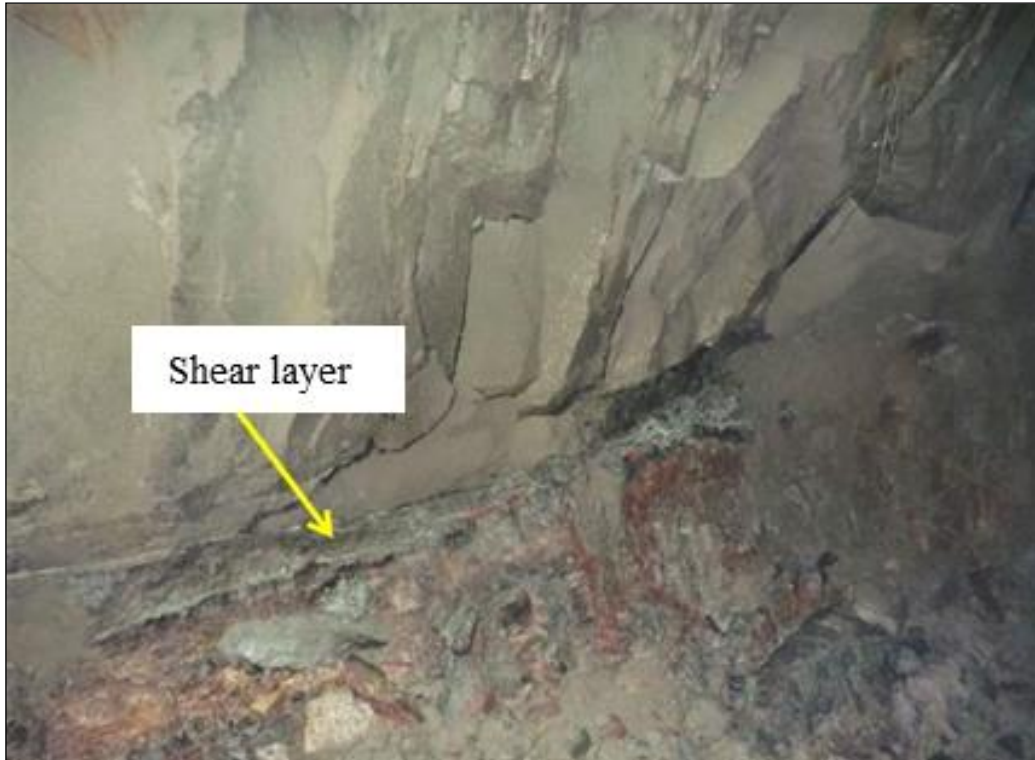
Figure 2.39: Shear layer exposed in the underground workings.

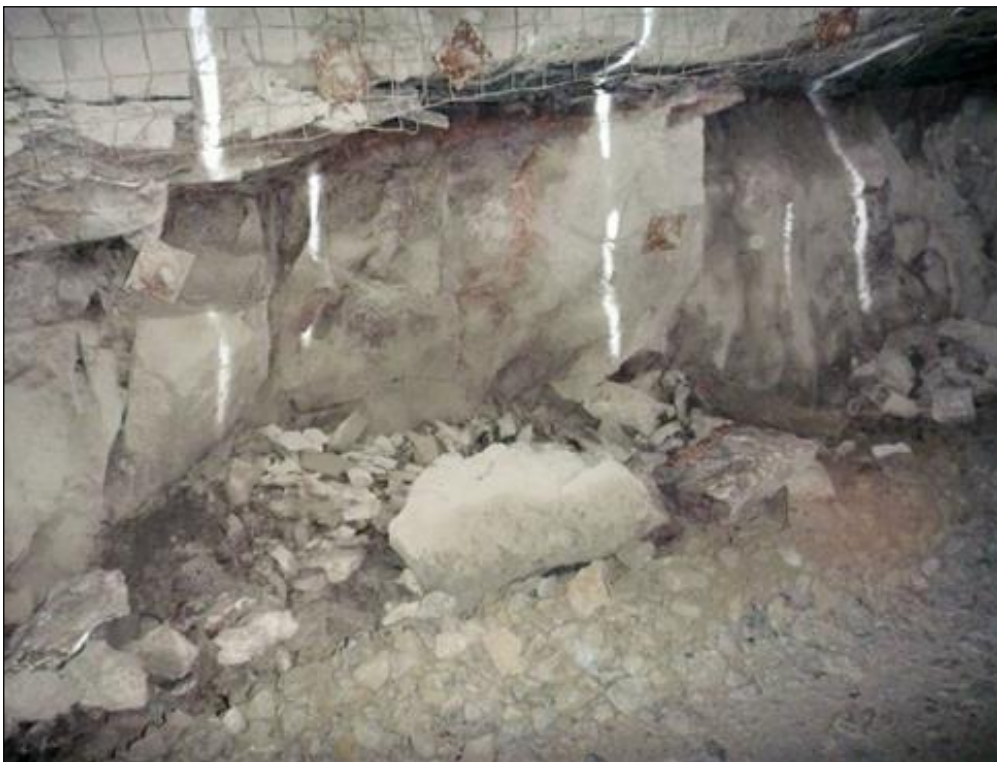
Figure 2.40: Unravelling of the pillar wall below the shear layer (More O'Ferrall and Du Plessis, 2017).

The pro-active identification of the early signs of pillar instability, which included squeezing out of the kimberlite below the shear layer, slabbing of pillar walls and footwall heave was not conducted. Remedial actions were taken to limit the extent of instability. In most cases, the lack of identification, investigation and understanding of the failures which occur (small- or large-scale) will cause unpredictable or large-scale instabilities.

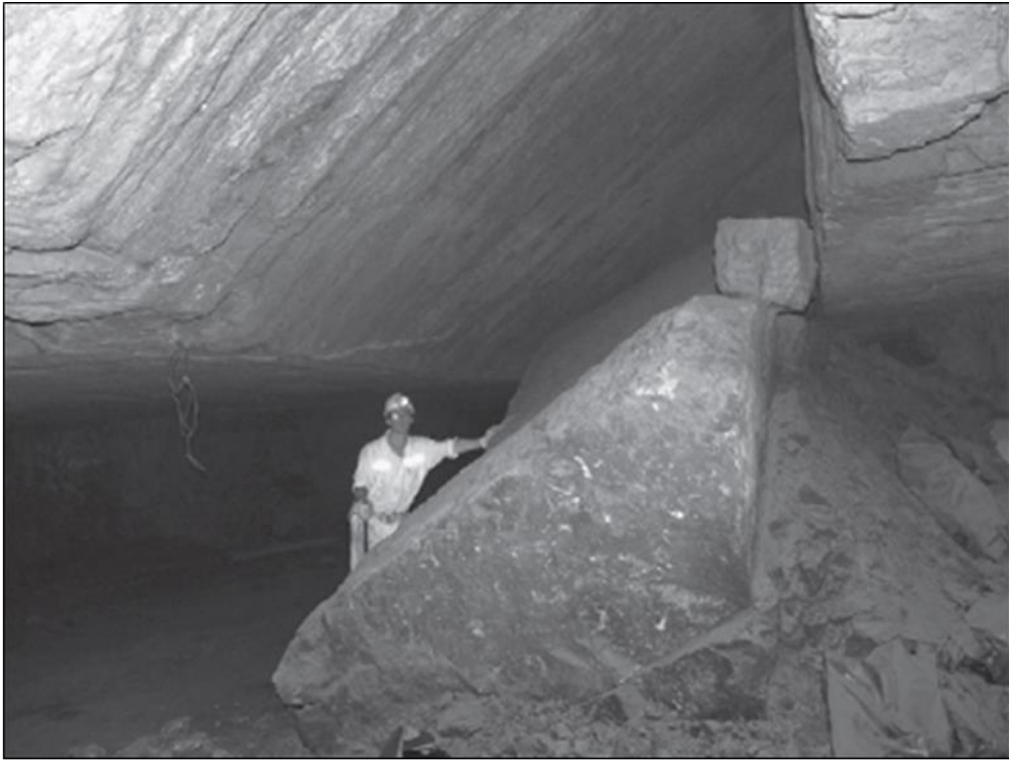
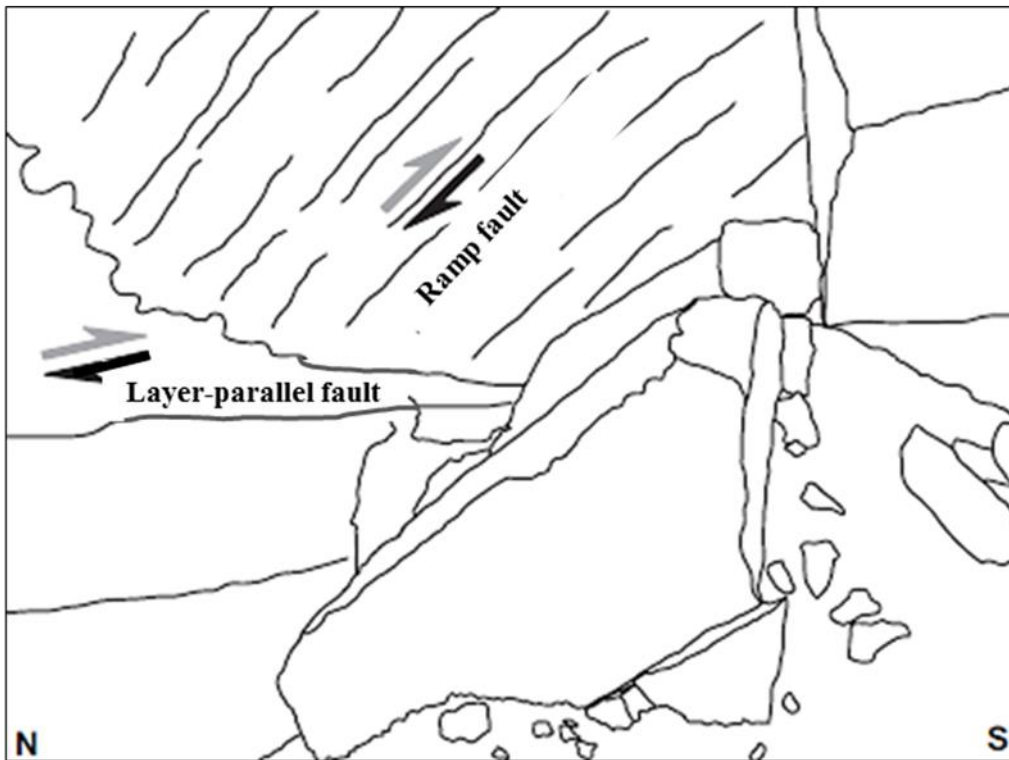
Figure 3.1: Photograph and interpretation of an underground exposure of layer-parallel faults and ramp faults (Perritt and Roberts, 2007).

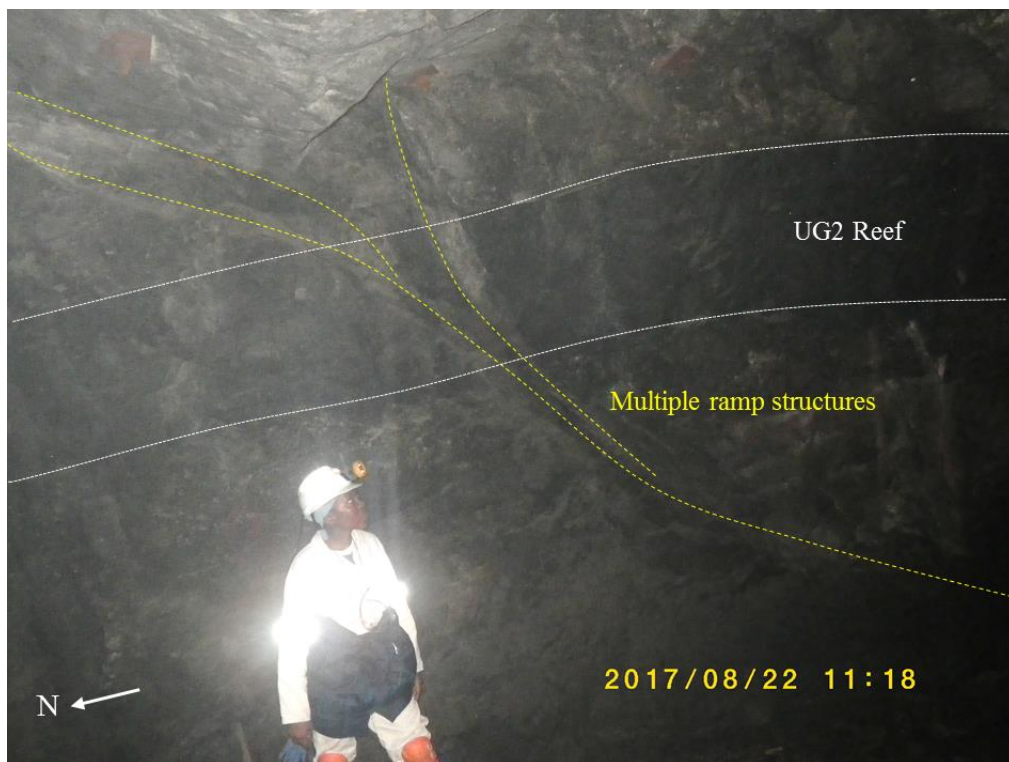
Figure 3.5: Interlinking ramp structures exposed along the UG2 Reef in a development end.

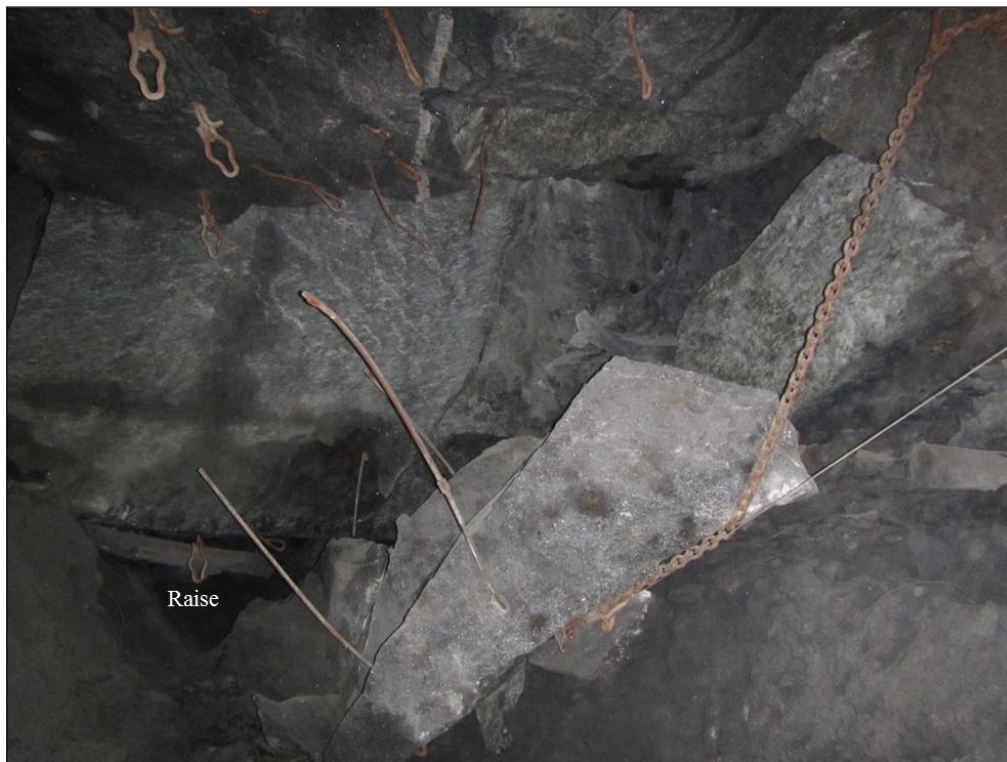
Rowland Shaft uses a conventional mining method within an up-dip and down-dip split panel configuration (half a panel is mined on both sides of the development end) at a stope width of approximately 1.2 m. A large collapse (approximately 14 000 tonnes) occurred at 16 West Level (Figure 3.6) where a WNW-ESE striking, reverse fault and associated secondary structures were exposed.

Figure 3.6: Fall of ground at 16 West Level, Rowland Shaft. Only approximately 0.5 m of the footwall raise is visible after the fall of ground occurred. The surface of the WNW-ESE trending down-dip boundary of the fall of ground is visible in the photograph.

(Marikana structures) have been identified at this site. Instability was initiated where the low-angle structures ramped to the hangingwall 1A/hangingwall 2 contact. Only timber elongates and rock bolts were installed in this area. The instability resulted in timber elongates buckling due to excessive deadweight loading and others riding out due to wedge rotation (Figure 3.9). This collapse triggered the unravelling of the affected area. There is no history of similar collapses on Rowland Shaft. This area is mining in close vicinity to a major, low-angle reverse fault zone and a pothole was exposed up-dip of the site. The buckling of timber elongates and then the installed closure logger that triggered, indicated hangingwall instability. The pro-active decision making from the Mining and Rock Engineering personnel prevented injuries by removing the crews from this working place 4 hours prior to the collapse. Figure 3.7 illustrates that the instability occurred as the panel advanced for a distance of twice the panel span.

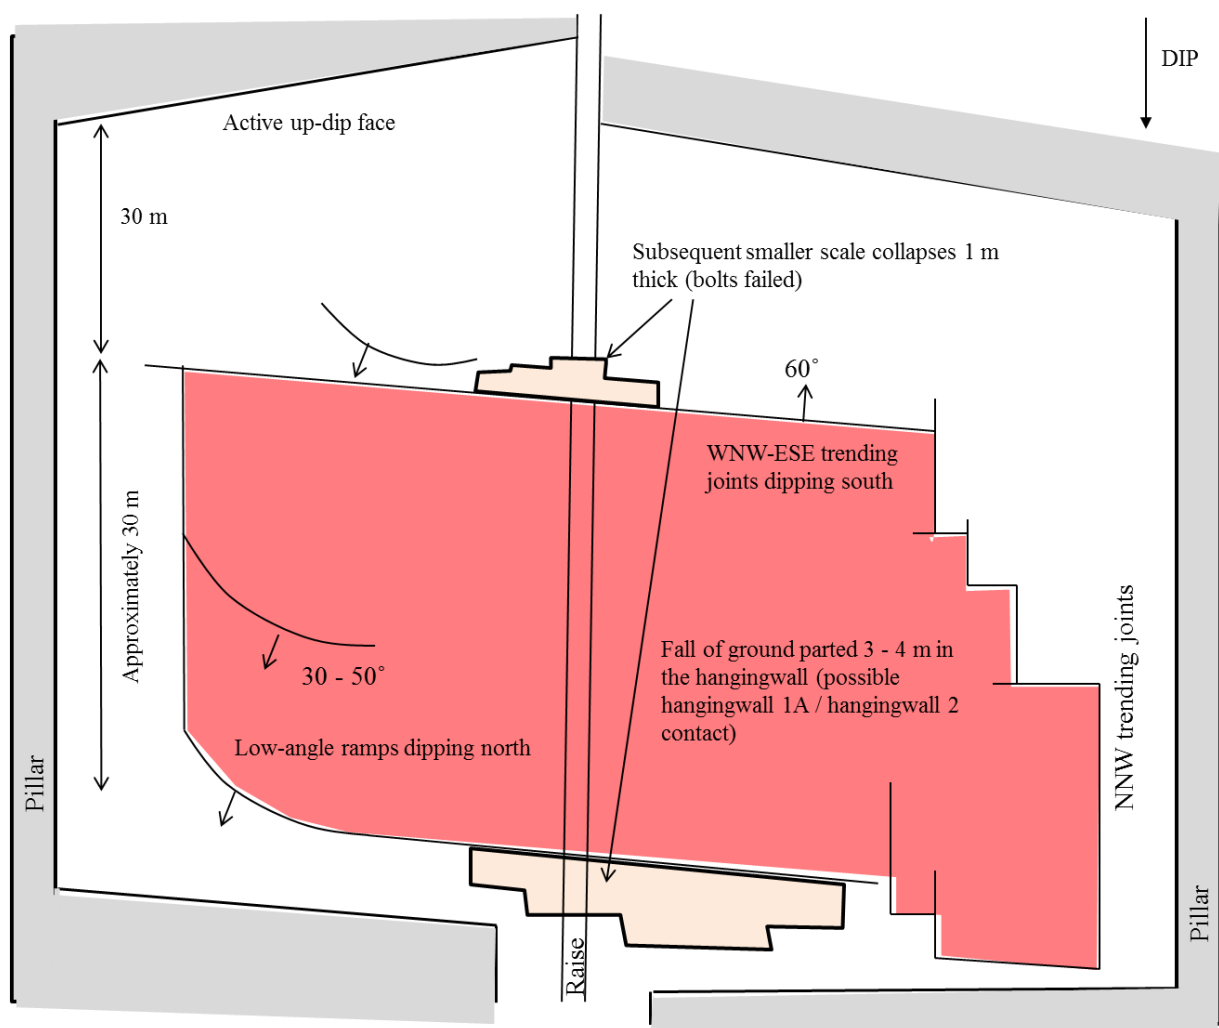
The plan view in Figure 3.7 and section view in Figure 3.8 show the geologic structures that contributed to the collapse. These structures coincide with the structures shown in Figures 3.1, 3.2 and 3.4. A network of ramp structures dipping north and problematic WNW-ESE striking joints that dip towards the south

Figure 3.7: Plan view of geologic structures identified at the fall of ground site. The red hatching indicates the initial collapsed area and the orange show the subsequent unravelling. This panel has advanced approximately twice the panel span.

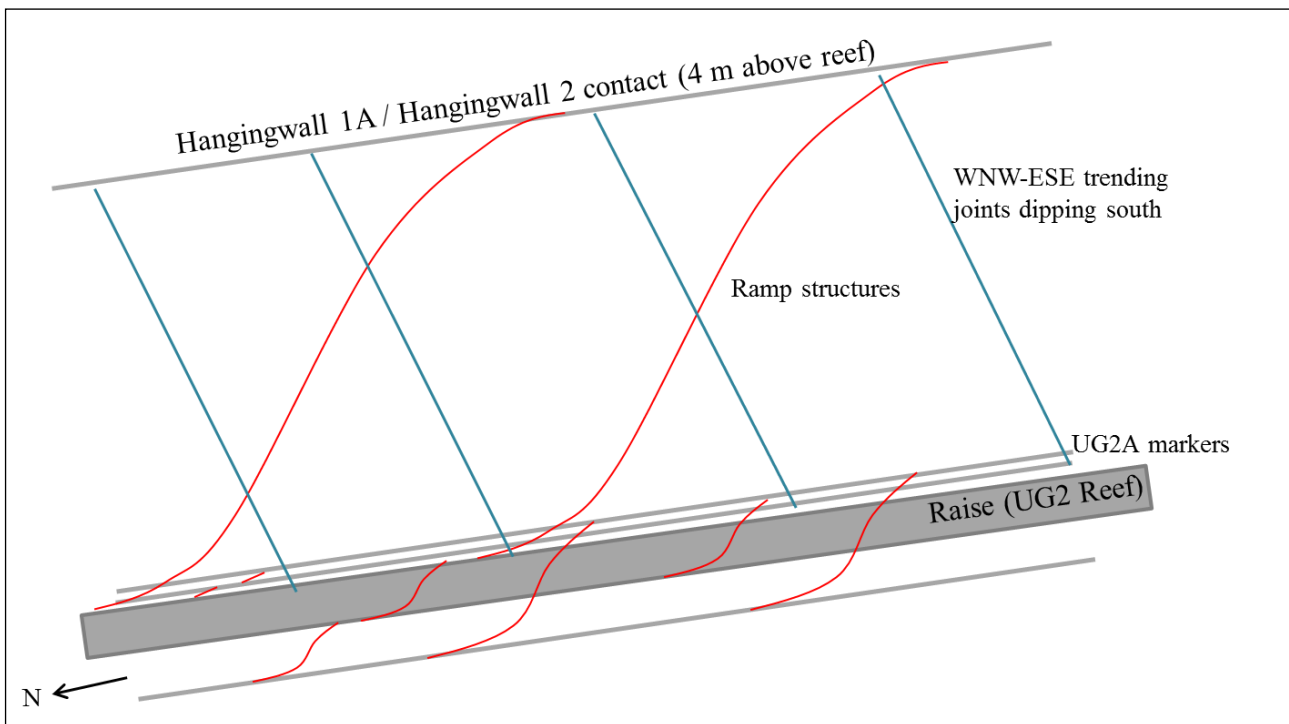
Figure 3.8: Section view of geologic structures, Marikana structures and interlinking ramp structures, identified at the fall of ground site.

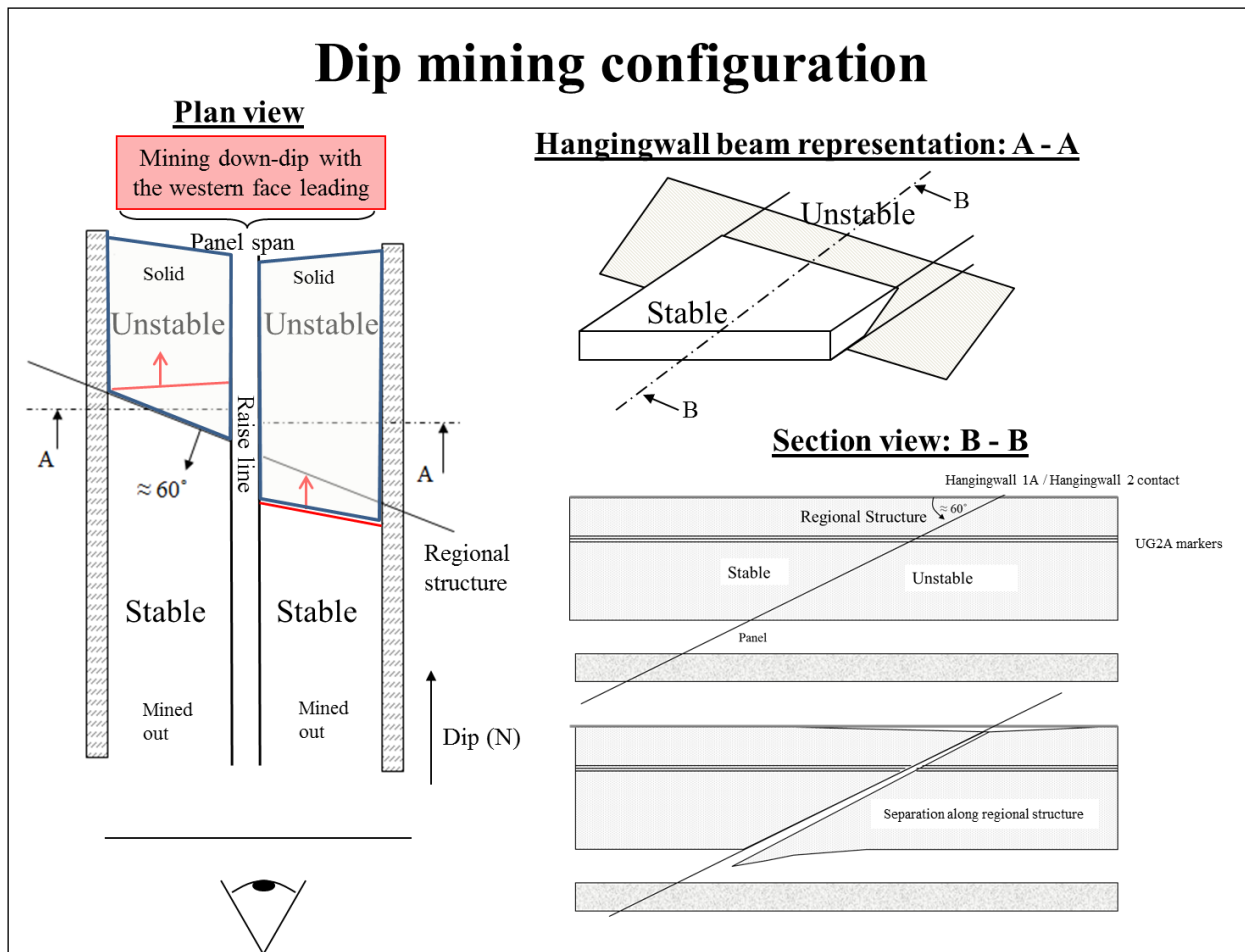
Figure 3.10 illustrates the most favourable dip mining layout and mining direction when intersecting the Marikana structures. In Figure 3.10, the structure cross-cuts the mining direction obliquely. Only a portion of the structure is exposed at a time (after each blast). The structure and associated behaviour can therefore be controlled by the timely installation of the appropriate support. The span will only reach its maximum once the structure is fully exposed. Figure 3.10 shows that when only a half panel is mined at a time, the overall mining span is limited (controlled by leading and lagging panels). For a split-dip mining configuration, down-dip mining is more stable. The panel is mined from the stable side; the western face must lead to only expose half of the ‘potentially’ unstable structure. The eastern face supports the structure (unmined area). The support along the western panel must be installed in time before the lagging eastern panel face exposes the entire structure. Du Plessis (2009) suggested that by limiting the inter-pillar span to 27 m, the potentially unstable beam should not experience any deflection. The installed support units should therefore not be compromised and overall hangingwall stability should improve.

Figure 3.10: Recommended split down-dip mining configuration, with the western face leading to control the associated behaviour when intersecting the regional (Marikana) structures.

The alternative strategy as shown in Figure 3.10 is to mine using a split down-dip configuration with the western face leading. Other orientations have shown to be problematic and result in instabilities (e.g. breast mining towards the west, up-dip mining and long panel down-dip).

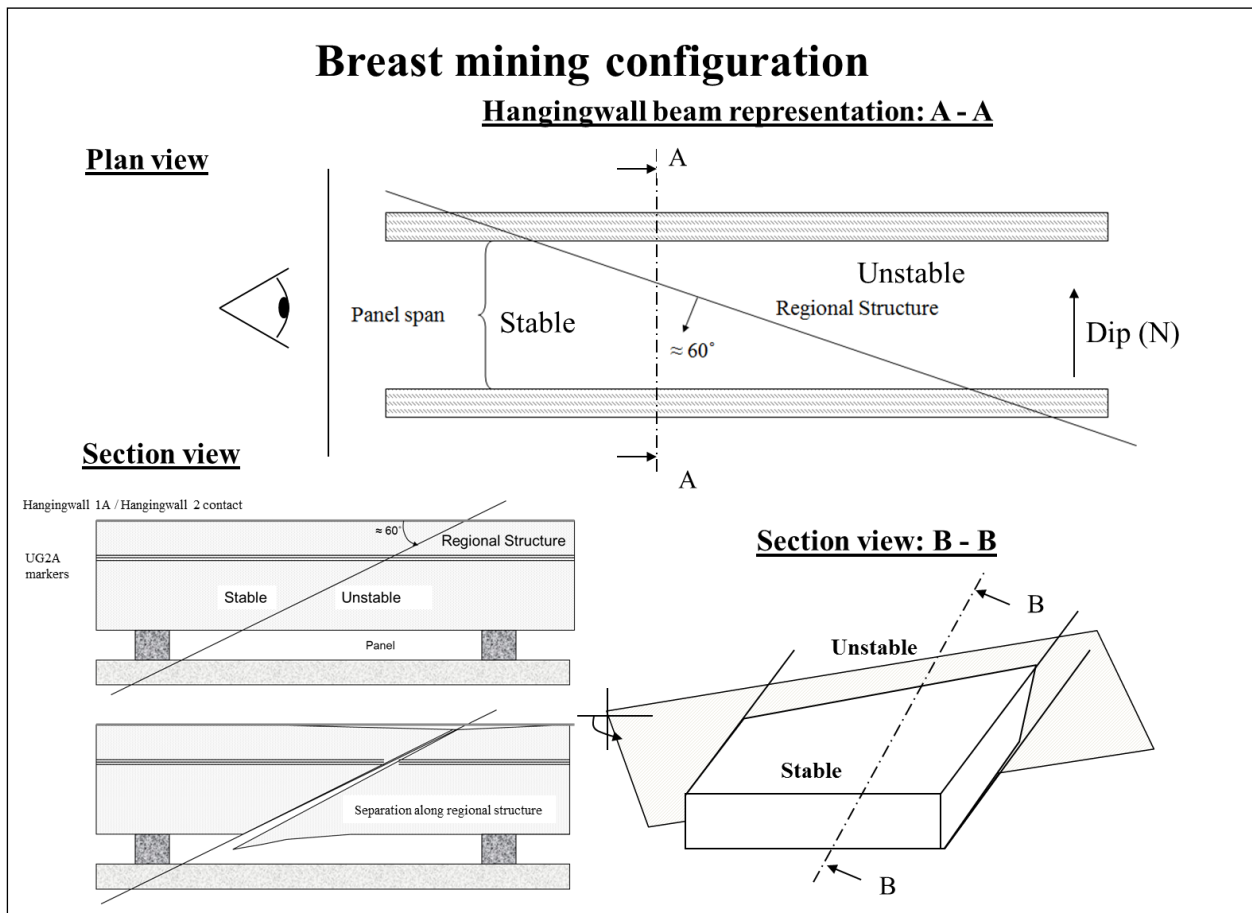
At some sites with similar geotechnical conditions, a breast mining configuration (Figure 3.11) is applied. These sites (Saffy, Hossy and Eastern Platinum Limited 2 Shafts) are discussed later in this chapter. Van Zyl (2011) did extensive joint mapping and joint modelling (using JBlock) to consider the impact of the structures on the mining layout and support strategies. In the case where a breast mining configuration is implemented, the low risk option is to mine in an eastern direction, limiting the inter-pillar span to 27 m. The mining face will incrementally increase the span as the Marikana structure is exposed. Only a portion of the structure is exposed after each blast. The structure and associated behaviour can therefore be controlled by the appropriate support. The span will only reach its maximum if the structure is fully exposed by the mining span. Stiff, active support is required to support to the height of the potentially unstable beam. If grout pack support is considered, the grout packs must be stiff and active in order to provide high early strength close to the face and prevent back breaks.

Figure 3.11: Recommended breast mining configuration, mining in an eastern direction to approach the regional (Marikana) structures from the stable side.

In the case where a breast mining method is used and the Marikana structures are encountered, the best option is to mine in an eastern direction, limiting the inter-pillar span to 27 m (Figure 3.11). The mining face will incrementally increase the span as the Marikana structure is exposed at the advancing face position. As the structure obliquely cross-cuts the mining direction, only a portion of the structure is exposed at a time (after each blast). The structure and associated behaviour can therefore be controlled by the appropriate support. The span will only reach its maximum if the structure is fully exposed by the mining span.

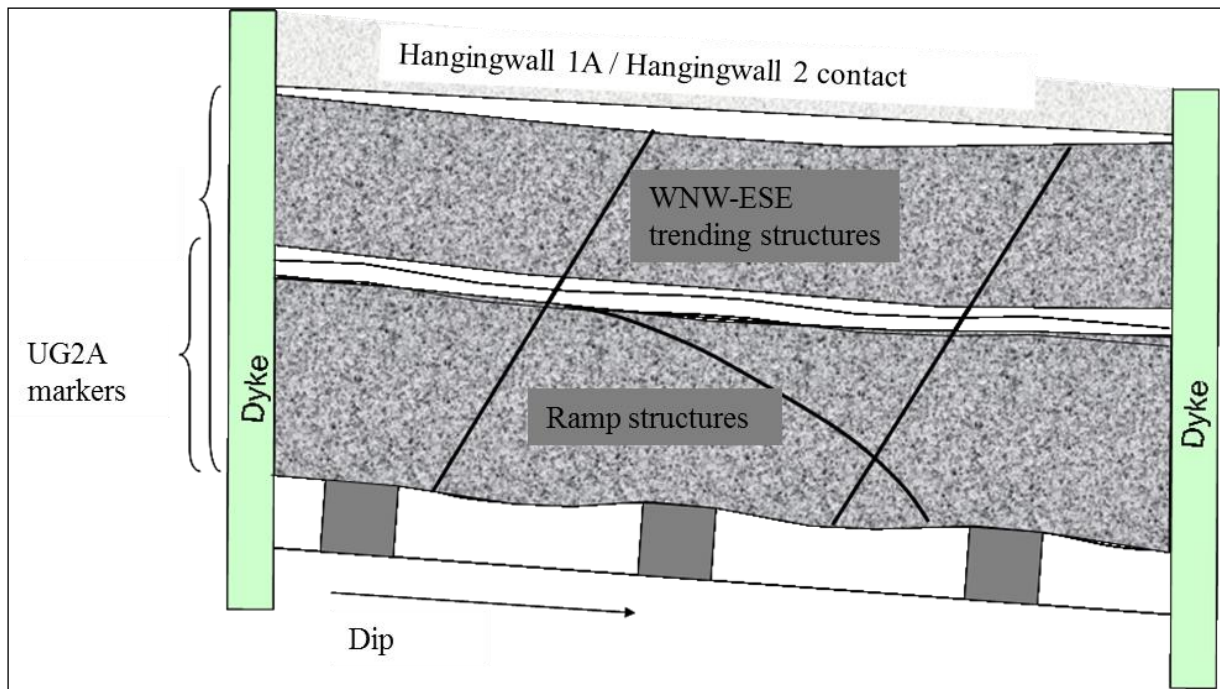
The hangingwall beams are not continuous as a result of the dyke intrusions and the presence of regional structures. Figure 3.13 show the probable hangingwall behaviour through the interaction of dykes, jointing and ramp structures. The grout packs and timber elongates experienced excessive loading from the collapse of the beam (Figure 3.15).

Figure 3.13: Hangingwall behaviour where it is cut off between the two dykes. It is hypothesised that this beam is in compression as discussed below. Major structures cause beam separation at the hangingwall 1A/hangingwall 2 contact, resulting in excessive support loading and failure in the panels.

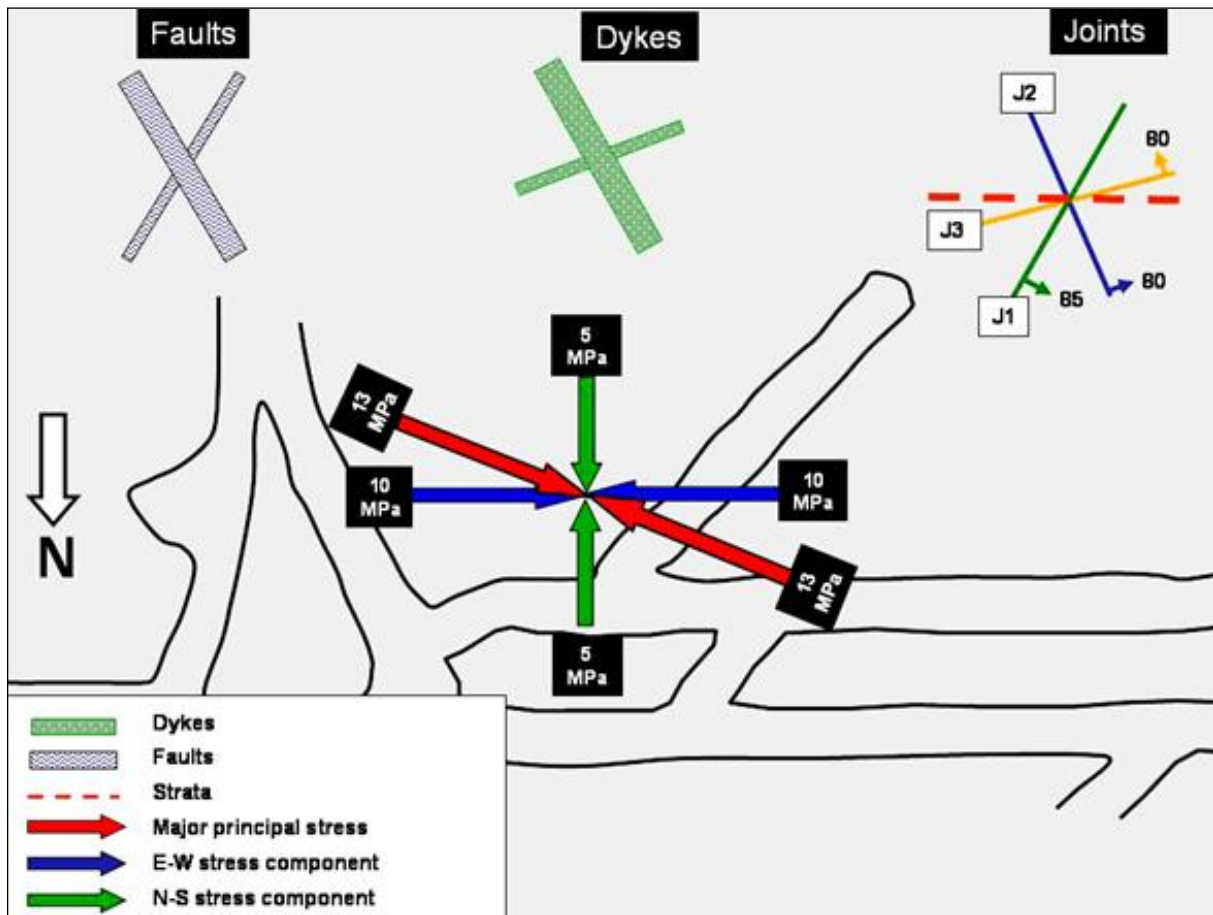
Stress measurements have been conducted at the Marikana Operations, including Saffy Shaft. The measurements showed that the major principal stress across the Marikana Operations is approximately in a NNW-SSE direction (parallel to the Wegener Stress Anomaly and major fault structures across the property). However, an anomalous measurement in the vicinity of where the instabilities occurred at Saffy Shaft indicated that the major principal stress direction is approximately in a WNW-ESE direction (Figure 3.14). It was only after the instabilities shown in Figure 3.12 occurred that this measurement was considered as part of the investigation. It is hypothesised that the intrusions of the dykes increased the horizontal stresses (k-ratio of 1.8), resulting in hangingwall instability and support failure in the panels (Figures 3.13 and 3.15). The high horizontal stress may cause failure in the hangingwall in areas where flat dipping structures form a discontinuous beam.

Figure 3.14: Stress magnitudes and orientations from a measurement at Saffy Shaft (Du Plessis, 2010). The measurement show high WNW-ESE stress in the vicinity of the dykes. It is assumed the magnitudes shown here is applicable to the area of instability in Figure 3.12.

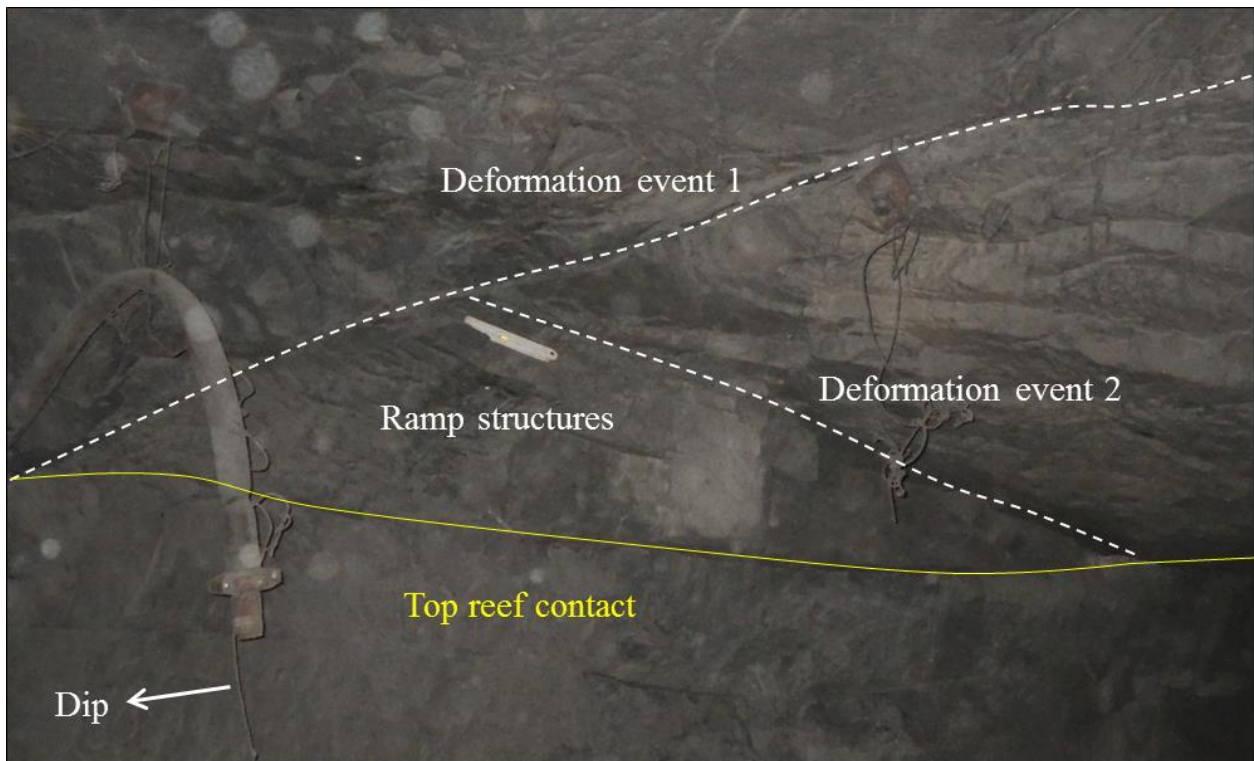
E-W striking, flat north and south dipping ramp structures (Figure 3.16) are seen to splay from the major structures (Figure 3.4). These structures also contribute to the instabilities experienced. Two deformation events have been identified which are believed to be associated with the formation of the ramp structures. Deformation event 1 is characterised by layer-parallel, south-directed at Lonmin, outward flexural-slip thrusting from the centre of the Bushveld Complex along prominent lithological contacts during the cooling phase. Deformation event 2 refers to regional extension across the area of the Bushveld Complex towards the centre of the Bushveld Complex (north-directed at Lonmin).

Figure 3.16: Ramp structures (Deformation events 1 and 2) splaying along the top reef contact into the hangingwall. These structures typically ‘ramp up’ to the next potentially weakness plane (UG2A markers or the hangingwall 1A/hangingwall 2 contact).

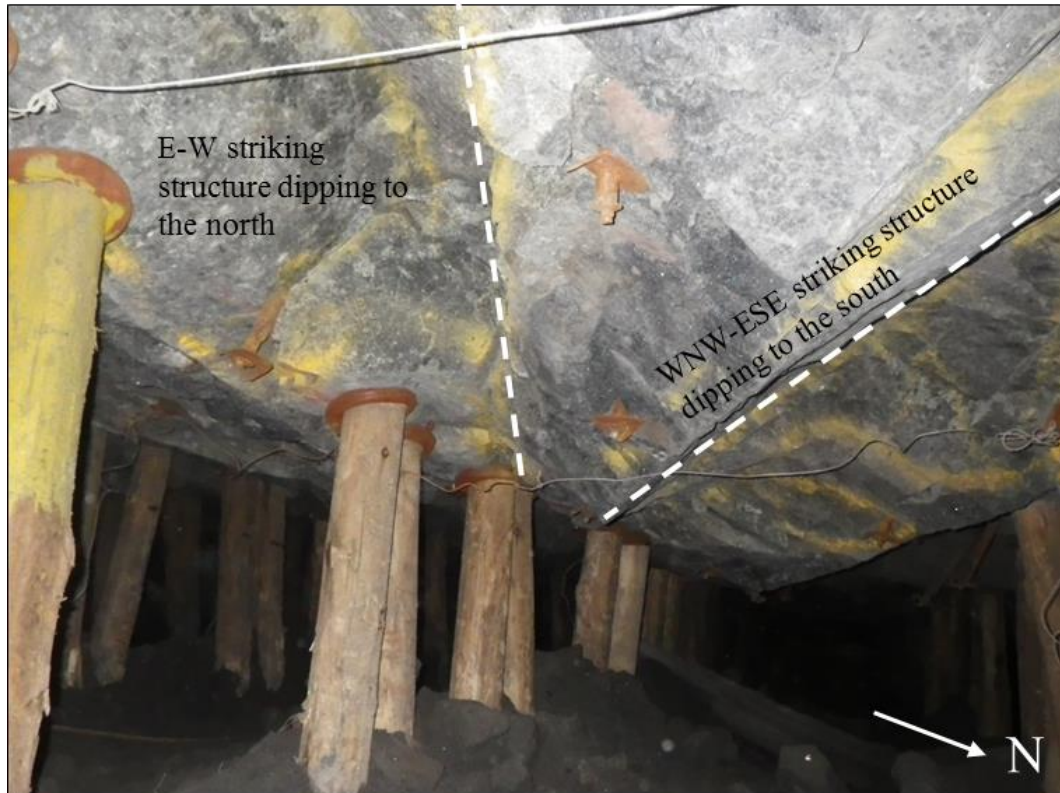
At the intersection of NNW-SSE clusters (Figure 3.17) and WNW-ESE or E-W striking geologic structures (Figure 3.18), structural wedges form. This results in poor hangingwall conditions and potential falls of ground. The fallout height of the falls of ground depends on where both structure sets intersect one another above the UG2 top reef contact. The wedges that formed grow in size where ramp structures (Figure 3.16) intersect the layer-parallel structures developed along the UG2A markers. At Hossy and Saffy Shafts these can be situated 7 – 10 m above the top reef contact.

Figure 3.18: E-W and WNW-ESE striking structures exposed in a panel.

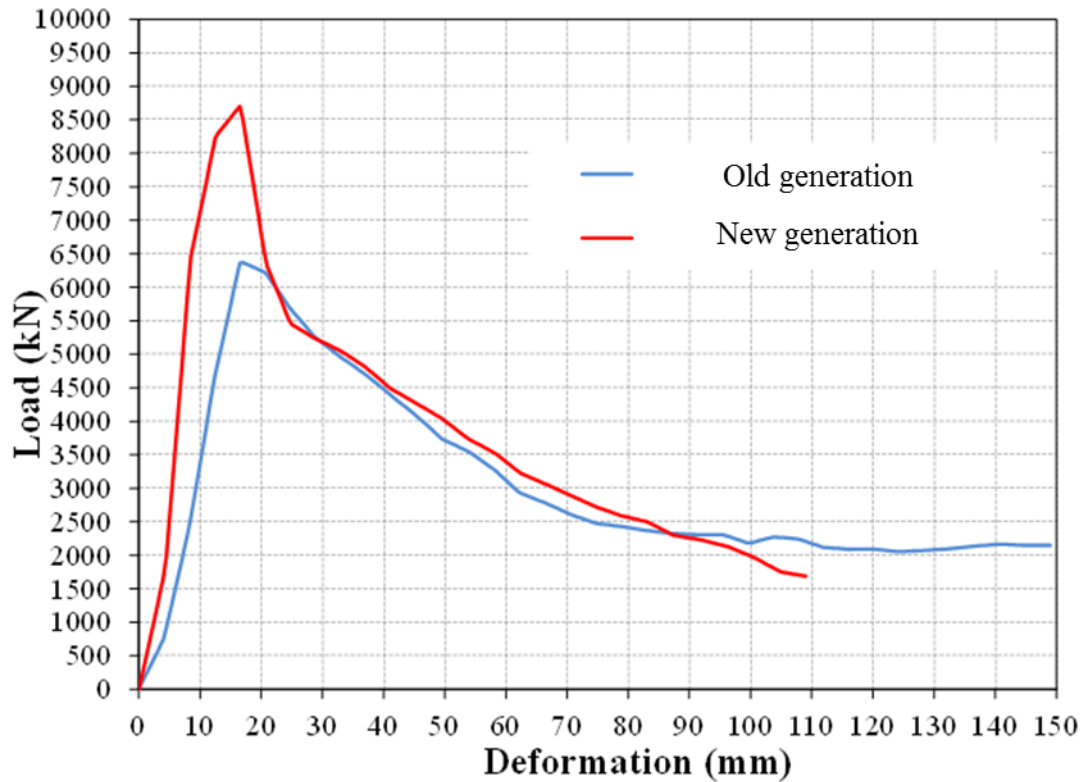
Figure 3.19: Load performance characteristics of the new generation grout pack versus the old generation grout pack filled with the same 16 MPa grout mix. Higher, early strength is obtained from the new generation grout pack. The new generation pack provided approximately 870 t and the old generation pack provided 600 t.

- Denser timber elongates to support to the height of the UG2A markers.
- Replace the passive grout packs with the stiff; active new generation grout packs (Figures 3.19 and 3.20). More timber elongates (primary support) and high strength grout packs (secondary support) can be implemented or closely spaced high strength grout packs (as both primary and secondary, back area support) should be implemented. These new generation grout packs have fast curing time properties. These packs can therefore be installed closer to the face which will promote improved mining cycle times. These grout packs also have a pre-stress ability and provides high early strength which will increase the overall stability. Load data have been obtained from a MatlaMat (load cell) installed on two new generation grout packs, as shown in Figure 3.20. A pre-stress (approximately 40 tonnes) load was achieved by the packs through regular filling activity. The advantage of the system would be that, even if the hangingwall does unravel, as a result of separation along joint and faults, the packs will provide a secondary support function after a certain degree of compression and will stabilise the rock mass.

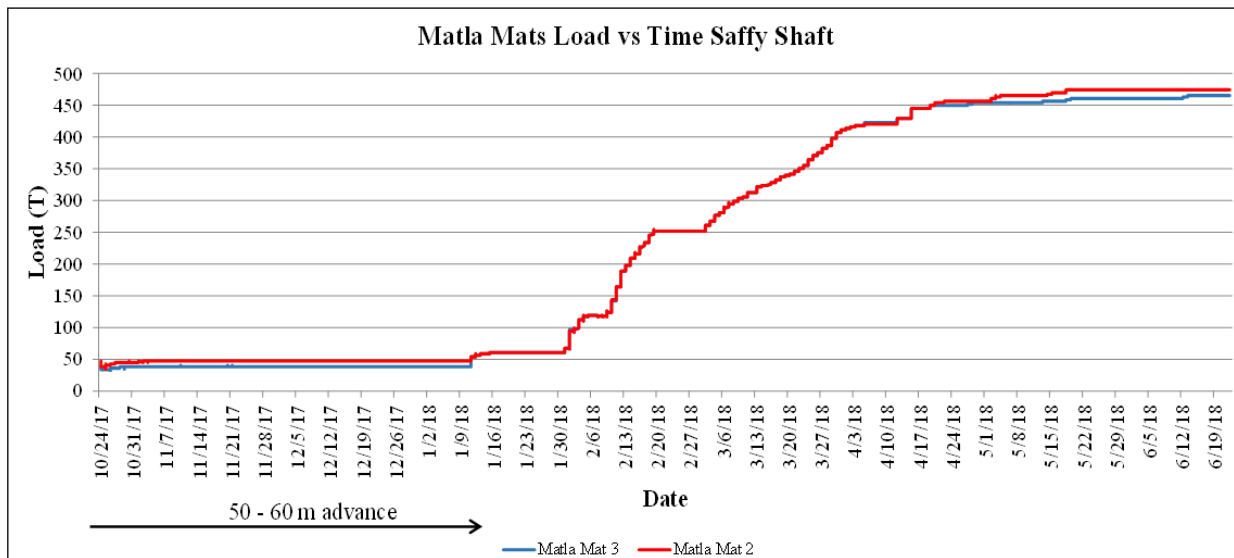
The instrumentation (MatlaMats) in Figure 3.20 results illustrates an increase in load after 50 – 60 m face advance. This confirmed observations made from case studies by the author on adjacent Lonmin Operations which indicated that back breaks typically occur where associated structures were intersected once the panel had advanced for approximately twice the panel span. This was confirmed at Rowland Shaft (Figure 3.7) as well as at Saffy and Eastern Platinum Limited 2 Shafts.

Figure 3.20: Load data obtained from a MatlaMat (load cell) installed on two new generation packs. Note the pre-load (approximately 40 tonnes) achieved by using the packs. The instrumented packs experienced an increase in load when the panel advanced approximately 50 m as a result of the surrounding hangingwall instability. The panel was only supported with old generation grout packs (no pre-load) on a 3 m square grid pattern (Liebenberg and Du Plessis, 2018).

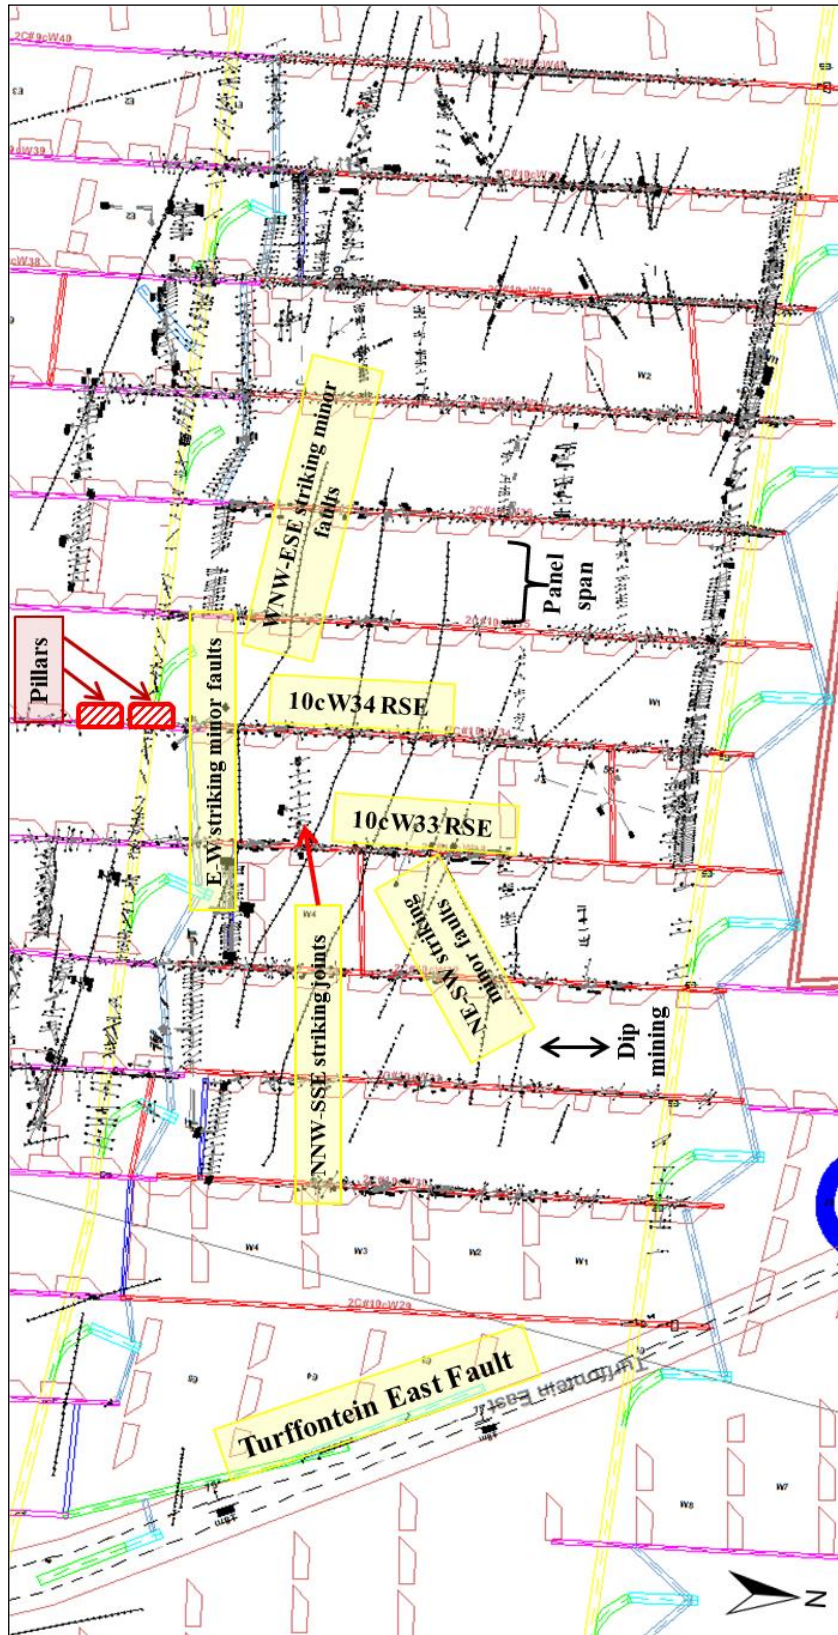
Instabilities were reported at 10 Chrome West 33 and 34 Raise lines (Figure 3.21). Figure 3.22 shows the geologic structures exposed in the panel, including NNW-SSE striking, near-vertical joints and faults, WNW-ESE striking, low-angle joints and faults (Marikana structures) as well as interlinking joints and faults which alternate in strike direction from E-W to NE-SW.

The anomalous conditions reported included unstable hangingwall behaviour with separation occurring along low-angle geologic structures, pillar slabbing experienced along the in-stope dip pillars (Figure 3.23) and buckling of the timber elongates (Figure 3.24).

Figure 3.21: Mining layout and geologic structures at Eastern Platinum Limited 2 Shaft.
