**STRUCTURAL MECHANISMS CONTRIBUTING TO
LARGE-SCALE HANGINGWALL INSTABILITIES ON THE
UG2 REEF HORIZON**

MSc Mining

UNIVERSITY OF PRETORIA

2019

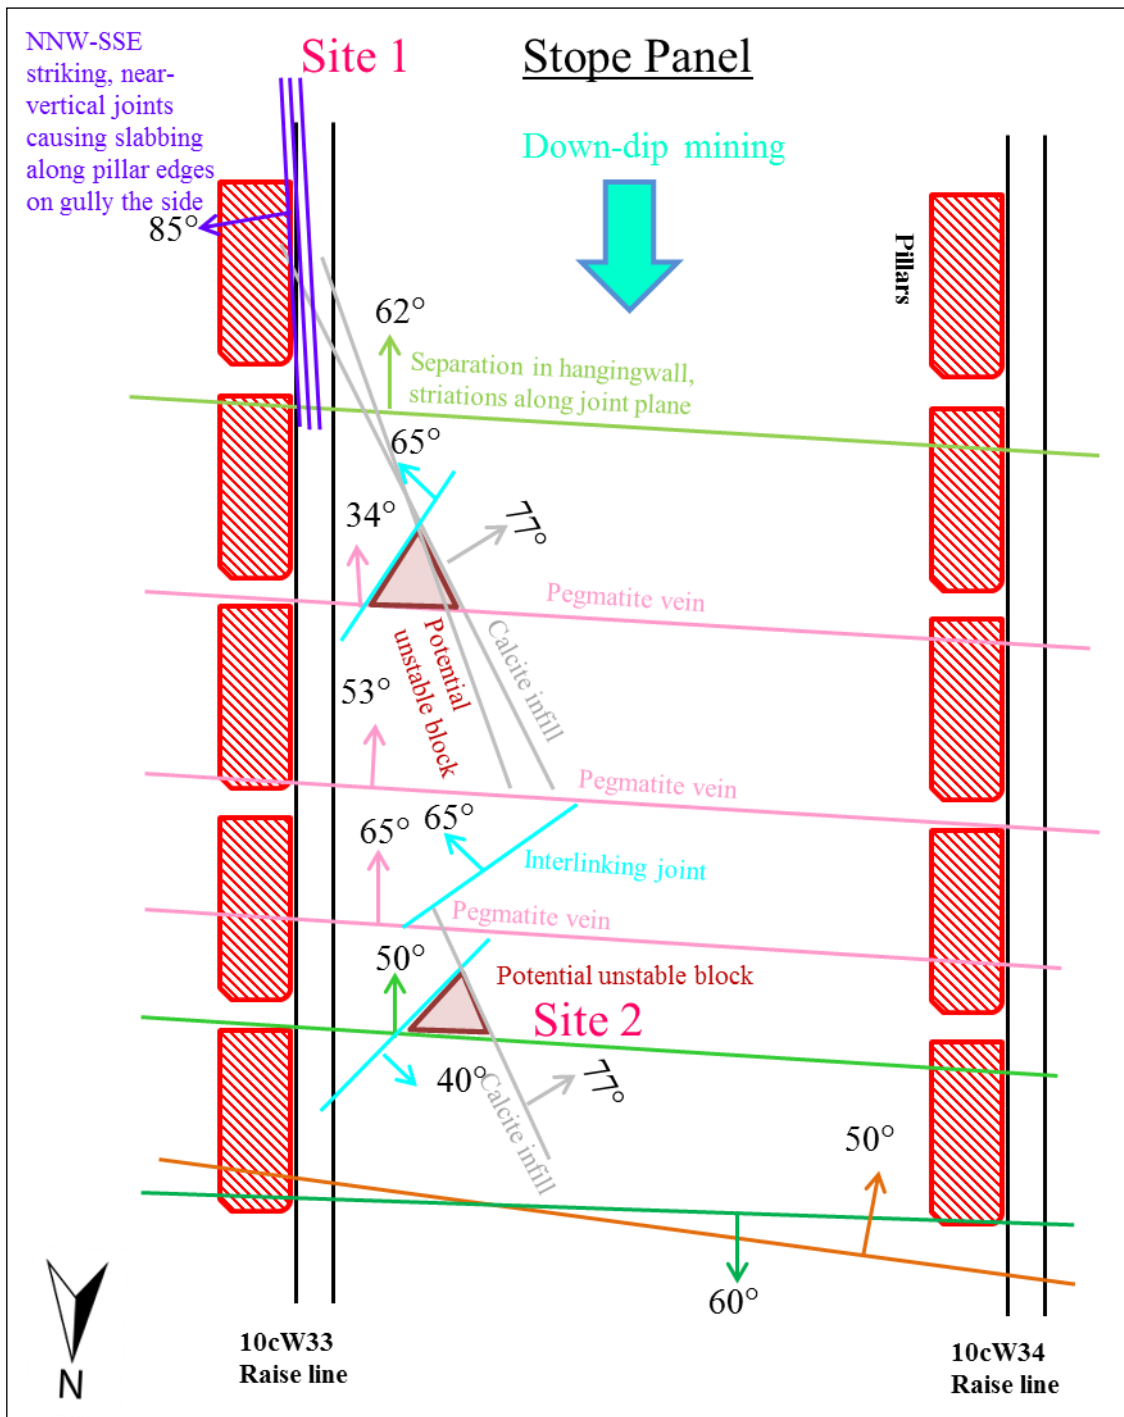
From the investigation conducted by the author, the slabbing of the non-yield pillars was found to be a result of both the joint orientation and an alteration zone present along the reef top and/or bottom contacts. Site 1 in Figure 3.22 shows the orientation of the NNW-SSE striking joints in relation to the dip pillars. The joints intersect the pillars at oblique angles (Figure 3.23). These slabs defined by the joint planes are mobilised where an alteration zone is present along the pillar top- or bottom contacts of the UG2 Reef. This results in the observed ‘pillar slabbing’ experienced.

Figure 3.22: Geotechnical mapping of the down-dip panel at Eastern Platinum Limited 2 Shaft where two sites with anomalous rock mass conditions have been identified along 10 Chrome West 33 Raise line.

At site 2 (Figure 3.22), timber elongate failure was observed (Figure 3.24) as a result of the intersection of a Marikana structure. The critical span seems to be reached when the panel has advanced for approximately twice the panel span (e.g. 60 m). The dislocated block causes overloading of the support units and ultimately support units fail. This behaviour results in large-scale back breaks and the hypothesis of a critical span of 60 m has been confirmed by the instrumentation results obtained from Saffy Shaft (Figure 3.20).

Similar to the Saffy site where these Marikana structures are intersected, the hangingwall is of a discontinuous nature (Figure 3.24). A breast mining configuration (Figure 3.11) in an eastern direction or a split down-dip configuration with the western face leading (Figure 3.10) are the most suitable layouts and mining directions when the Marikana structures are exposed.

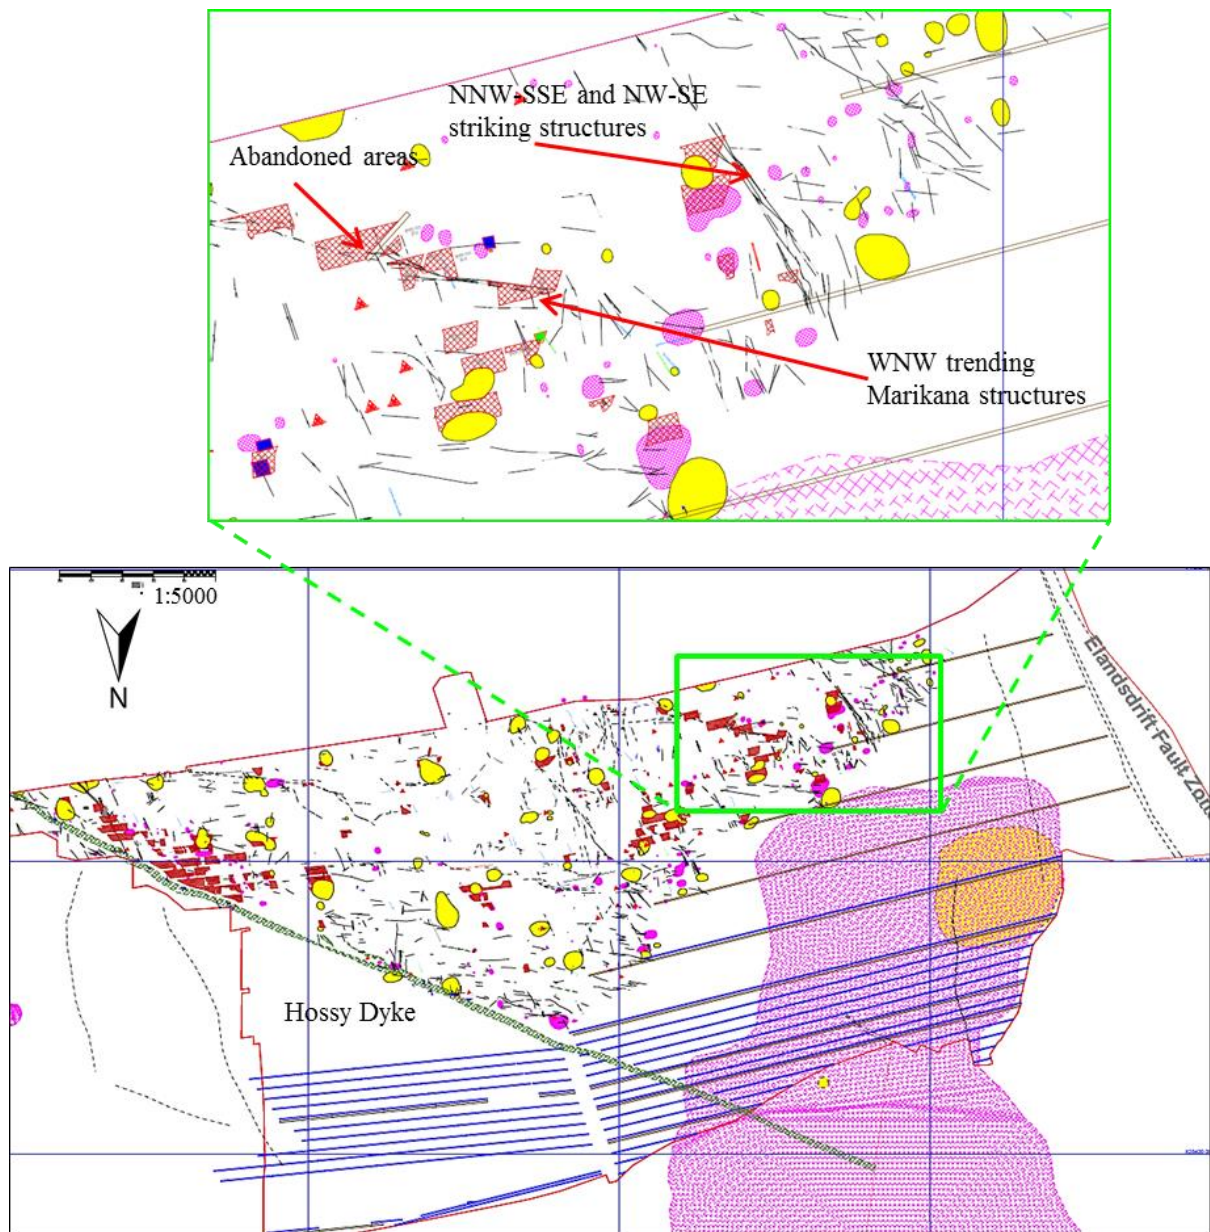
Hossy Shaft is currently operating as a hybrid mining operation. Conventional mining and mechanized cleaning is conducted using strike and dip belt drives. Figure 3.25 illustrates that the main geologic structures exposed along the western levels strike NNW-SSE, NW-SE and WNW-ESE (Marikana structures). Ore reserves have been abandoned in the vicinity of these structures (red hatching in Figure 3.25) due to the associated hangingwall instabilities experienced. Some critical belt drives, the main arteries of the shaft have collapsed, as shown in Figures 3.26 and 3.27. The excavation widths of the belt drives are 5 m. Although it is a relatively small span, the geologic structures exposed in the belt drives contributed to the instabilities and large-scale hangingwall unravelling. Pillar slabbing (Figure 3.28) has also been identified in the belt drives where alteration is present along the top reef contact. The joint planes are mobilized, especially when intersecting the pillar at oblique angles. This results in the observed slabbing.

Figure 3.25: A 1:5000 plan of Hossy Shaft, showing the Hossy Dyke along the eastern boundary and the Elandsdrift Fault Zone forming the western boundary of this shaft. The green block is zoomed in on the western, upper levels of this shaft. The geologic structures exposed in this area was indicated and the abandoned ground (red hatched areas) shown, caused by falls of ground and adverse hangingwall conditions.

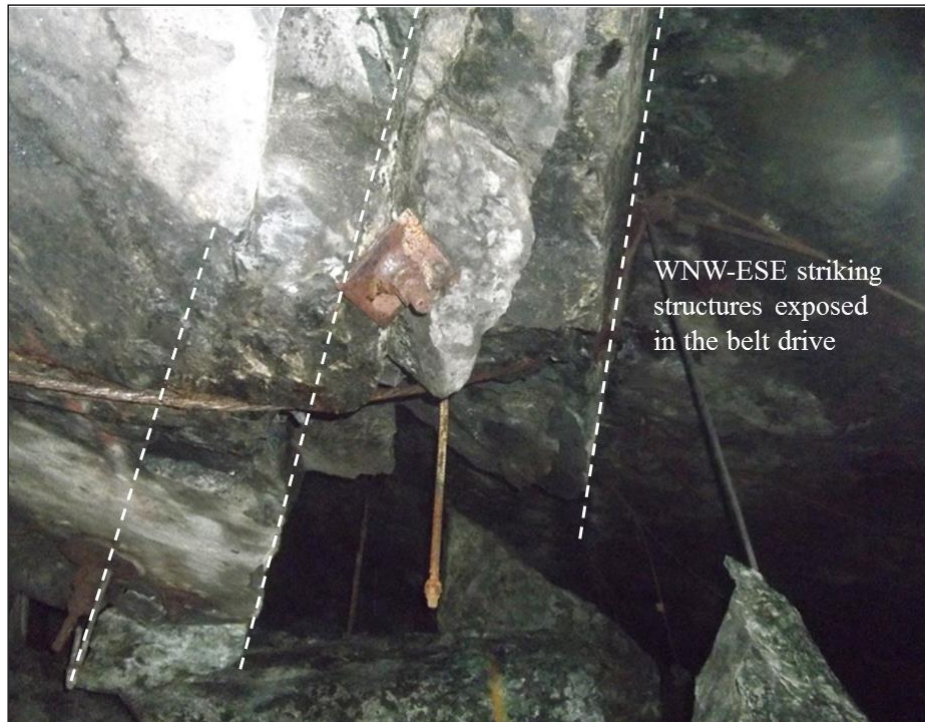
Figure 3.26: Hangingwall and support failure in the belt drive where Marikana structures were intersected. This area was supported by 1.8 m long resin bolts and 4 m long cable anchors and trusses. The support was clearly not adequate in this area.

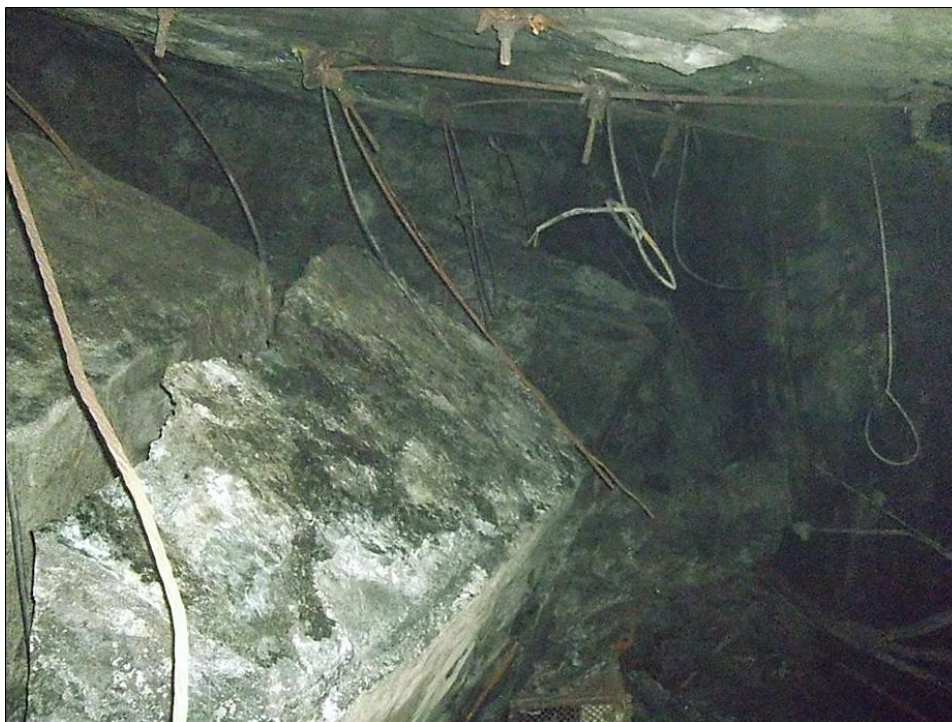
Figure 3.27: Collapse in a belt drive. It is suspected that the poor quality of cable anchor installation contributed to the collapse.

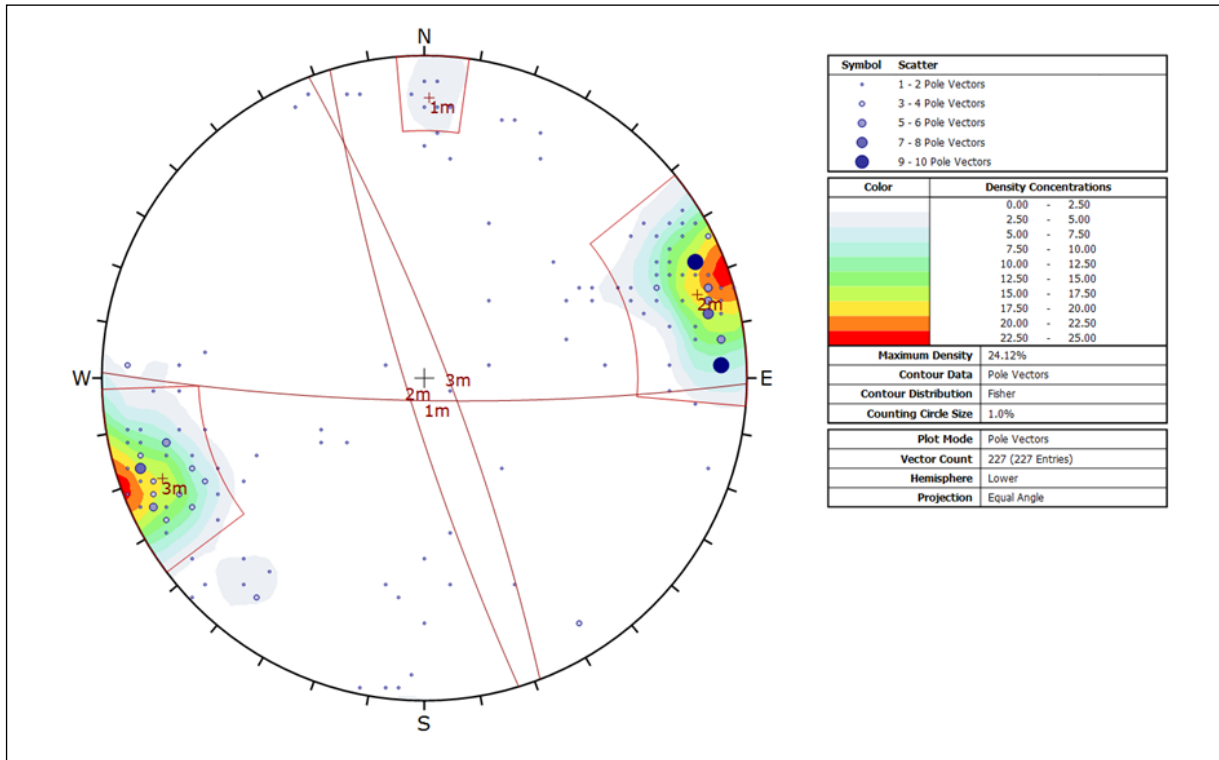
Joint mapping conducted by the author along the western levels were captured in the Dips software package. The 227 entries are summarised in Figure 3.29. The results show that the majority of structures strike NNW-SSE and WNW-ESE, which corresponds with the major structural orientations. The Marikana structures are exposed throughout Hossy Shaft. These structures are continuous over long distances (more than 5 m). The combination of these structures with the deformation event 1 and deformation event 2 (ramp structures) and alteration can cause adverse hangingwall conditions and a fall of ground risk (Figures 3.30 and 3.31). Deformation events 1 and 2 have been discussed in Section 2.4.1. Figure 3.32 shows the Marikana structure with pegmatite infill.

Figure 3.29: Representation of the joint mapping conducted by the author along the western levels at Hossy Shaft. The trends of these structures are similar to the structures exposed at Saffy Shaft, shown in Figure 2.21.

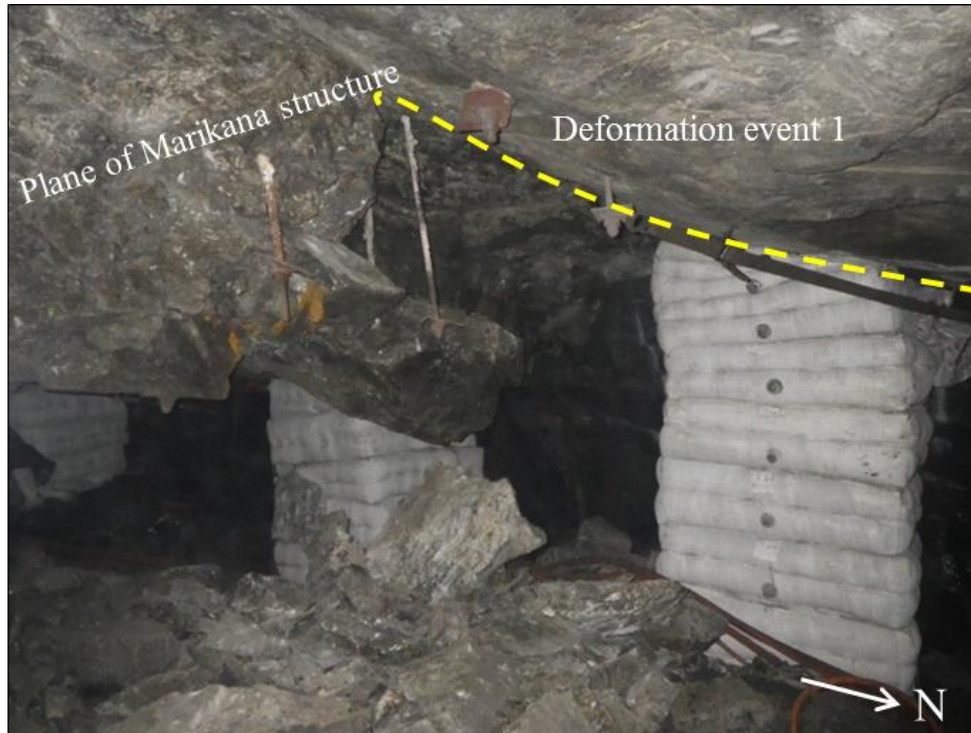
Figure 3.30: Intersection of deformation event 1 (ramp structure) and a Marikana structure. Alteration has also been exposed along the hangingwall pyroxenite units. This represents the worst case scenario and unfavourable conditions. Rock bolt support failure is also visible in the vicinity of the fall of ground.

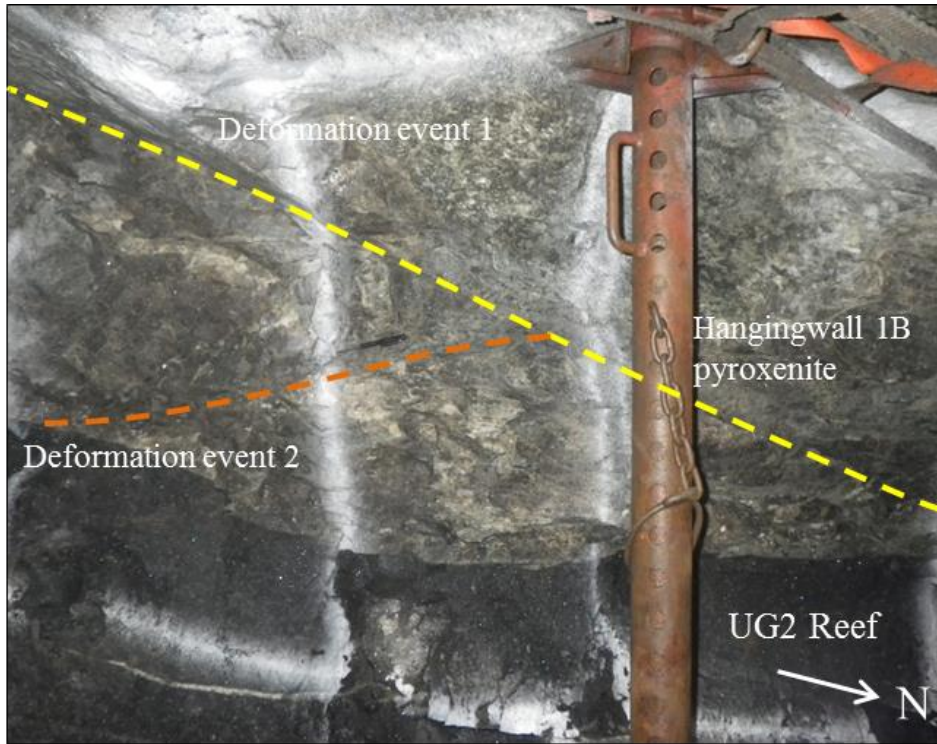
Figures 3.31: Deformation event 1 and 2 (ramp structures) together with alteration exposed along the stope face as discussed in Section 2.4.1.

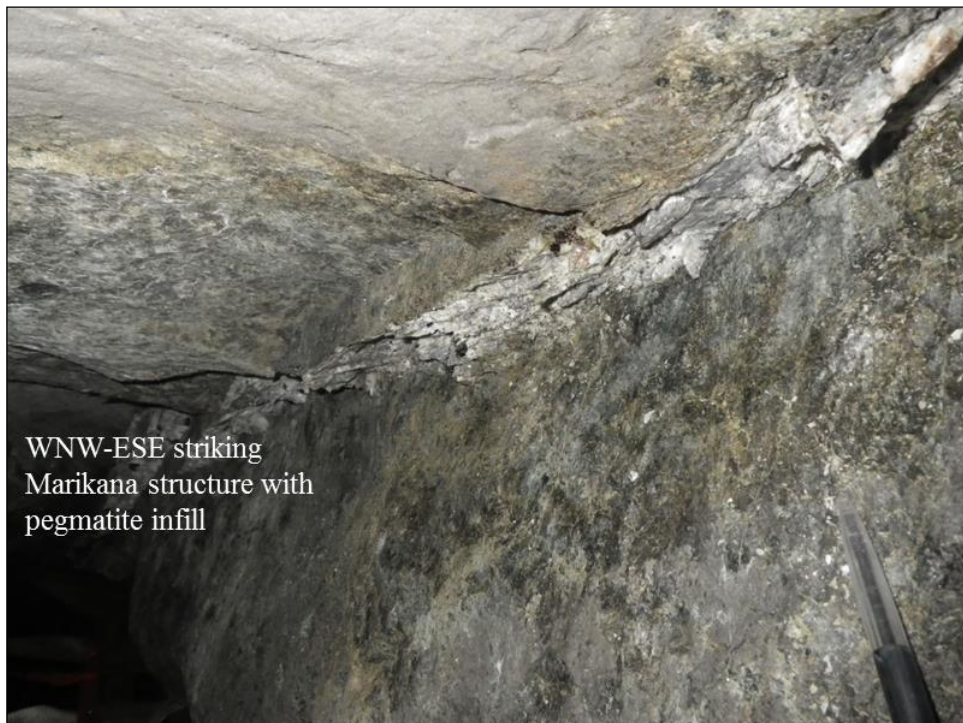
Figure 3.32: Marikana structure with pegmatite infill exposed in a development where a fall of ground occurred.

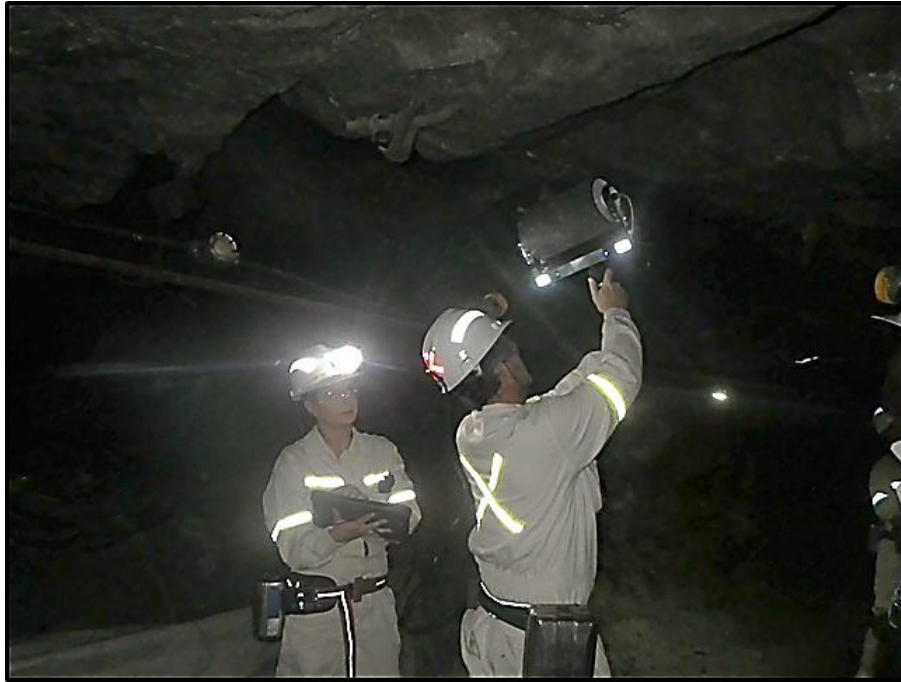
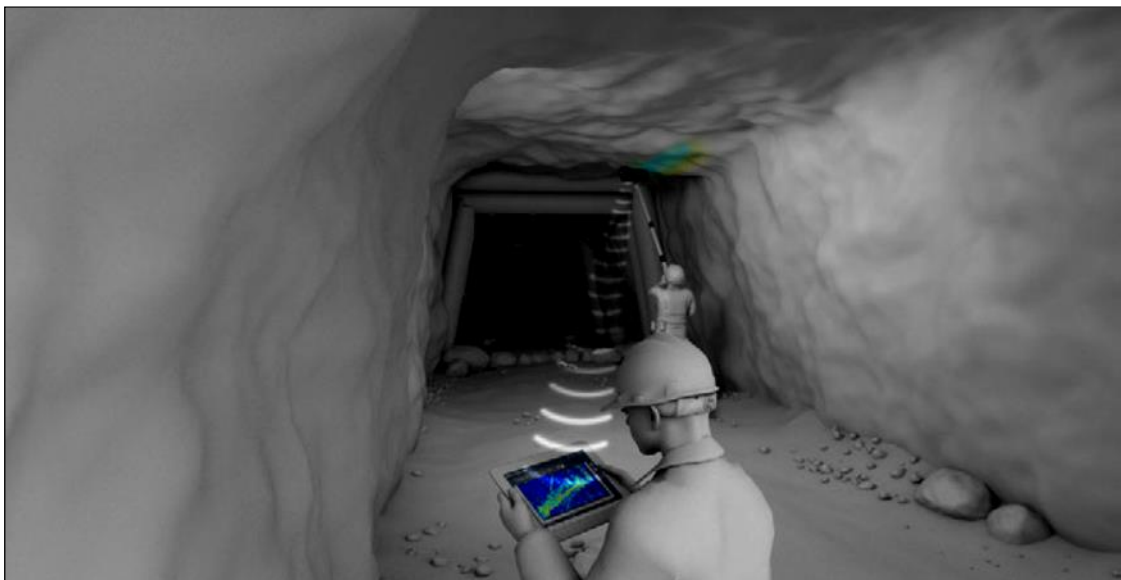
In an attempt to identify and confirm the occurrence and extent of the geologic structures in the hangingwall, a sub-surface profiler (ground penetrating radar system) was used by the author to scan up to 10 m into the hangingwall. This ground penetrating radar (GPR) system is designed specifically for the challenges faced by underground mining operations. The scanner is rolled along the hangingwall and the data collected is wirelessly transmitted and processed in real time. This gives instant feedback on the geologic structures present in the area (Figure 3.33).

Figure 3.33: Illustration of how to operate the sub-surface profiler in an underground environment to detect the geologic structures in the hangingwall. The results and interpretation of the geologic structures (Figure 3.34) is shown in Figure 3.35.

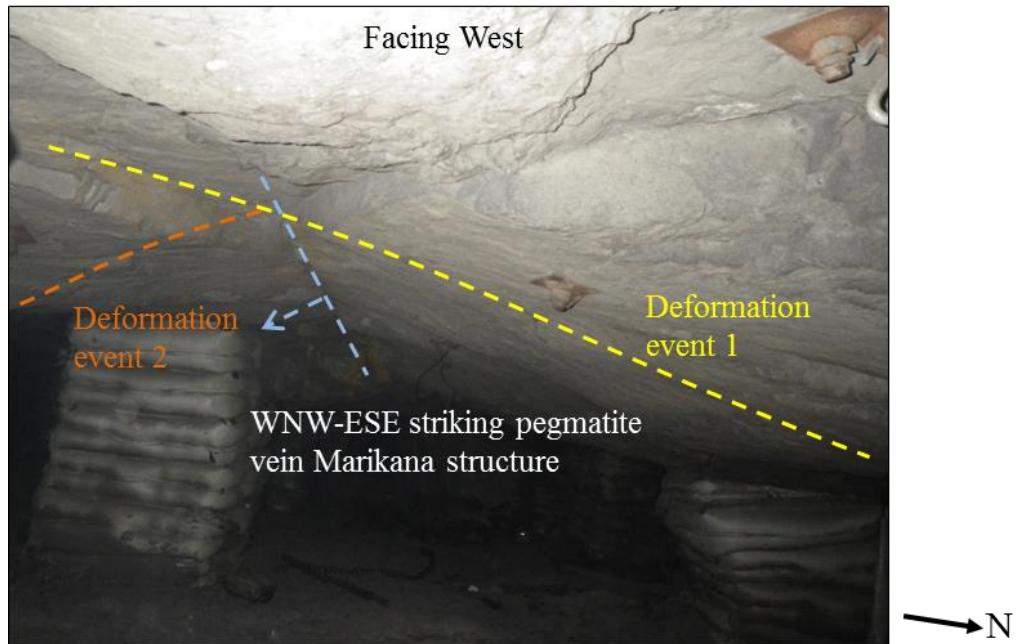
A scan was done in a down-dip direction in a panel for a distance of 34 m. The ground conditions in the panel appeared to be competent from observations in the stope (Figure 3.34). The scan in Figure 3.35, however, shows that the area is structurally complex. Ramp structures (deformation events 1 and 2) as well as Marikana structures are present in the hangingwall of the panel. The results from the scanner indicated that some of the structures ramp up to the position of the UG2A markers (3 – 4 m in the hangingwall) where others ramp up to the hangingwall 1A/hangingwall 2 contact (8 m in the hangingwall). Also, the Marikana structures cut into the hangingwall beyond the 10 m depth that the profiler can detect. The scan confirmed the findings at Saffy, Eastern Platinum Limited 2 and Hossy Shafts that the ramp structures ‘ramp up’ to the prominent weakness planes (UG2A markers and/or the hangingwall 1A/hangingwall 2 contact). With this new technology, it was the first time that the presence of these structures could be confirmed in the hangingwall in areas where the hangingwall still appeared competent. This contributes to an improvement in the spatial understanding of these structures and what should be considered in terms of mining strategies and support design.

Figure 3.34: A mining panel with geologic structures exposed. The hangingwall appears to be competent.

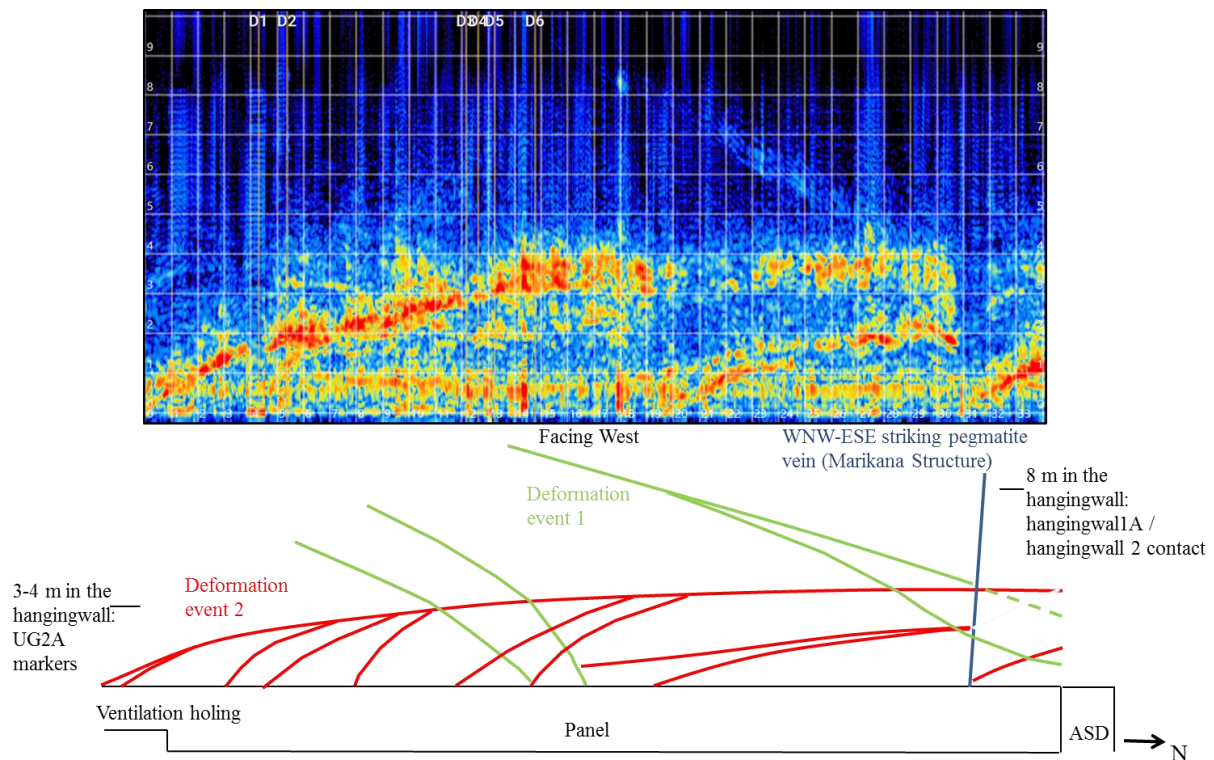
Figure 3.35: Scan along dip for 34 m with a sub-surface profiler showing the geologic structures exposed up to 10 m in the hangingwall. The bottom diagram shows the interpretation of the data captured in the scan.

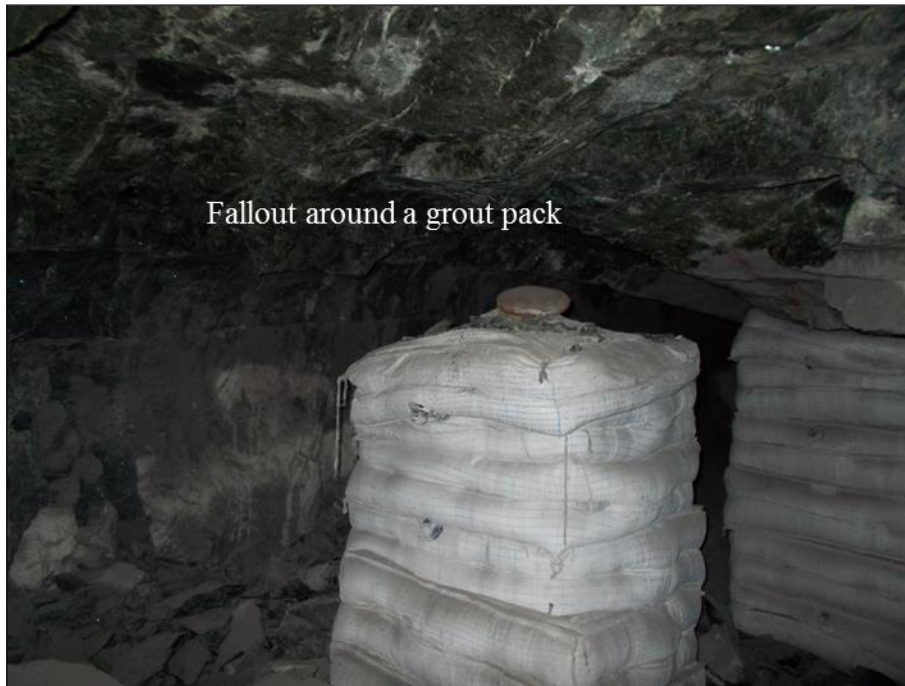
Figure 4.1: An alteration zone along the top contact of the UG2 Reef, causing fallout around an installed grout pack. This results in ineffective support being provided to the hangingwall which could result in large-scale unravelling, especially when intersected by prominent regional geologic structures as described in Chapter 3.

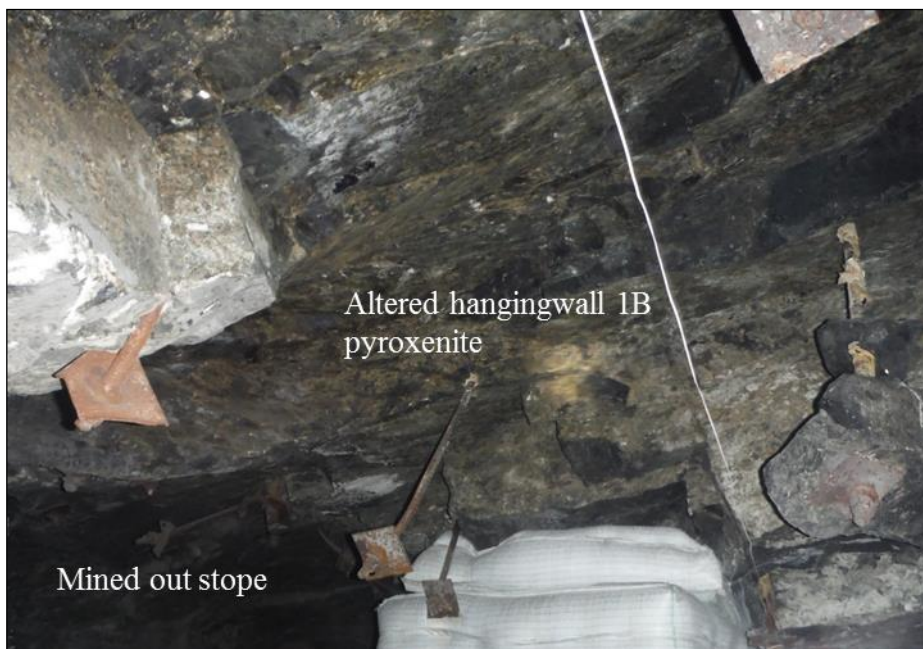
Figure 4.2: Alteration zone along the top contact of the UG2 Reef resulting in the unravelling of the immediate hangingwall around the installed rock bolts. This impacts the overall hangingwall stability.

The core was logged in order to determine the position of the altered hangingwall material relative to the UG2 Reef. The first four boreholes were drilled vertically into the hangingwall along dip in 6 West 40 Raise line (Figure 4.5). Figures 4.9 and 4.10 illustrate that the alteration zone is present directly above the top contact of the UG2 Reef, as can be seen in the underground exposure and borehole logs. The underground observations showed that the alteration zone had a thickness of 0.3 m where it was exposed in this area. Although the rock bolt support caters for the expected fallout thickness (1.2 m), it will be a challenge to support this material as it unravels between and around the installed support units (Figure 4.2). The

unravelling of this altered material also causes dilution and impact on the grade. If the mining grade is too low it will not be economically viable to mine the affected area. A remedial support strategy could be mining with permanent blast resistant mesh in an attempt to provide additional areal support and prevent the possible unravelling.

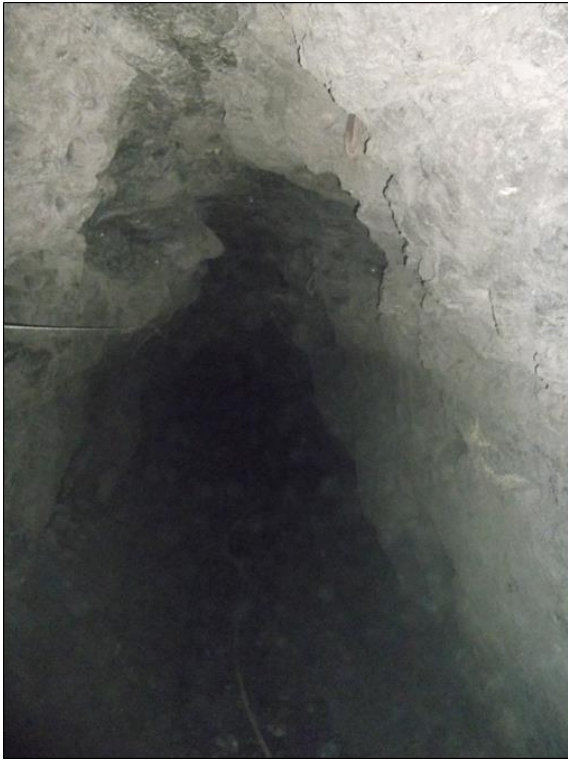
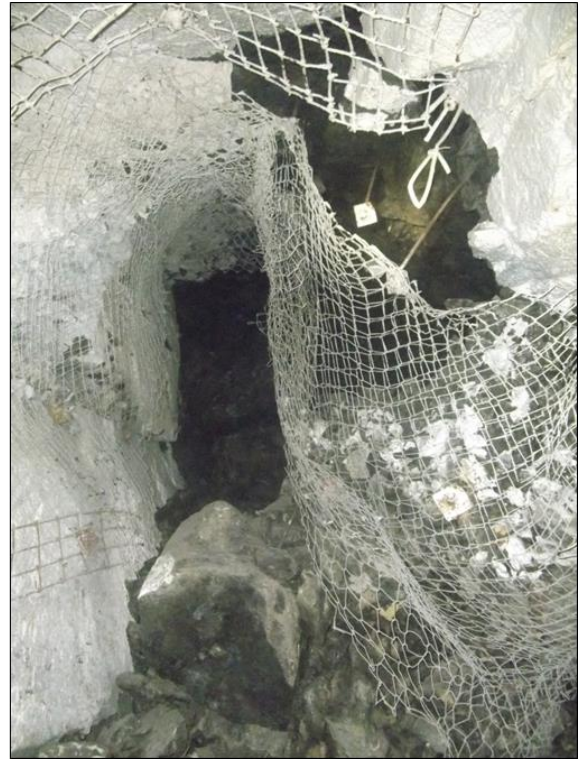
Figure 4.3: The effect of an alteration zone exposed along the top reef contact in a development end. This resulted in unravelling of the hangingwall in the excavation. This figure also shows the failure of secondary support due to the unravelling of this 'clay-like' alteration zone (approximately 10 cm up to 1 m in thickness) that is present along the top reef contact.

The resulting conditions are difficult to support and secondary support seemed to be ineffective (Figure 4.3). Furthermore, as a result of the weak nature of the 'clay-like' pyroxenite material, the immediate hangingwall layer will be extracted with the reef and this will impact on stoping width and grade. Where the alteration zone is located deeper into the hangingwall, it is very difficult to detect and it poses a risk in terms of large-scale instabilities (Figure 4.6). It can also occur along the bottom contact of the UG2 Reef (Figures 4.7 and 4.8). In these areas, the footwall is less competent and does not provide a solid foundation for the installation of timber elongates or grout packs (Figure 4.8). The location of the alteration zone relative to the UG2 Reef therefore provides challenges in terms of the mining as well as the support strategy.

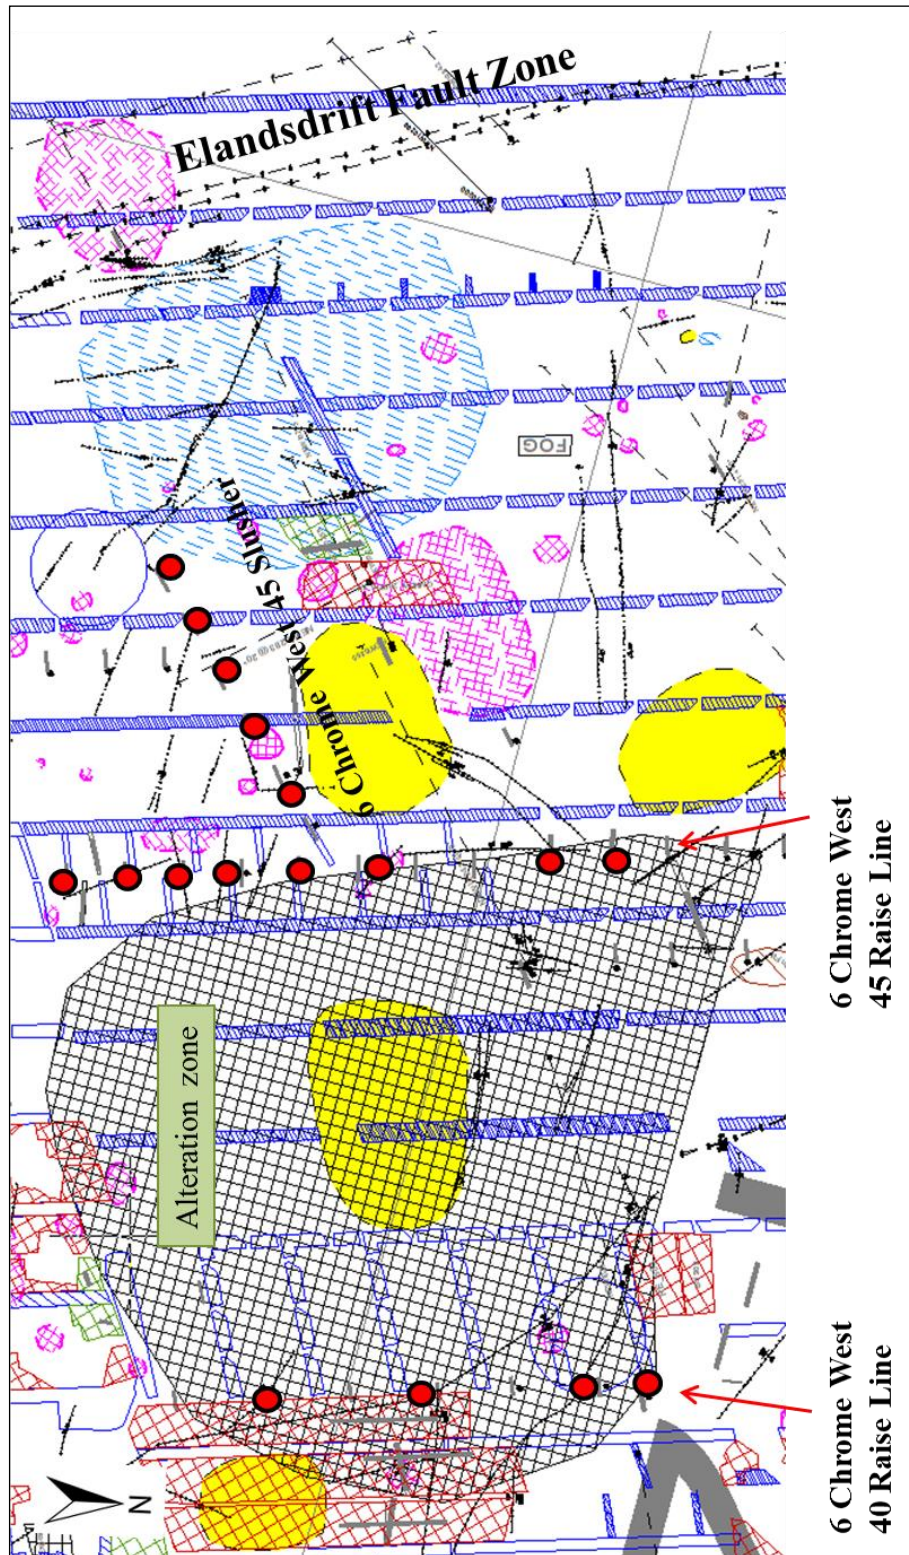
The western areas of Newman Shaft (Figure 4.5) are mining towards the Elandsdrift Fault Zone. The structural geology of Newman Shaft is complex and contributes to the instability of the excavations as mining approaches this fault zone. Mining at 6 Chrome West Level exposed an alteration zone along the top contact of the UG2 Reef. On-reef development (raise lines) indicated that the position of the alteration zone is not restricted to the top contact of the UG2 Reef only, but can extend to the pyroxenite hangingwall and/or footwall units. This zone created challenges for mining operations as it contributed to adverse ground conditions and falls of ground. The area affected by this alteration zone extends across six raise lines (refer to the black hatched area in Figure 4.5).

Figure 4.5: Mine plan of 6 Chrome West Level at Newman Shaft, indicating areas affected by the alteration zone. The boreholes that were drilled vertically into the hangingwall are indicated by the red ellipses. Six raise lines of ore reserves were abandoned due to the anomalous hangingwall conditions encountered as a result of the alteration zone.

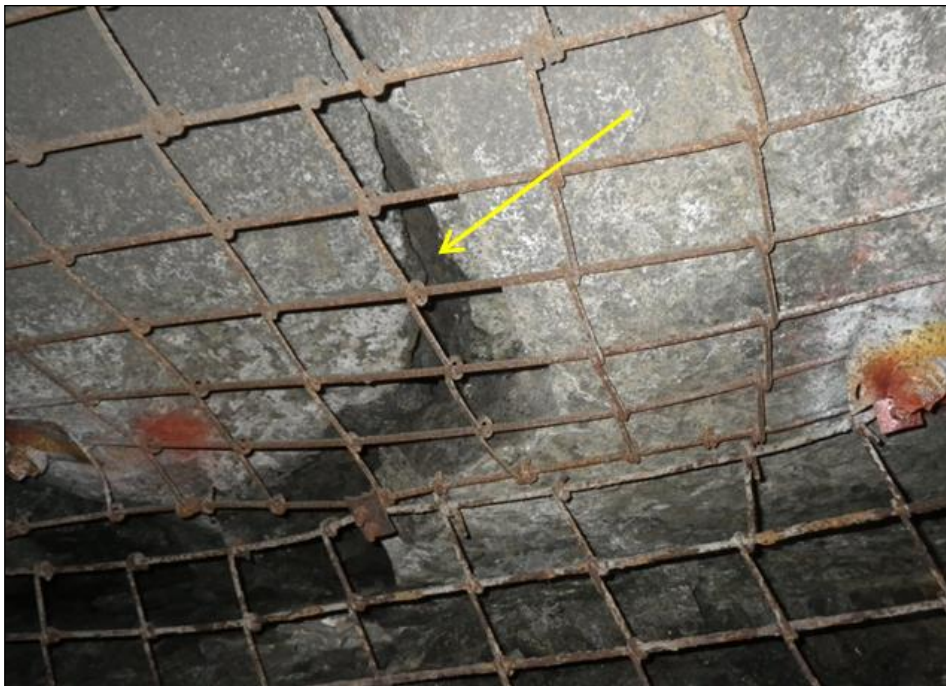
Figure 4.6: An alteration zone in the hangingwall can cause the unravelling of key blocks due to separation along joints or parting planes.

Figure 4.6 show the separation along joints at 6 West 45 Raise line. The raise line was developed 1.4 m wide supported with rock bolts and no stoping was done at this panel. The instability might be due to the presence of the alteration zone in the vicinity of the UG2A markers or the hangingwall 1A / hangingwall 2 contact. The alteration zones in the hangingwall are already creating unstable conditions during the development phase (span of 1.4 m), stoping in these areas may be challenging, if at all possible.

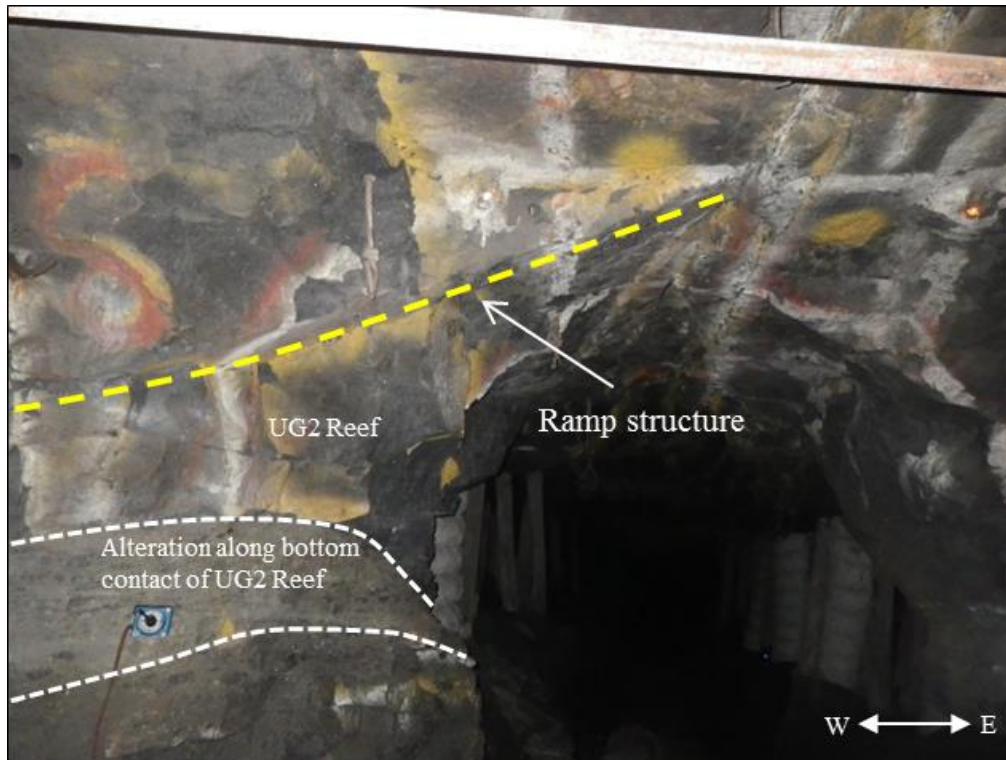
Figure 4.7: The presence of an alteration zone along the bottom contact of the UG2 Reef. Also note the ramp structure present along the hangingwall.

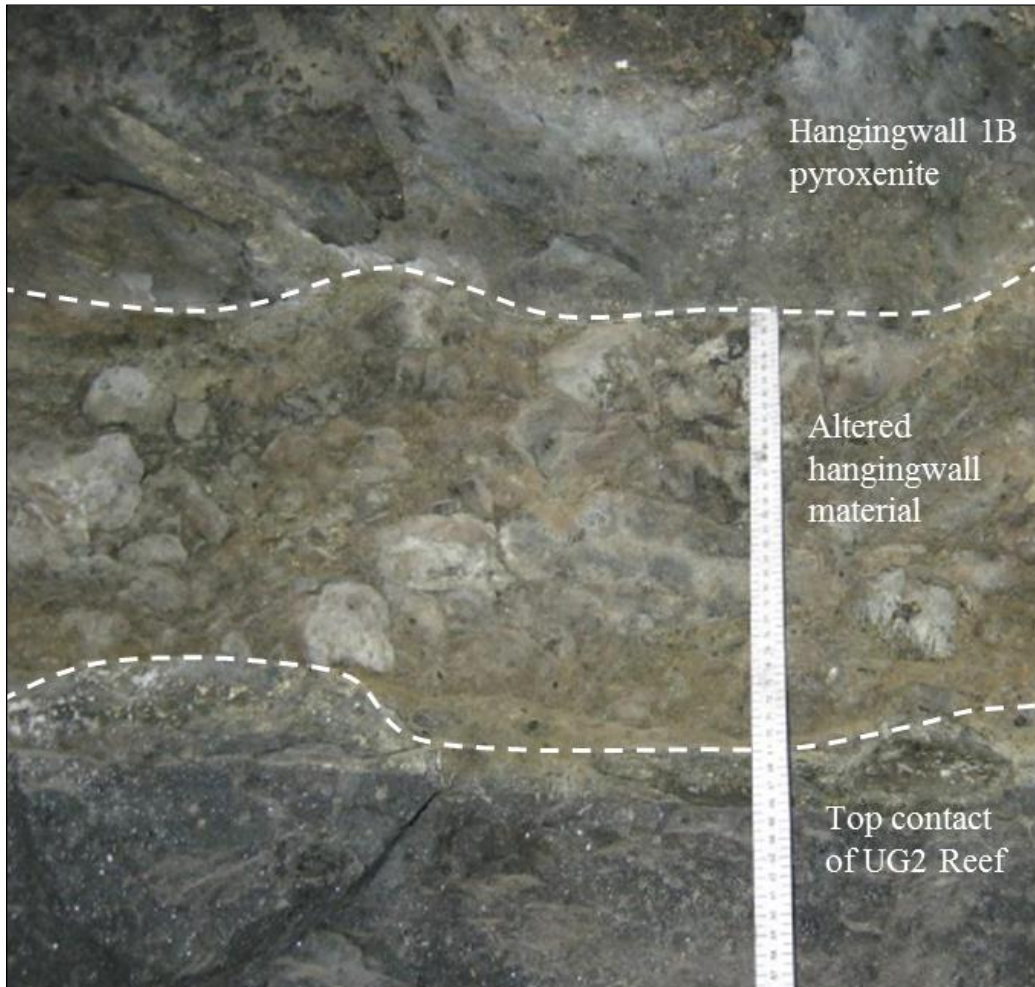
Figure 4.9: Photograph of the alteration zone along the top contact of the UG2 Reef (approximately 0.3 m thick).

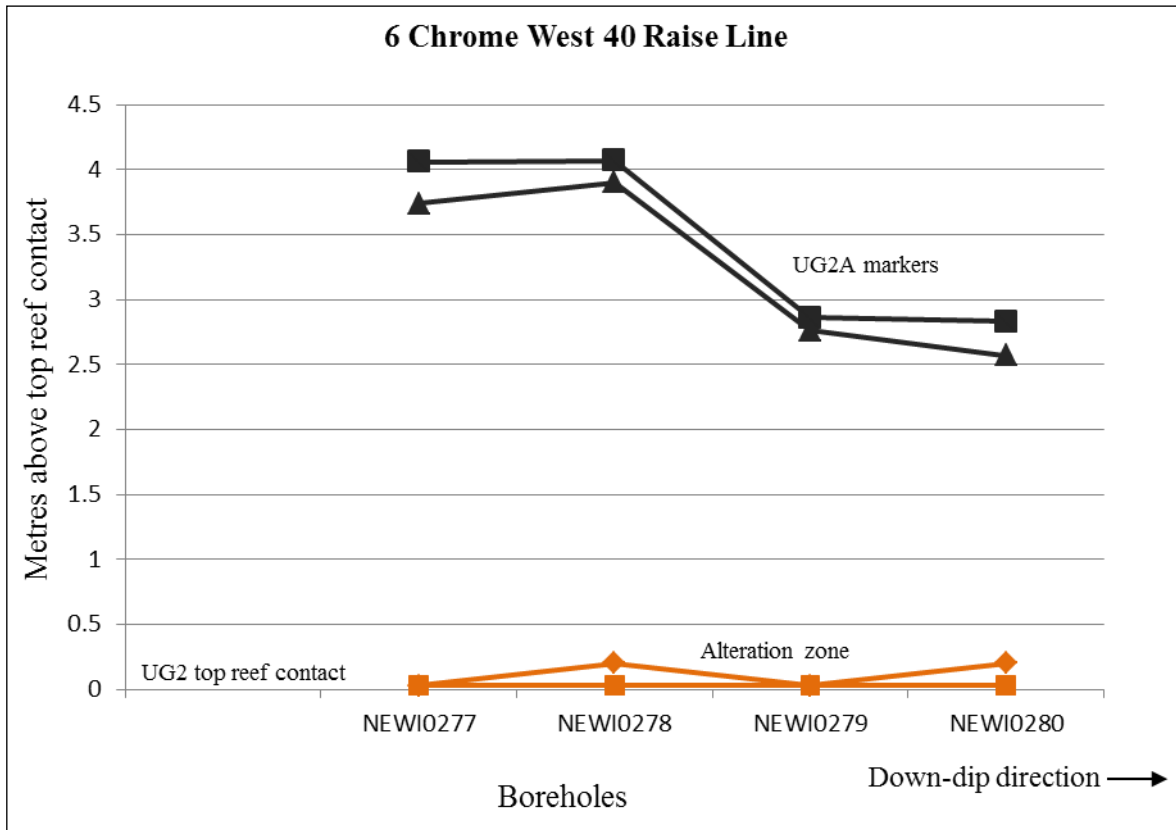
Figure 4.10: Location of alteration zone with reference to the UG2 Reef and UG2A markers along the 6 West 40 Raise line. The orange lines are the position of the alteration zone contacts and the black lines are the position of the UG2A markers contacts.

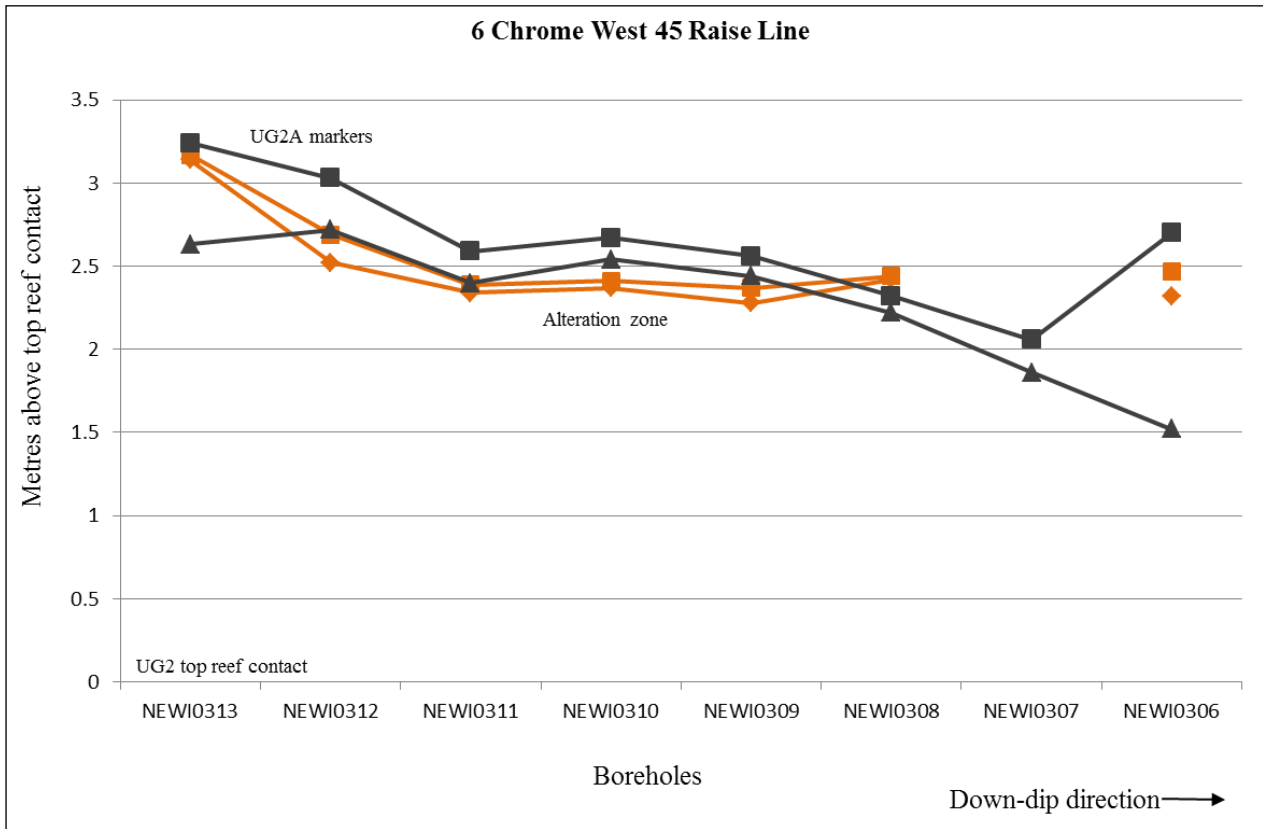
Another eight boreholes were drilled vertically into the hangingwall along 6cW 45 Raise line (Figure 4.5). Figure 4.11 shows that the alteration zone is situated in the vicinity of the UG2A markers in seven of the eight boreholes drilled. As can be seen from Figure 4.11, the UG2A markers are situated at 1.5 m to a maximum of 3.25 m above the UG2 top reef contact. The support strategy implemented at Newman Shaft ensures that the timber elongates support up to this natural parting plane. With the UG2A markers being a known parting plane, the presence of the alteration zone at this location contributes to a decrease in the friction angle and cohesion of the alteration zones and other contacts. On Newman Shaft, grout packs are also installed as supplementary back area support to prevent large-scale hangingwall instabilities and back breaks. However, the alteration zone can also be present at the hangingwall 1A/hangingwall 2 contact (at 7 m), exacerbating the problem (Figure 4.12). This scenario does not have a dilution risk, but rather a large-scale instability risk. The effectiveness of the support (timber elongates and grout packs) in these conditions is questionable. High strength, stiff active support will be required to support to the highest possible partible plane. An example of a suitable product is the recently developed, new generation modular grout pack. Figures 3.19 and 3.20 show the support characteristics of these grout packs.

Figure 4.11: Location of alteration zone with reference to the UG2 Reef and UG2A markers along 6 West 45 Raise line. The orange lines are the position of the alteration zone contacts and the black lines are the position of the UG2A markers contacts.
