**STRUCTURAL MECHANISMS CONTRIBUTING TO
LARGE-SCALE HANGINGWALL INSTABILITIES ON THE
UG2 REEF HORIZON**

MSc Mining

UNIVERSITY OF PRETORIA

2019

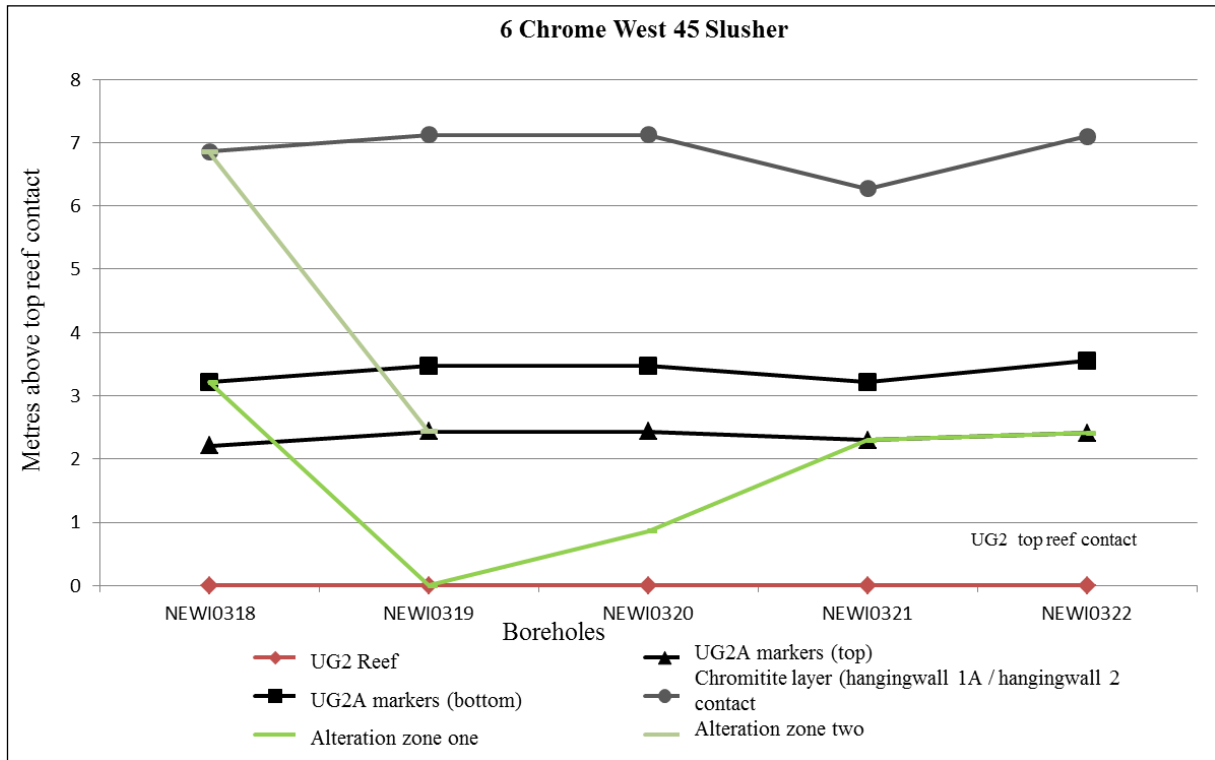
Figure 4.12 is an illustration of the five boreholes that were drilled vertically into the hangingwall along 6 West 45 middle slusher (see Figure 4.5), that was developed on strike from east (NEWI0318) to west (NEWI0322). Two alteration zones can be identified in Figure 4.12. It is hypothesised that *alteration zone one* migrates from the top UG2A marker to the top contact of the UG2 Reef and again towards the bottom UG2A marker. *Alteration zone two* is only present in the first two boreholes, NEWI0318 and NEWI0319. The alteration zone migrates from the hangingwall 1A/hangingwall 2 contact (7 m) towards the lower UG2A marker. Figure 4.12 show that the alteration zones possibly follow ramp structures (Figure 3.2), as discussed in Chapter 3. Hangingwall separation can therefore occur at various positions. This contributes to the

Geotechnical logging of the boreholes was conducted by the author and Q-ratings ranging from 0.001 to 0.5 were calculated. This indicates exceptionally poor to extremely poor ground conditions.

Figure 4.12: Location of alteration zones with reference to the UG2 Reef and UG2A markers along 6 West 45 Slusher. The alteration zones possibly follow ramp structures (Figure 3.2) and may also ‘ramp up’ from the UG2A markers, as can be seen in borehole NEWI0318 and NEWI0319 (alteration zone two).

unpredictability and scale of potential instabilities and will have an effect on the installed support. Stiff, active support units will be required to support to the highest possible parting plane.

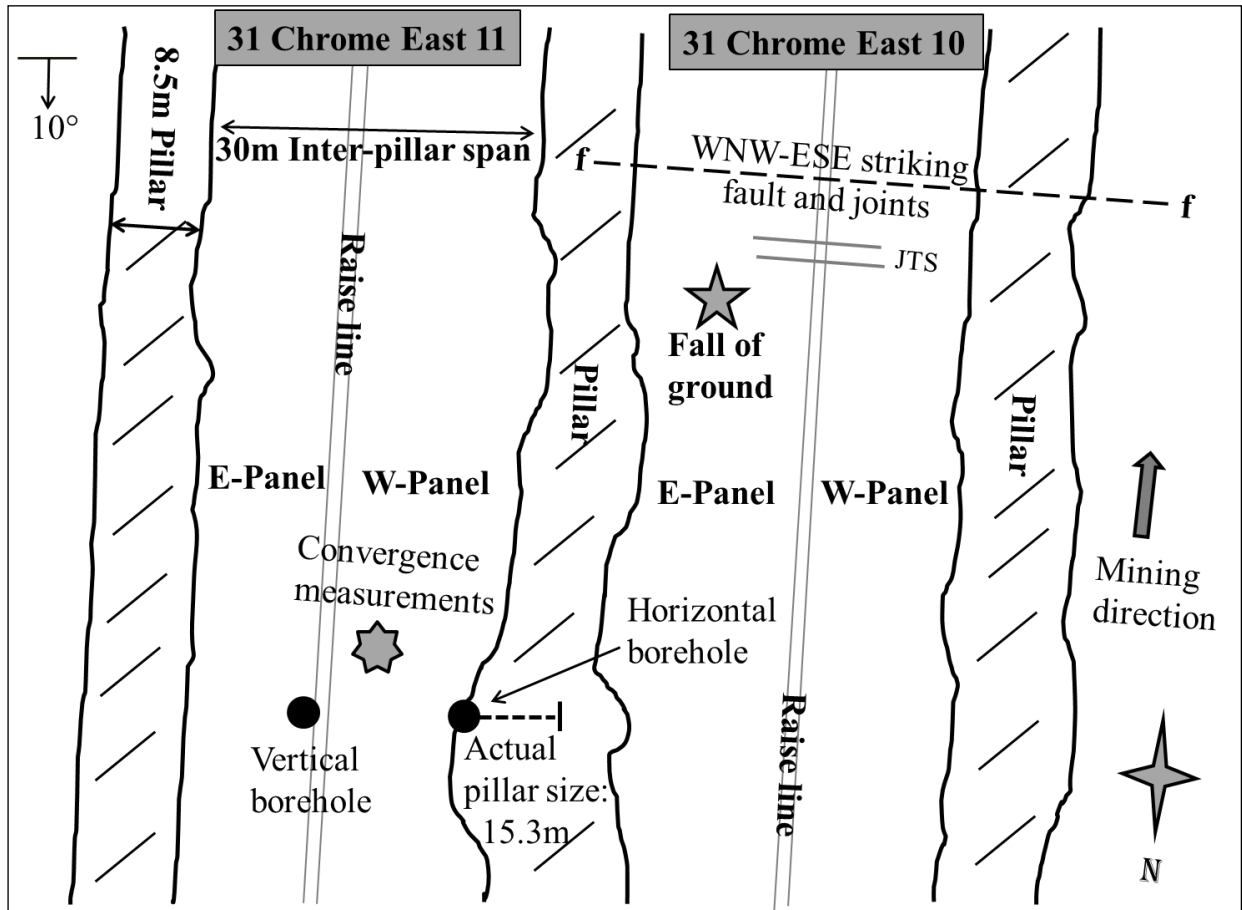
In a non-yield pillar environment, hangingwall convergence and scaling pillars are not anticipated. The study site on 31 East Level at Rowland Shaft, including the split up-dip mining configuration and layout parameters are illustrated in Figure 4.15. The fall of ground occurred in East 10 East Panel as shown in Figure 4.15.

Figure 4.15: Split up-dip mining layout at 31 Chrome East Level, showing the fall of ground and where the vertical and horizontal boreholes were drilled as well as where the convergence measurements were taken.

Figure 4.15 illustrates that the pillar between East 11 Panel and East 10 Panel had an actual width of 15.3 m (exceeding the required width). Also, the pillars were continuous with no pillar holings along the entire level. Therefore, it seems unlikely that the mechanism causing the observed scaling should be as a result of the pillar exceeding its peak strength.

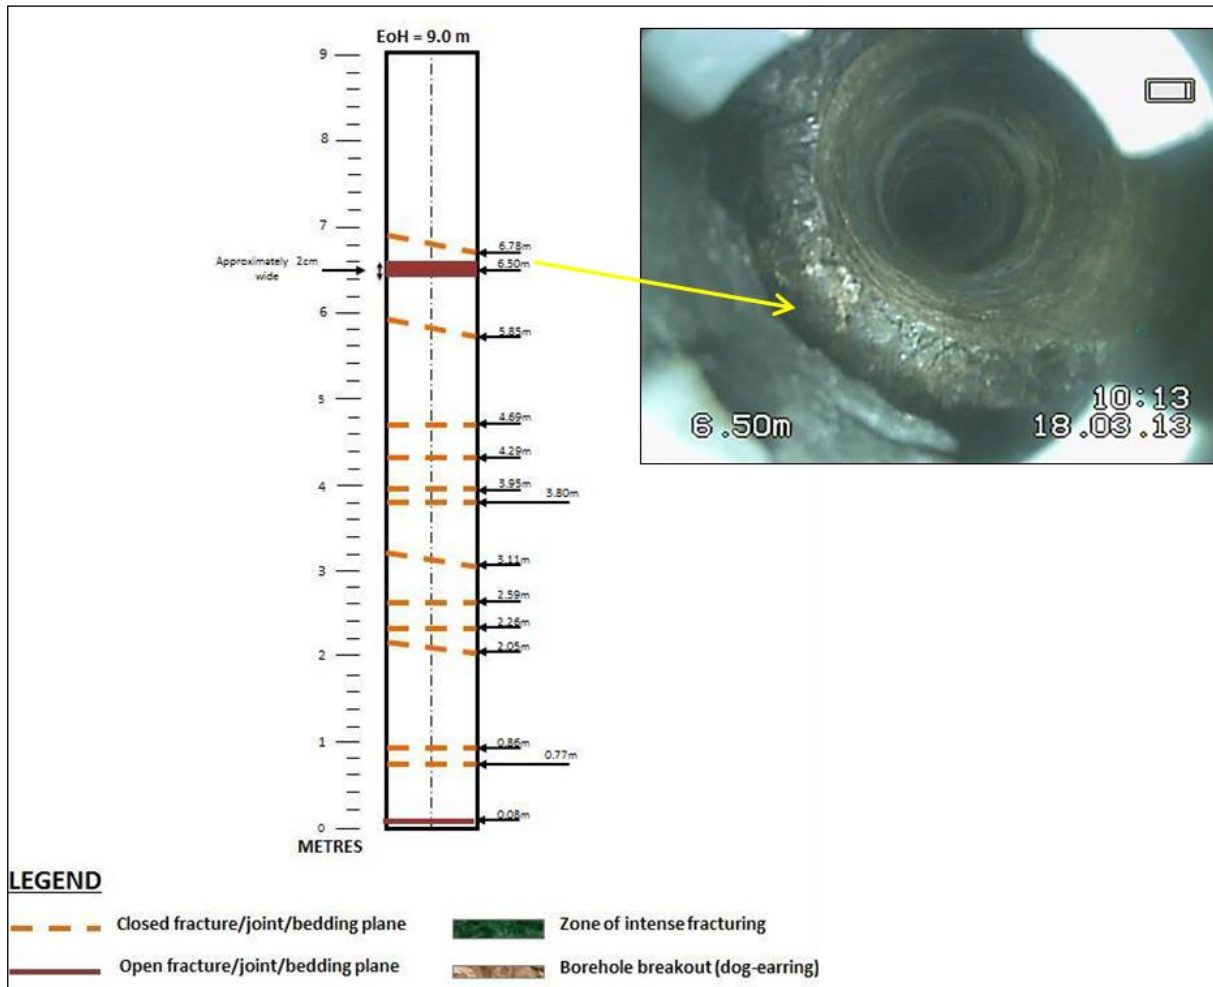
Figure 4.16: Vertical borehole log indicating an open discontinuity in the hangingwall at 6.5 m (possible hangingwall 1A/hangingwall 2 contact).

Figure 4.16 show that instability was also experienced as a result of possible separation along the hangingwall 1A/hangingwall 2 contact (Figure 1.3).

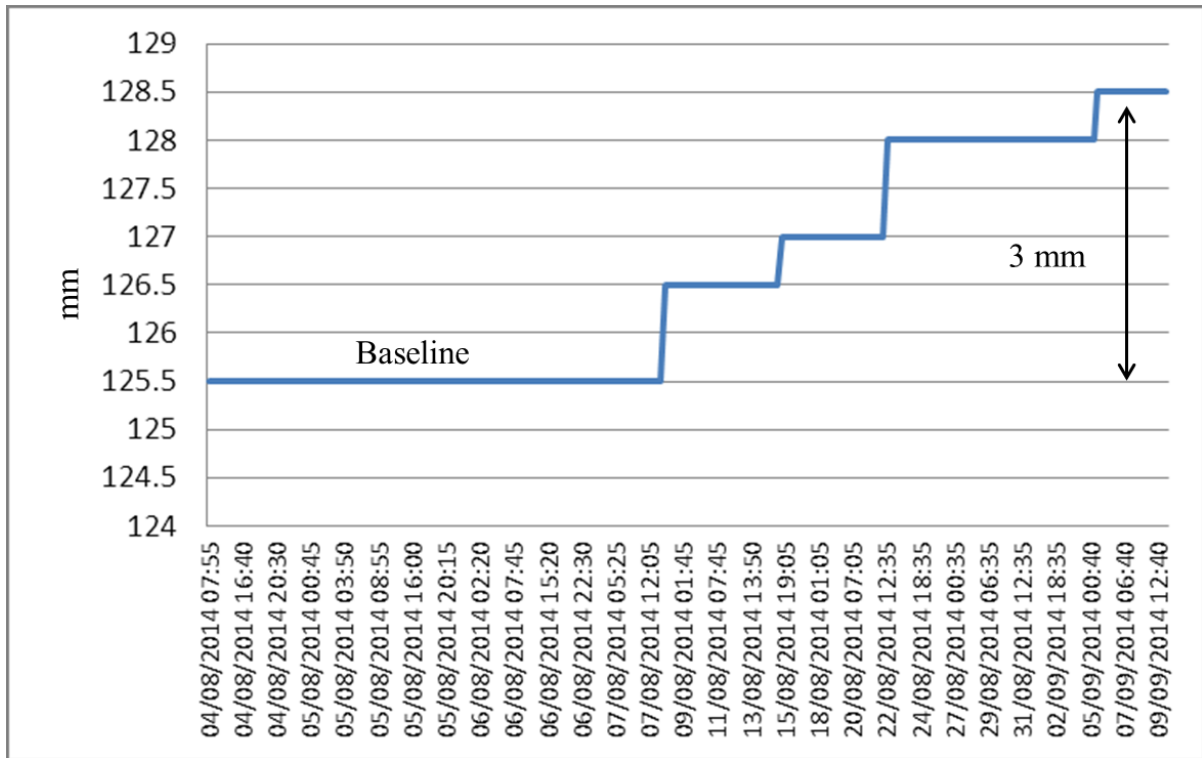
Convergence measurements were conducted in East 11, Western Panel using continuous closure loggers. The objective of the monitoring was to give early warning of any potential instability and to understand the convergence behaviour. Figure 4.17 shows that 3 mm of additional convergence were recorded over a period of approximately 6 weeks. Once mining activities stopped, the convergence also stopped. Restricting the mining span also controls convergence.

Figure 4.17: Convergence measurements conducted at East 11, Western Panel.

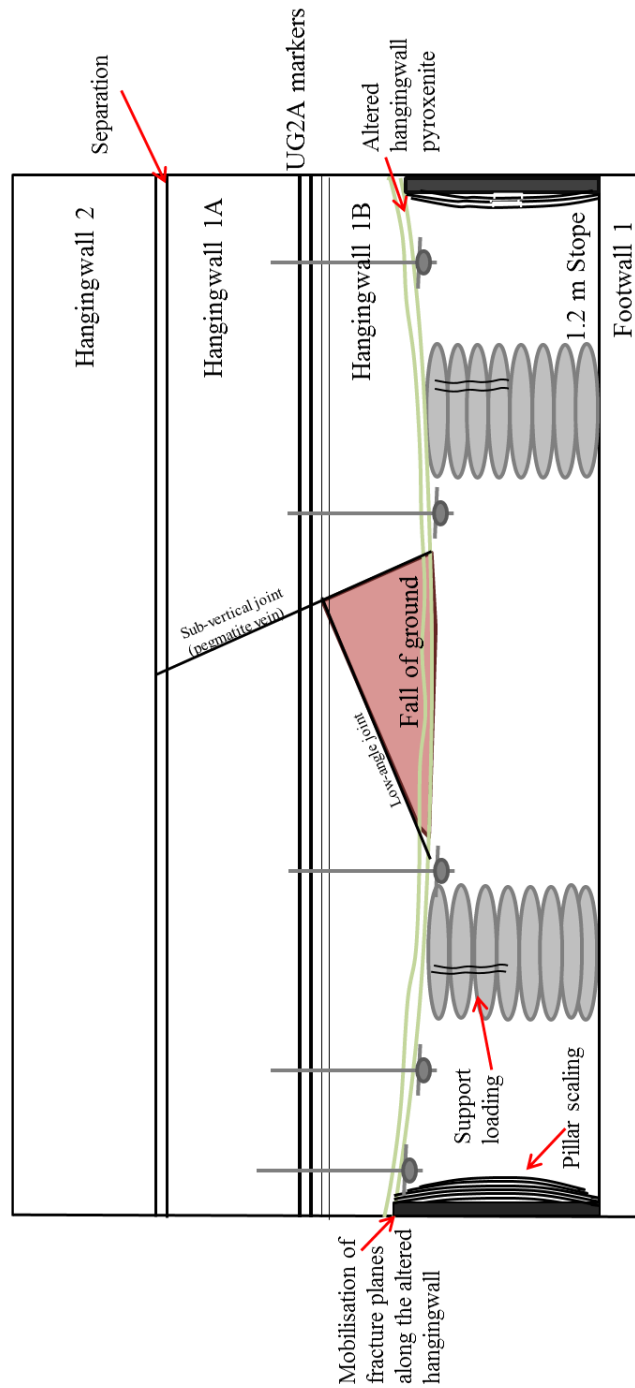
Figure 4.19 illustrates the proposed failure mechanism that was identified at the fall of ground site. The alteration zone will contribute to the formation and migration of the failed pillar material observed.

Figure 4.19: Illustration of the proposed failure mechanism when separation occurs in the hangingwall and mobilization along altered material along the top reef contact.

A remedial strategy proposed was to implement stiff, active support in order to support to the height of potential parting planes. High strength active (new generation) grout packs should be considered to provide high early strength close to the face and prevent back breaks.

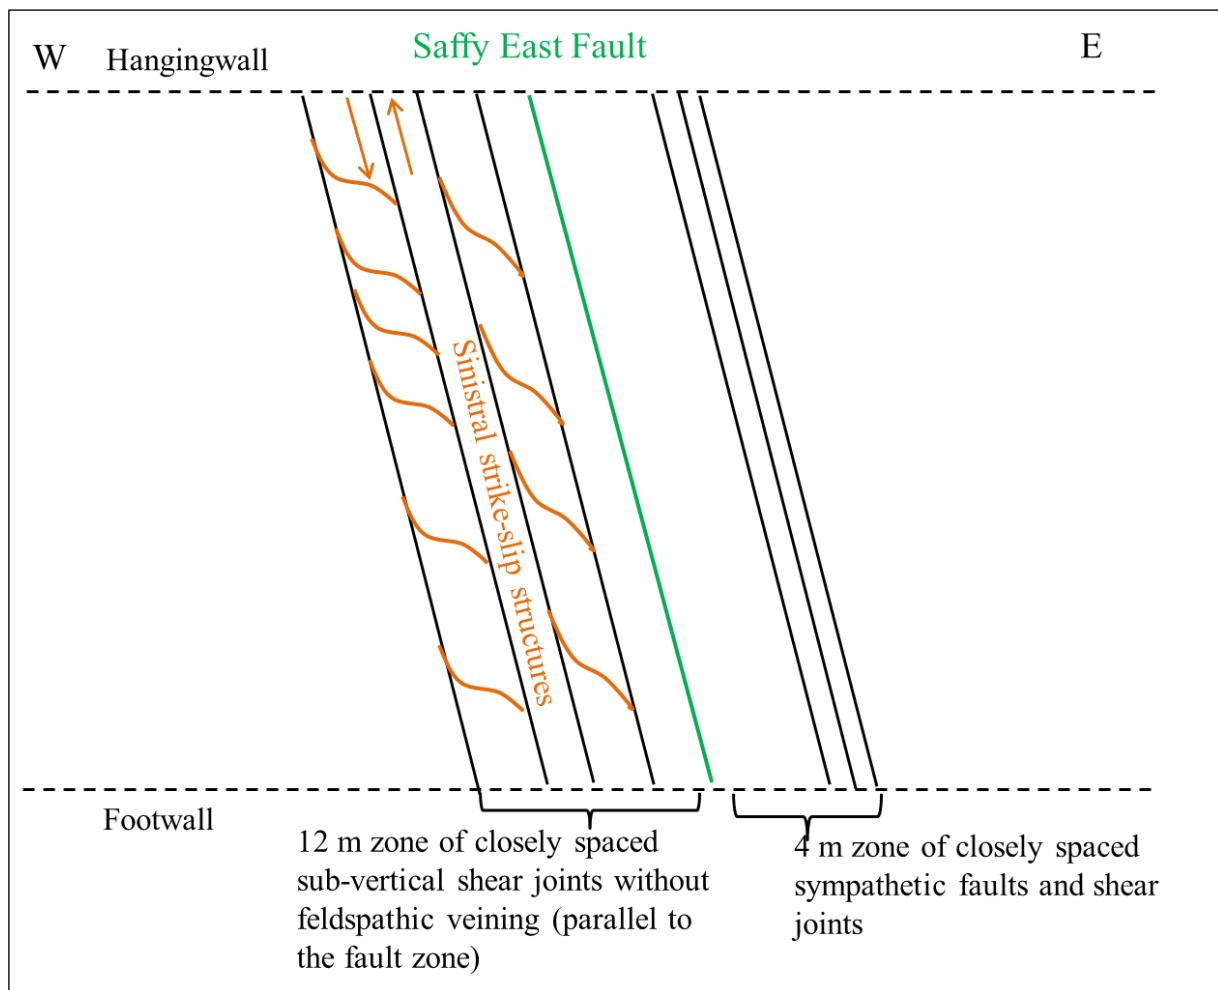
A series of NNW-SSE to NW-SE striking, 10 – 65° dipping, WSW- to SW-dipping, listric-shaped minor faults, splay from the latter on its eastern side. They merge with sub-horizontal layering; thereby forming layer-parallel extensions of variable dimensions (Figure 4.22). All these structures form part of a shear joint envelope that developed when the Saffy East Fault underwent a later reactivation phase of sinistral strike-slip. Figure 4.22 indicates that the intersection of closely spaced faults and joints can result in adverse ground conditions. The intersection of steeply dipping faults and listric faulting might lead to falls of ground. These structures strike parallel to the Wegener Stress Anomaly.

Figure 4.22: Schematic representation of the section view with the secondary structures associated with the Saffy East Fault as observed in the sidewall of a haulage. The fault is dipping at 85° with a throw of 10 m.

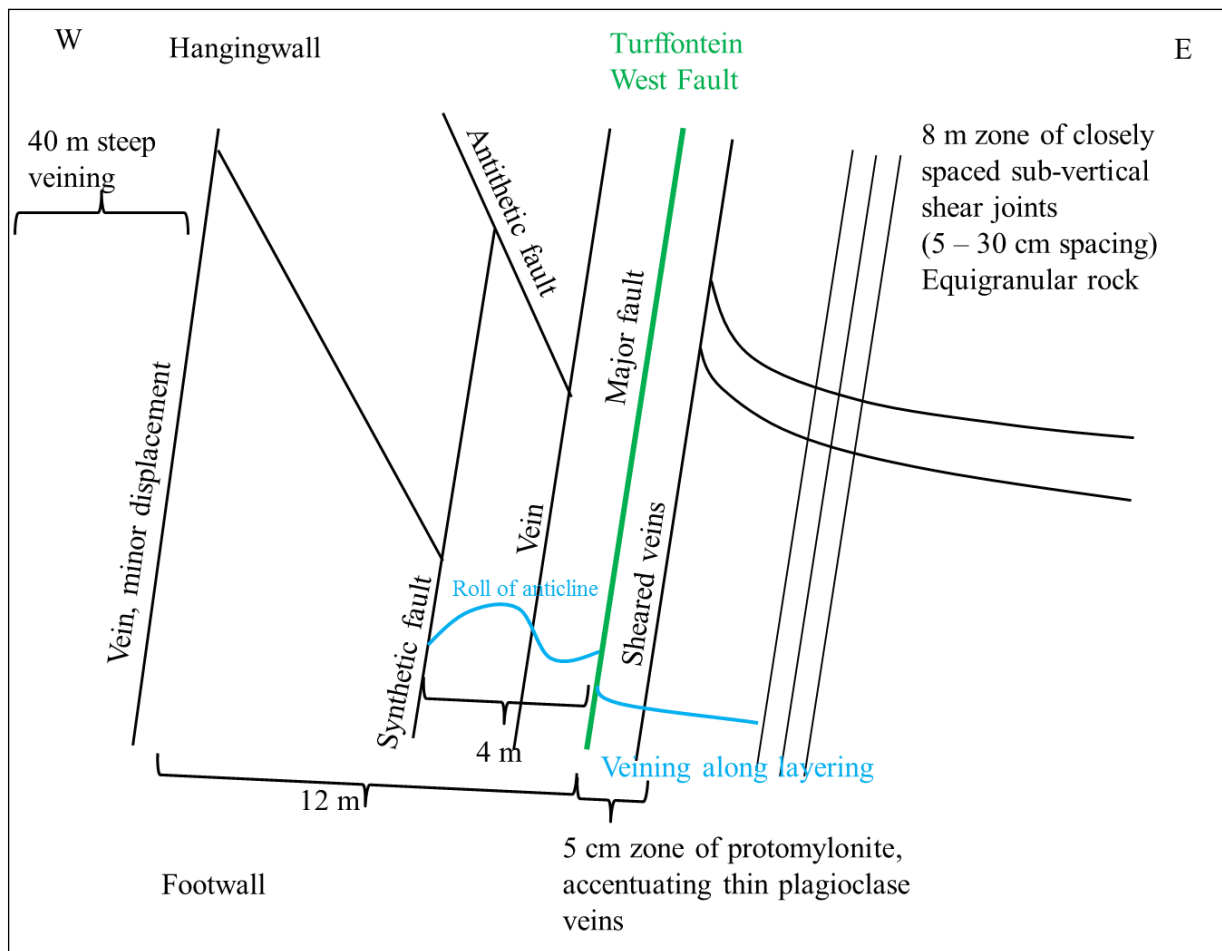
The secondary faulting (Figure 4.23) comprises of both sub-vertical shears and shear joints sympathetic to the Turffontein West Fault, as well as extensional, listric-shaped, westerly inclined splays merging with the layering. The listric extensional faults contain thin (a few centimetres wide) plagioclase-quartz veins. Furthermore, subsidiary extensional normal dip-slip faults (with 40 – 50 cm offsets) antithetic to the Turffontein West Fault are developed in its immediate hangingwall. When these structures are exposed by mining operations, adverse ground conditions might occur. These exhibit normal dip-slip movements and

Figure 4.23: Schematic representation of the section view of structural elements associated with the Turffontein West Fault exposed in the sidewall of a haulage.

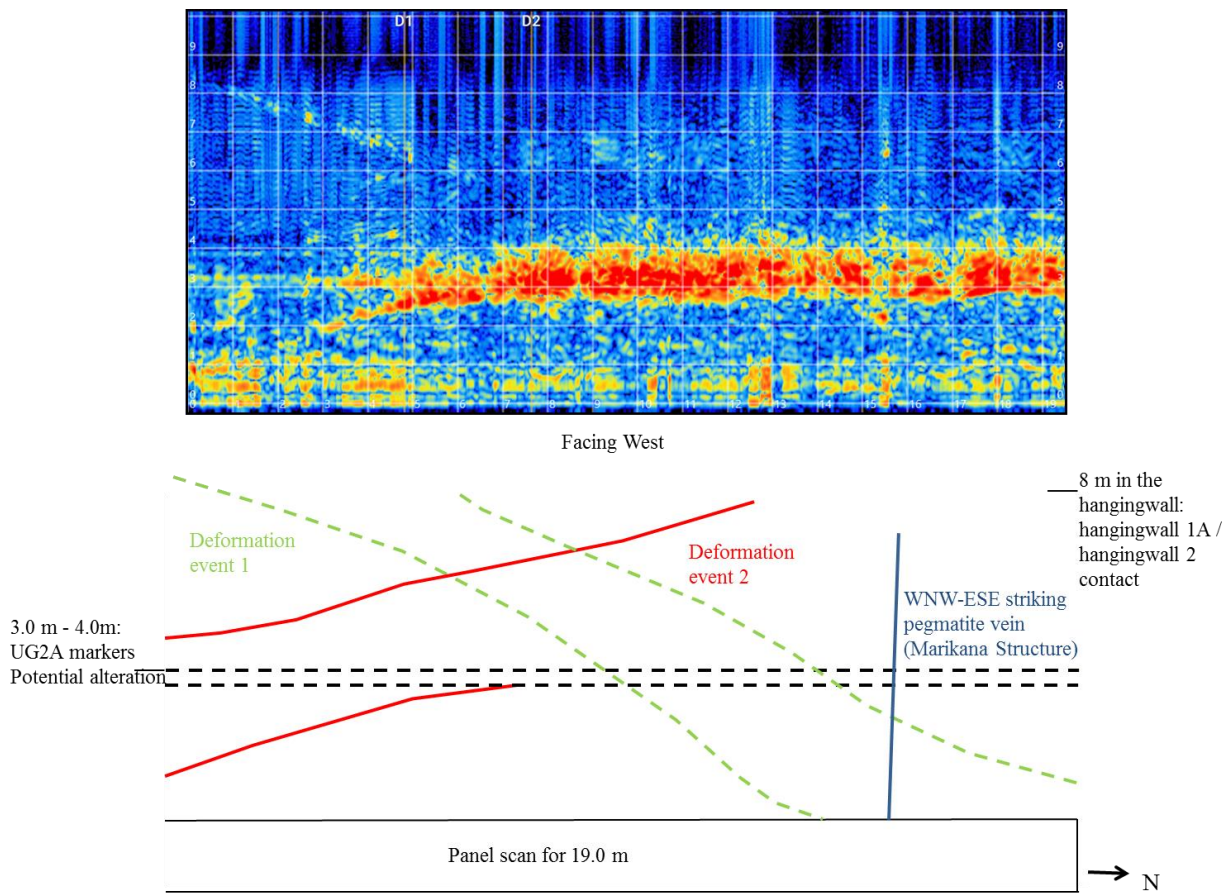
Figure 4.24 show the scanned image along dip in a panel for 19 m, as well as an interpretation from a sub-surface profiler. Notice how the deformation events 1 and 2 (ramp structures) ‘ramp up’ to the potential weakness planes. These are also possible sources/locations of the alteration zones. The red zone from the scanned image confirms that a significant alteration zone is present along the UG2A markers, at the scanned location.

Figure 4.24: Sub-surface scan and interpretation of the hangingwall, showing a Marikana structure, deformation events 1 and 2 as well as an alteration zone along the UG2A markers.

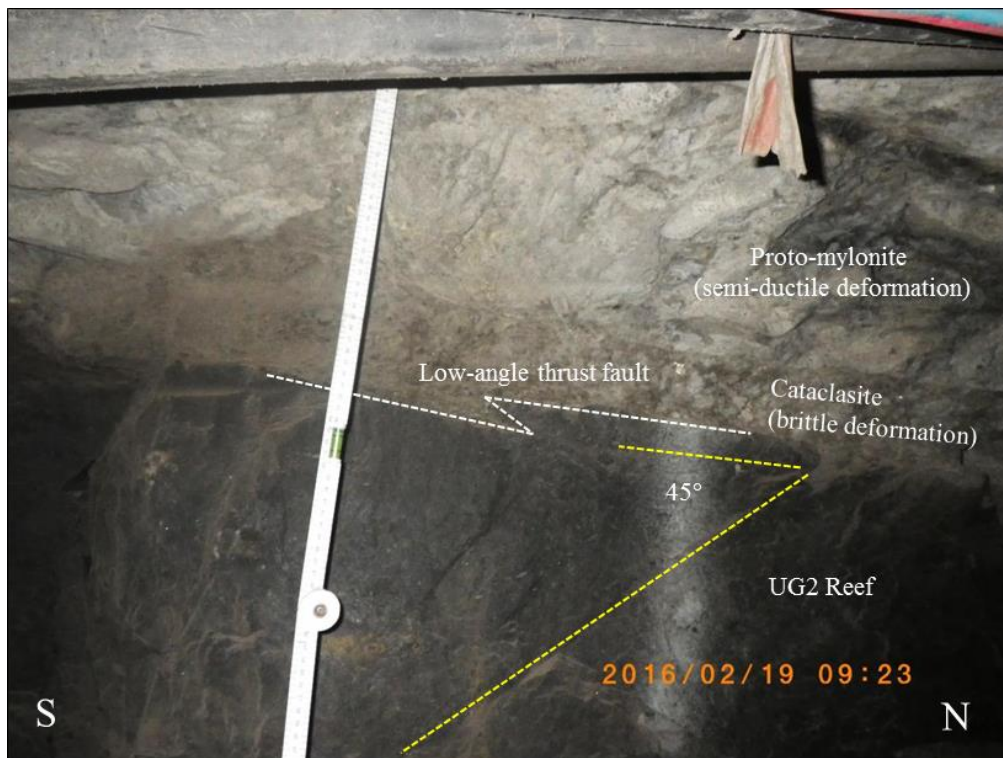
On-reef pillars often exhibit fracturing at an angle of 45° (Figure 4.25) to the layer-parallel shear zone developed along the UG2 top reef contact. Pillar failure in the form of slabbing usually occurs along this fracture system in the vicinity of the altered hangingwall 1B pyroxenite. This fracture system is interpreted preliminarily to be part of an extensional shear fracture system, which formed between the layer-parallel footwall 5/footwall 6 and the UG2 top reef contact shear zones. It is hypothesized that this occurred during a phase of post-Bushveld Complex extensional reactivation of late-Bushveld flexural-slip thrusts, referred to as alteration zones (Figure 4.25). As more ground water is introduced into the rock mass it will contribute towards deterioration in the ground conditions which will promote large-scale instabilities.

Figure 4.25: Late-Bushveld Complex layer-parallel flexural-slip thrusting towards the south (out of the Bushveld Complex at Lonmin) along the UG2 top reef contact.

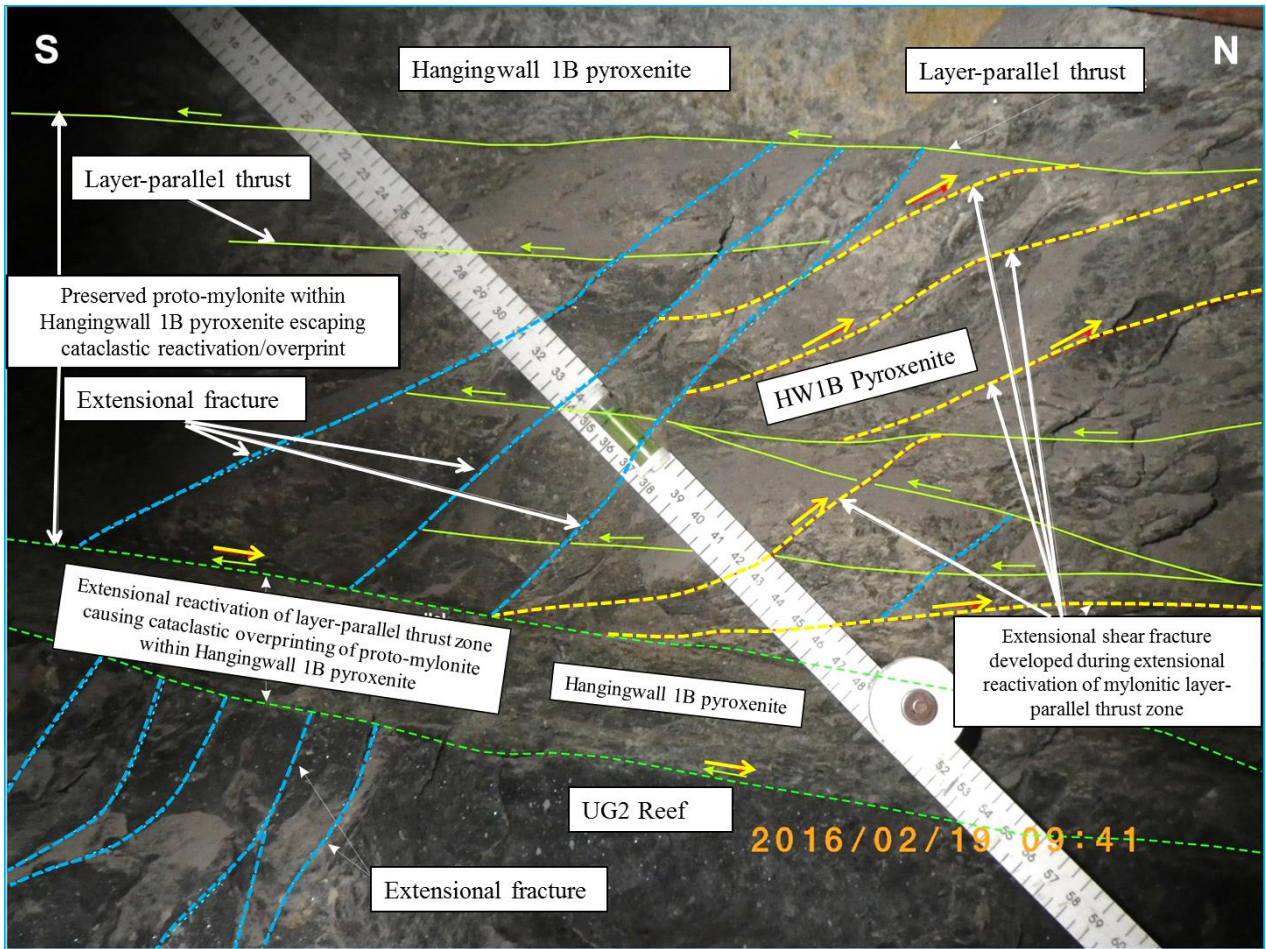
Although the descriptions discussed above appear complex, the associated behaviour can be identified from the structures exposed (Figure 4.26). The inflow and presence of water will impact on the degree of alteration along these deformation zones. It is hypothesized that the discontinuities (top reef contact, UG2A markers and hangingwall 1A/hangingwall 2 contact) are water bearing structures. The water is mobilized along the geologic structures when mining starts and this may possibly have a destabilizing effect. It has been noted during the site investigations that the alteration zones are dry in old mined out areas, as opposed to the current mining operations where it has a ‘clay-like’ nature (wet) that promotes unravelling and instability.

Figure 4.26: Alteration and ramp structures exposed in the hangingwall 1 B pyroxenite.

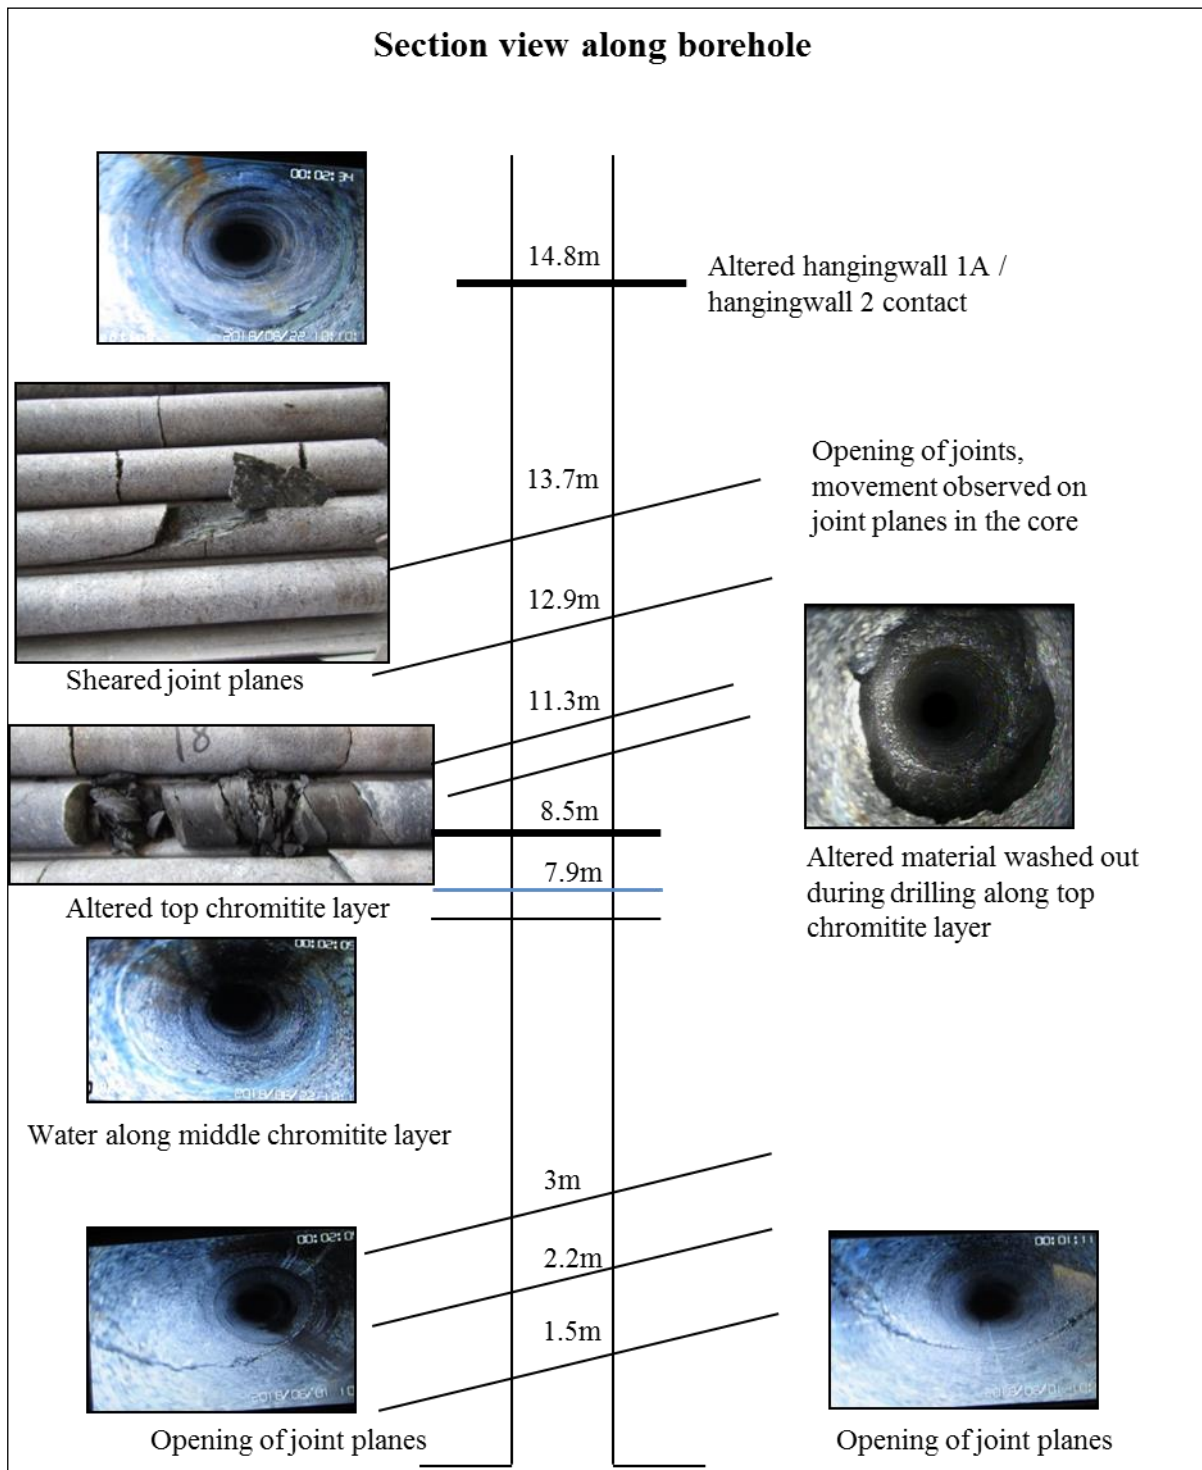
Figure 4.27 is a section view of a borehole that was drilled into the hangingwall, beyond the hangingwall 1A/hangingwall 2 contact in an area which experienced instability. From this borehole it is clear that multiple structures, including possible ramp structures, joints and alteration zones are present in the hangingwall. Separation is identified along some of these structures by means of a borehole camera. The storage of the ground water is predominantly along the UG2A markers and hangingwall 1A/hangingwall 2 contact as shown in Figure 4.27. The first phase of instability is anticipated to occur up to the UG2A markers which will be followed by subsequent instability up to the hangingwall 1A/hangingwall 2 contact. This information coincides with the sub-surface profile scan (Figure 4.24) that confirmed the occurrence of multiple geologic structures and how these combinations contribute to large-scale instabilities.

Figure 4.27: Section view of borehole log with images illustrating multiple geologic structures exposed in the hangingwall, in an area where large-scale hangingwall instability was experienced (Liebenberg and Du Plessis, 2018). All of the structures shown in the log experienced minor movement on the alteration.

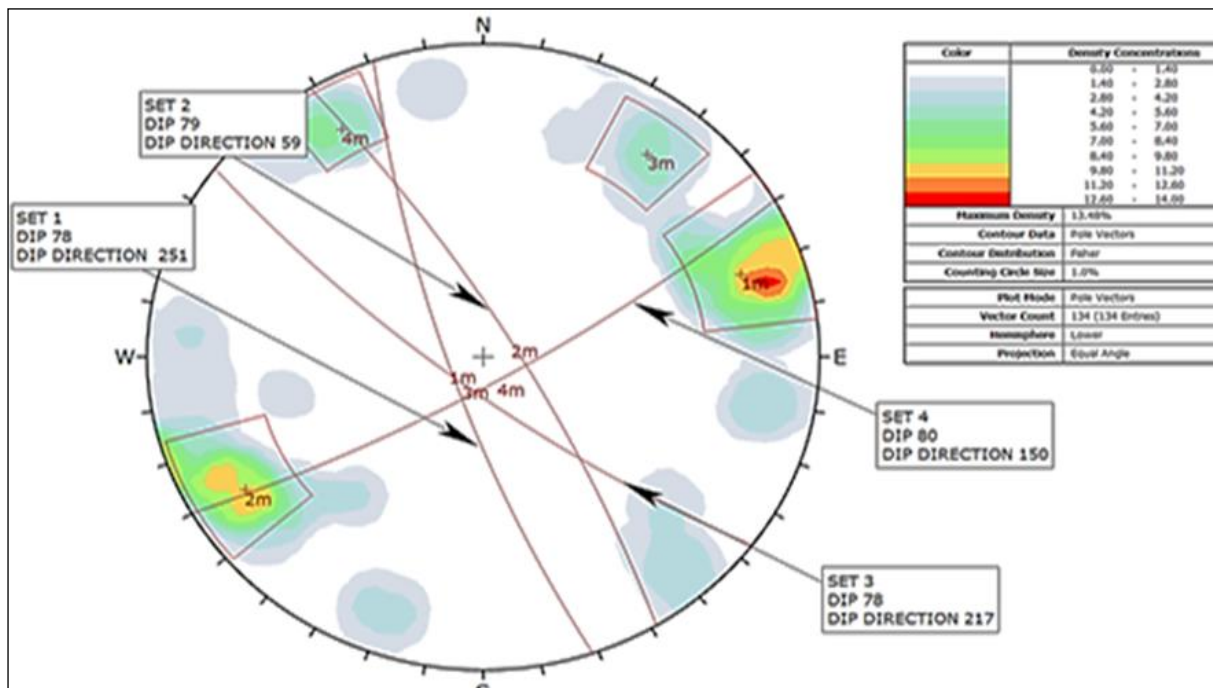
Figure 4.28: DIPS stereo net projection indicating the grouped joint sets. Predominant strike direction of the structures is NW-SE, which may promote ground water inflow.

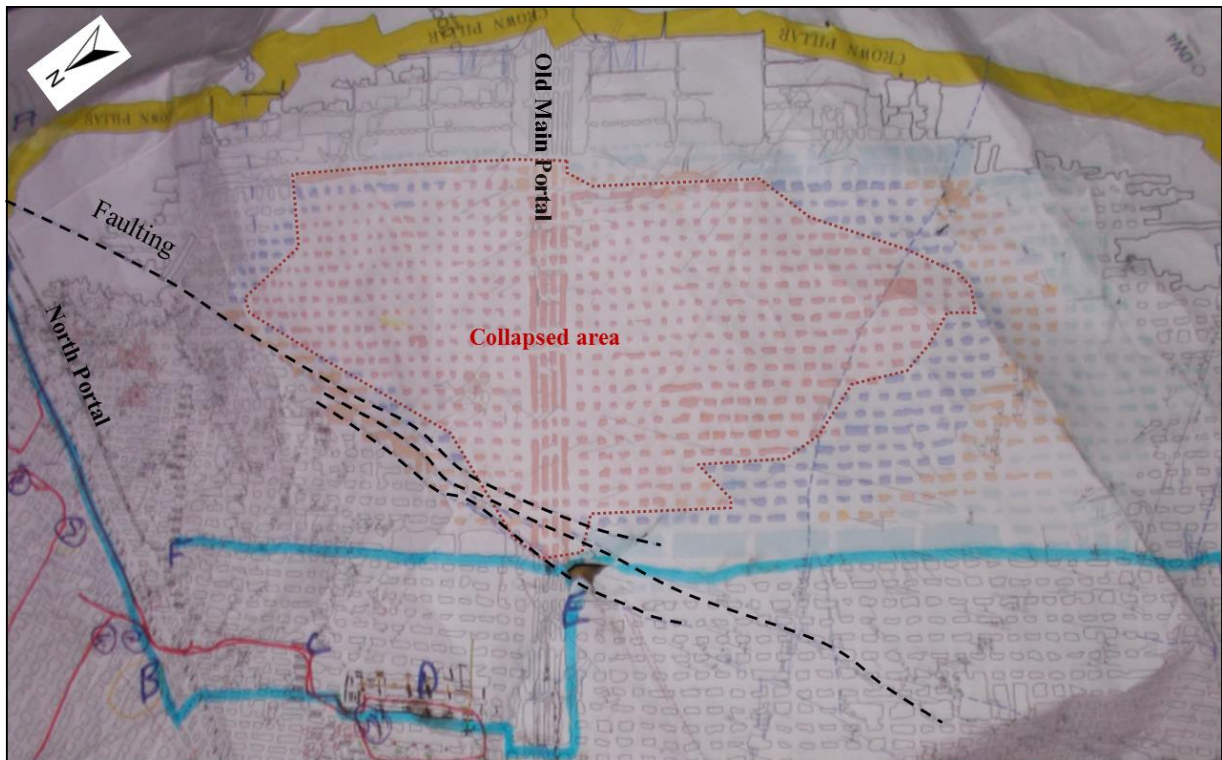
Similarly on Everest Mine (Figure 4.29), situated along the Eastern Limb of the Bushveld Complex, anomalous pillar behaviour was observed by the author as a result of a significant alteration zone present along the top of the pillars (Figure 4.30). The pillars deteriorated to such an extent that the mine stability was jeopardised. From the underground investigations, the failure of pillars was caused by the presence of the alteration zone and is not due to excessive stress.

Figure 4.29: Everest Mine where the red hatched area show the collapsed area.

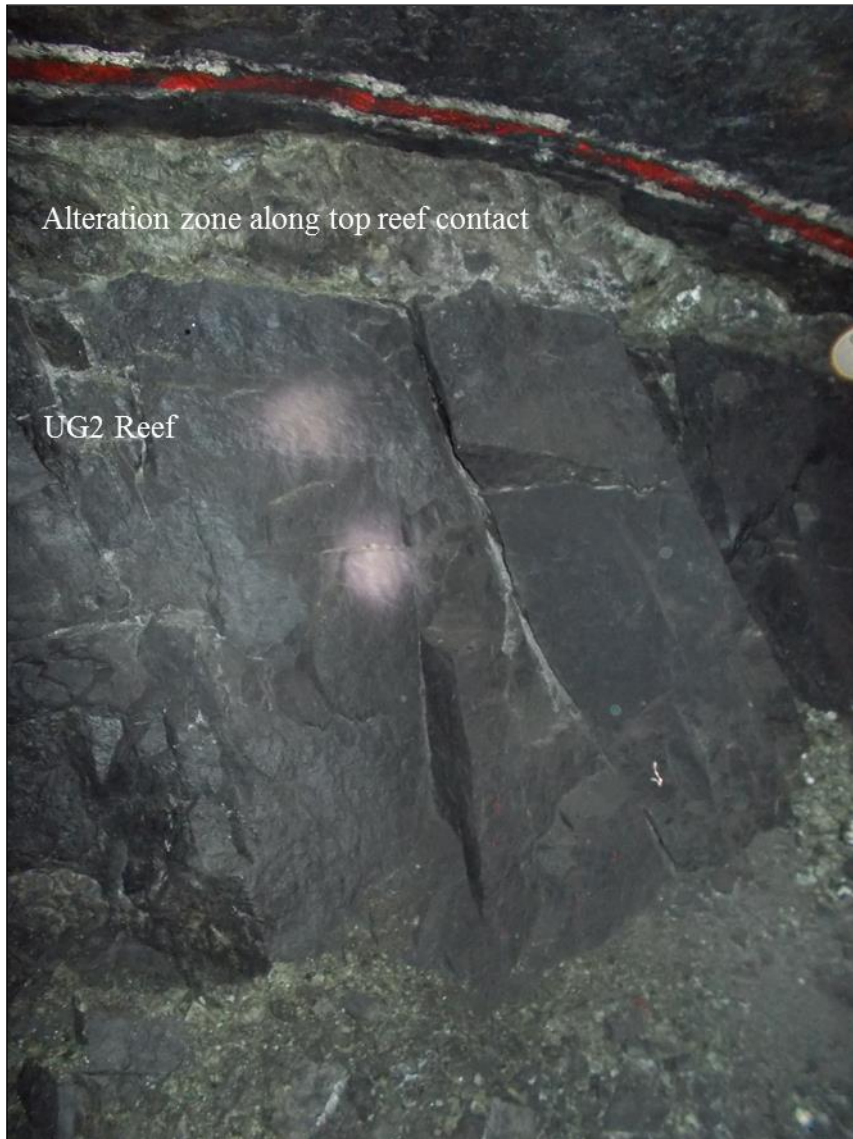
Figure 4.30: Alteration zone exposed along the top reef contact.

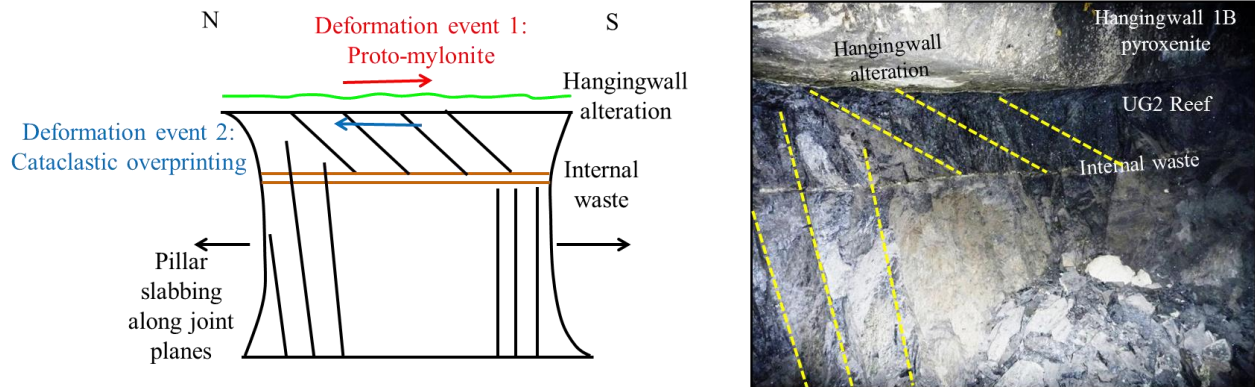
Figure 4.31 shows the modes of failure along the in-stope pillars where alteration is present. Mobilisation can be identified along the alteration zone, causing the joints to dilate. The slabs of rock defined by the joint planes are mobilised, resulting in the external pillar slabbing observed. As with the Bimha instability at the Great Dyke, tension cracks were visible on surface as a result of the pillar failure. It is therefore very important to understand this change in pillar behaviour where alteration zones are present to ensure that it is anticipated in the pillar and mine design. Further work is required to understand this pillar behaviour.

Figure 4.31: Pillar behaviour when an alteration zone and jointing is present.

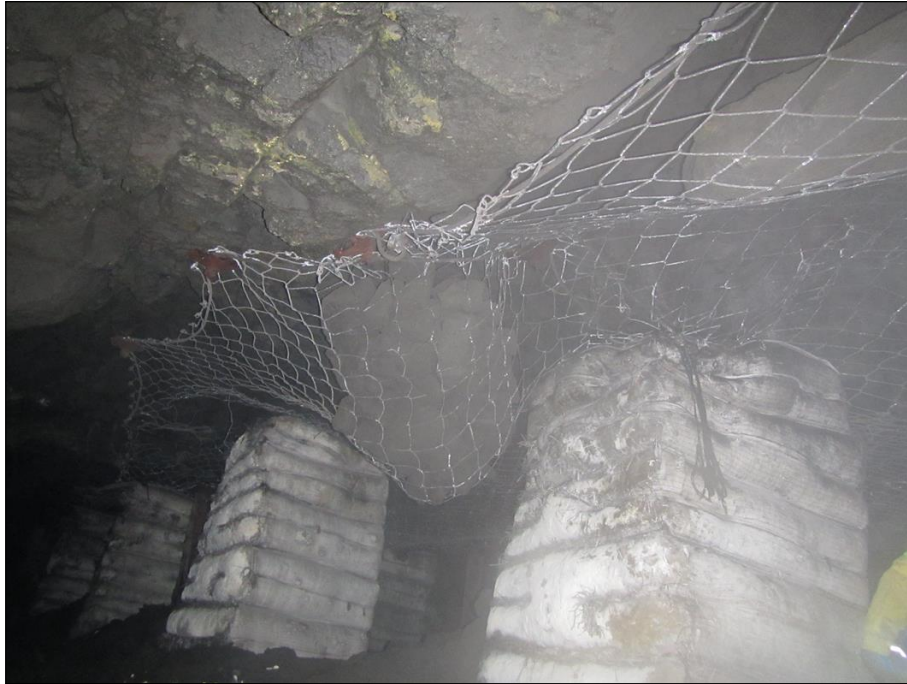
Figure 4.32: Permanent, blast resistant mesh to prevent the unravelling of the alteration zone.

Conditions	Remedial strategies proposed
Alteration zone is located at the top contact of the UG2 Reef.	<ul style="list-style-type: none"> • Apply permanent blast resistant mesh (Figure 4.32) in an attempt to contain the possible unravelling between support. • Use flexible mining cycles to ensure daily blasting is not required. This will allow time for support installation. • If the grade is too low (dilution), abandon the problematic areas. • Use ground penetrating radar technology (sub-surface profiler) to identify the structures. • Pinning and strapping of the pillars to prevent pillar slabbing. • Increase the factor of safety of the pillars to ensure that the unravelling pillars (slabbing phenomena) are accommodated. • Further work is required on the design of pillars where alteration zones are present.
Alteration zone is located in the hangingwall or footwall units of the UG2 Reef.	<ul style="list-style-type: none"> • Implement stiff, active rock bolt support to reinforce the hangingwall up to the UG2A markers. • Implement the stiff, active (new generation) modular grout pack to prevent separation in the hangingwall. • Limit the mining spans to 27 m.

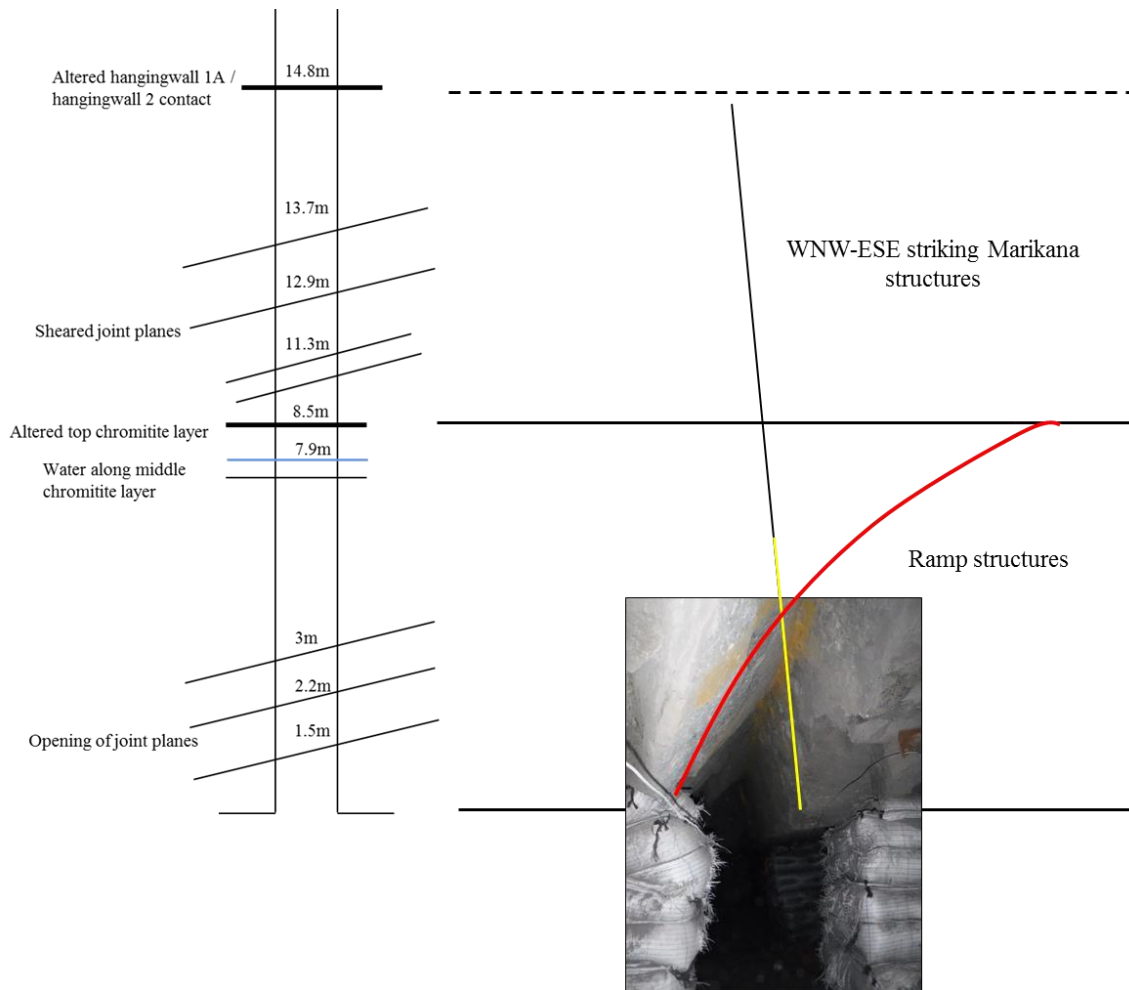
Figure 5.1: Structural interpretation of a borehole drilled into the hangingwall units. Alteration zones could be identified at the UG2A markers and the hangingwall 1A/hangingwall 2 contacts. The ramp structures were identified with separation along some of the structures, causing instability of the hangingwall. The exposure of the ramp structures, Marikana structures and alteration zones may cause large-scale collapses.

The remedial strategies in affected areas where the alteration zone is located in the hangingwall include mining with either new generation, high strength active cementitious grout packs only, or integrating these packs with alternating lines of timber elongates. In the case where the alteration zone is located along the top reef contact, mine with permanent blast resistant mesh in an attempt to contain the potential unravelling between support. Flexible mining cycles should be considered that daily blasting is not required. This will allow time for support installation. However, if the grade is too low as a result of the added dilution, abandon the problematic areas. If the alteration zone is located in the footwall, the potential exist that the support units will fail prematurely. The support resistance could be impacted, resulting in falls of ground. Alternative support systems should be considered where instability is anticipated. The installation of 'fit for purpose' monitoring devices is recommended to provide early warning of potential related instabilities.
