Marina el-Alamein. Polish-Egyptian Restoration Mission: Conservation work in 2008

Author(s): Stanisław Medeksza and Rafał Czerner with Grażyna Bąkowska, Wiesław Grzegorek, Renata Kucharczyk, Joanna Lis and Piotr Zambrzycki

Source: *PAM 20 (Research 2008)*, 103-128

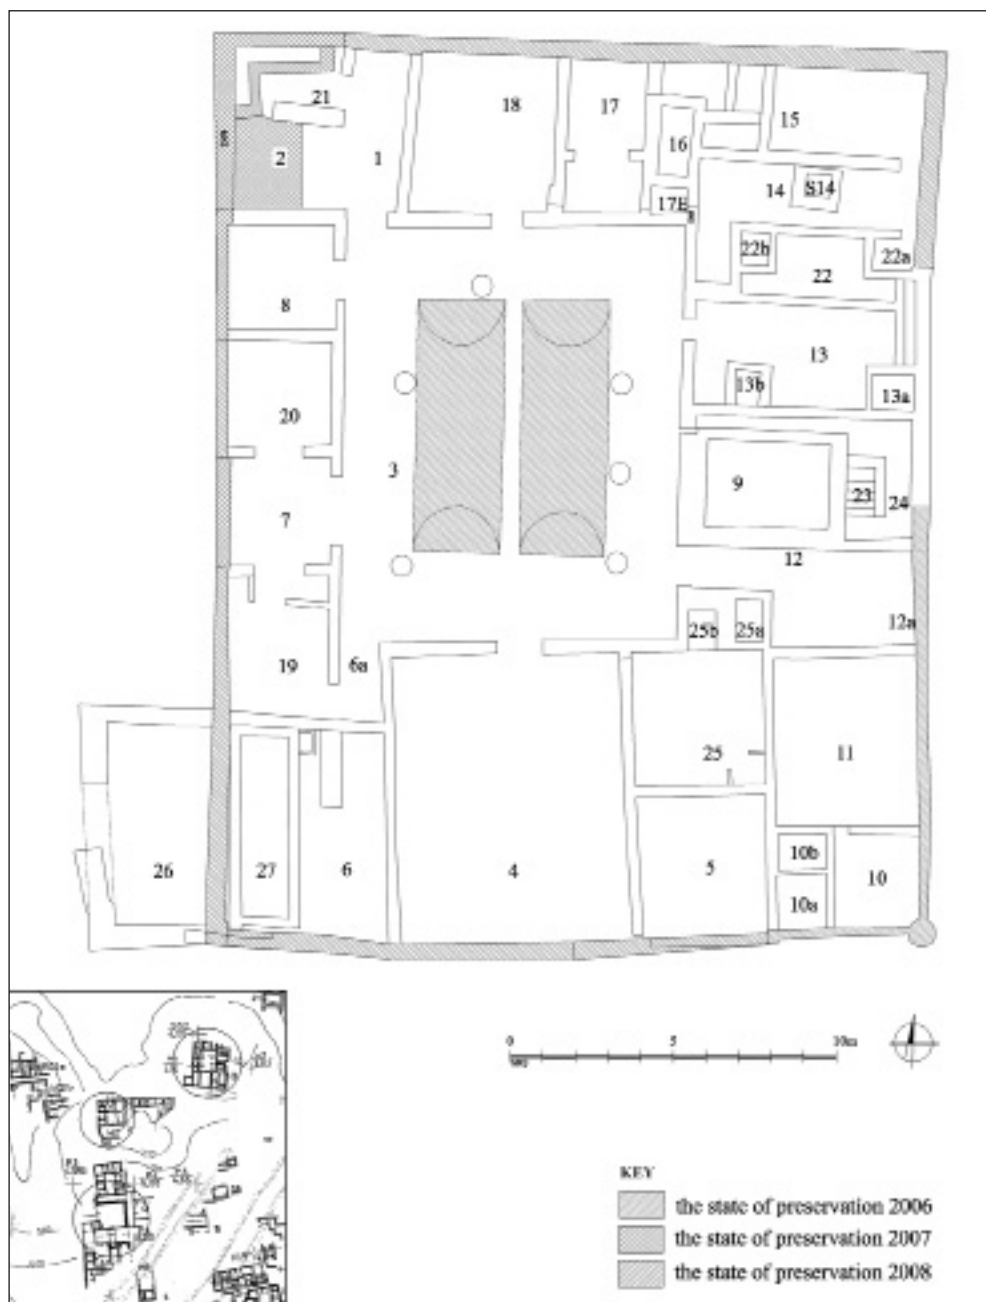
The southwestern part of the enclosure wall, encompassing the south and west walls of Room 27, which are at the same time the outer walls of the house [*Fig. 1*], continued to be reconstructed, building up now on the foundations and lower courses laid already in 2006 and 2007 — three courses in the south and five in the west (using blocks 0.30 m wide). By the same, the corner of the house has finally been raised high enough to become visible in the surrounding area [*Fig. 2*].

Fig. 1. Plan of house H1 showing stages of preservation works; inset, localization of the house on the town plan (Drawing M. Krawczyk-Szczerbińska; updated plan PCMA archives)

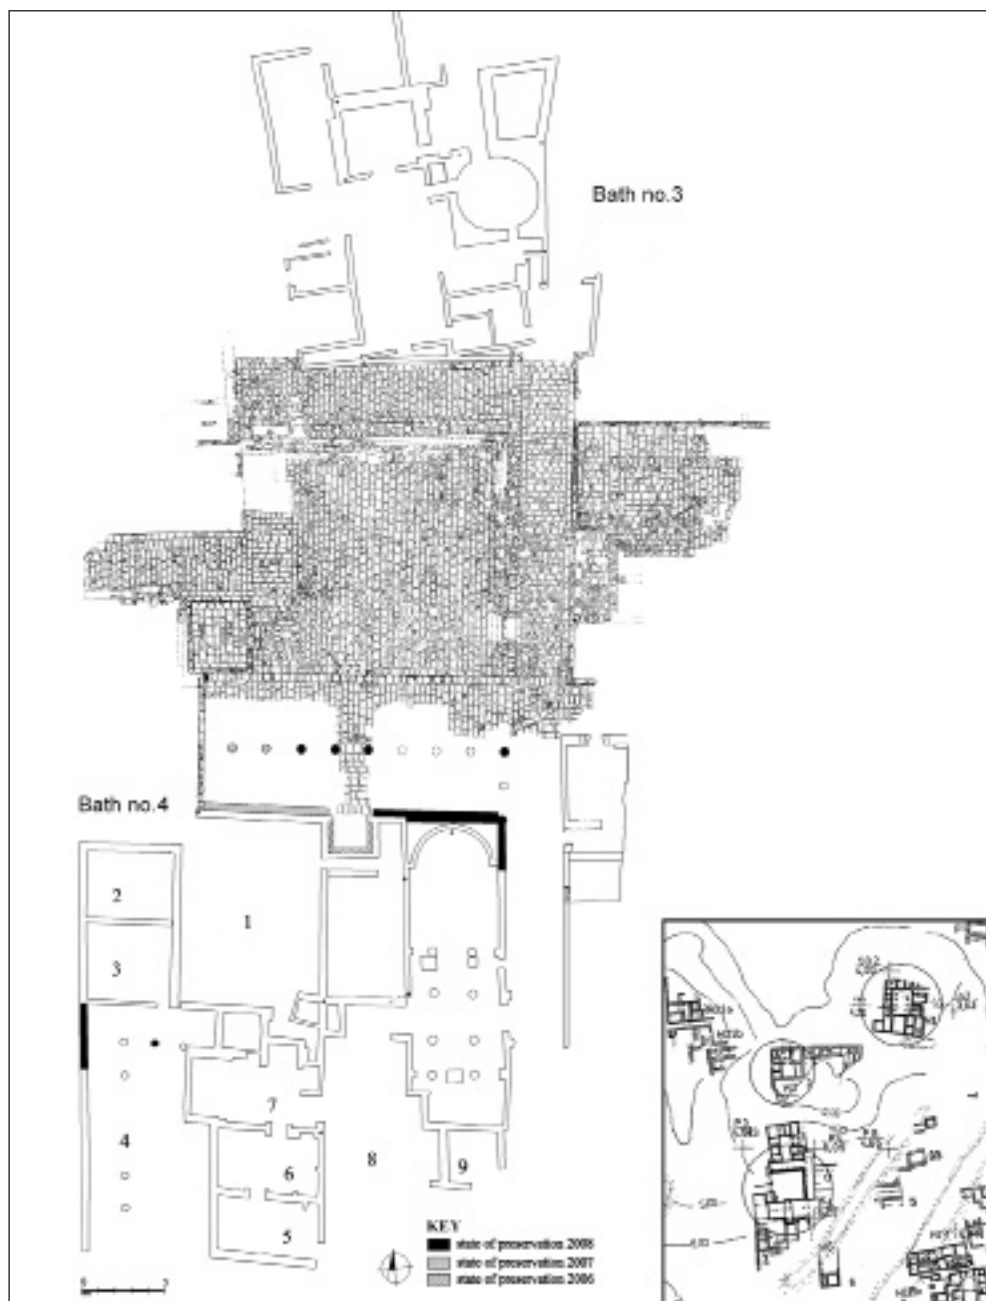
The architecture of the southern portico of the main town square (forum) started being conserved in 2006 and was continued on a broader scale in 2007 [Fig. 5].² The work included the stone benches, beginning with the section in the portico exedra in the center of the south wall and encompassing the part by the south wall to the west of this exedra. Three columns of the southern row of the portico, located at the extreme west, were raised, two to full height and the third to mid-height. The engaged column at the extreme west end of the northern row of columns in the portico facade was also reconstructed in its lower part (Medeksza 2010: 88–91, Fig. 7).

Fig. 5. Plan of the main town square and bath complexes: no. 3 to the north and no. 4 to the south (Plan M. Krawczyk-Szczerbińska, after J. Dobrowolski, A. Błaszczuk, updated, PCMA archives)

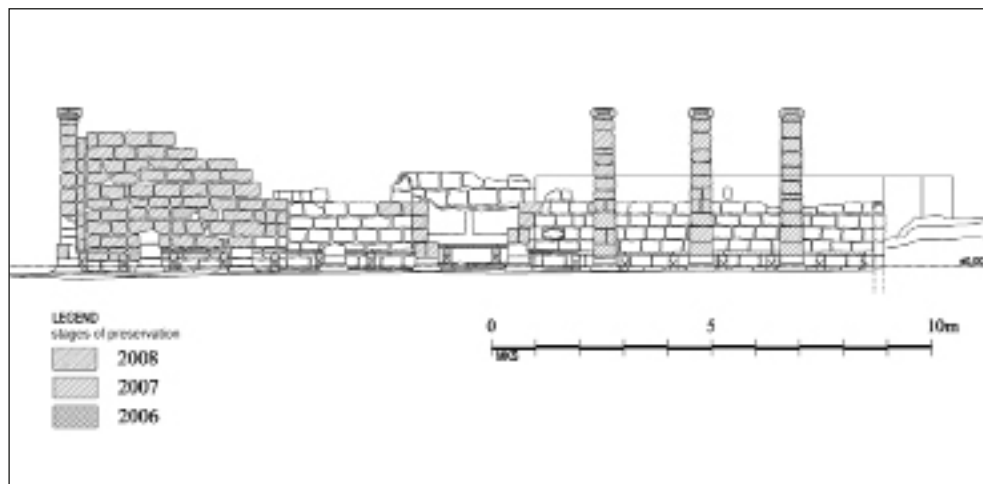
Fig. 9. *Anastylosis of the columns and back wall in the south portico of the main town square*
(Drawing M. Krawczyk-Szczerbińska)

in the pseudo-Ionian order common in the Marina el-Alamein region [Figs 9, 10]. Column height, according to a study by the discoverer Wiktor A. Daszewski, was about 3.60 m (Daszewski 2005: 86; 2007: 88–90), composed as a rule of a base, eight to nine drums from 0.28 m to 0.35 m high, and a capital in a style resembling the Ionian order. A soft limestone was used for these pieces of the architectural order. The bottom drums were usually made up of two half-drums joined vertically. The bottom drums were 0.50 m in diameter, the upper ones 0.43 m. The columns were all coated with lime mortar render and plaster with relief fluting.

ancient procedure for the lower parts of column shafts. Usually only one half of the lowermost drums needed replacement. The bases were all original, preserved in good condition and requiring only consolidation and strengthening of the substructure. Four drums (about a third of the height, that is, 1.51 m) of the easternmost column in the middle row were thus put together to await anastylosis, as were two drums (0.78 m in height) of the easternmost column in the northern front row (fifth counting from the corner).
