## Understanding the “Blue Spot”

### *Sodium Chloride Hot Salt Stress-Corrosion Cracking in Titanium-6246 during fatigue testing at low pressure*

EA Saunders<sup>1</sup>, TP Chapman<sup>2</sup>, ARM Walker<sup>3</sup>, TC Lindley<sup>2</sup>, RJ Chater<sup>2</sup>, VA Vorontsov<sup>2</sup>, D Rugg<sup>3</sup>, D Dye<sup>2</sup>

<sup>1</sup>Rolls-Royce plc., Materials – Failure Investigation, Bristol, BS34 7QE, UK

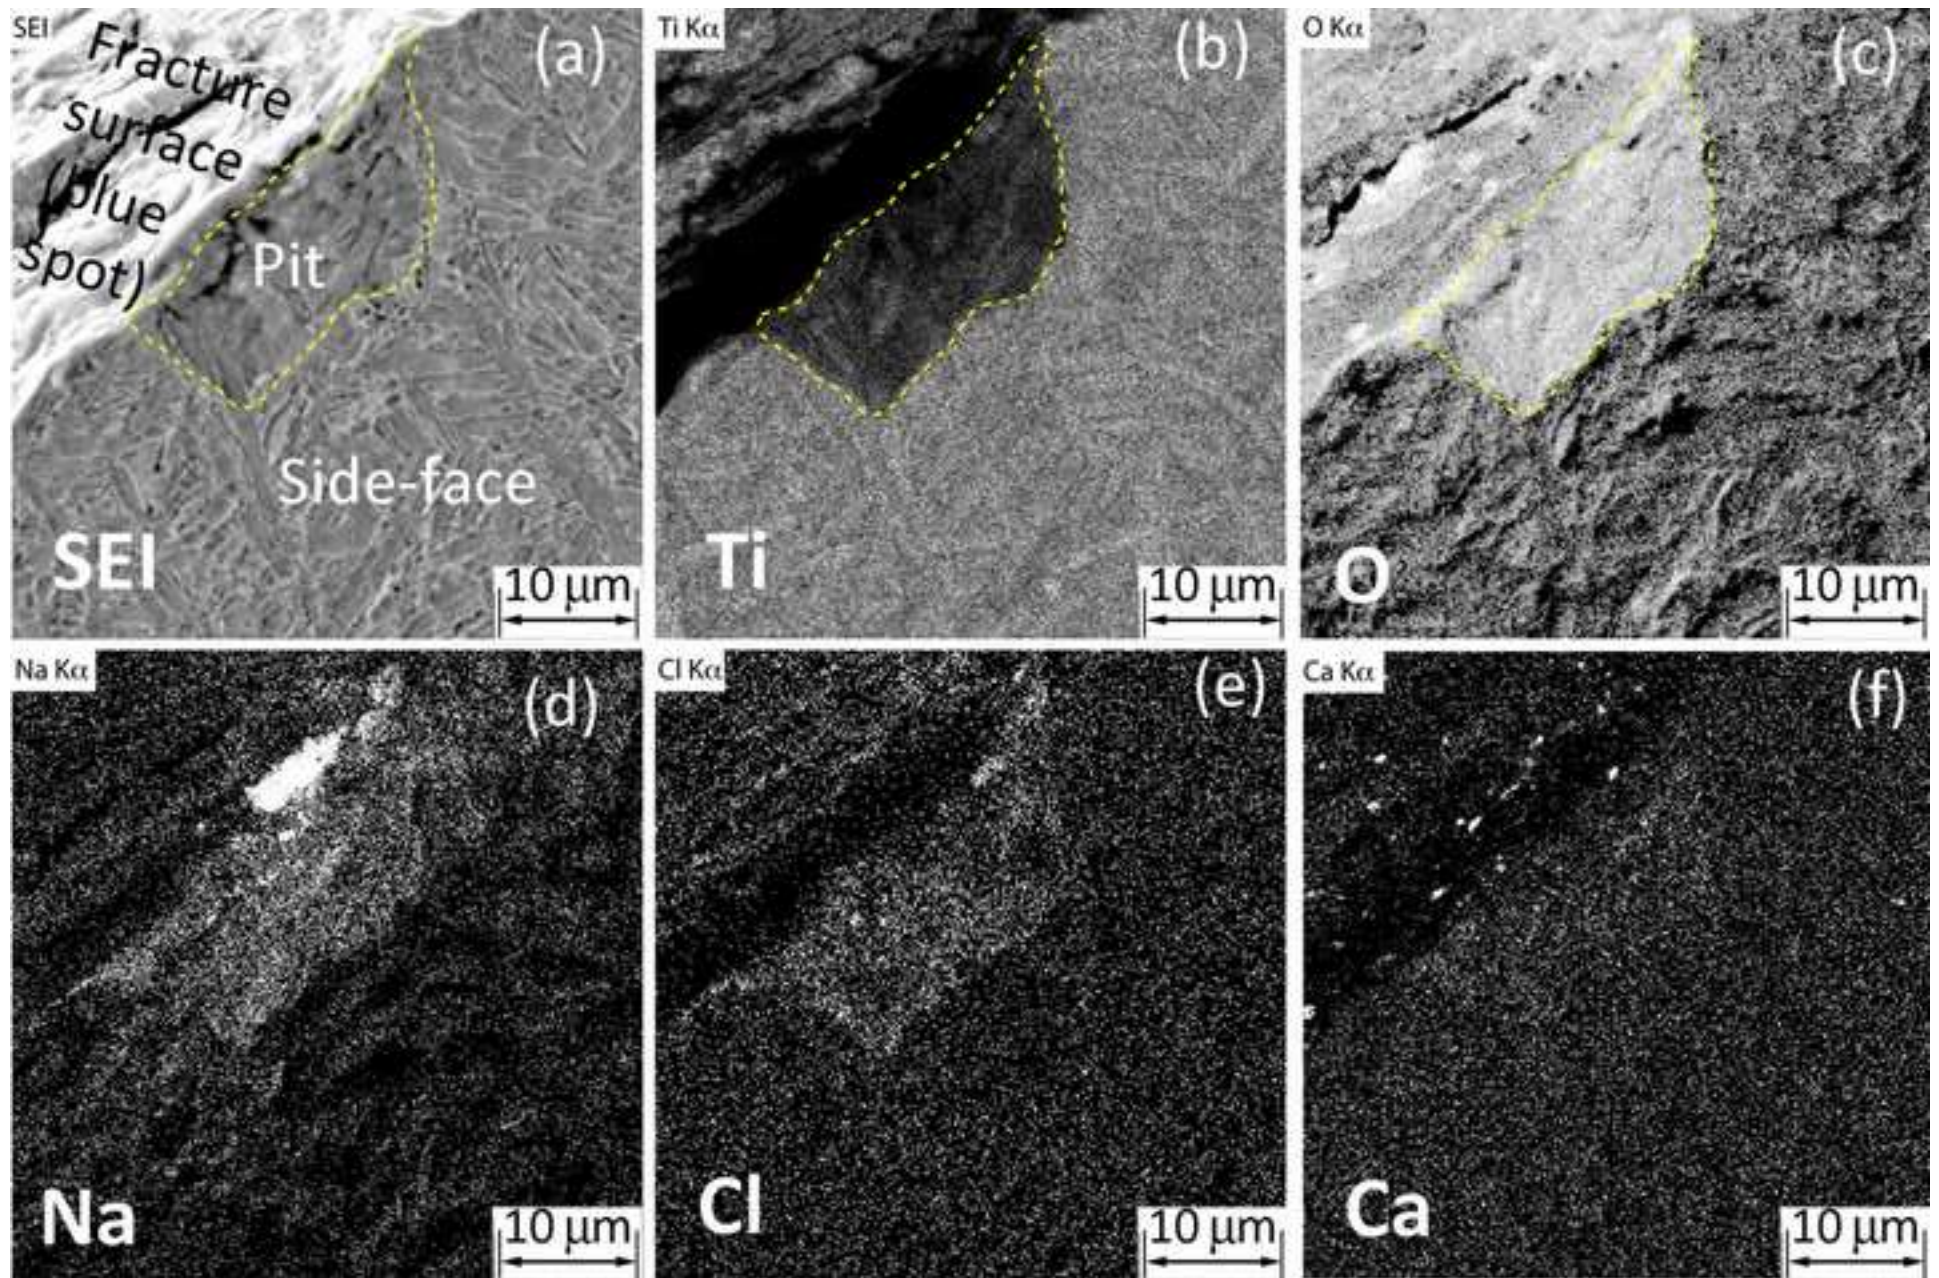
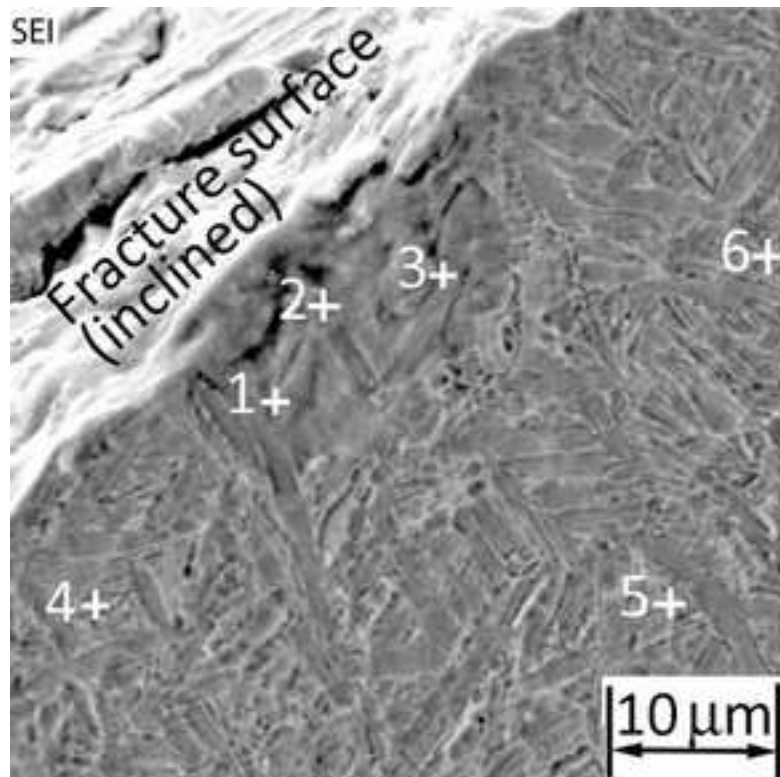
Figure 11 including table 2

**Figure 11 and Table 2** - Semi-quantitative EDX spot analyses within and outside the ST1 pit. Enrichment of O and depletion of Ti with low levels of sodium and chlorine confirmed (with some Na outside the pit at a lower level).

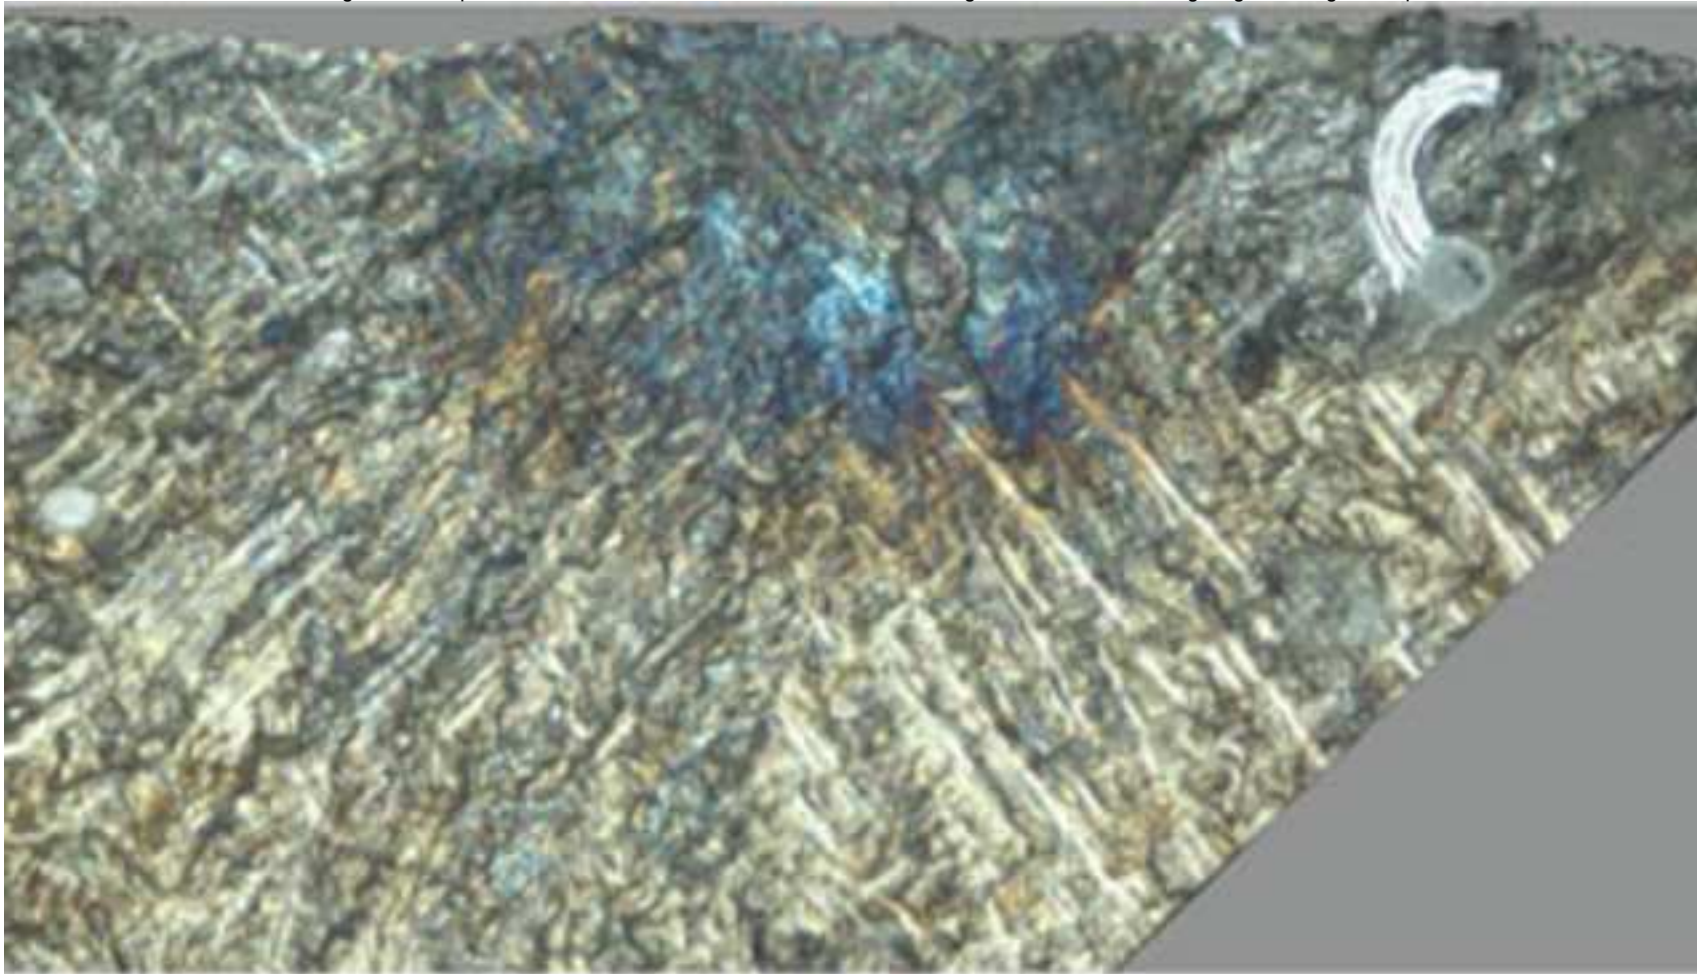
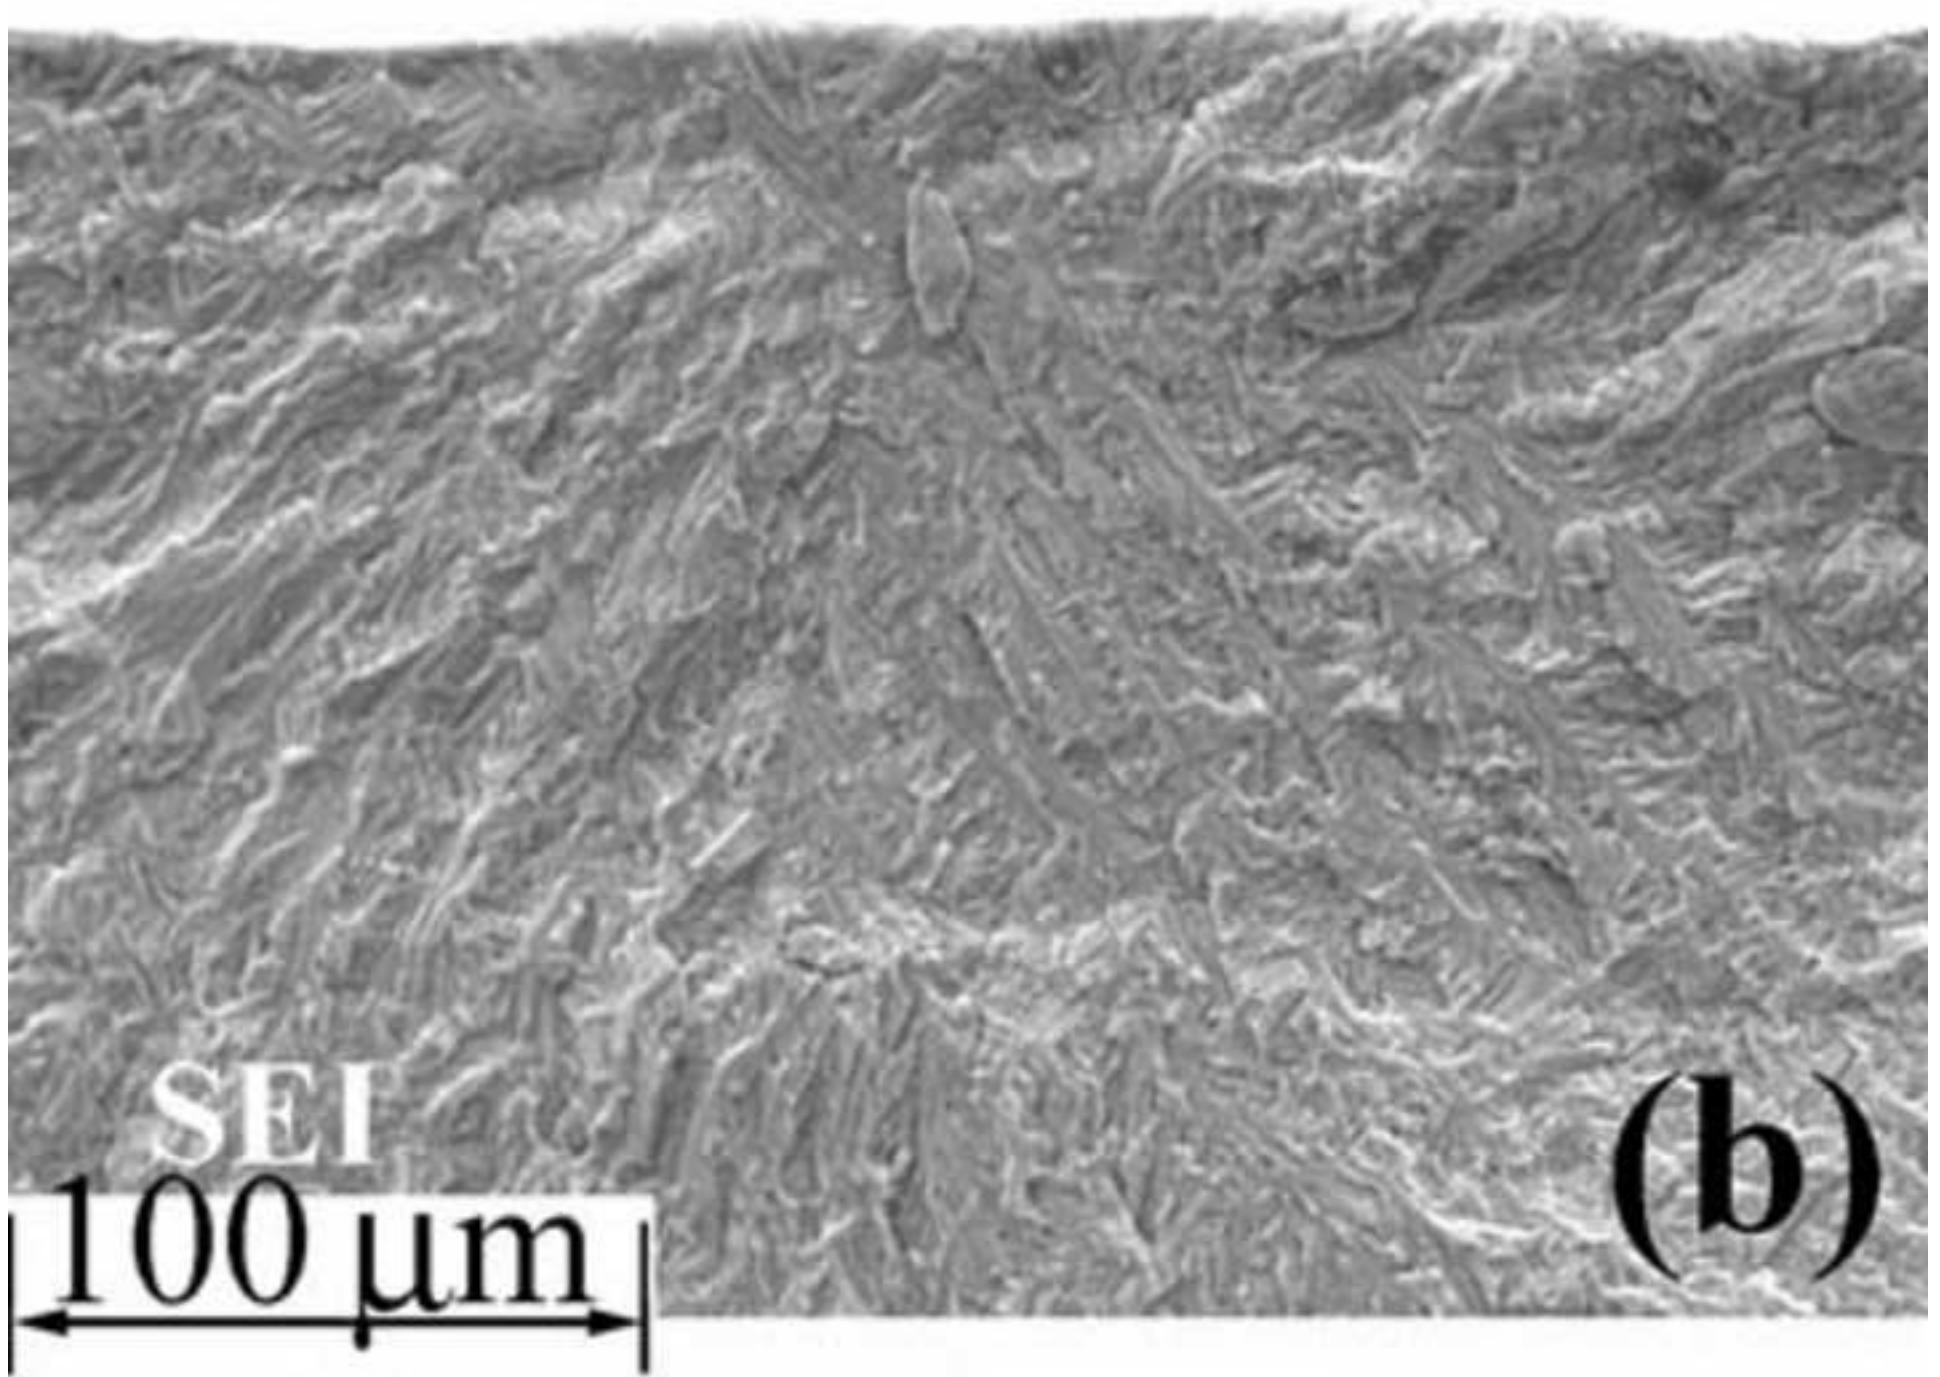
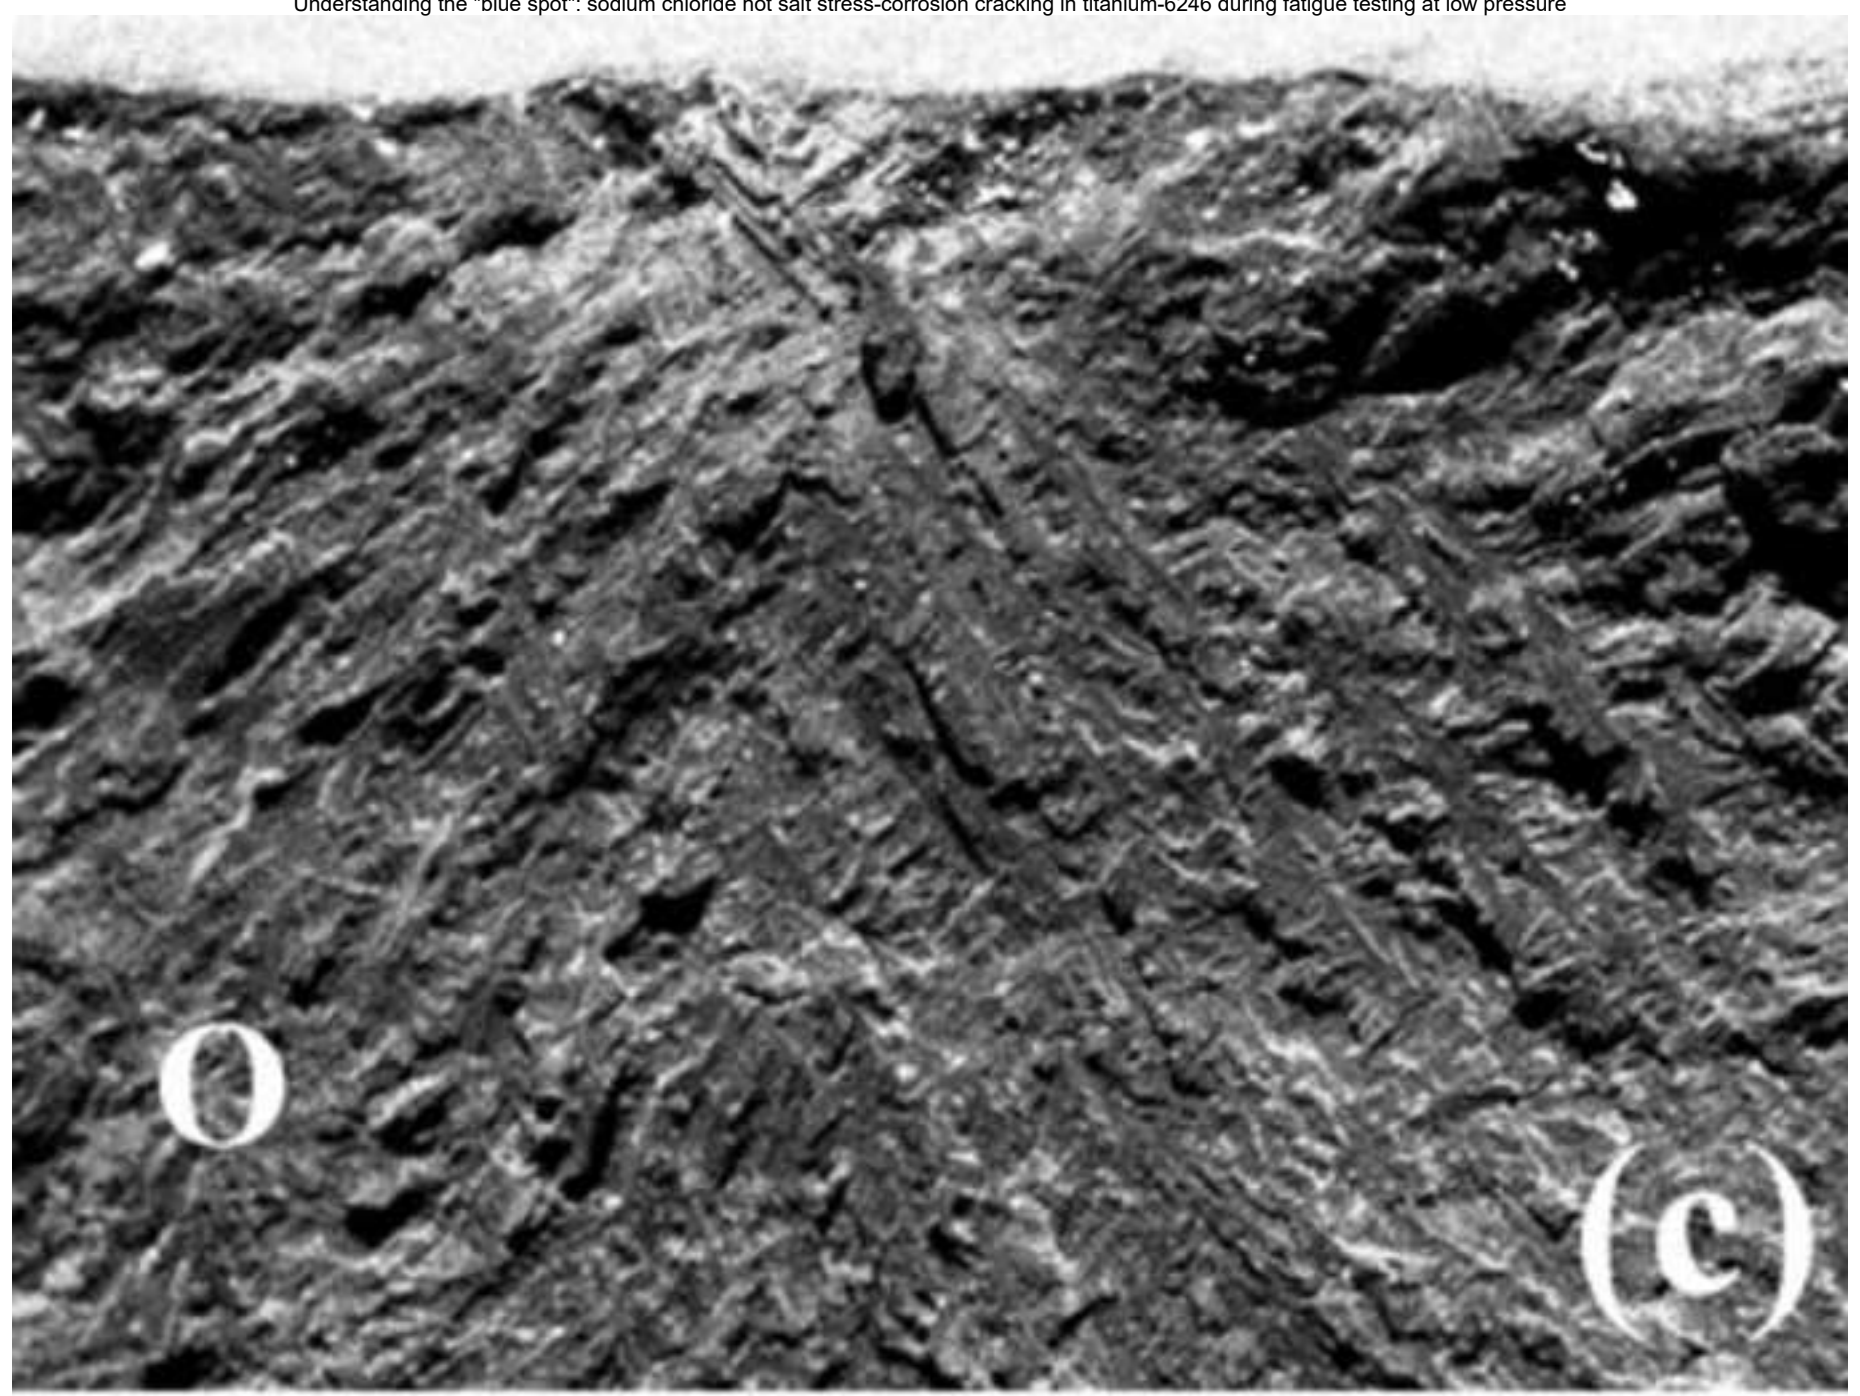
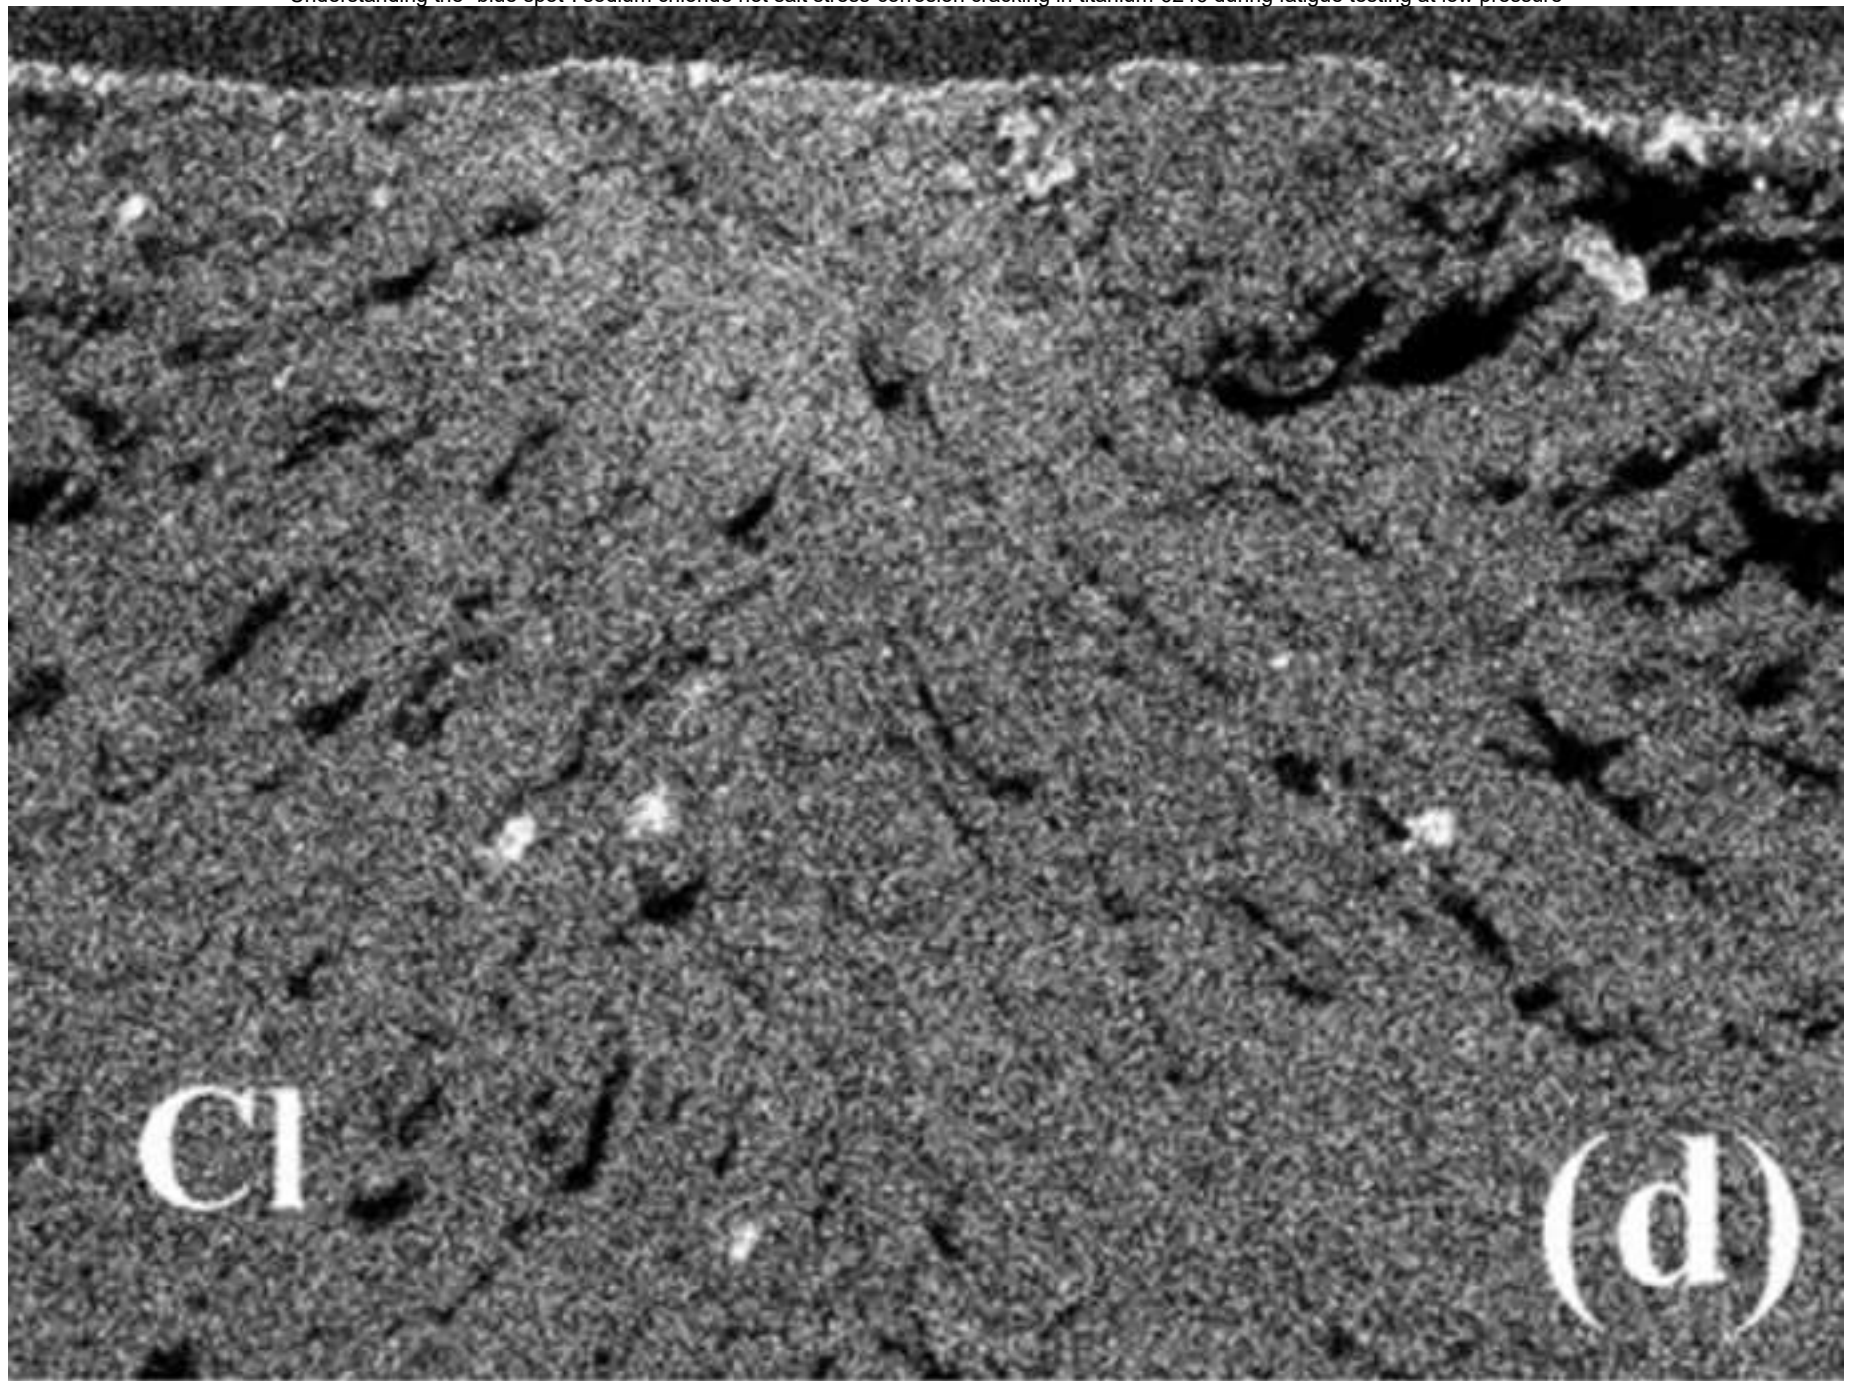
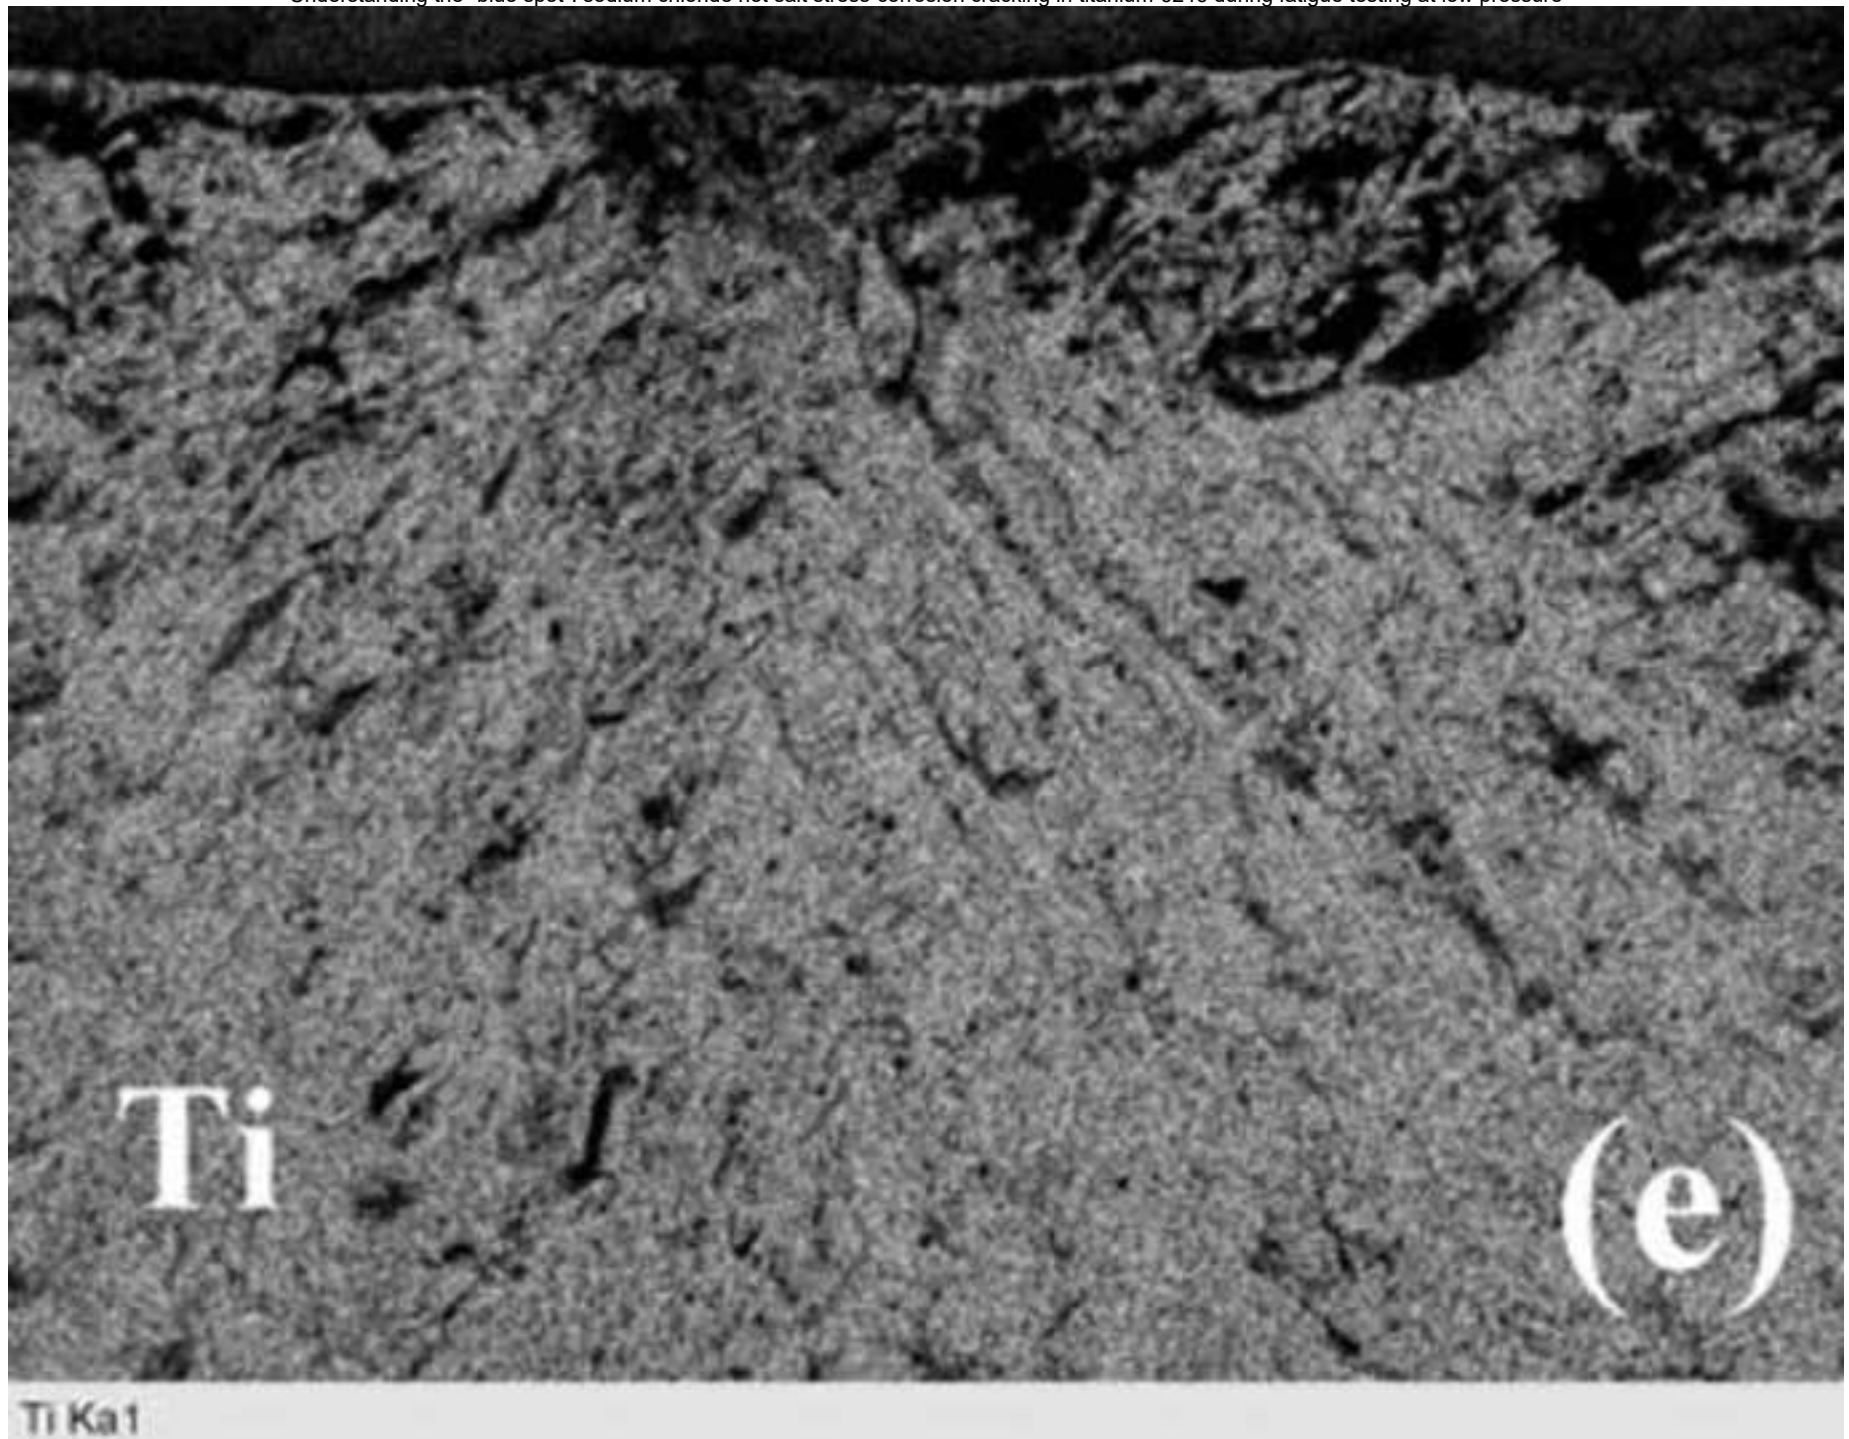
Figure 12a

**Figure 12** - (a) and (b) Blue spot fractographs compared against low potential long term duration SEM-EDX dot maps for ST2: (c) Ti K $\alpha$ , (d) O K $\alpha$  and (e) Cl K $\alpha$ . Although faint, the oxygen „marks out“ the blue spot shape, with tentative Cl visual evidence.

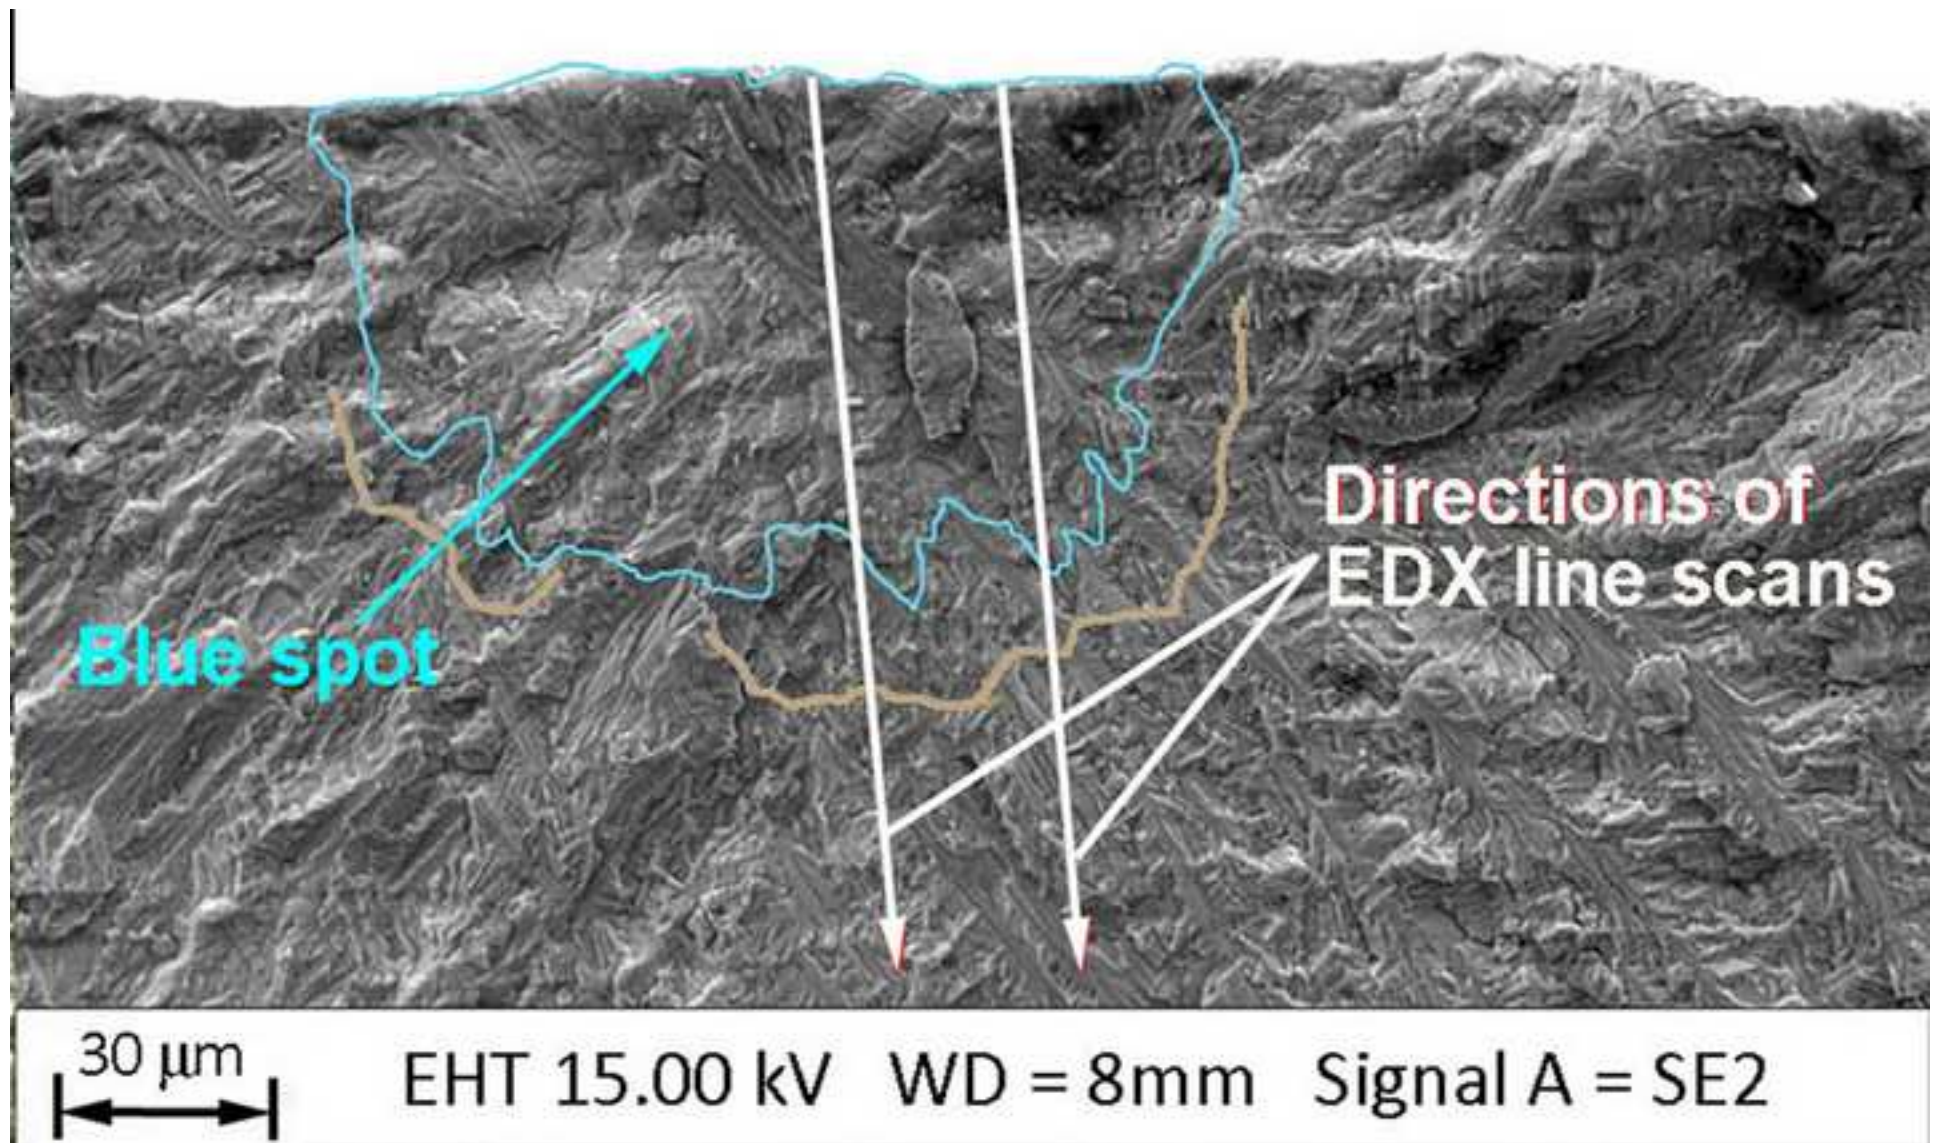
Figure 13

**Figure 13** - Depiction of the semi-quantitative EDX line scan directions across the specimen ST2 „blue spot“. The blue line depicts the optically blue periphery, and the brown line the periphery of a surrounding narrow dark straw-coloured band. Compare with optical image; figure 7b.
